Pedestrian Bridge Task Force
Report to the Selectboard
January 21, 2021

SUSPENSION BRIDGE EVALUATION HARDWICK, VT

Re: Preliminary Engineering assessment
Pedestrian Suspension Bridge- Hardwick, VT EV # 20470

Reference: Hardwick Suspension Bridge General Conditions Assessment
46 Vermont Route 15, Hardwick Vermont

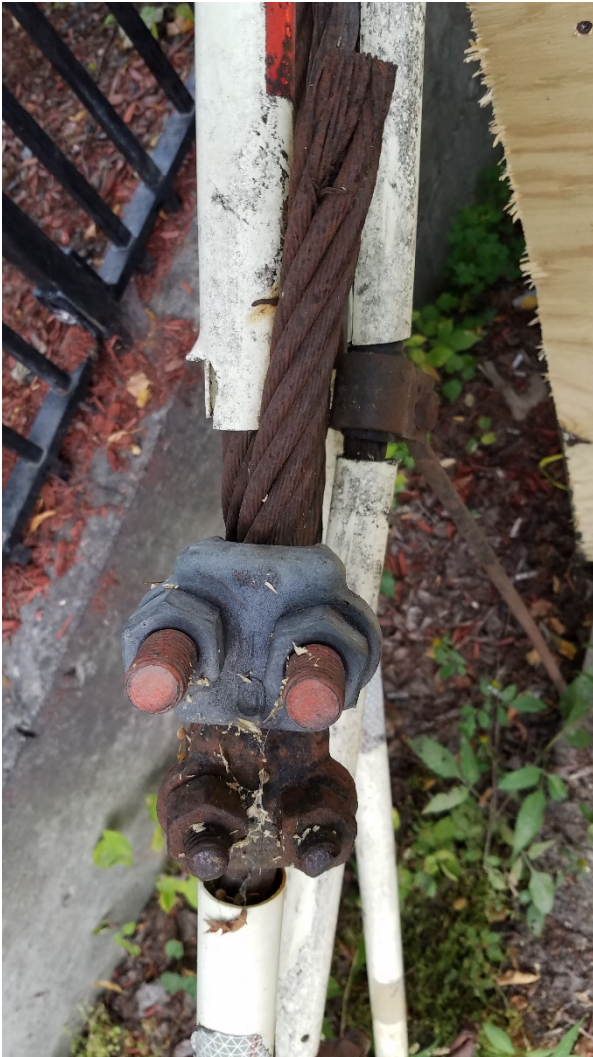
- Bridge main cable anchorage is inadequate
 - The 1” main bridge cable is anchored with 2 Crosby clamps at each end and the clamps are installed backwards (See photograph #1). The required number of clamps for a 1” cable is 5 per end.
 - Several of the wire rope clamps that anchor the bridge are severely decayed (See photograph #2).
 - The original wire rope is brittle.
 - The end connection plates are severely rusted.
 - The additional wire ropes that have been installed are not effectively reinforcing the main cable.
- Some drop cables have slipped on the main cable and no longer support the deck beams resulting in significantly increased floor deck joist spans (see photograph #3).
- The main beams that support the deck are showing significant signs of rust (see photograph #4).
- The rail system does not meet the code guard rail requirements.

Photograph #1 – Cable clamp on backwards and less than recommended quantity

Based upon my visual inspection and subsequent calculations, it is my opinion that the bridge should be closed to public access until repairs can be made. Furthermore, initial evaluation indicates that repairs are likely to be extensive given the decay discovered throughout the bridge structure. In fact, it is likely that replacement of the bridge will be less expensive than repair of the extensive decay, however, given the historic nature of the bridge restoration may be the preferred solution.

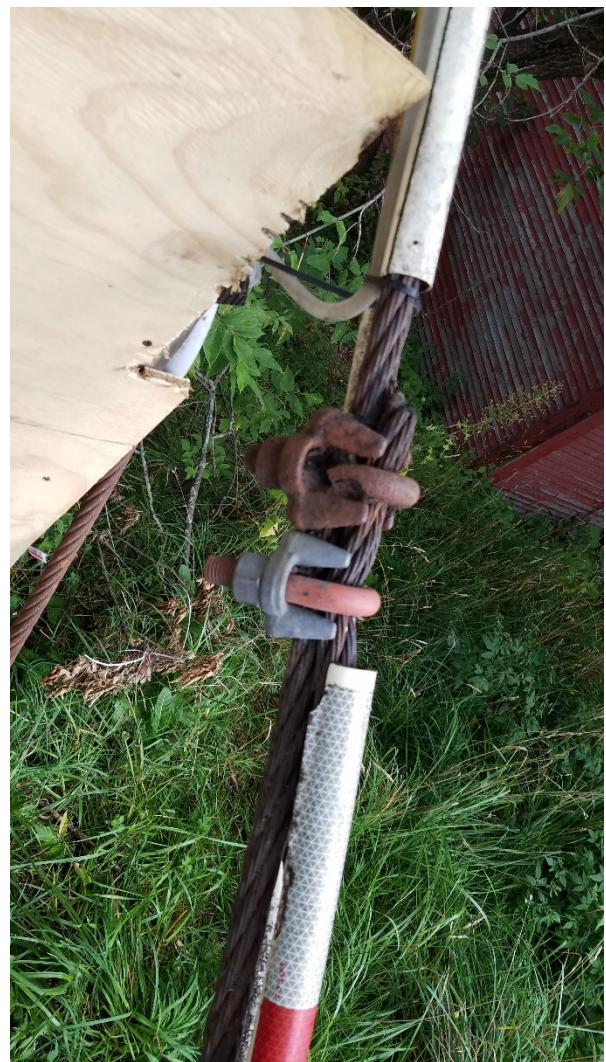
Photograph #2 – Cable clamp decay

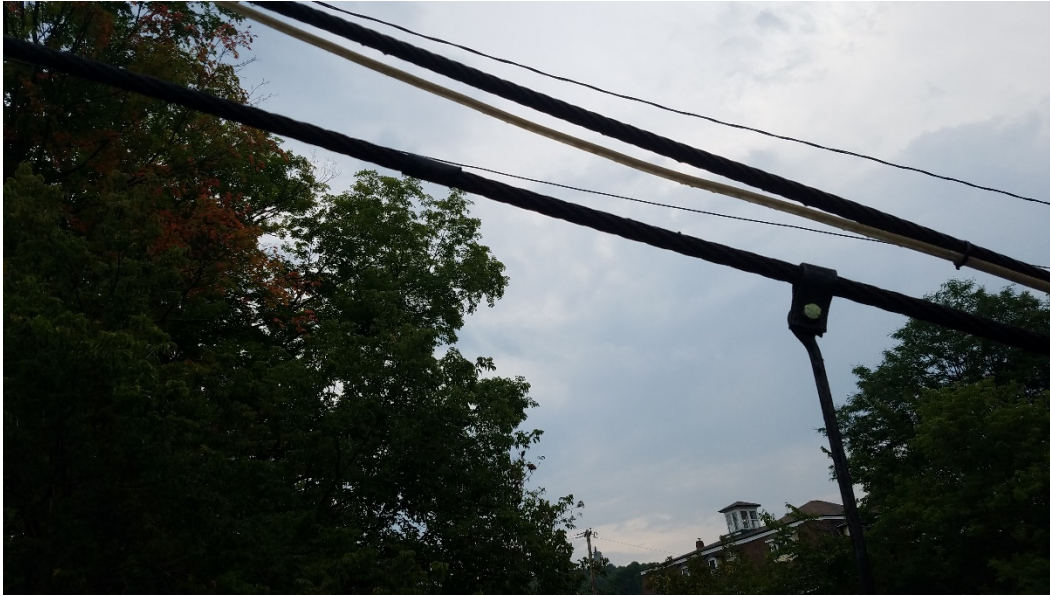
Photograph #3 – Drop cable slip

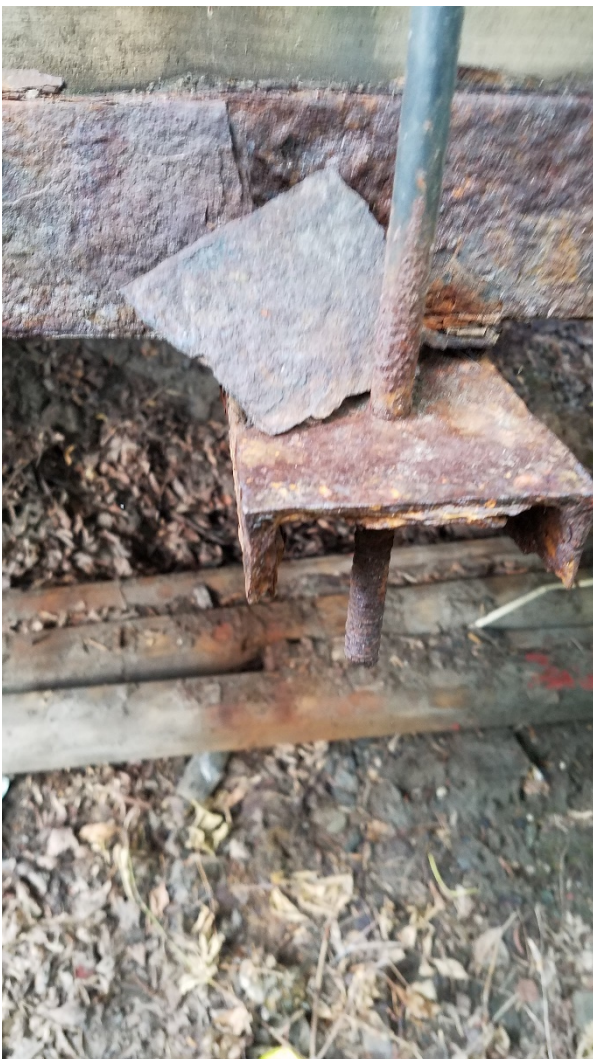
Photograph #4 – Deck Beam decay
