AARP Community Walk Audit location:

West Church Street, Hardwick

Date: 9/21/21 Started at 11:00 am and completed at Noon

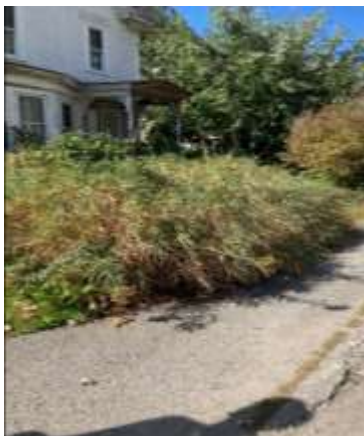
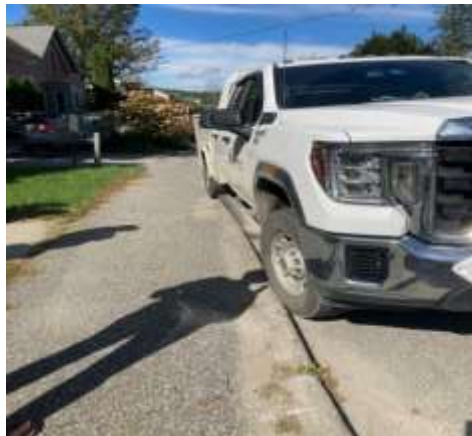
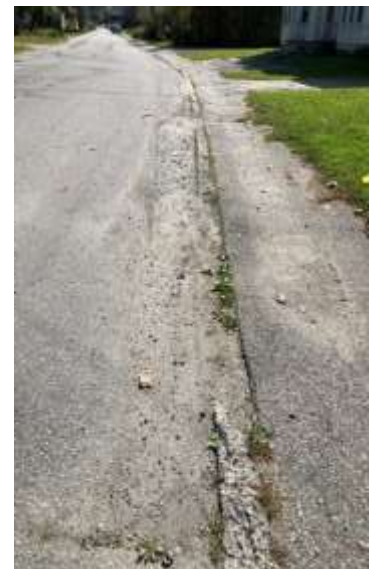
- 1) The sidewalk has curbs but often the curb is crumbling and/or does not match the elevation of the sidewalk (usually too low). The north side does not have a sidewalk and, therefore, does not have a curb to separate pedestrians from the road.
- 2) The sidewalk has multiple obstacles. The sidewalk is cracked, broken and storm drains are either within the actual sidewalk or have aspects which make travel difficult. Multiple cars and trucks park on the sidewalk (reducing the width available). The sidewalk is overgrown with vegetation both in the pedestrian travel lane and next to the sidewalk from the abutting properties.

The location could be improved by trash bins near the Library, sidewalk repairs, and enforcement of speed limits. A thorough examination of possible approaches to safety should occur. Possible improvements could include changing the street to a one-way street, installing traffic calming speed “humps,” and reviewing the parking situation.

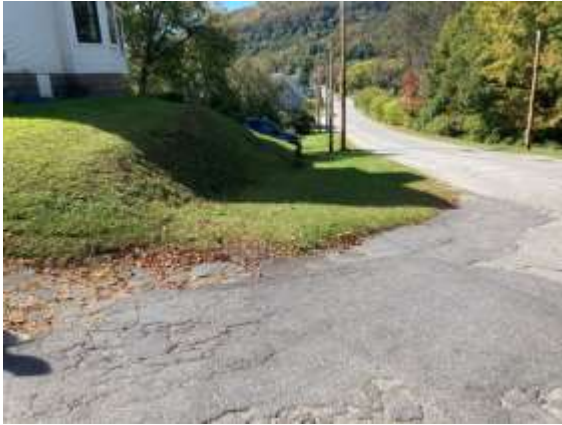
- 3) The sidewalk is continuous – no segments are missing. However, the sidewalk has a variety of angles and elevations which make walking difficult and virtually impossible to be utilized by a wheelchair or other form of mobility assistance.

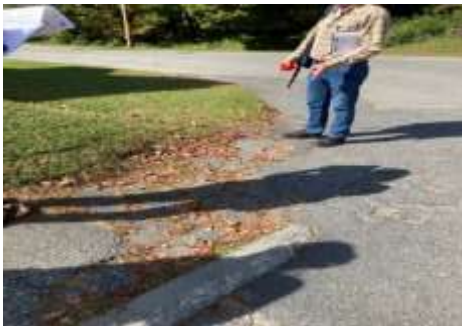
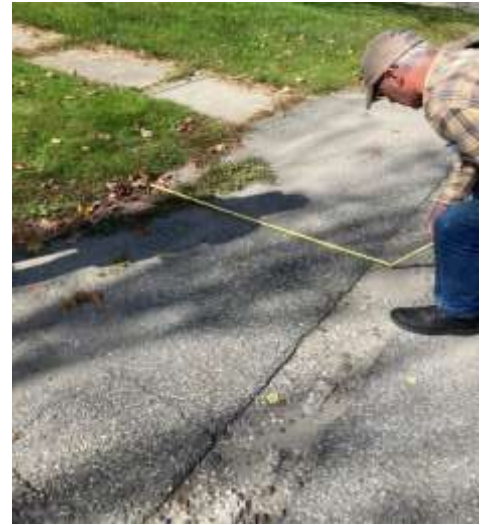
4) The sidewalk is not complete – the section randomly ends at the corner and does not have any indication that the sidewalk is ending.

5) The sidewalks are barely wide enough for two people to walk side by side (4 ½ feet in most sections). The sidewalks are definitely not wide enough for two people to use while social distancing. Road needs to be utilized if 6 feet apart is sought.

6) There are no indicators so that users with vision impairments will know when the path is ending.

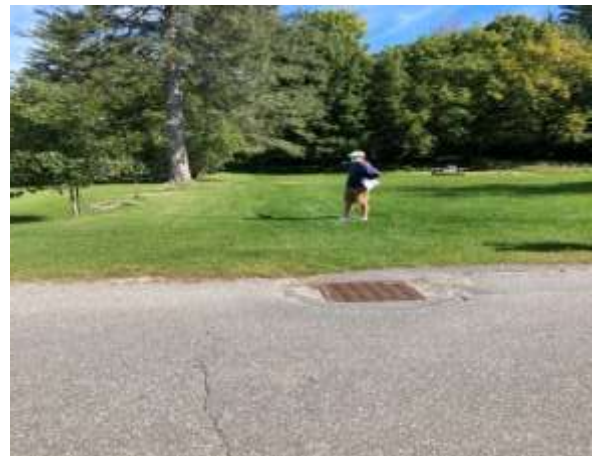
7) The street does not have a designated bicycle lane but with the completion of the Lamoille Valley Rail Trail (which runs parallel to West Church Street), there may be an increase of bike usage which necessitates more bike options.

8) No crosswalks exist at the intersection at the beginning of West Church Street and there are no additional crosswalks on West Church Street. There is a path which is utilized by the students at Hazen Union and students were observed walking on the north side of the street – which does not have a sidewalk and is used as the travel lane by both directions of traffic. The expansion of the public library may increase traffic at the intersection of Church and North Main Street and may suggest the need for a crosswalk. In addition, the Lamoille Valley Rail Trail may create a need for a safe crossing on West Church Street.

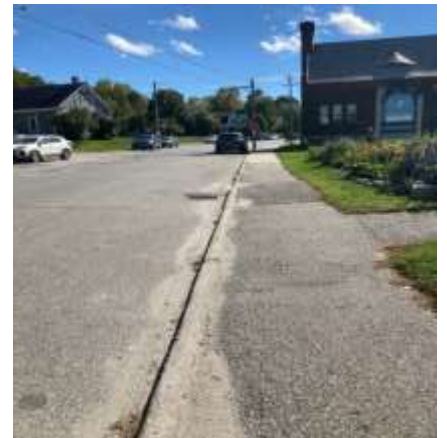
- 11) Parking in general is difficult to navigate. Many vehicles were observed stopping to allow oncoming traffic to pass in an attempt to navigate the roadway. The road width of 22-23 feet does not allow for parked vehicles and two lanes of traffic.
