**AARP Community Walk Audit location:  
Main Street from Perry Lane to Holton Hill, Hardwick**

Date: 10/19/21 Started at 11:00 am and completed at Noon

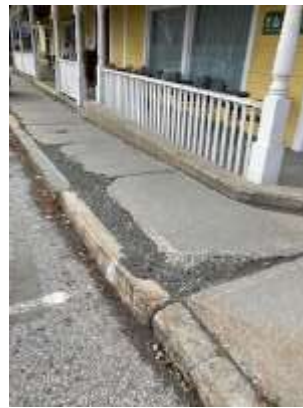
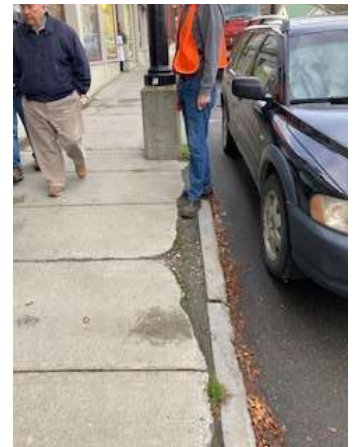
1) The south sidewalk on Main Street has curbs which are often sufficient to separate pedestrians from the road. However, there are sections of this sidewalk which have been lowered by wear and tear and do not provide the same level of protection. The north sidewalk is nearly even with the street at times and, lacking the parking spaces of the southern side, does not provide separation from the traffic. Over the span of 10 minutes, 15 to 20 heavy and/or large trucks traveled west through the downtown and were precariously close to the pedestrians on the sidewalk (see photo at the top of the page). The section of the north sidewalk in front of Mike's Service Station does not have a sidewalk and, therefore, does not have a curb to separate pedestrians from the road.

The location could be improved by increased disposal of municipal trash cans, sidewalk repairs, sidewalk installation, and access management on the northern side of the street.

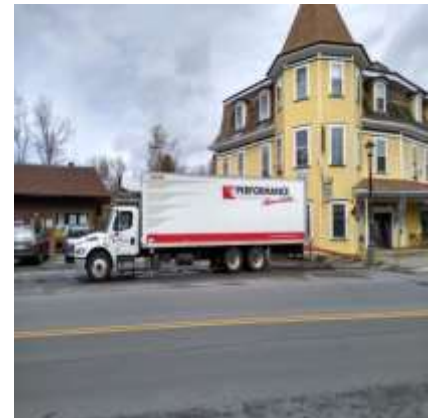
2) The south sidewalk has multiple obstacles. The sidewalk is cracked, broken, uneven, and undulating (angled) and difficult to navigate at times. Municipal garbage can placement reduces the available walking section. The street lights further reduce the width of the sidewalk. The north sidewalk near the Hardwick Inn is broken and cracked. Delivery truck traffic will also park both on top of the north sidewalk and in the path of pedestrians in front of Mike's Service Station.

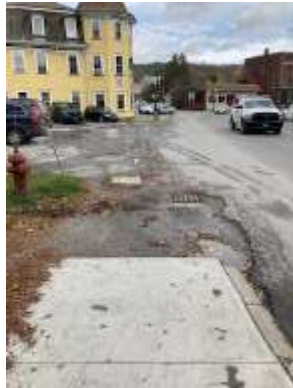
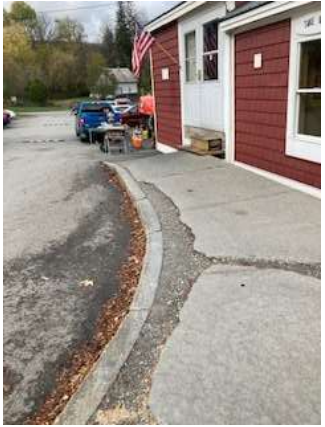
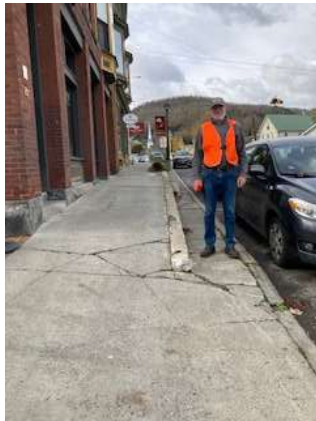
3) The south sidewalk is continuous – no segments are missing. However, the south sidewalk has a variety of angles and elevations which make the sidewalk difficult to be utilized by a wheelchair or other form of mobility assistance. The north sidewalk near the Village Diner also has angles and elevations that preclude easy use by pedestrians. The north sidewalk between the swinging bridge and Mike’s Service Station is relatively flat and able to be utilized by pedestrians who need mobility assistance. The north sidewalk is missing a section in front of Mike’s Service Station and the pavement in this area is cracked and broken.

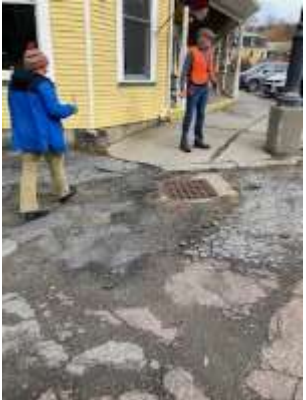
5) The north sidewalk is not complete – the section randomly ends at Mike’s Service Station and does not have any indication that the sidewalk is ending.

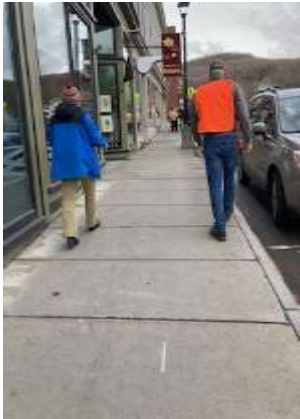
6) The sidewalks are typically wide enough for two people to walk side by side

(between 4 ½ feet to 8 feet in width). The sidewalks are typically not wide enough for two people to use while social distancing. The south sidewalk segment between the Perry Hill Lane and the two-level sidewalk allows for social distancing.
