**AARP Community Walk Audit location:
Mill Street from North Main Street Intersection to Glenside Avenue, Hardwick**

Date: 10/19/21 Started at 11:00 am and completed at Noon
Posted Speed Limit: 25 mph

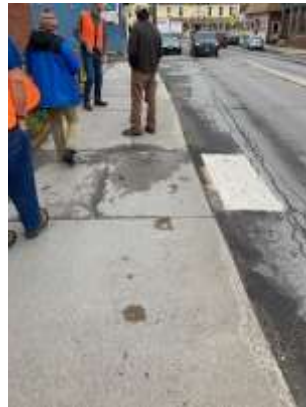
- 1) The south sidewalk on Mill Street has curbs between Sumner Street and Perry Lane Hill but often the curb is crumbling and/or does not match the elevation of the sidewalk. The curb at the public parking area near Glenside Avenue does not have a curb and the sidewalk edge has been poorly patched with asphalt. The north sidewalk between North Main Street and Brochu's Garage has granite trim and is angled. The remaining section of the north side does not have a sidewalk and, therefore, does not have a curb to separate pedestrians from the road.

The location could be improved by trash bins near the public parking area, extensive sidewalk repairs on the southern side, access management on the northern side and the installation of additional sidewalks.

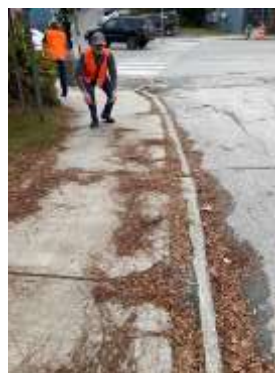
- 2) The existing sidewalks have multiple obstacles. The sidewalks are cracked,

broken and storm drains are either within the actual sidewalk or have aspects which make travel difficult. The section of sidewalk near the public parking area has an asphalt patch which makes travel nearly impossible for most pedestrians and impossible for anyone who needs mobility assistance. Between the Post Office parking lot and Perry Lane Hill, there are cables set into the sidewalk which are in the pedestrian path.

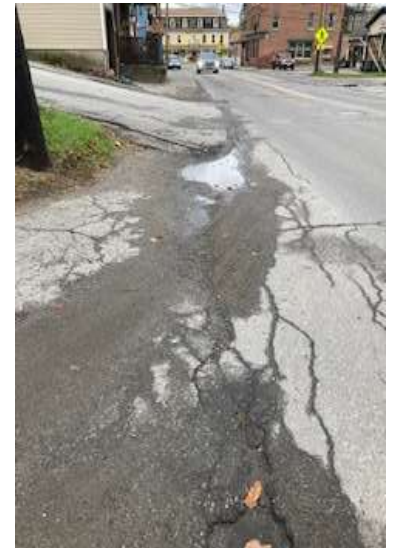
- 3) The existing sidewalk on the south side has a variety of angles and elevations which make walking difficult and virtually impossible to be utilized by a wheelchair or other form of mobility assistance. The small portion of existing sidewalk on the northern side is relatively flat and able to be utilized by pedestrians who need mobility assistance. The intersection of Sumner Street is angled and difficult to navigate, especially in the winter when ice forms on the pavement. The intersection of Perry Lane Hill is cracked and uneven and is 1.5" drop from the Main Street sidewalk.

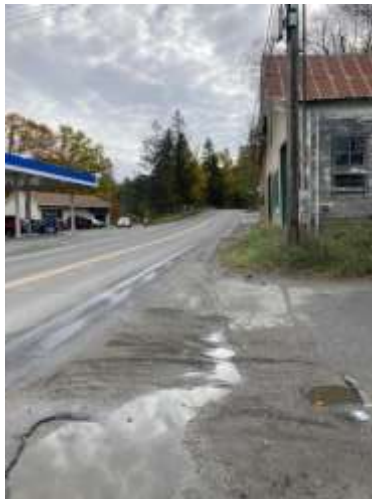
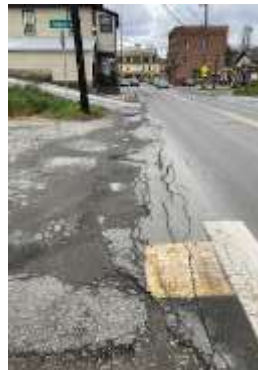
- 4) The sidewalk is not continuous – multiple segments are missing. The northern side does not have a sidewalk from Hays Service Center to the edge of the Brochu Garage property. Currently, extensive open access to the road exists at Hardwick Village Market, GRACE, and the Brochu Garage. On the southern side, the sidewalk does not exist from Glenside Avenue to

the public parking area. The sidewalk also disappears between the public parking area and the intersection of Sumner Street.

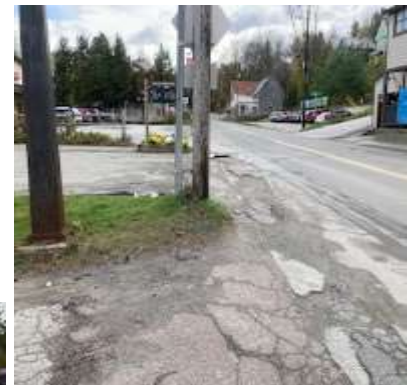
- 5) The sidewalk is not complete – sections randomly end and never have an indication that the sidewalks are ending.

- 6) The sidewalks are barely wide enough for two people to walk side by side on the southern side. The distances vary from 4½ feet to 5 feet to 6 ½ feet. The sidewalk section on the northern side is 8 feet in width but is interrupted by the placement concrete steps from the Laundry (5 ¾ feet). The sidewalks are definitely not wide enough for two people to use while social distancing.

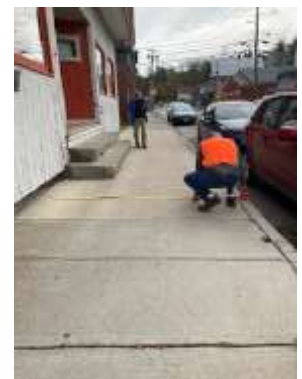
- 7) There are no indicators so that users with vision impairments will know when the path is ending.

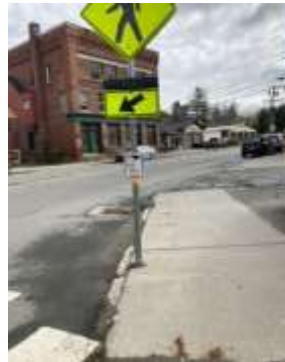
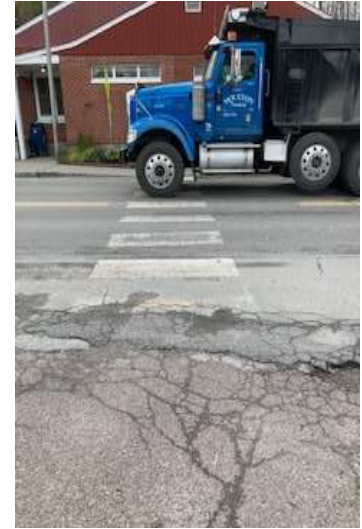
9) There are three crosswalks across this segment of the street. The crosswalk between the public parking area and the Hardwick Village Market does not have a sign for traffic and is located between parking area locations. No landing areas are on either side. *(This crosswalk is currently slated to be removed after the repaving of Mill Street in 2022).* The crosswalk between the Post Office and Brochu’s Repair does have signs indicating a pedestrian crossing but does not have a landing area on the northern side. The crosswalk between the Clip Joint and the Laundry (north side) has pedestrian signs and a flashing ?????? (name?) which has already been defaced by the placement of a sticker over the instructions.

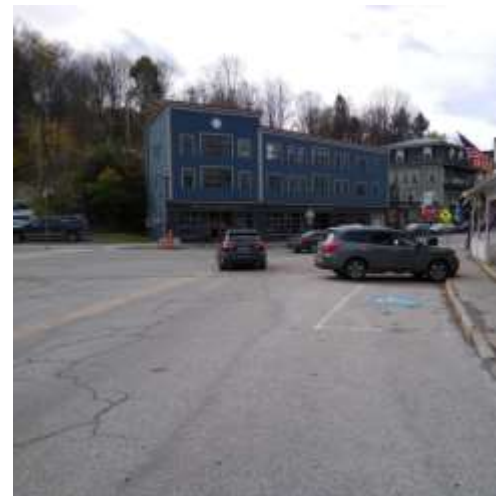
11) The stop sign adjacent to the Hardwick Inn is not always easy to observe. The Mill Street segment near Glenside Avenue does not have any signage alerting drivers to the increased presence of pedestrians. Over the course of an hour, 20+ pedestrians were observed. The northern side of the street serves as a main corridor for high school students who are shopping at Hardwick Village Market during the school day. Extremely high vehicular traffic counts occurred throughout the time frame of the audit.
