**AARP Community Walk Audit location:
Main Street from School Street to Brickhouse
Road and to East Church Street, in East Hardwick**

Date: 5/18/22 Started at 10:30 am and completed at Noon
Posted Speed Limit: 25 mph

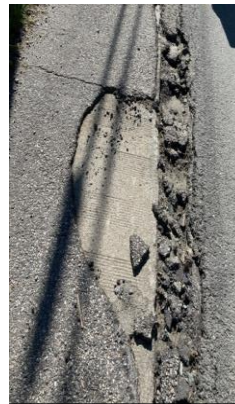
- 1) The existing sidewalk on Main Street does not consistently have a curb which is sufficient to separate pedestrians from the road. There are sections of this sidewalk which have been lowered by wear and tear and do not provide any level of protection. Portions of the sidewalk are up to 10" below street level (see photo below – Issue 1).

View on Main Street

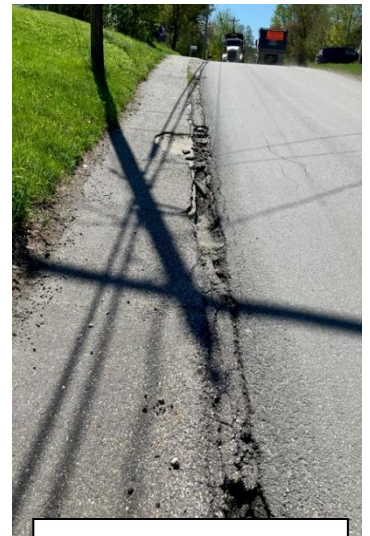
Uphill View on Main Street

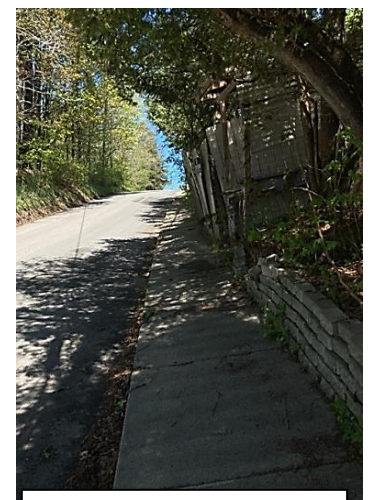
- 3) The existing sidewalk is continuous – no segments are missing. However, the sidewalk has a variety of angles and elevations which make the sidewalk difficult to be utilized by a wheelchair or other form of mobility assistance.

Uphill View of Brickhouse Rd

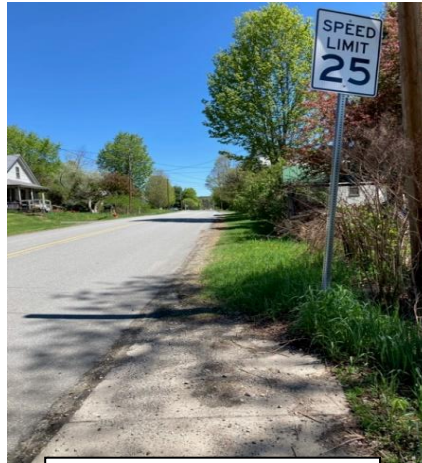
4) The sidewalk ends abruptly after the Lamoille River Bridge and the sidewalk is physically missing from the East Church Street section of town. The sidewalk abruptly ends on Brickhouse Road.

View on East Church Street

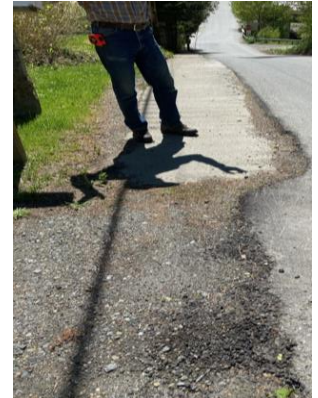
View on Brickhouse Road

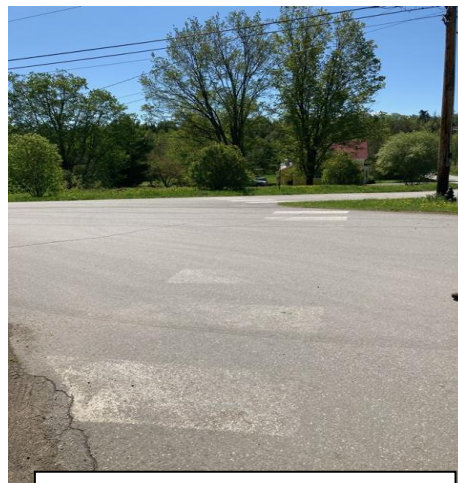
8) The only crosswalks that exist in East Hardwick are located at the intersection of School Street and Main Street. The crosswalks are faded and do not have landings or caution signs.

View across School Street intersection

The location could be improved by installation of additional crosswalks, drainage repairs, sidewalk repairs, sidewalk installation, and access management at the intersection of Cedar Street and Main Street and at the intersection of School Street and Main Street. The bridge over the Lamoille Valley River should also be examined for life expectancy.

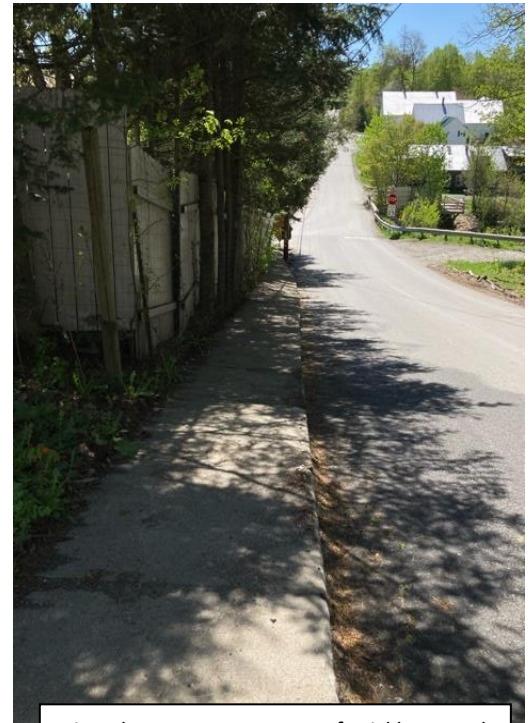
7) The street does not have a designated bicycle lane which becomes problematic with large truck traffic. With the impending completion of the Lamoille Valley Rail Trail, there may be an increase of bike usage which will necessitate more bike options. Brickhouse Road has a steep segment from the LVRT to the Main Street. Space is limited for bicycles and pedestrians.

View down steep segment of Brickhouse Rd

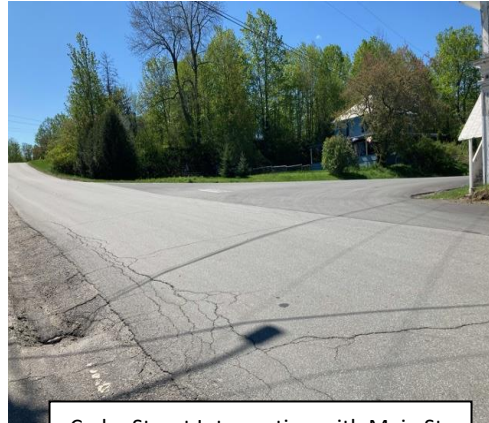
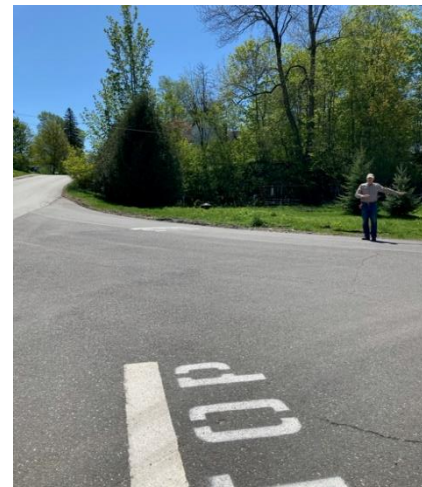
10) The Cedar Street intersection with Main Street has too much space for vehicular travel. The intersection has in excess of three lanes and lacks separation.

Cedar Street Intersection with Main St

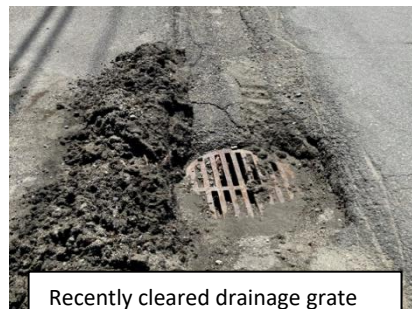
11) Drainage on Main Street does not appear to be adequate for increased capacity rain events.

Recently cleared drainage grate (cleared by citizen volunteer).

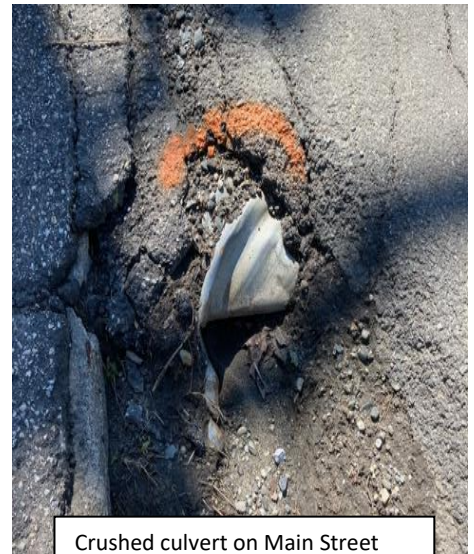
Crushed culvert on Main Street

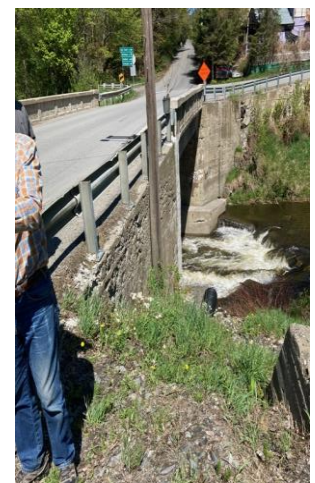
Bridge over the Lamoille River

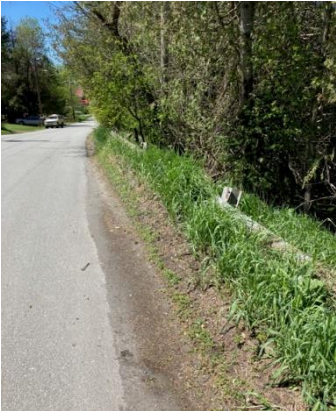
School Street intersects with Main Street and provides an important link to the only operating store in the village center. School Street does not currently have any sidewalks or lanes for pedestrians and/or bicycles. Sections of School Street have steep embankments and are not adequately protected by guardrails. School Street connects with Mini Mart Drive which is also lacking delineation as a viable street and pedestrian precautions.

School Street embankment with dysfunctional guardrail

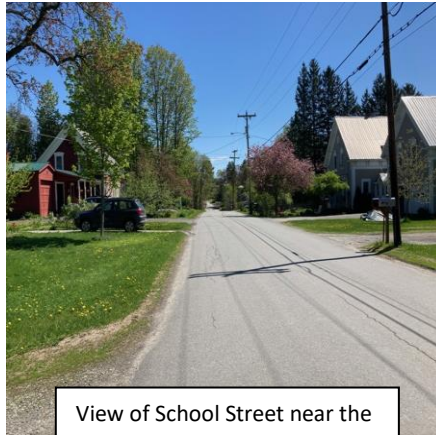
View of School Street near the Main Street Intersection

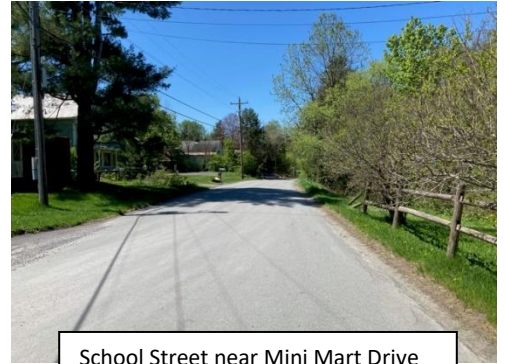
School Street near Mini Mart Drive

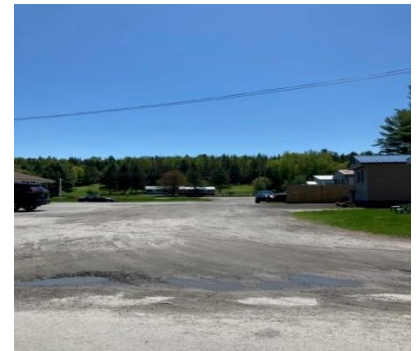
Mini Mart Drive as viewed from School Street toward VT Route 16
