Town: 95 - HARDWICK

(1) State Names	50 - Vermont
(8) Structure Number	100305000403051
(5) Inventory Route	1
(2) Highway Agency District	7 - District 7
(3) County Code	5 - CALEDONIA
(4) Place Code	31825
(6) Features Intersected	LAMOILLE RIVER
(7) Facility Carried	C2002
(9) Location	0.1 MI JCT TH 2 + TH 6
(11) Mile Point	0 mi
(12) Base Highway Network	No
(13) LRS Inventory Rte & Subrte	
(16) Latitude	44.5211388888889
(17) Longitude	-72.3079555555556
(98) Border Bridge State Code	
(99) Border Bridge Structure No.

Team Lead: Justin White, Inspection Date: 08/14/2023

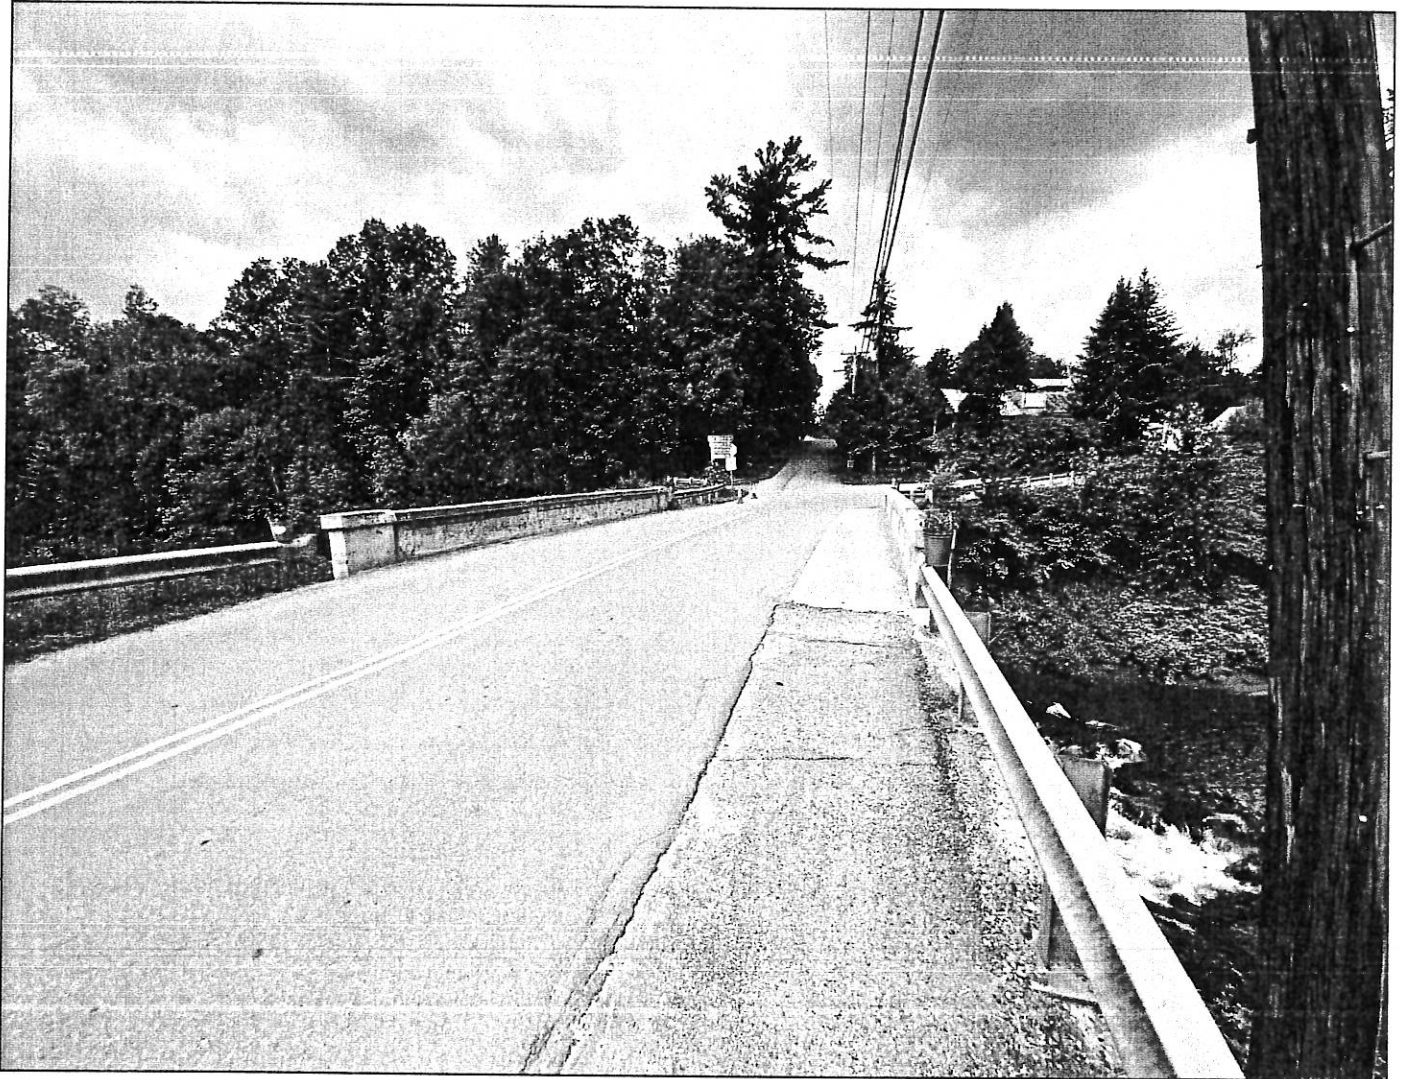
8/14/2023 Flooding event inspection has found extensive bank erosion at the end of the downstream abutment 1 wingwall extending up into the roadway above. The area of erosion measures lineal 14' +/- at the toe of the bank, 30' +/- at the top of the bank, and is approximately 35' +/- vertically. Erosion has exposed a 5'x 5' void behind the base end of the wingwall, exposing boulders and some timber cribbing. A void between the cribbing and boulders penetrates up to 9'. The eroded area along the roadway shoulder extending under the roadway measures 12' lineally and 3'- 4' wide. No new issues were found with the structure and it remains in fair condition.
