AARP Community Walk Audit location: Hardwick, Church Street and Maple Street

Date: 9/21/2020 Start at 10:11 AM and End at 10:50 AM

Church Street to Maple Street in Hardwick

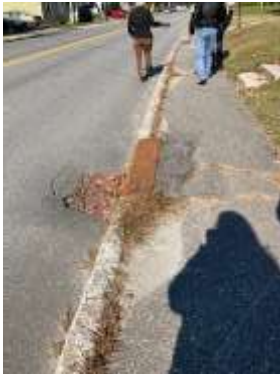
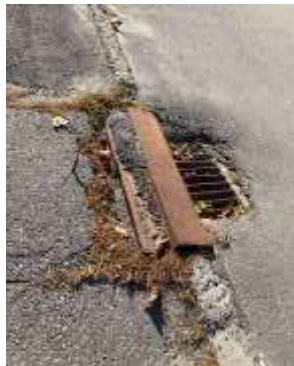
- 1) Both sides of the sidewalk have curbs but often the curb is crumbling and/or does not match the elevation of the sidewalk (either too high or too low).
- 2) Both sides of the sidewalk are not free of obstacles. The sidewalks are

The location can be improved by trash bins (especially with the installation of the Rail Trail), Sidewalk Repairs, and the removal or repair of vacant houses (two exist in this section).

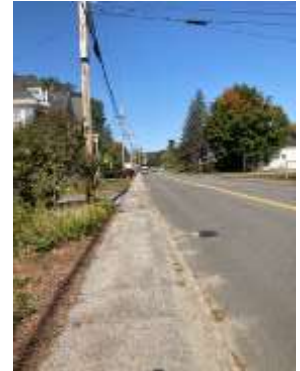
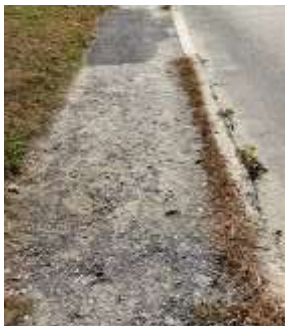
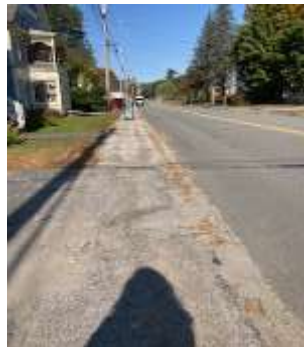
cracked, broken and storm drains are either within the actual sidewalk

or have aspects which make travel difficult. Pedestrian with a walker was observed moving into the road to navigate an uneven grade.

- 3) The sidewalk are not continuous – several of the multi-unit buildings have created parking “yards” and are accessing their parking by driving over the curb and the sidewalk. This has occurred for many years and the result is that the sidewalks are no longer intact.

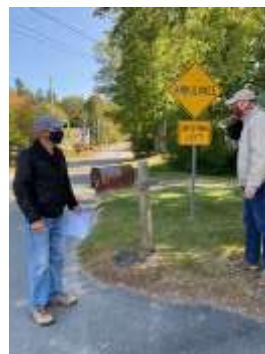
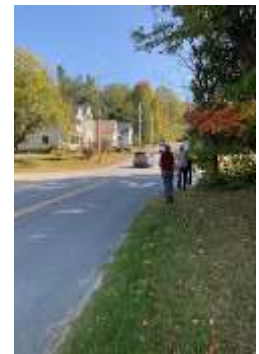
- 4) The sidewalks are not complete – the section on Maple Street next to the Maple Street Apartment complex randomly ends at a mail box. Approximately 150 feet from the entrance to the Hardwick Health Center. Section is utilized to

reach the Hardwick Health Center – grass shows pattern of wear consistent with repeated pedestrian usage.

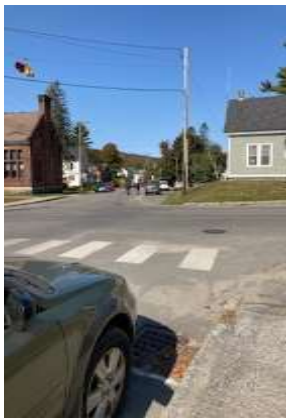
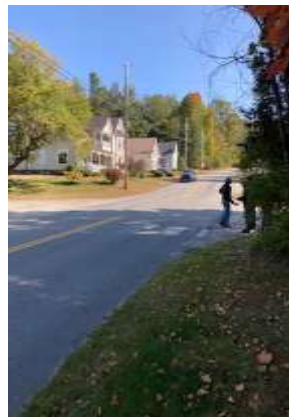
- 5) The sidewalks are barely wide enough for two people to walk side by side (3 feet and 4 feet appear to be the width amounts). The sidewalks are definitely not wide for two people to use while social distancing. Road needs to be utilized if 6 feet apart is utilized.
- 6) There are no indicators so that users with vision impairments will know when the path is ending.
- 7) The street does not have a designated bicycle lane but with the introduction of the LVRT, there may be an increase of bike usage.
- 8) There is a crosswalk at the intersection of the beginning of Church Street but then there are no

additional crosswalks until the end of Maple Street – where the LVRT crosses. Crosswalk on this end is faded and not visible. No signs warn of possible pedestrian or bike crossing.

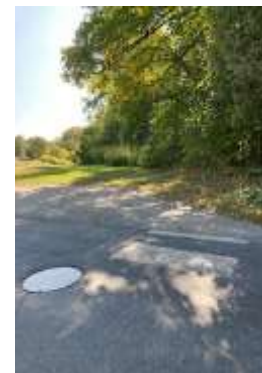
- 9) The question of whether motorists are following the speed limit became difficult to answer because there are no signs posted on the approach to Maple Street – Church Street. The last posted speed is 35 mph at the top of Slapp Hill.

- 10) The sidewalks have vegetation growing between the curb and in the gutters.

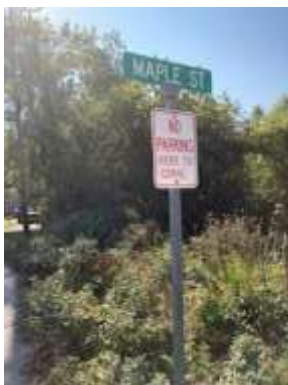
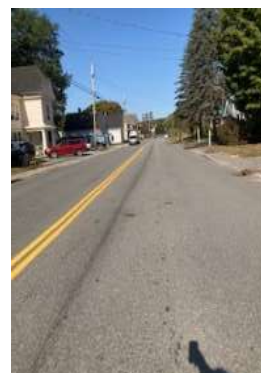
- 11) The place of the No Parking sign on Church Street is confusing. And parking in general is still difficult to navigate. Many vehicles were

observed crossing the center yellow line in an attempt to navigate the roadway.
