**AARP Community Walk Audit location:**  
**Main Street from School Street to Brickhouse Road and to East Church Street, in East Hardwick**  
 Date: 5/18/22 Started at 10:30 am and completed at Noon  
 Posted Speed Limit: 25 mph  
*\*The speed is posted on Main Street (at entrance from Route 16), School Street (near the intersection with Route 16), Cedar Street (at the intersection with Route 16), Brickhouse Road (near the LVRT), and East Church (near the LVRT.)*  
 Total Number of Vehicle Lanes: 2  
 Two-Way Street  
 Sidewalks exist on only one side of the street.

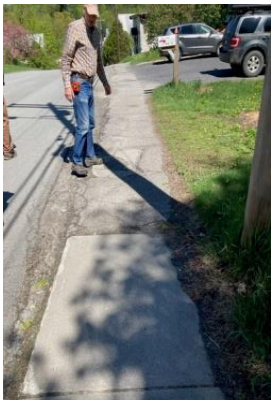
- 1) The existing sidewalk on Main Street does not consistently have a curb which is sufficient to separate pedestrians from the road. There are sections of this sidewalk which have been lowered by wear and tear and do not provide any level of protection. Portions of the sidewalk are up to 10" below street level (see photo below – Issue 1).

Main Street – near School Street

**The location could be improved by installation of additional crosswalks, drainage repairs, sidewalk repairs, sidewalk installation, and access management at the intersection of Cedar Street and Main Street and at the intersection of School Street and Main Street. The bridge over the Lamoille Valley River should also be examined for life expectancy.**

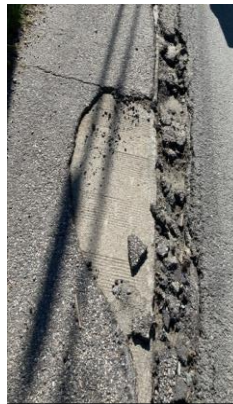
View on Main Street

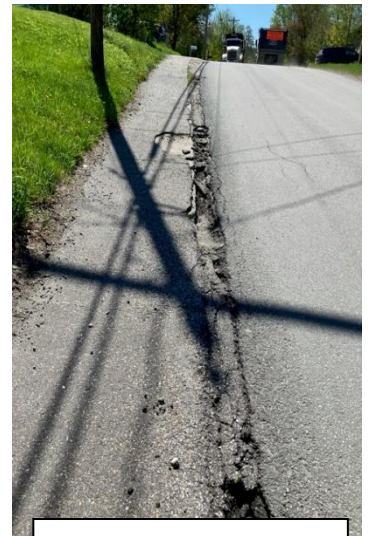
Uphill View on Main Street

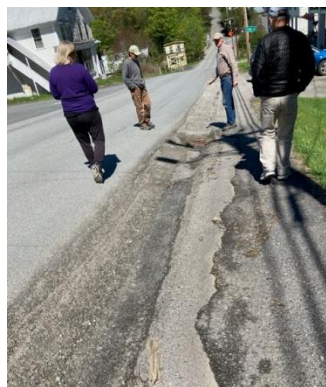
- 2) The existing sidewalk has multiple obstacles. After the initial section from the intersection of School Street and Main Street, the sidewalk is cracked, broken, uneven, and undulating (angled) and difficult to navigate.

Downhill view on Main Street (Issue)

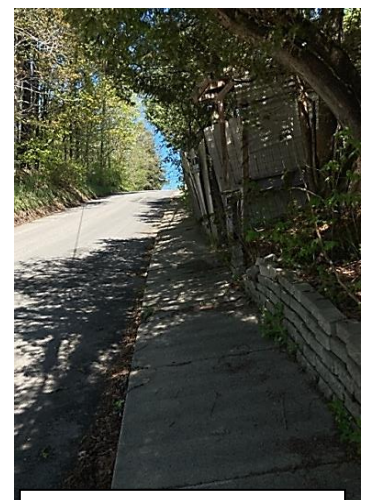
- 3) The existing sidewalk is continuous – no segments are missing. However, the sidewalk has a variety of angles and elevations which make the sidewalk difficult to be utilized by a wheelchair or other form of mobility assistance.

Uphill View of Brickhouse Rd

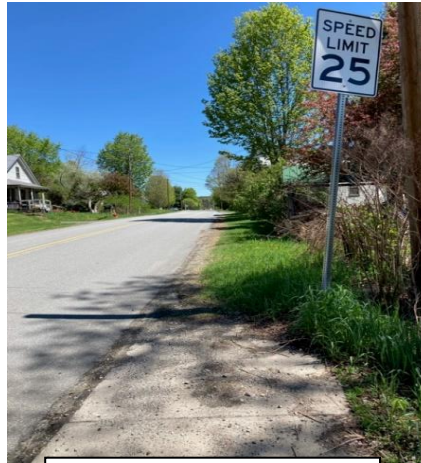
- 4) The sidewalk ends abruptly after the Lamoille River Bridge and the sidewalk is physically missing from the East Church Street section of town. The sidewalk abruptly ends on Brickhouse Road.

View on East Church Street

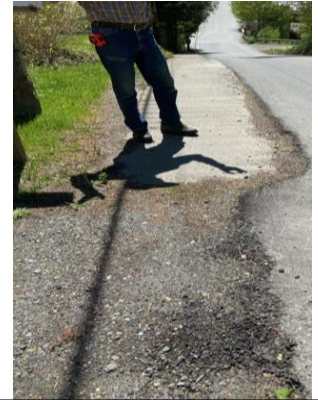
View on Brickhouse Road

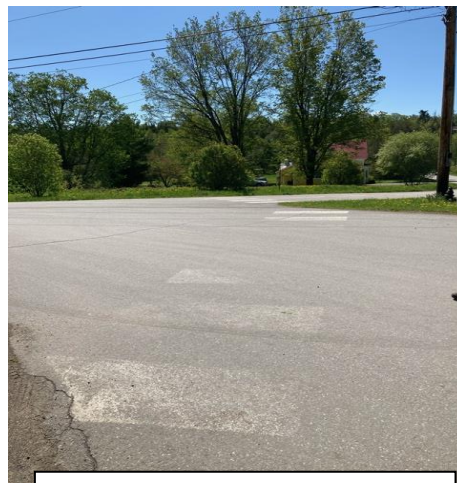
- 8) The only crosswalks that exist in East Hardwick are located at the intersection of School Street and Main Street. The crosswalks are faded and do not have landings or caution signs.

View across School Street intersection

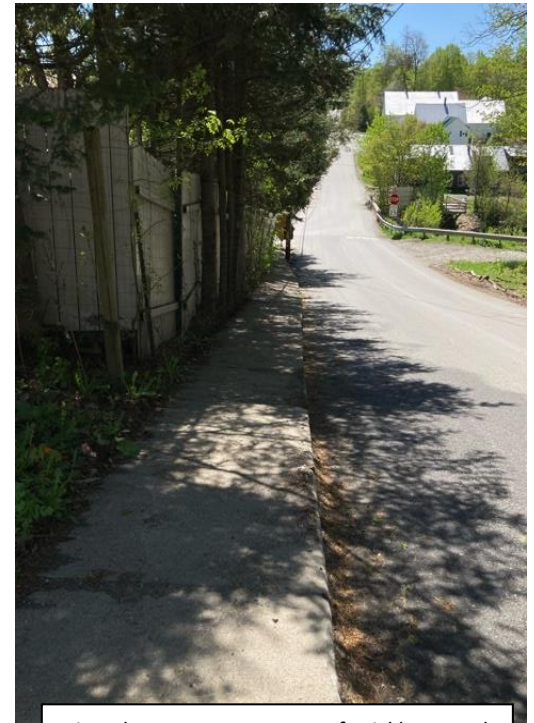
- 5) The sidewalks are usually wide enough for two people to walk side by side (approximately 4 feet in width). The sidewalks are not wide enough for two people to use while social distancing.
- 6) There are no indicators so that users with vision impairments will know when there is a crosswalk or an intersection.
- 7) The street does not have a designated bicycle lane which becomes problematic with large truck traffic. With the impending completion of the Lamoille Valley Rail Trail, there may be an increase of bike usage which will necessitate more bike options. Brickhouse Road has a steep segment from the LVRT to the Main Street. Space is limited for bicycles and pedestrians.

View down steep segment of Brickhouse Rd

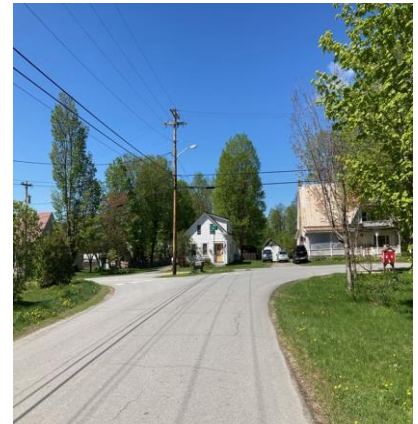
9) The intersection at School Street and Main Street does not have any type of traffic calming signage such as a yield or a stop sign.

School Street & Main Street Intersection

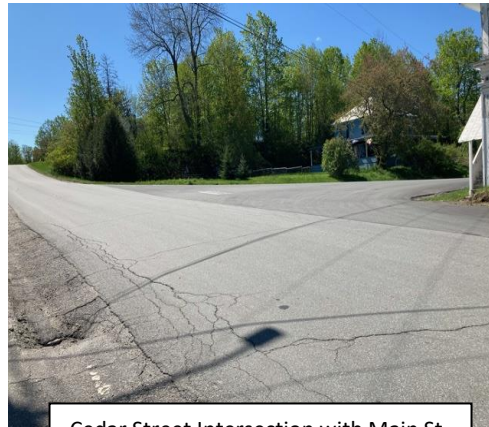
10) The Cedar Street intersection with Main Street has too much space for vehicular travel. The intersection has in excess of three lanes and lacks separation.

Cedar Street Intersection with Main St

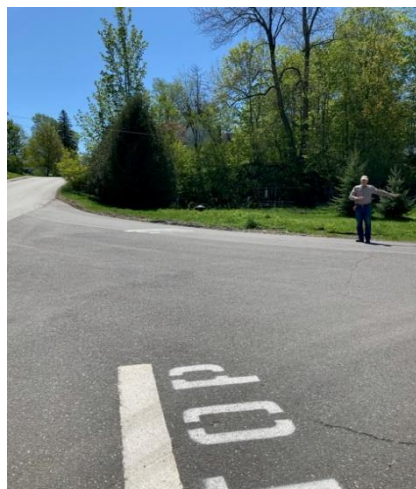
Cedar Street Intersection with Main St

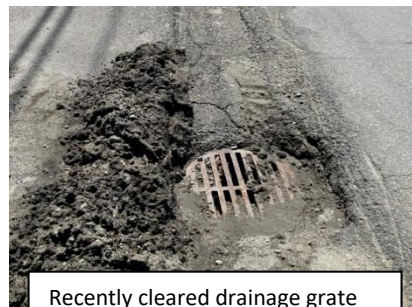
11) Drainage on Main Street does not appear to be adequate for increased capacity rain events.

Recently cleared drainage grate (cleared by citizen volunteer).

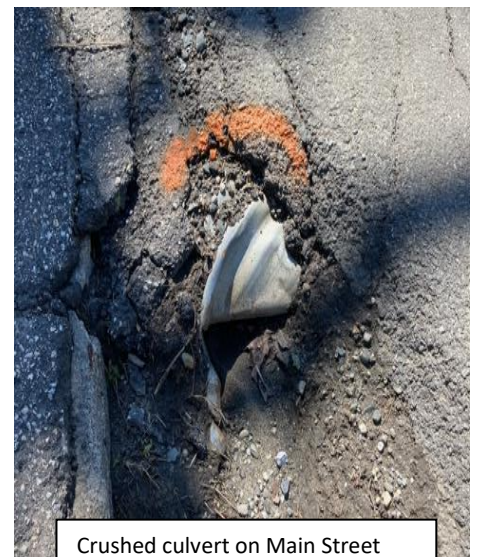
Crushed culvert on Main Street

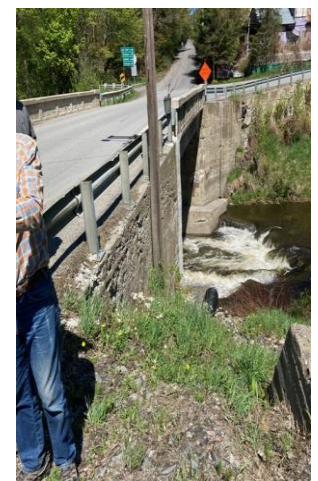
Bridge over the Lamoille River

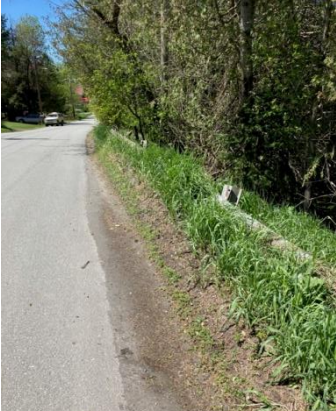
School Street intersects with Main Street and provides an important link to the only operating store in the village center. School Street does not currently have any sidewalks or lanes for pedestrians and/or bicycles. Sections of School Street have steep embankments and are not adequately protected by guardrails. School Street connects with Mini Mart Drive which is also lacking delineation as a viable street and pedestrian precautions.

School Street embankment with dysfunctional guardrail

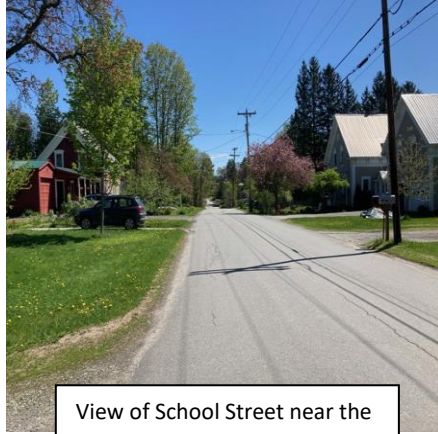
View of School Street near the Main Street Intersection

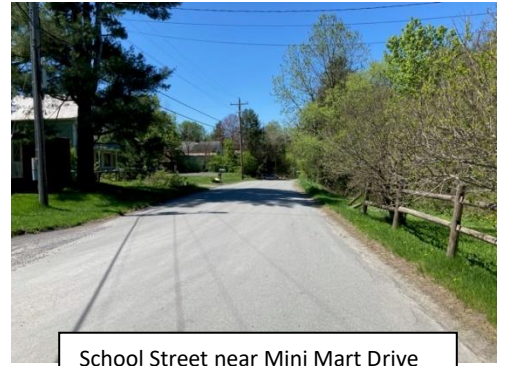
School Street near Mini Mart Drive

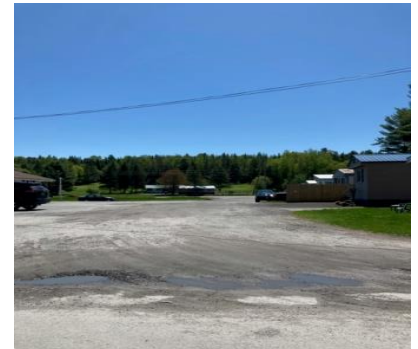
Mini Mart Drive as viewed from School Street toward VT Route 16
