AARP Community Walk Audit location:

Main Street from Perry Lane to Holton Hill, Hardwick

Date: 10/19/21 Started at 11:00 am and completed at Noon

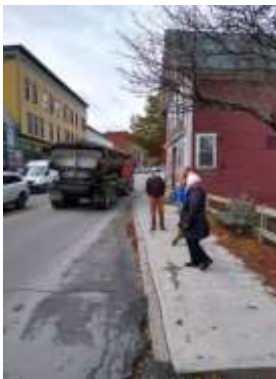
- 1) The east sidewalk on Main Street has curbs which are often sufficient to separate pedestrians from the road. However, there are sections of this sidewalk which have been lowered by wear and tear and do not provide the same level of

protection. The west sidewalk is nearly even with the street at times and, lacking the parking spaces of the eastern side,

does not provide separation from the traffic. Over the

span of 10 minutes, 15 to 20 heavy and/or large trucks traveled west through the downtown and were precariously close to the pedestrians on the sidewalk. The section of the west sidewalk in front of Mike's Service Station does not have a sidewalk and,

therefore, does not have a curb to separate pedestrians from the road.

The location could be improved by more frequent disposal of municipal trash cans, sidewalk repairs, sidewalk installation, and access management on the western side of the street.

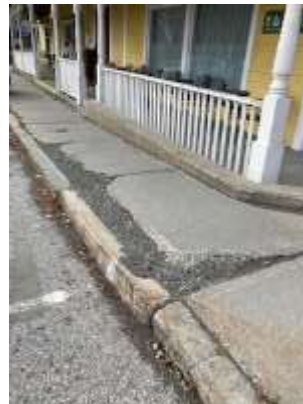
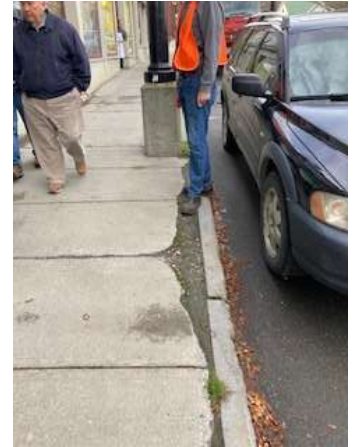
- 2) The east sidewalk has multiple obstacles. The sidewalk is cracked, broken, uneven, and undulating (sloped) and difficult to navigate at times. Municipal garbage can placement reduces the available walking section. The street lights further reduce the width of the sidewalk. The west sidewalk near the Hardwick Inn is broken and cracked. Delivery trucks park on top of the sidewalk and in the path of pedestrians in front of Mike's Service Station.

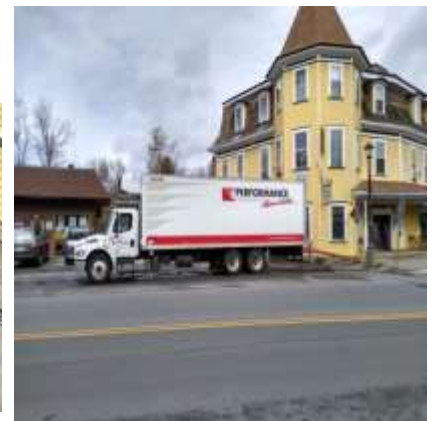
3) The east sidewalk is continuous – no segments are missing. However, the east sidewalk has a variety of slopes and elevations which make the sidewalk difficult to be utilized by a wheelchair or other form of mobility assistance. The west sidewalk near the Village Diner also has slopes and elevations that preclude easy use by pedestrians. The west sidewalk between the swinging bridge and Mike’s Service Station is relatively flat and able to be utilized by pedestrians who need mobility assistance. The west sidewalk is missing a section in front of Mike’s Service Station and the pavement in this area is cracked and broken.

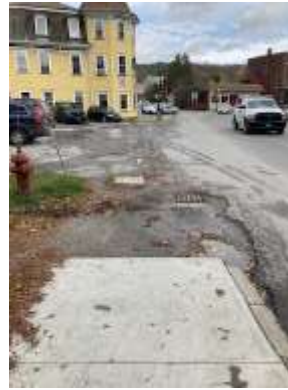
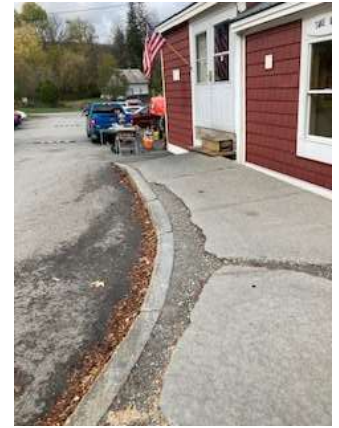
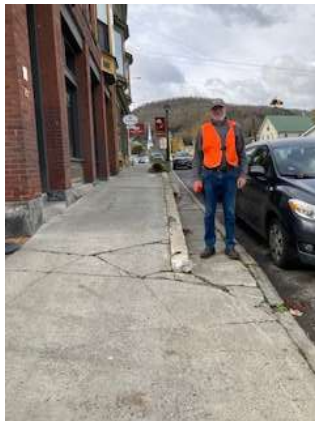
4) The east sidewalk splits into a two-level situation directly before the Holton Hill intersection. The upper level of the sidewalk has 6 ½ feet of width and then drops substantially and has an additional 2 feet.

5) The westsidewalk is not complete – the section randomly ends at Mike’s Service Station and does not have any indication that the sidewalk is ending.

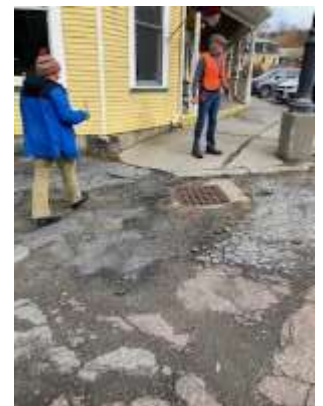
6) The sidewalks are typically wide enough for two people to walk side by side

(between 4 ½ feet to 8 feet in width). The sidewalks are typically not wide enough for two people to use while social distancing. The east sidewalk segment between the Perry Hill Lane and the two-level sidewalk allows for social distancing.

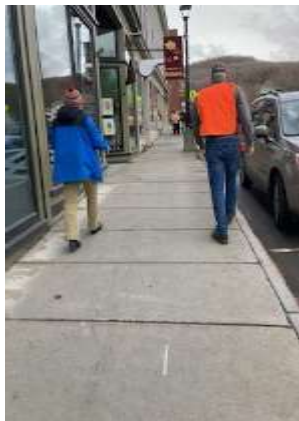
7) There are indicators so that users with vision impairments will know when there is a crosswalk but these indicators have been covered with sediment and are not currently operational.
