**AARP Community Walk Audit location:  
Mill Street from North Main Street Intersection to Glenside Avenue, Hardwick**

Date: 10/19/21 Started at 11:00 am and completed at Noon  
Posted Speed Limit: 25 mph

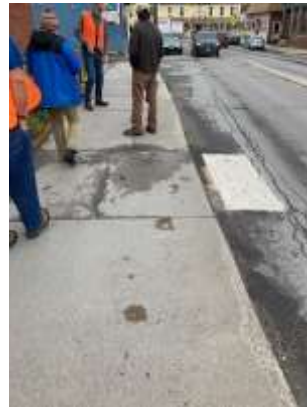
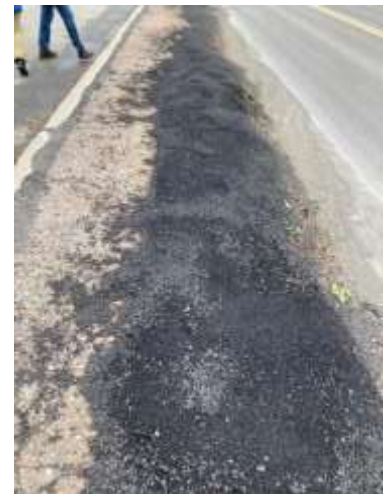
- 1) The south sidewalk on Mill Street has curbs between Sumner Street and Perry Lane Hill but often the curb is crumbling and/or does not match the elevation of the sidewalk. The curb at the public parking area near Glenside Avenue does not have a curb and the sidewalk edge has been poorly patched with asphalt. The north sidewalk between North Main Street and Brochu’s Garage has granite trim and is angled. The remaining section of the north side does not have a sidewalk and, therefore, does not have a curb to separate pedestrians from the road.

The location could be improved by trash bins near the public parking area, extensive sidewalk repairs on the southern side, access management on the northern side and the installation of additional sidewalks.

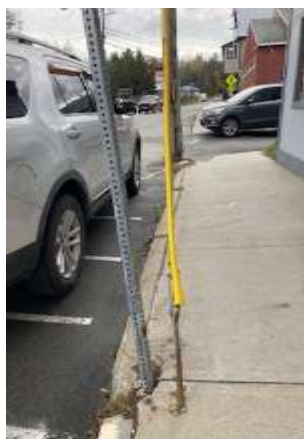
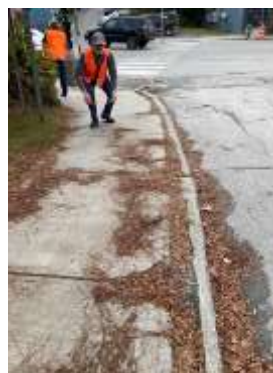
- 2) The existing sidewalks have multiple obstacles. The sidewalks are cracked,

broken and storm drains are either within the actual sidewalk or have aspects which make travel difficult. The section of sidewalk near the public parking area has an asphalt patch which makes travel nearly impossible for most pedestrians and impossible for anyone who needs mobility assistance. Between the Post Office parking lot and Perry Lane Hill, there are cables set into the sidewalk which are in the pedestrian path.

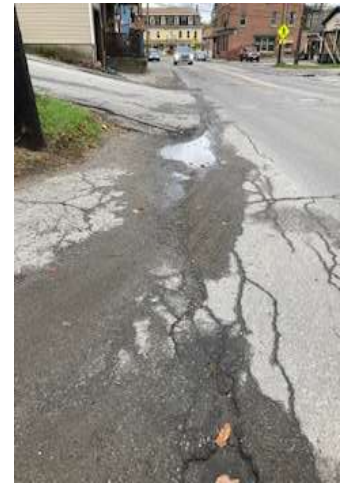
- 3) The existing sidewalk on the south side has a variety of slopes and elevations which make walking difficult and virtually impossible to be utilized by a wheelchair or other form of mobility assistance. The small portion of existing sidewalk on the northern side is relatively flat and able to be utilized by pedestrians who need mobility assistance. The intersection of Sumner Street is sloped and difficult to navigate, especially in the winter when ice forms on the pavement. The intersection of Perry Lane Hill is cracked and uneven and is 1.5" drop from the Main Street sidewalk.

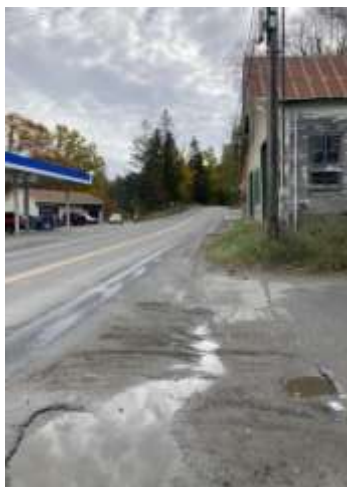
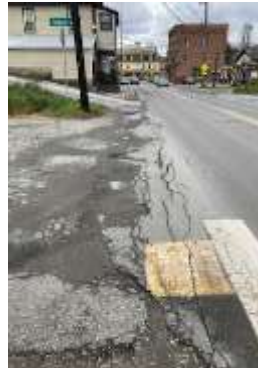
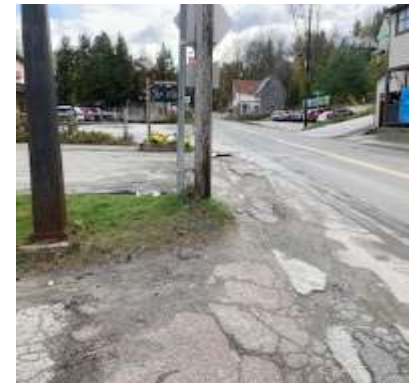
- 4) The sidewalk is not continuous – multiple segments are missing. The northern side does not have a sidewalk from Hays Service Center to the edge of the Brochu Garage property. Currently, extensive open access to the road exists at Hardwick Village Market, GRACE, and the Brochu Garage. On the southern side, the sidewalk does not exist from Glenside Avenue to the public parking area. The sidewalk also disappears between the public parking area and the intersection of Sumner Street.

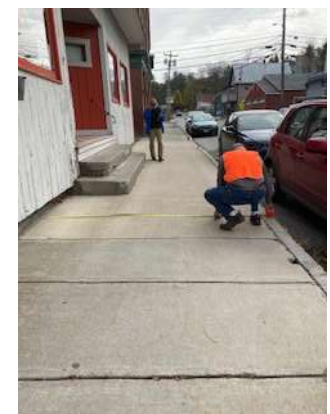
- 7) There are no indicators so that users with vision impairments will know when the path is ending.

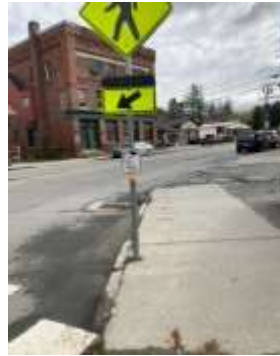
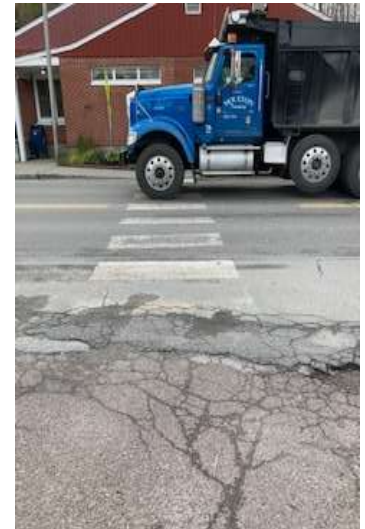
9) There are three crosswalks across this segment of the street. The crosswalk between the public parking area and the Hardwick Village Market does not have a sign for traffic and is located between parking area locations. No landing areas are on either side. *(This crosswalk is currently slated to be removed after the repaving of Mill Street in 2022).* The crosswalk between the Post Office and Brochu's Repair does

have signs indicating a pedestrian crossing but does not have a landing area on the northern side. The crosswalk between the Clip Joint and the Laundry (north side) has pedestrian signs and a Rectangular Rapid Flashing Beacon (RRFB) which has already been defaced by the placement of a sticker over the instructions.

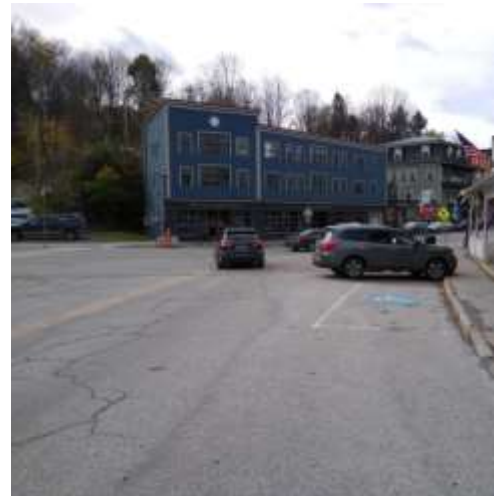
11) The stop sign adjacent to the Hardwick Inn is not always easy to observe. The Mill Street segment near Glenside Avenue does not have any signage alerting drivers to the increased presence of pedestrians. Over the course of an hour, 20+ pedestrians were observed. The northern side of the street serves as a main corridor for high school students who are shopping at Hardwick Village Market during the school day. Extremely high vehicular traffic counts occurred throughout the time frame of the audit.
