Upper Lamoille River
Stream Geomorphic Assessment Phase 2 Report
Greensboro and Hardwick, Vermont
February 2009

Prepared By:
Kerry O'Brien, District Manager

Caledonia County Natural Resources Conservation District

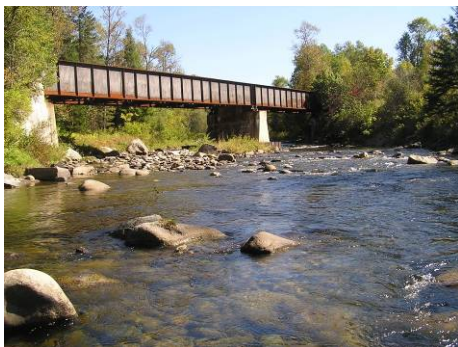
- The historic rail bed along this reach does little to change valley width, but it does have two stream crossings where there is apparent long term conflict. The upstream bridge has alignment problems and mid-channel piers, forcing the stream to make wide meander bends upstream and downstream of the bridge. Modification of the upstream railroad bridge should be considered if the opportunity arises. Both bridges are accumulating sediment upstream.

Figure 2. R26 Railroad bridge with mid-channel pier and aggradation

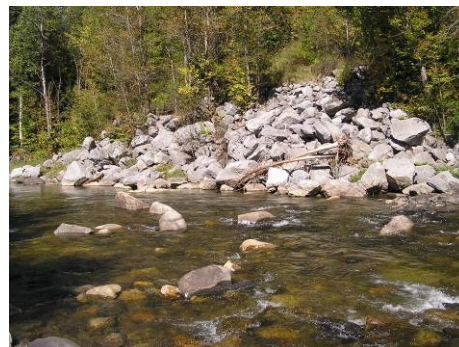
- Some potential conflicts where river abuts Rte 15 on outside bends. There is existing armoring in most locations but there may be sections where conflicts will be observed in the future.

Figure 3. R26 Riprap at river’s abutment with railroad bed

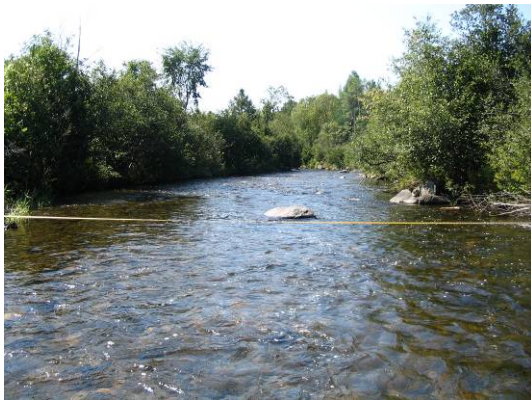
Figure 4. Plane bed features in R30A

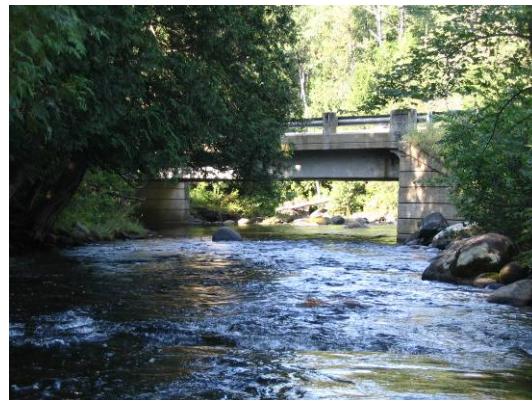
Figure 5. R30A. Bridge and channel constriction

- Farm practices in the lower section are contributing to water quality issues and bank erosion. Livestock exclusion and fencing is recommended.
- Considering the smaller lots and multiple landowners along this segment, small individual buffer projects are needed. The Trees for Streams program would be an appropriate program to re-vegetate individual landowner's streamside land.
- The mid-segment forest products industry yard needs to have a long term strategy for moving its operation back from the river's edge. The accumulation of fill and forest products at this site is not sustainable. Heavy erosion and fracturing of the bank has been noted at this section and it will continue as the bank becomes higher.
- Bridges are currently channel constrictions. Bridge upgrades should be considered when the opportunity arises.

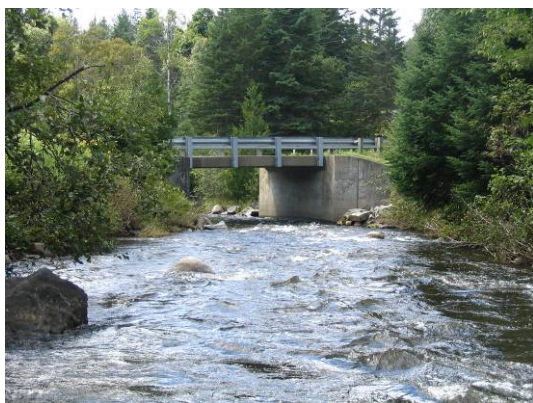
Figure 6. Undersized bridge with poor alignment in R30B

- There are multiple long term planning opportunities for the undersized bridge structures. A comprehensive bridge survey is recommended to help prioritize upgrades to these structures. The modification of the channel widths due to these undersized structures should be noted when the channel width of a new structure is considered.
- 1902 Greensboro Road (Route 16) is a long term area of conflict as the stream has been armored and modified around the house and yard. Restoring channel equilibrium at this section is greatly limited by the residence and land use. Installing vegetated buffers is recommended.
- The installation of buffers throughout open areas of the segment is also recommended.

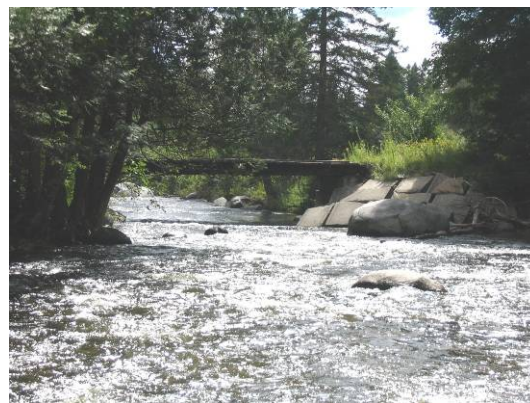
Figure 7. Problem bridge and channelization in R30B
