AARP Community Walk Audit location:

West Church Street, Hardwick

Date: 9/21/21 Started at 11:00 am and completed at Noon

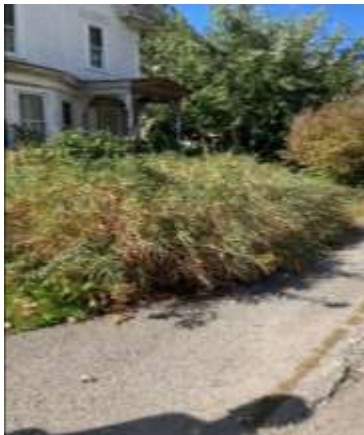
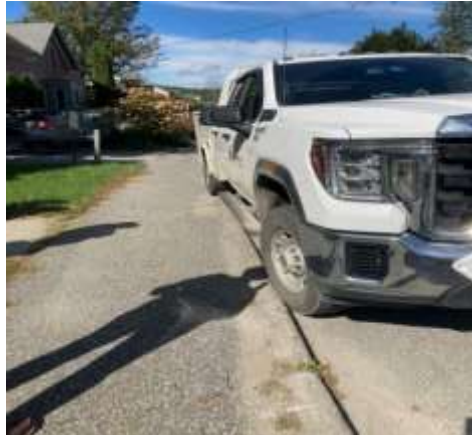
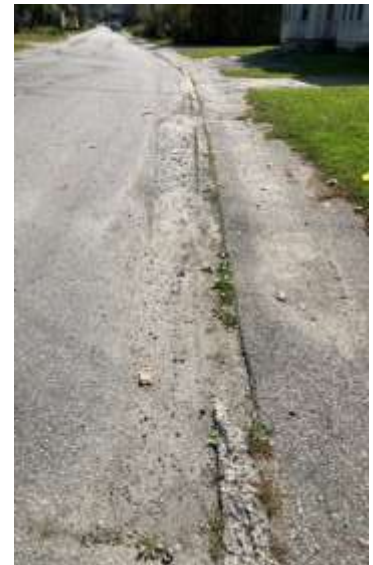
- 1) The sidewalk has curbs but often the curb is crumbling and/or does not match the elevation of the sidewalk (usually too low). The north side does not have a sidewalk and, therefore, does not have a curb to separate pedestrians from the road.
- 2) The sidewalk has multiple obstacles. The sidewalk is cracked, broken and storm drains are either within the actual sidewalk or have aspects which make travel difficult. Multiple cars and trucks park on the sidewalk (reducing the width available). The sidewalk is overgrown with vegetation both in the pedestrian travel lane and next to the sidewalk from the abutting properties.

The location could be improved by trash bins near the Library, sidewalk repairs, and enforcement of speed limits. A thorough examination of possible approaches to safety should occur. Possible improvements could include changing the street to a one-way street and installing traffic calming speed “humps.”

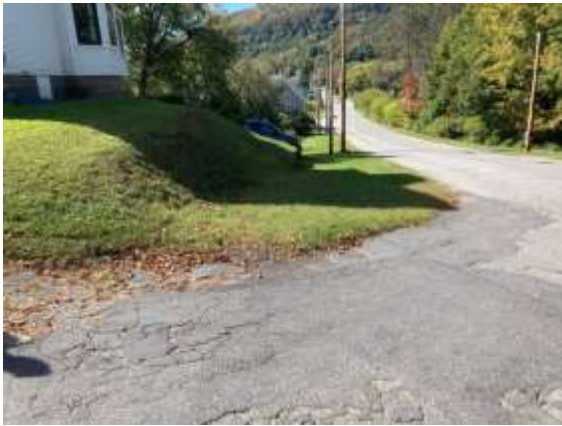
- 3) The sidewalk is continuous – no segments are missing. However, the sidewalk has a variety of angles and elevations which make walking difficult and virtually impossible to be utilized by a wheelchair or other form of mobility assistance.

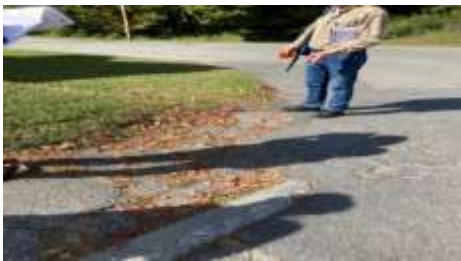
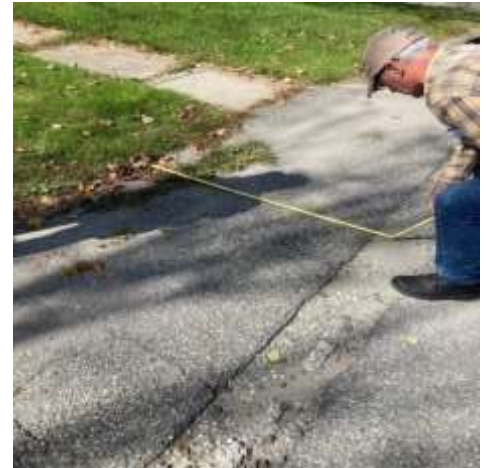
4) The sidewalk is not complete – the section randomly ends at the corner and does not have any indication that the sidewalk is ending.

5) The sidewalks are barely wide enough for two people to walk side by side (4 ½ feet in most sections). The sidewalks are definitely not wide enough for two people to use while social distancing. Road needs to be utilized if 6 feet apart is sought.

6) There are no indicators so that users with vision impairments will know when the path is ending.

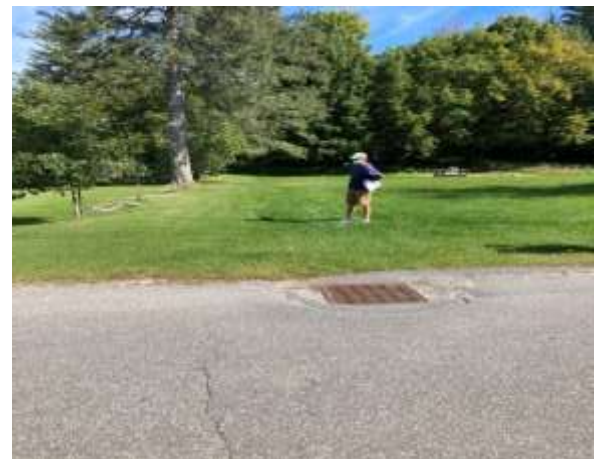
Hazen Walking Path

8) No crosswalks exist at the intersection at the beginning of West Church Street and there are no additional crosswalks on West Church Street. There is a path which is utilized by the students at Hazen Union (see photo to right) and students were observed walking on the north side of the street. This side does not have a sidewalk and is used as the travel lane by both directions of traffic. A crosswalk to the sidewalk is recommended. The expansion of the public library may increase traffic at the intersection of Church and North Main Street. A crosswalk in this location is also recommended. In addition, the Lamoille Valley Rail Trail may create a further need for a safe crossing on West Church Street.

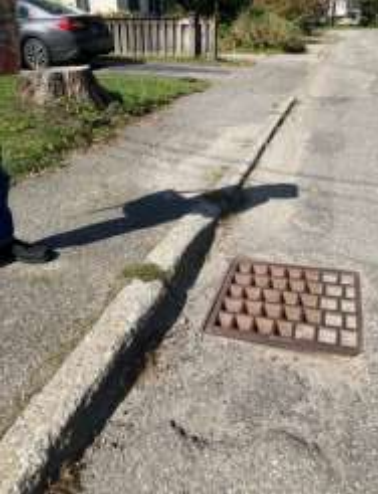
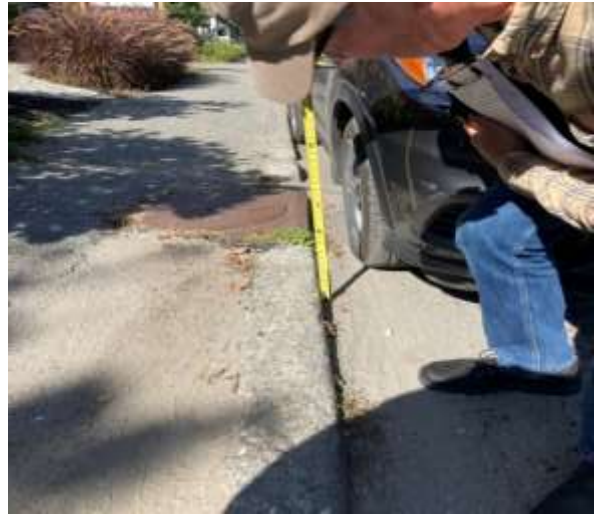
- 9) The sidewalks have vegetation growing between the curb and in the gutters. Drainage does not appear to be adequate for increased capacity rain events.

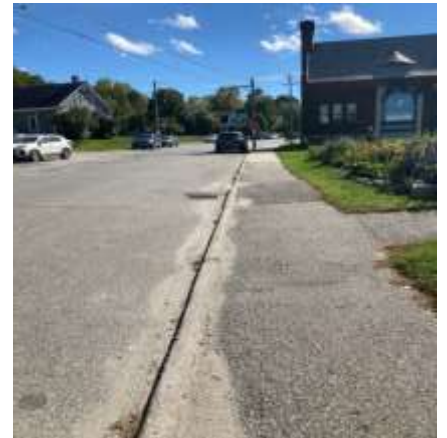
- 10) Several motorists did not appear to be following the posted speed limit. Speed was reduced to venture past parked cars – one lane only available to traffic. After the segment with this obstruction, vehicles picked up speed quickly.

- 11) Parking in general is difficult to navigate. Many vehicles were observed stopping to allow oncoming traffic to pass in an attempt to navigate the roadway. The road width of 22-23 feet does not allow for parked vehicles and two lanes of traffic. At this time, however, the parked cars act as traffic calming devices. (See #10)
