# Dam Safety Inspection Report

Name: **East Long Pond Dam**  
State ID: **252.02** NID ID: **VT00185**  
Hazard Class: **High Hazard Potential**

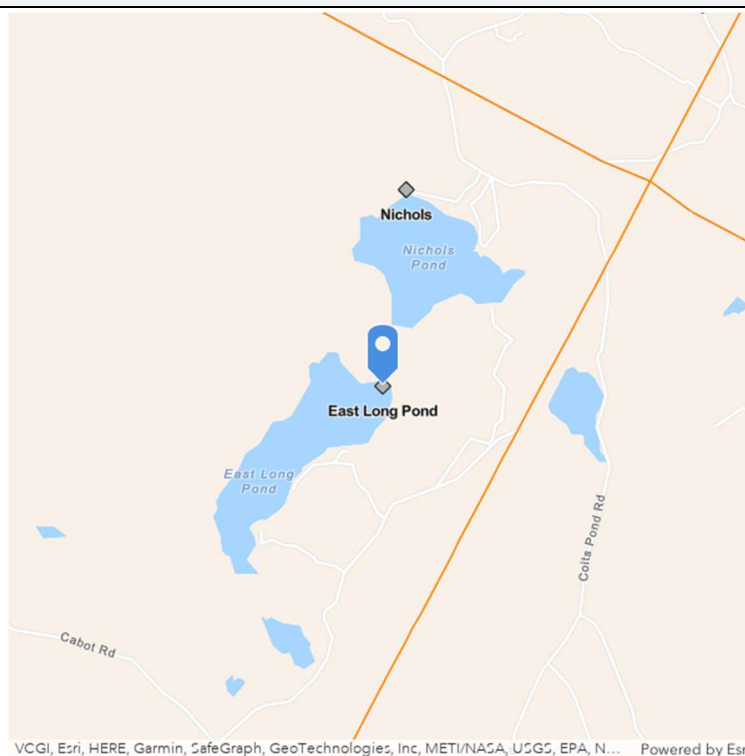
VCGL, Esri, HERE, Garmin, SafeGraph, GeoTechnologies, Inc, METI/NASA, USGS, EPA, N... Powered by Esri

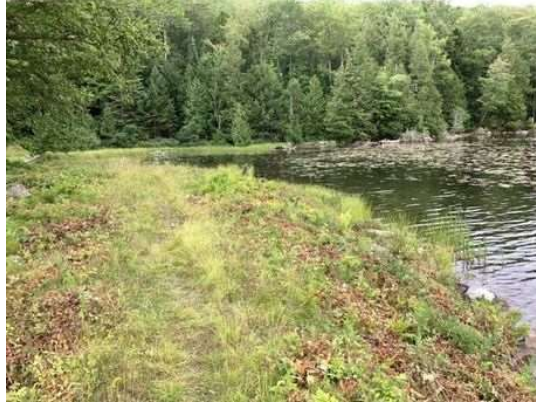
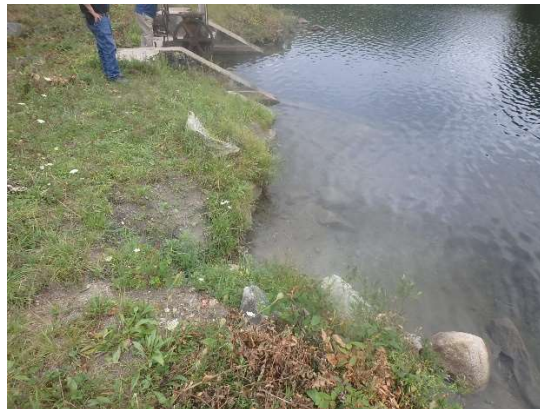
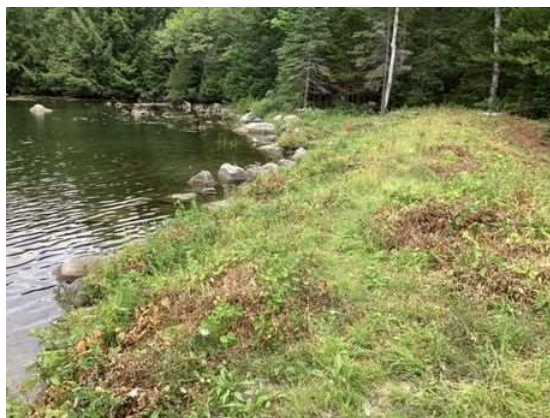
Crest	
<b>Length:</b> 260 ft	<b>Width:</b> 8 to 10 feet
<b>Freeboard:</b> Principal spillway to dam crest: 2.0 ft Auxiliary spillway to dam crest: 1.2 ft	
Additional comments:

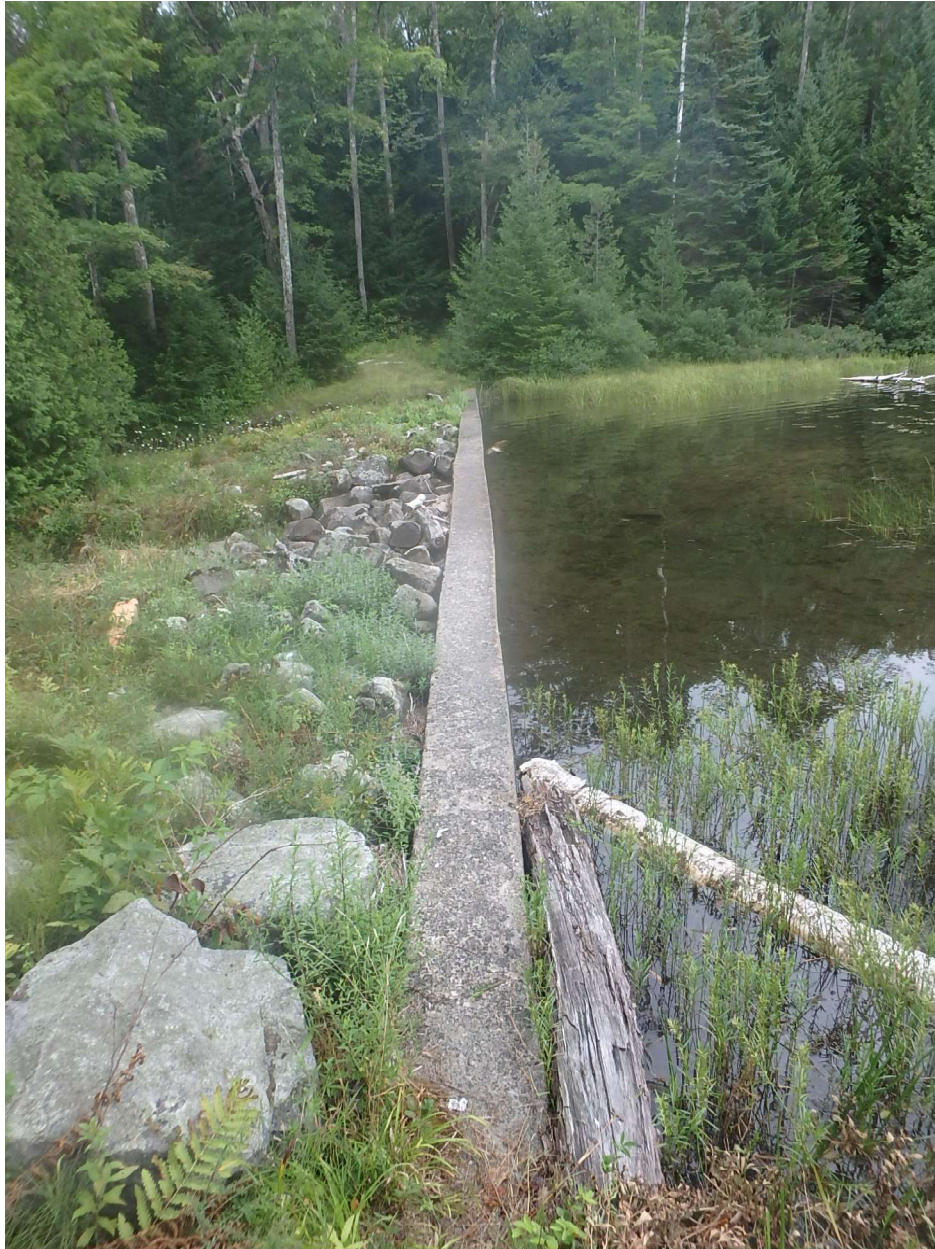
**Principal spillway images**

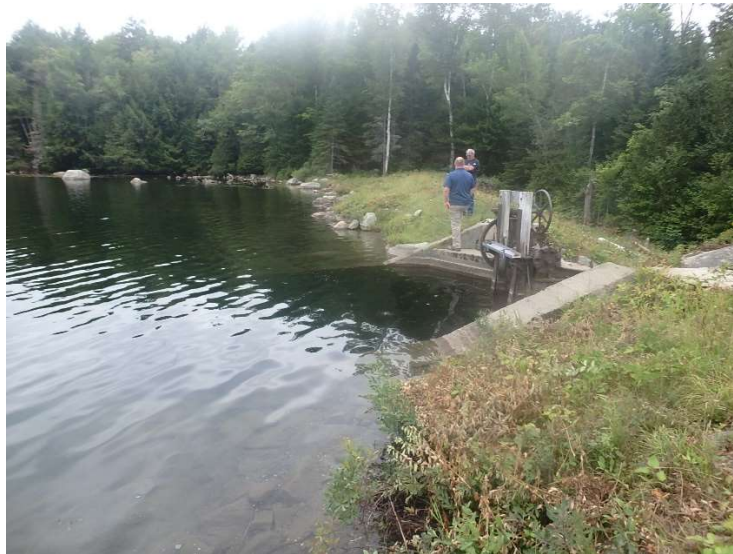
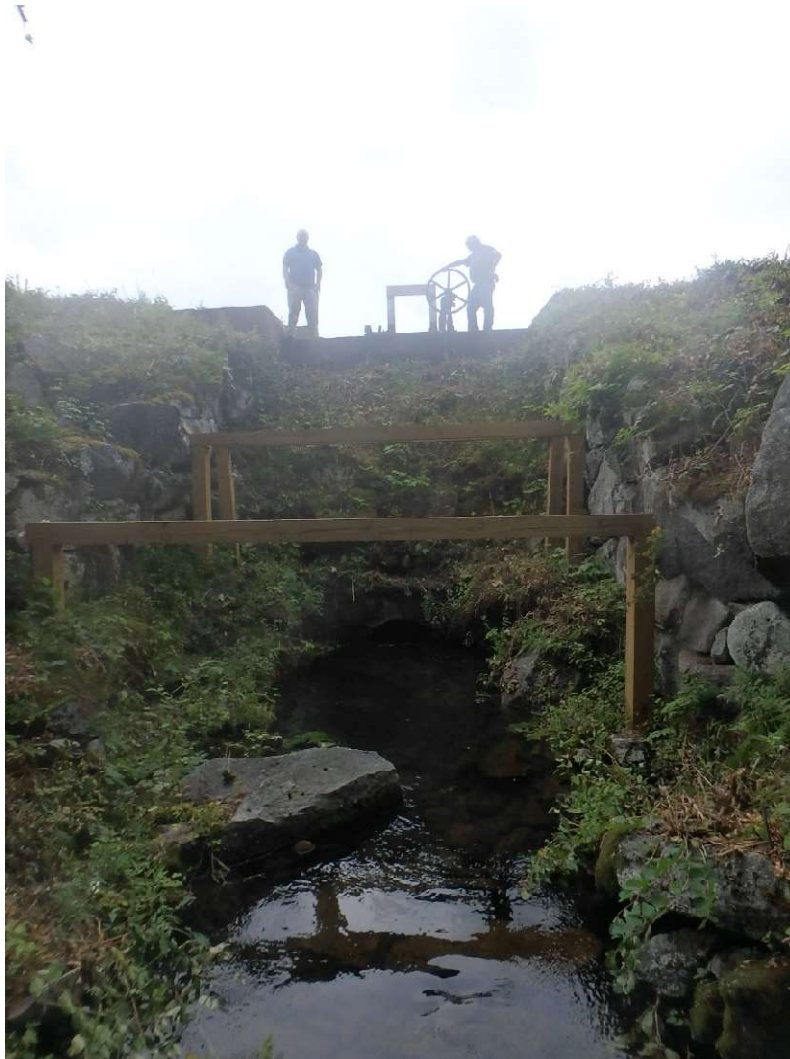
**Auxiliary spillway images**

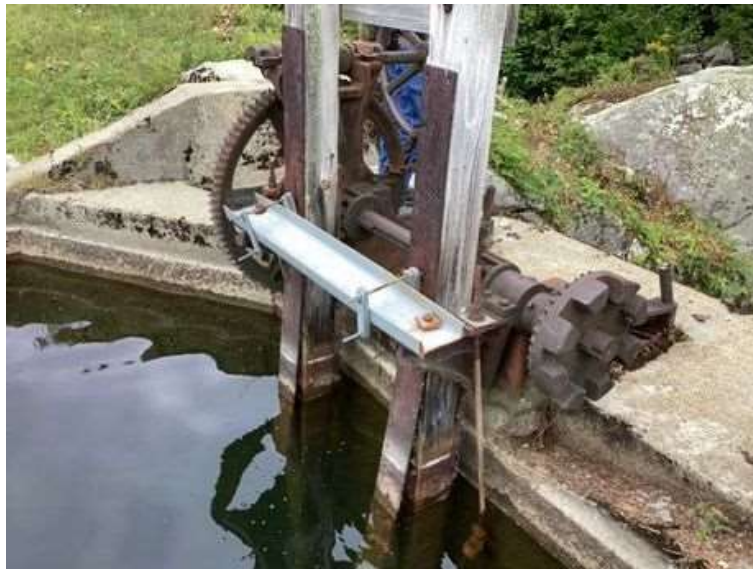
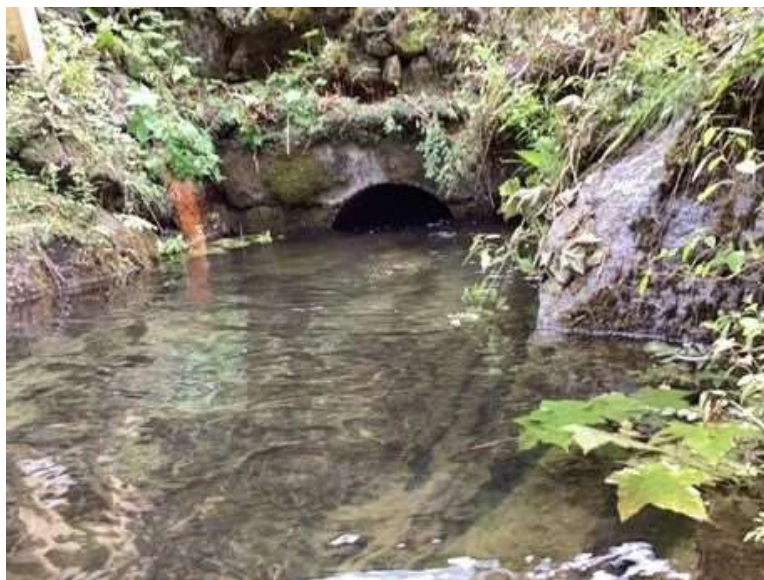
## GENERAL INFORMATION
