Dam Safety Inspection Report

Name: **Mackville Pond Dam**
State ID: **93.02** NID ID: **VT00245**
Hazard Class: **High Hazard Potential**

Town: **Hardwick**
Watershed: **Lamoille River**
Stream: **Nichols Brook**

Inspection date: 08/10/2022 10:02

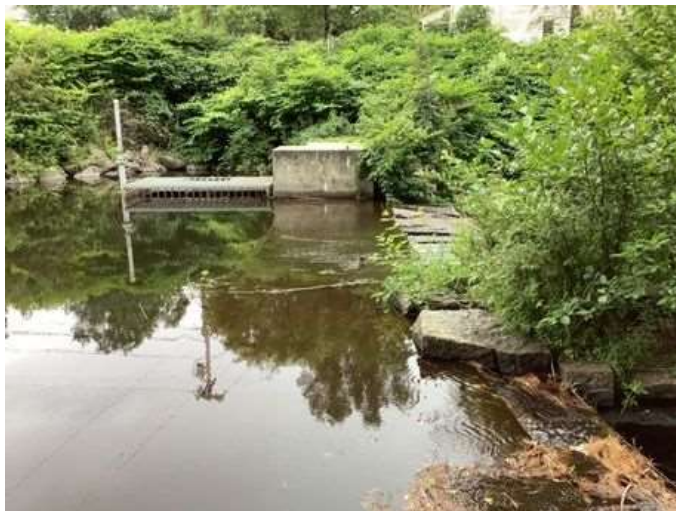
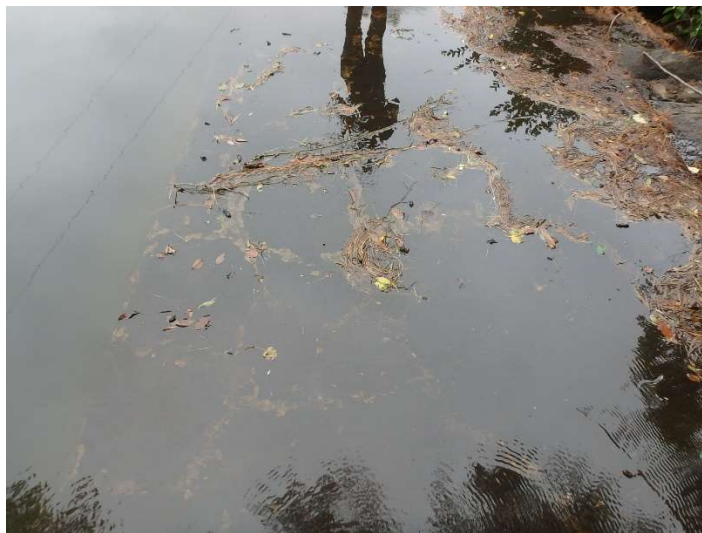
Crest images

Crest issues	Action
Concrete scaling was observed along the crest of the structurally independent concrete cutoff wall.	<input type="checkbox"/> None <input checked="" type="checkbox"/> Monitor <input type="checkbox"/> Maintenance <input type="checkbox"/> Engineer

Crest area	<ul style="list-style-type: none"> Monitor the concrete surface conditions. Perform minor surficial repairs as needed.

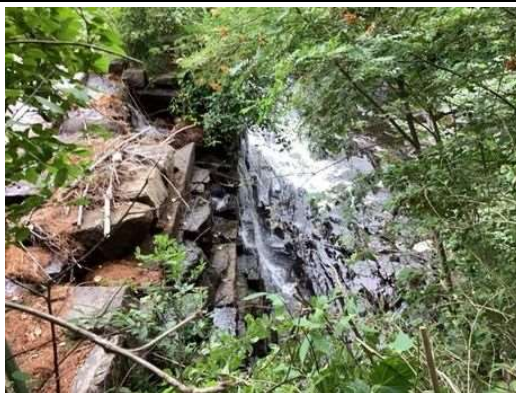
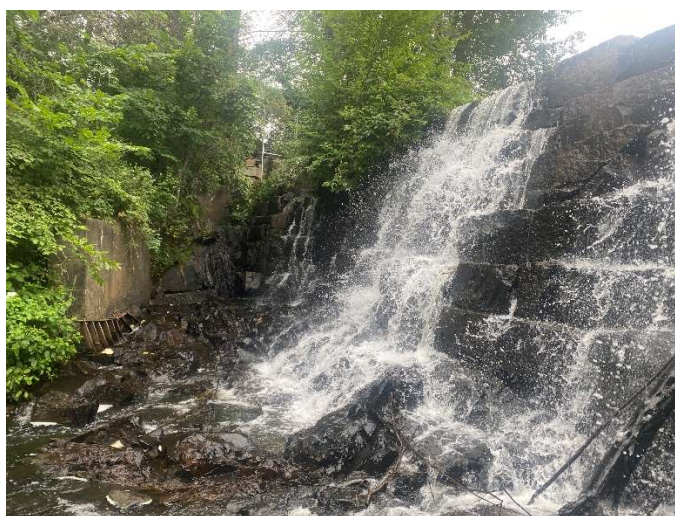
Downstream Masonry Wall Images

The downstream masonry wall appears stable based on visual observation. Several voids (missing stones) are present.

Downstream Masonry Wall Issues	Action
<i>The downstream masonry wall is not considered integral to the performance of the dam due to the structurally independent upstream concrete cutoff wall.</i>	n/a

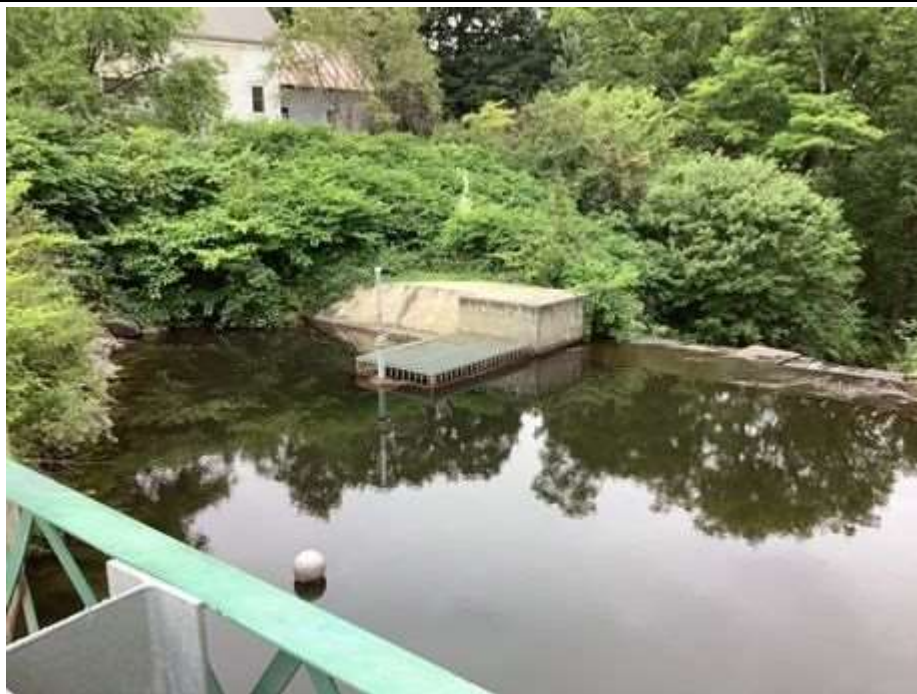
Principal spillway images

Principal spillway issues	Action
Deteriorating concrete Issues: <input type="checkbox"/> Bug holes <input checked="" type="checkbox"/> Popouts <input type="checkbox"/> Isolated crack <input checked="" type="checkbox"/> Hairline crack <input type="checkbox"/> Honeycombing <input type="checkbox"/> Exposed rebar <input checked="" type="checkbox"/> Efflorescence <input type="checkbox"/> Scaling <input type="checkbox"/> Disintegration <input type="checkbox"/> Spalling <input type="checkbox"/> Crazed/Map cracks <input type="checkbox"/> Other:	<input type="checkbox"/> None <input checked="" type="checkbox"/> Monitor <input type="checkbox"/> Maintenance <input type="checkbox"/> Engineer
Impacted area: Location: Other; Dam crest behind principal spillway. Other: The outlet barrel extending through the dam appeared to be in fair condition. The pipe is slightly squished, which has been observed during previous inspections.

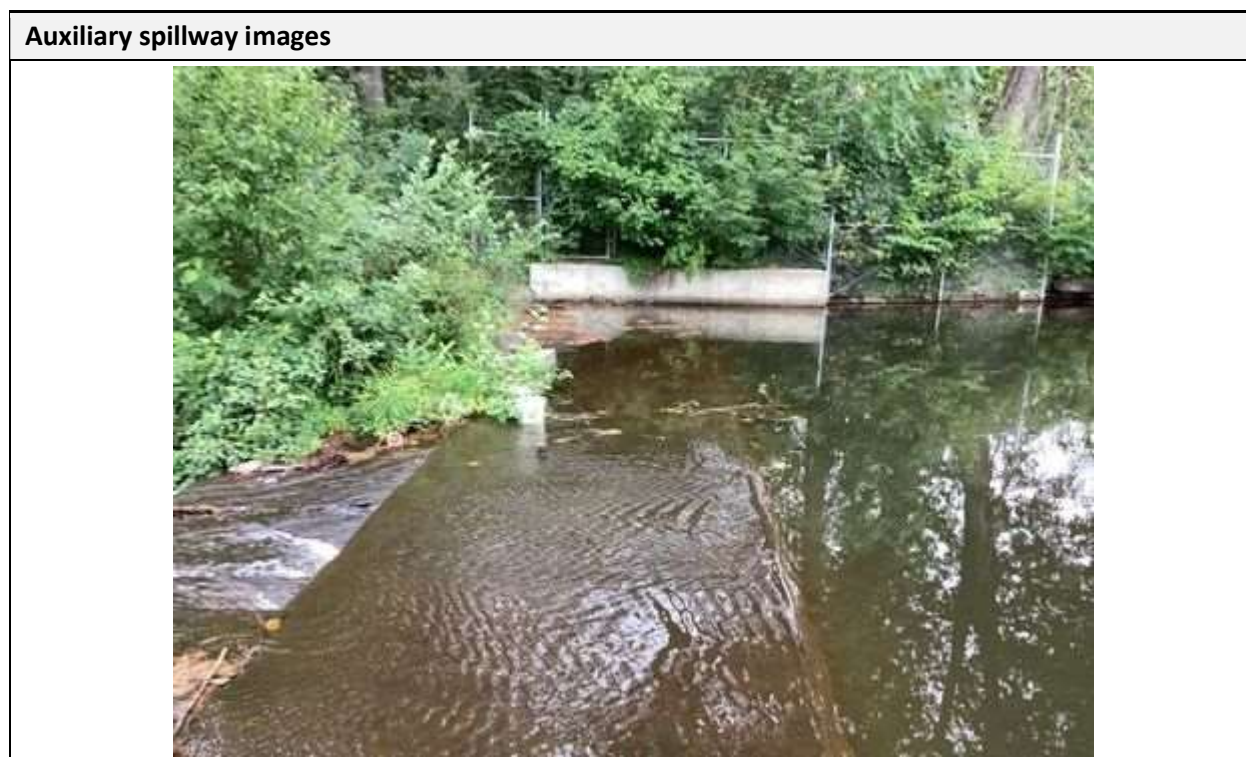
Auxiliary spillway issues	Action
Deteriorating concrete	
Issues:	
<input type="checkbox"/> Bug holes	<input type="checkbox"/> Popouts
<input checked="" type="checkbox"/> Hairline crack	<input type="checkbox"/> Honeycombing
<input type="checkbox"/> Efflorescence	<input checked="" type="checkbox"/> Scaling
<input type="checkbox"/> Spalling	<input type="checkbox"/> Crazed/Map cracks
Isolated crack	
Exposed rebar	
Disintegration	
Other:	
<input type="checkbox"/> None	
<input checked="" type="checkbox"/> Monitor	
<input type="checkbox"/> Maintenance	
<input type="checkbox"/> Engineer	
Impacted area: 7 ft x 7 ft ft	
Location: Right End

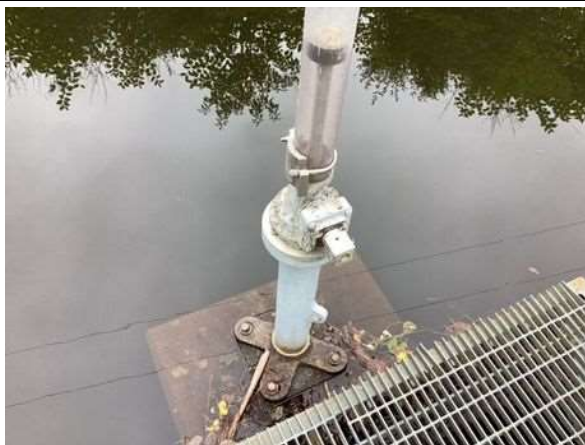
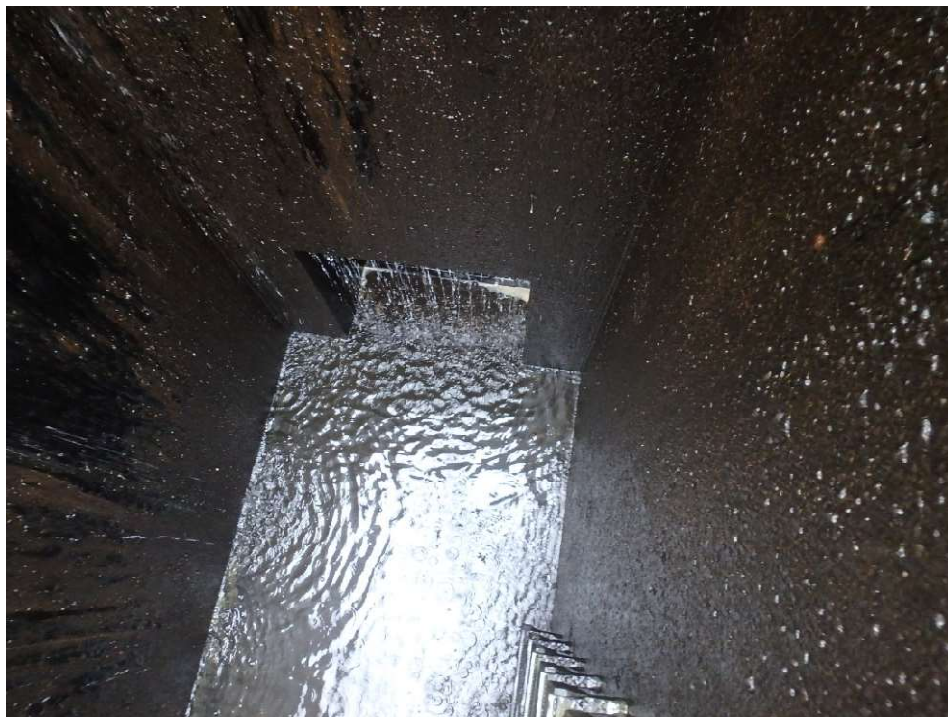
Low Level Outlet Images

The dam includes a low-level outlet (LLO) which can be used to drain the pond. The LLO consists of a slide gate located at the base of the principal spillway drop inlet structure which can be operated via an operator located in top of the drop inlet structure. There did not appear to be leakage at the LLO.

The LLO was not test operated during the inspection.

It is unknown when the LLO was last test operated.
