Dam Safety Inspection Report

Name: **Nichols Pond**
State ID: **252.01** NID ID: **VT00184**
Hazard Class: **High Hazard Potential**

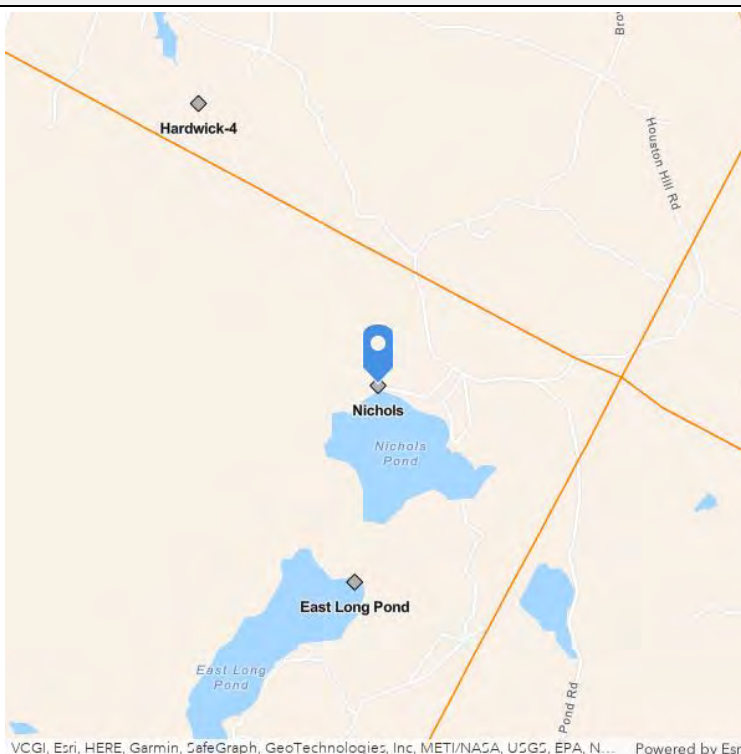
**Emergency Action Plan**

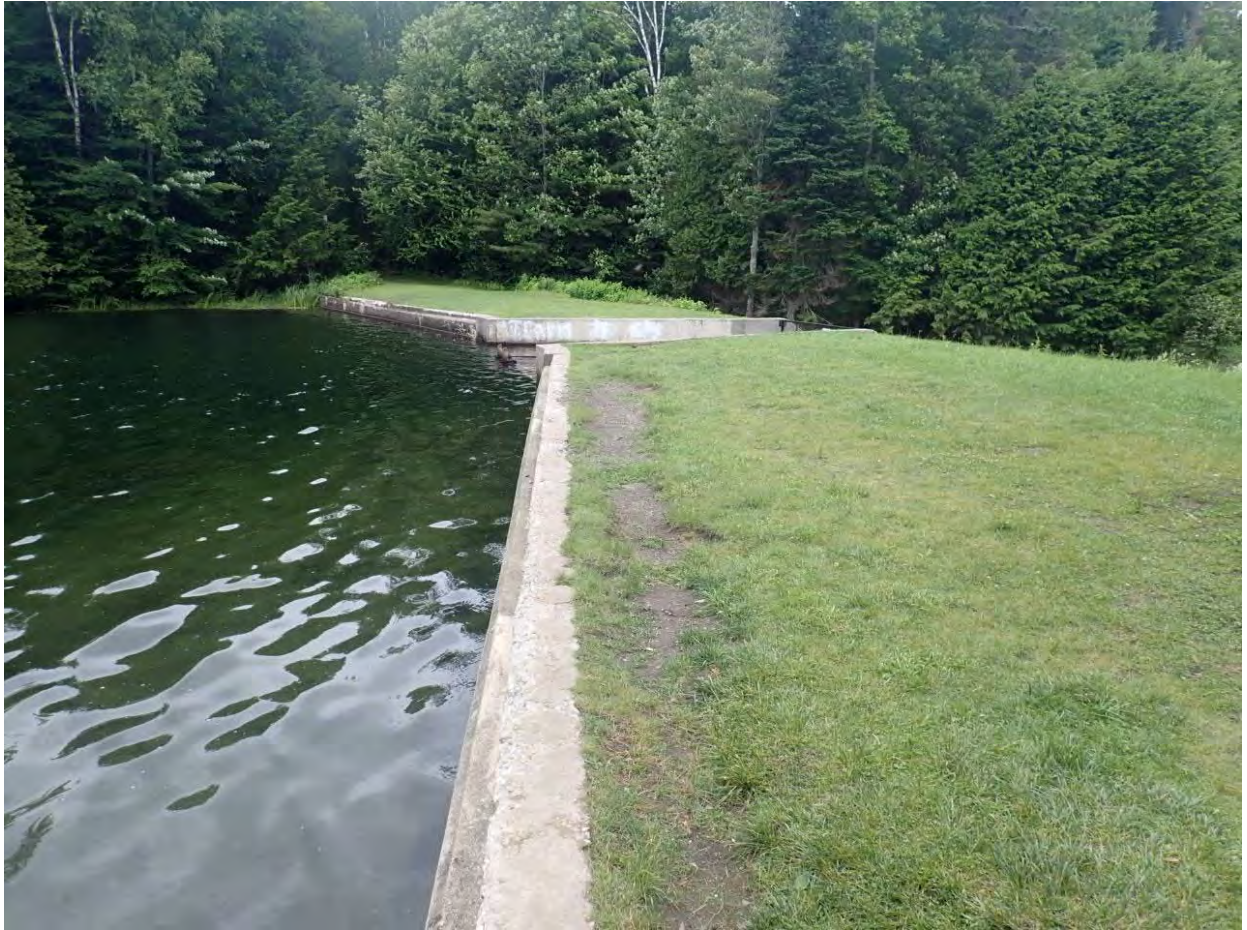
**Downstream Slope**

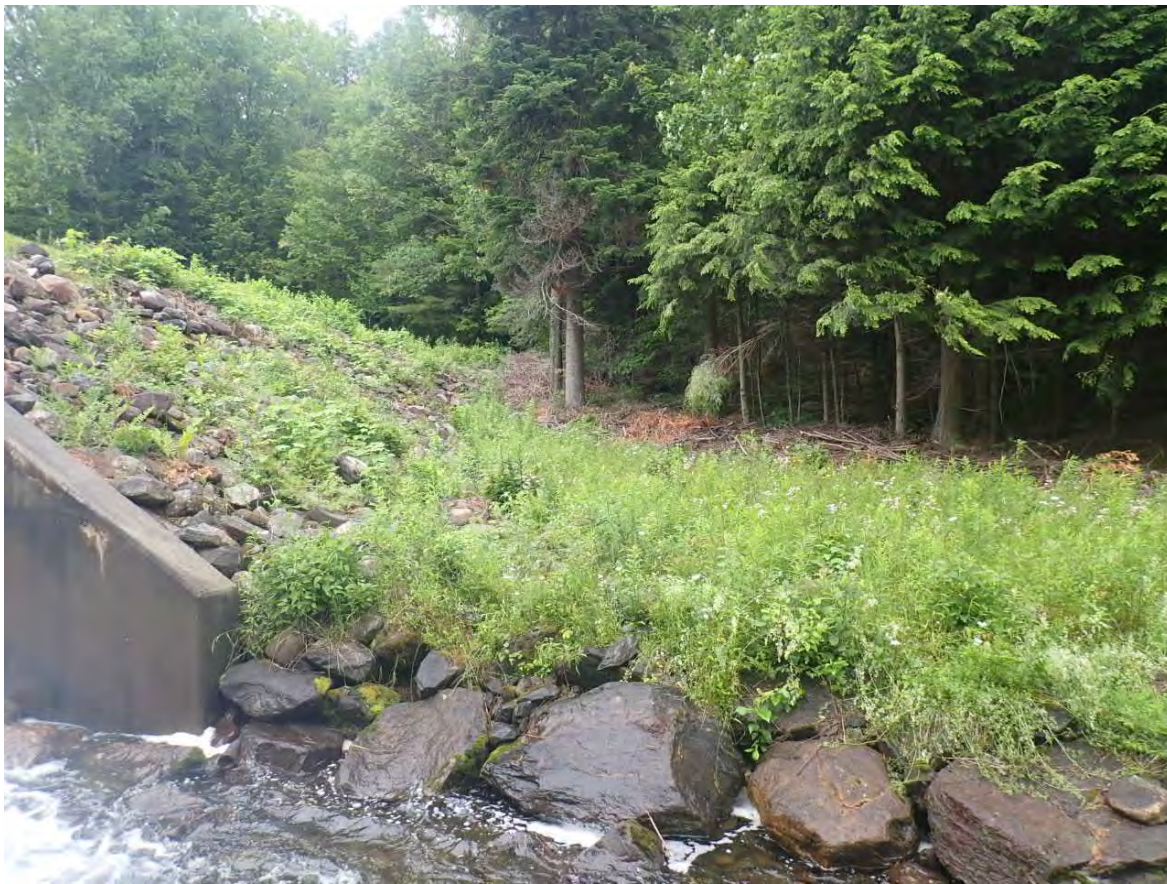
Downstream slope images

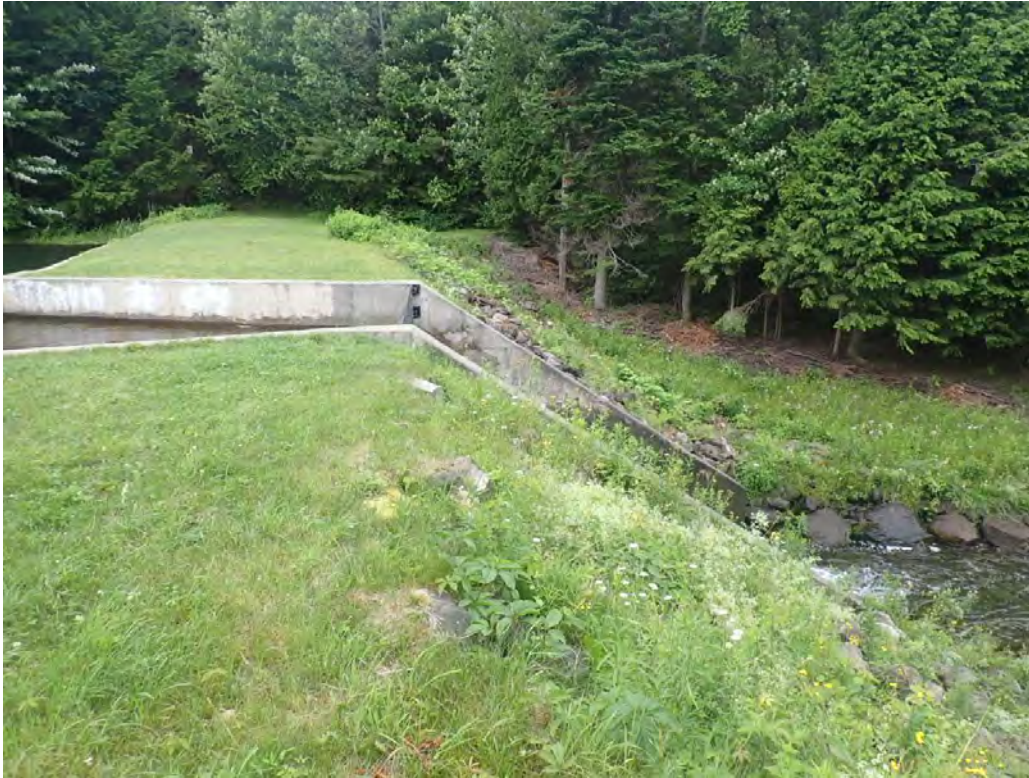
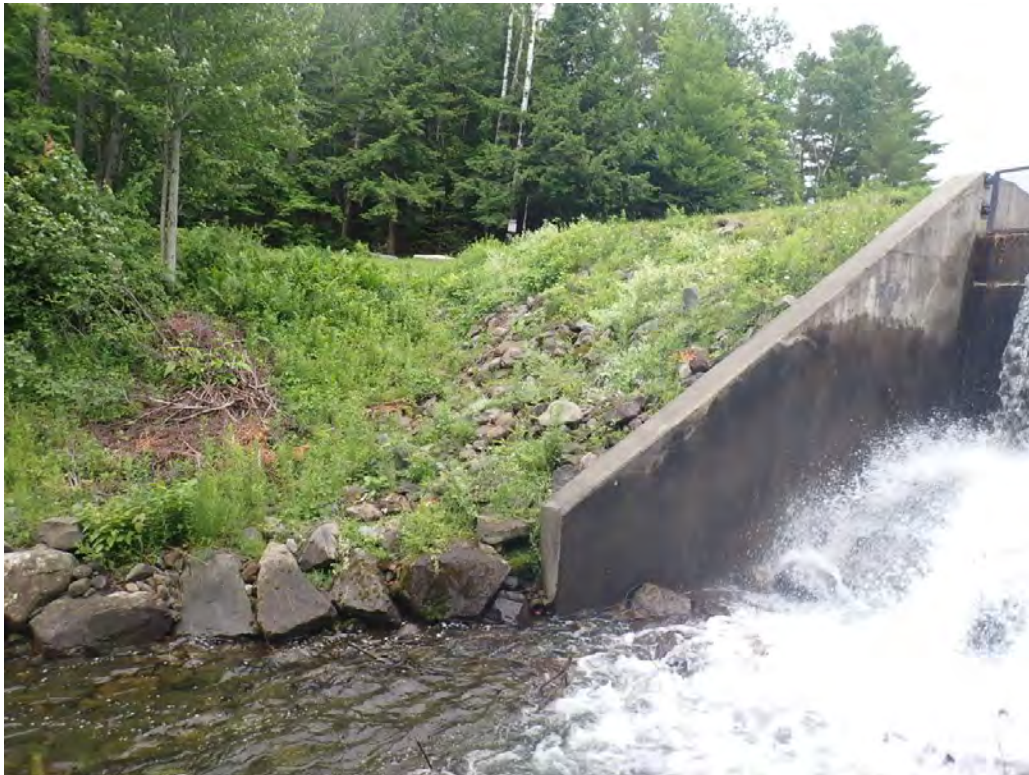
Instrumentation
No instrumentation found

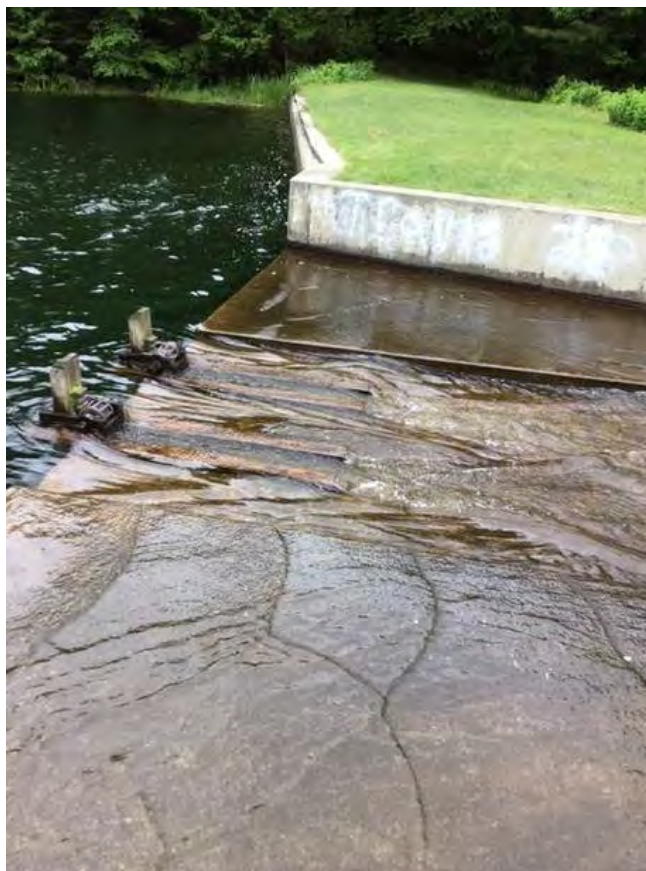
**Auxiliary Spillway****Spillway type:** Weir**Primary material:** Concrete**Weir:** Broad-Crested**Spillway location:** Center of dam**Water level measured against auxiliary crest:** 1"**Erosion control structures:** End Sill, Rock-Lined Channel**Spillway components:**☐ Anti-vortex plate☐ Filter Diaphragm☒ Training Walls☐ Flashboard☐ Trashrack☒ Other: Safety Rack

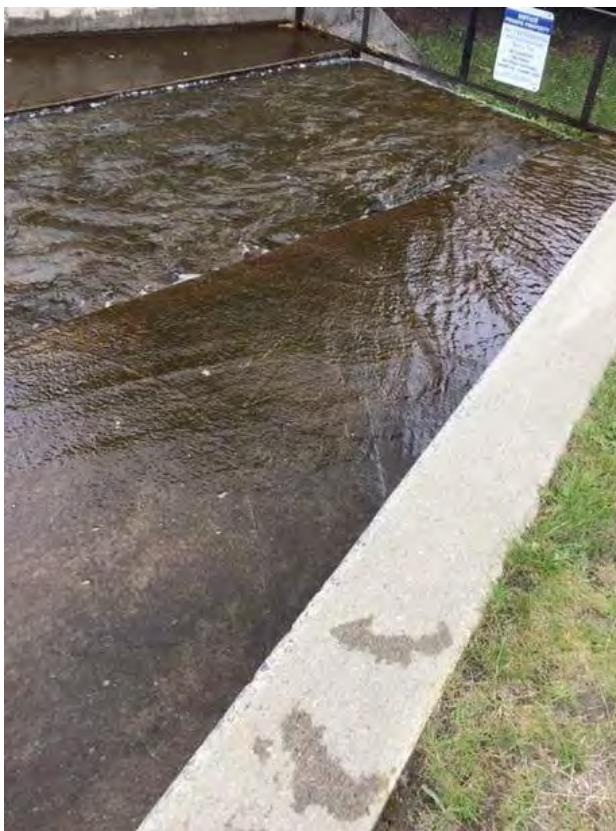
Auxiliary spillway images
