# Dam Safety Inspection Report

Name: **Hardwick Lake Dam**  
State ID: **93.01** NID ID: VT00186  
Hazard Class: Significant

Inspection date: 05/29/2024 08:36

Inspection type: Periodic

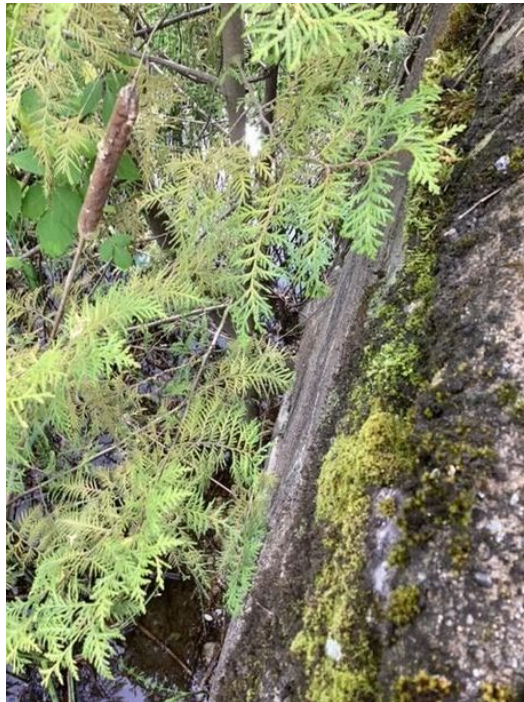
Could not inspect, brush covering areas preventing a thorough inspection. Several areas of minor damage.

Tree growing out of upstream wall about 150 feet down left wall.

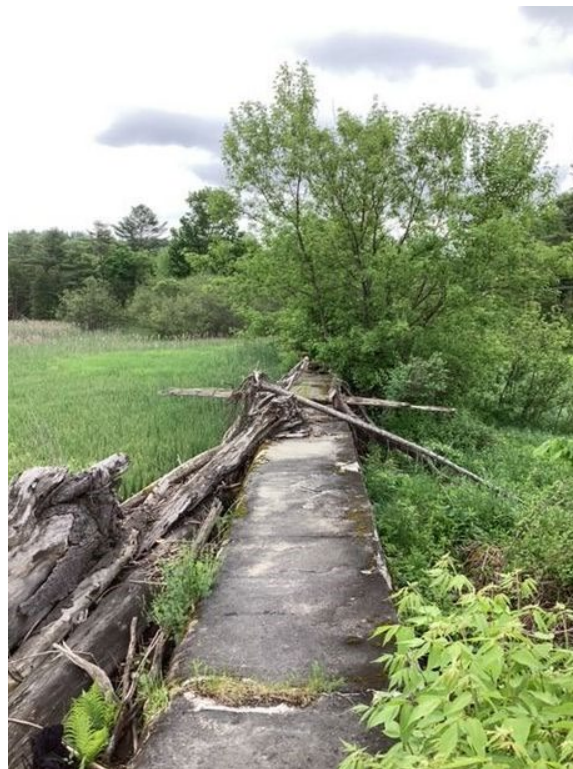
Debris and tree growth preventing a thorough inspection

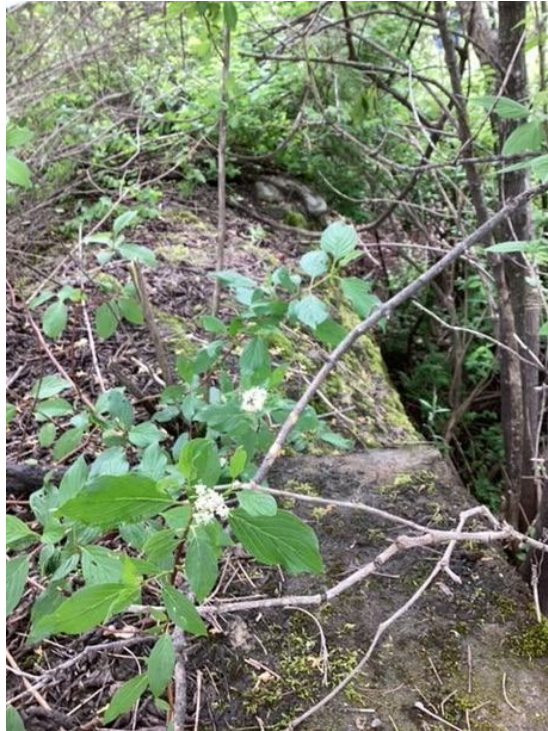
Part of left wall showing visible concrete deterioration and vegetation about 150 feet to the left of the principal spillway. Due to concrete deterioration, the crest elevation is lower than the rest of the wall at this location.

| Crest | Monitor the dam crest for signs of settlement, particularly to the left of the principal spillway along the non-overflow weir. Report any change of conditions to the DSP. |

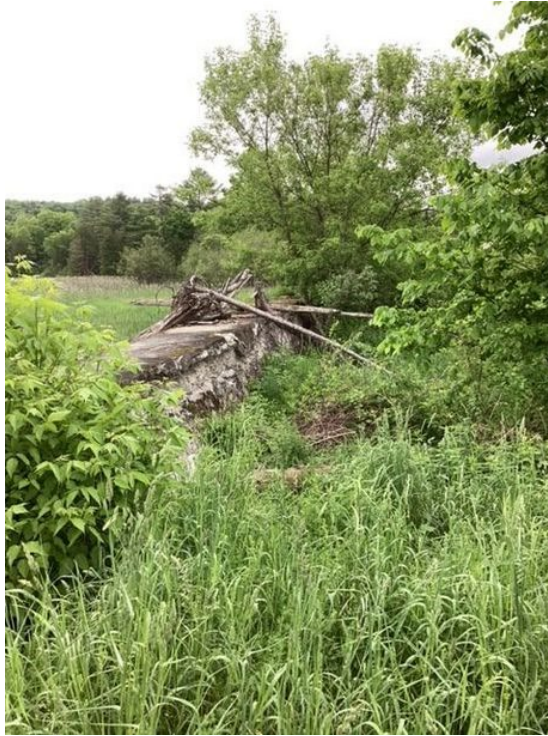
| Downstream Wall (Left Non-Overflow Wall) | |
|---|---|
| <b>Additional comments:</b> Largely overgrown with brush and trees which prevented a thorough inspection. Original wall appears to be encased in concrete which is delaminating in areas resulting in material loss on much of the downstream face. | <b>Surface condition:</b> Section loss to a depth of 3 to 5 inches is prevalent. |

Example of concrete deterioration and delamination on the downstream face.

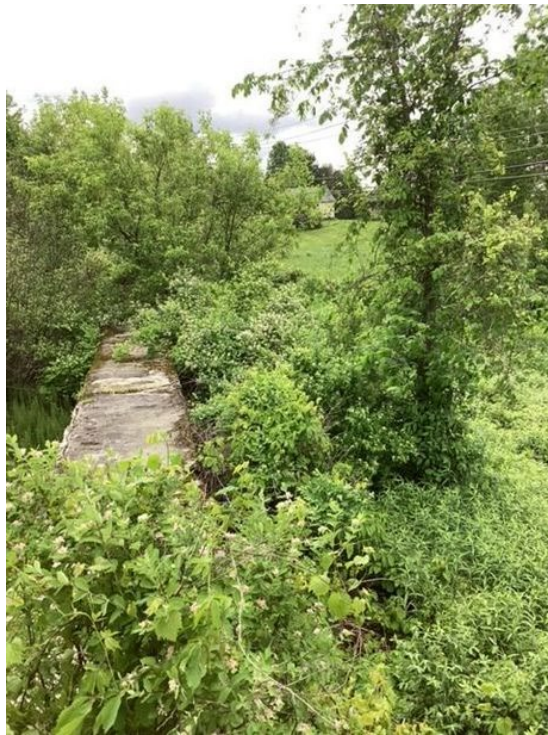
Vegetation obscuring downstream wall face.

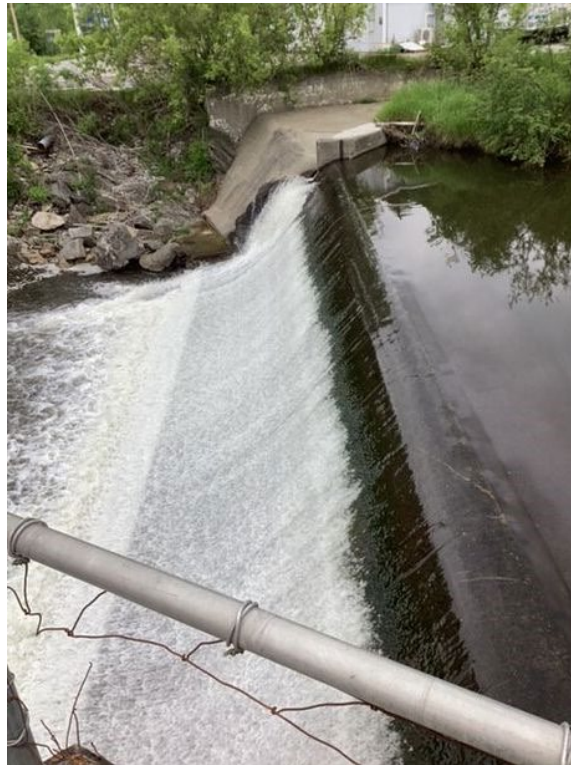
Ogee weir section on right side of dam.

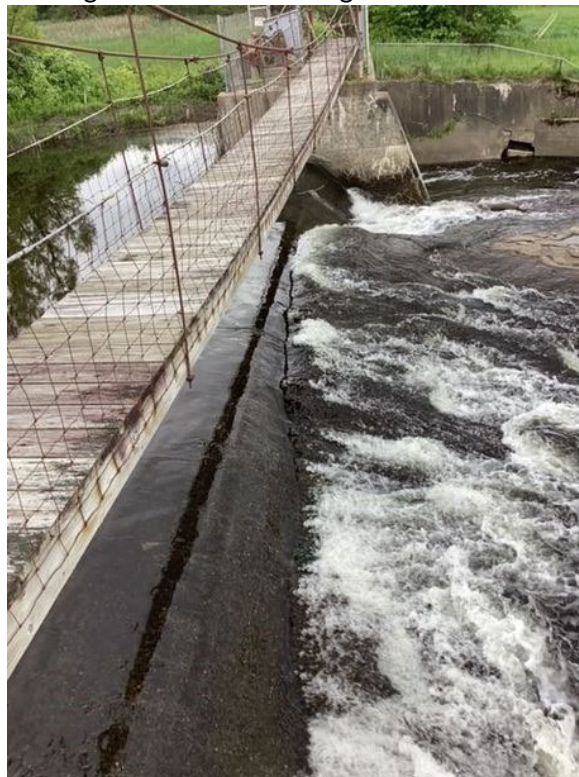
Weir section on left side.

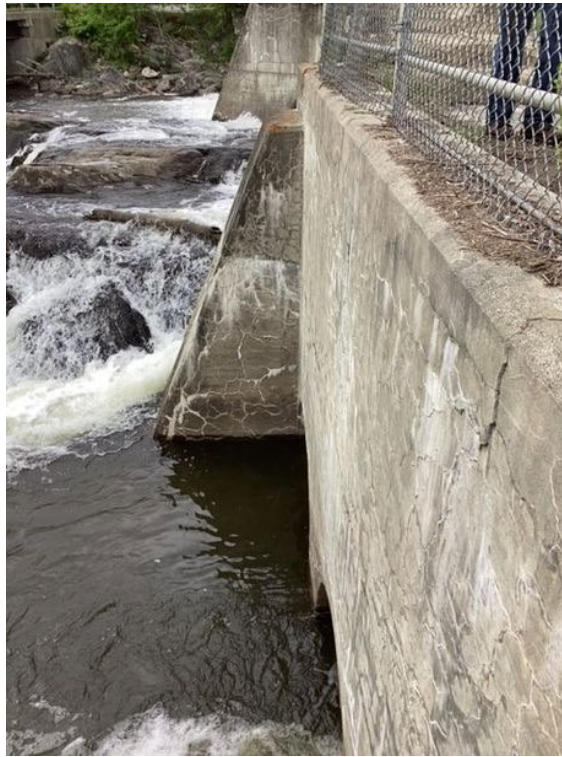
Effervescence and cracks above the two (2) 6-foot-diameter principal spillway outlet structure.

| Maintenance level recommendations | |
|---|---|
| | Monitor and repair minor concrete cracking and deterioration, as well as the condition of the concrete joints. |

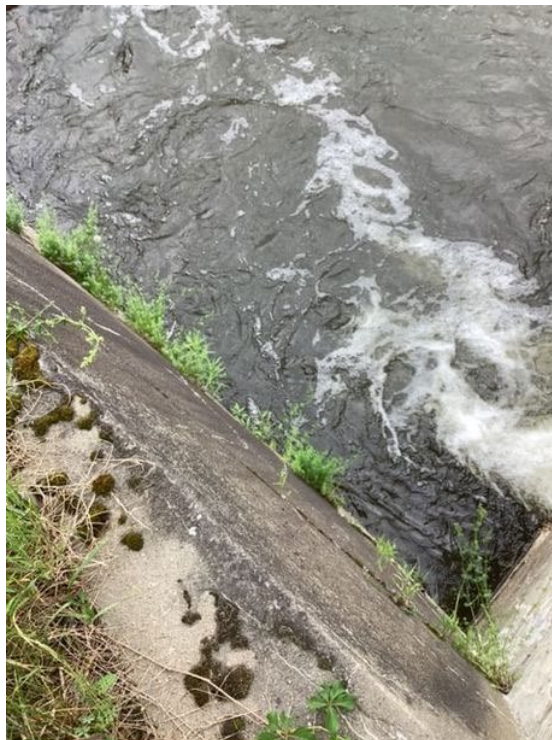
Bulging of the training wall on the left side of where the two (2) 6-foot-diameter principal spillway outlet barrels discharge.

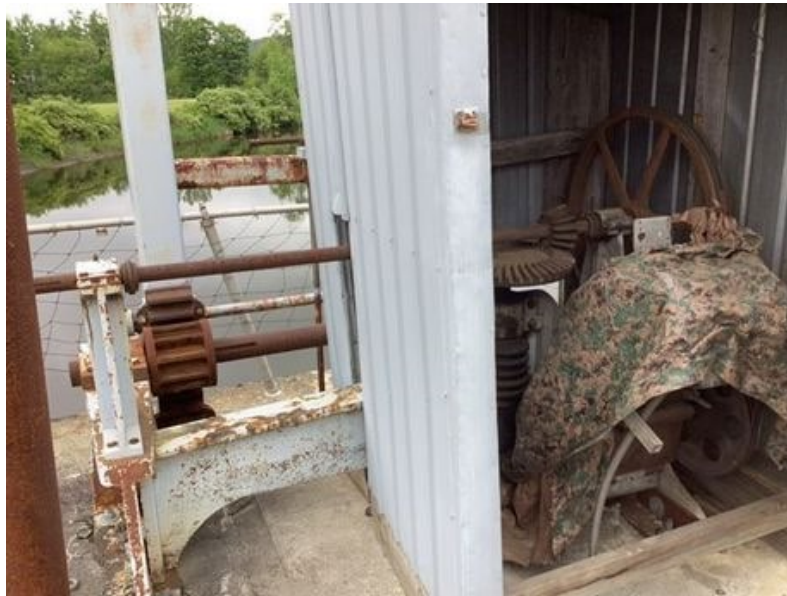
Gate across wooden spillway cable bridge.

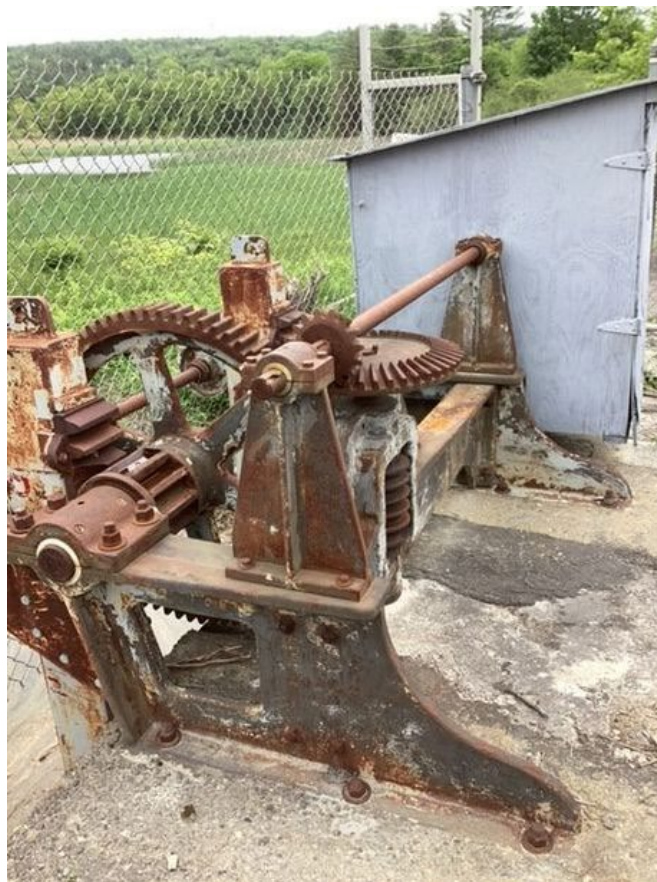
**Additional comments:** Outlet was not operated during inspection. The lake is reportedly lowered using this outlet works in the winter. Leakage through this gate was observable.

On left gate at the entrance of the spillway. Both gates are closed but are heavily leaking.

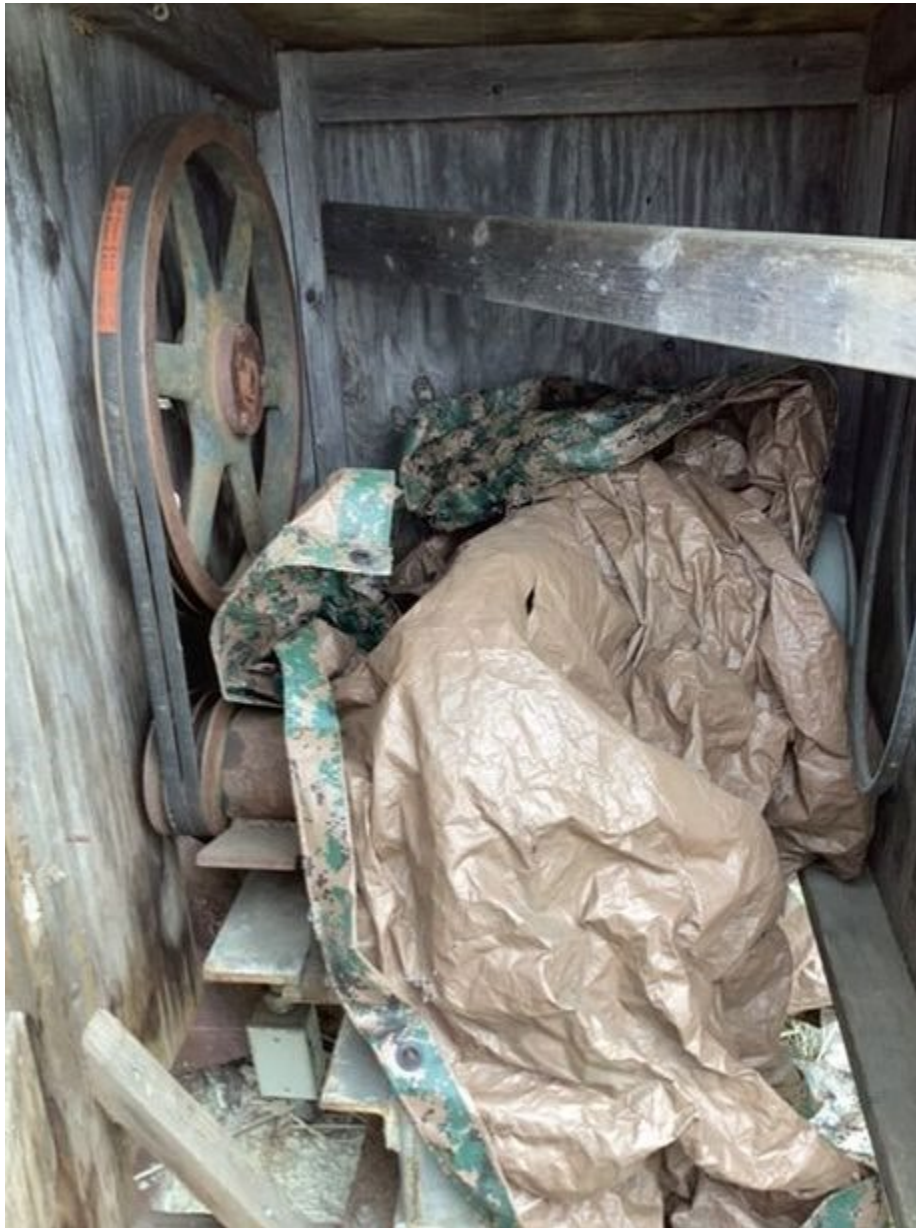
The mechanism and visible condition of the gate operator appears poor. The condition of the gate itself could not be determined.

Inside of the housing where the gate operator is located for the left main gate.

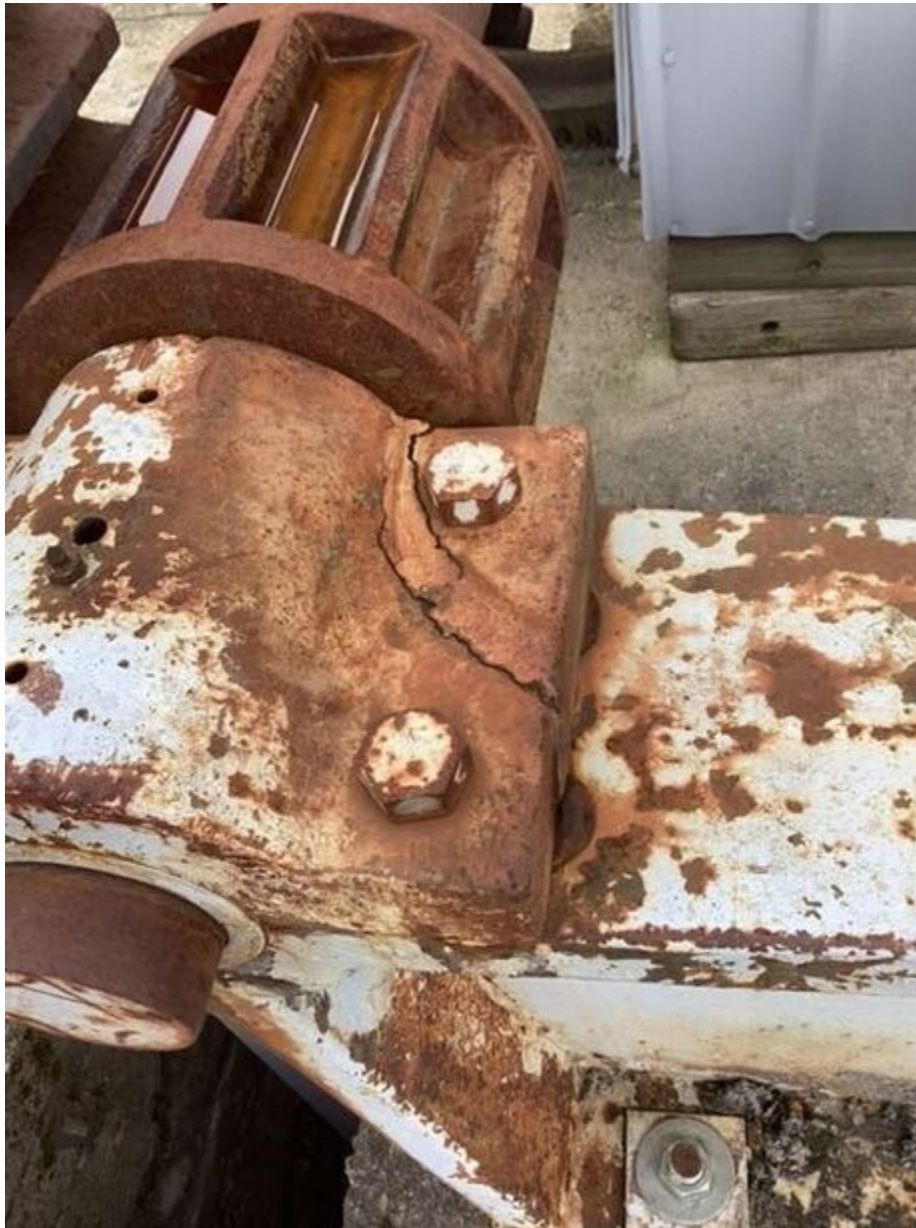
Crack observed in gate support.

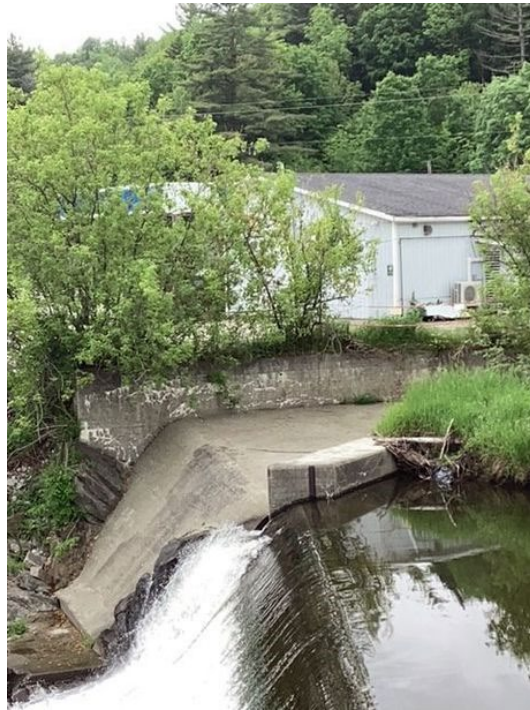
Auxiliary spillway at the right abutment.

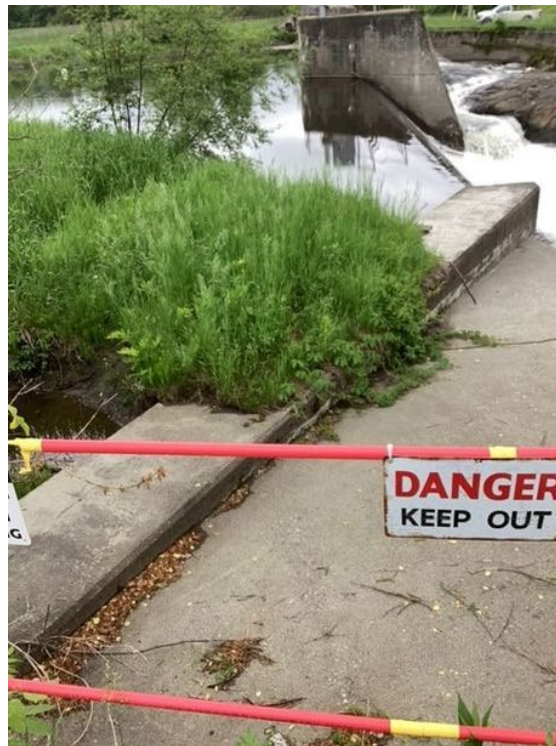
Broad crested auxiliary spillway weir from right abutment.

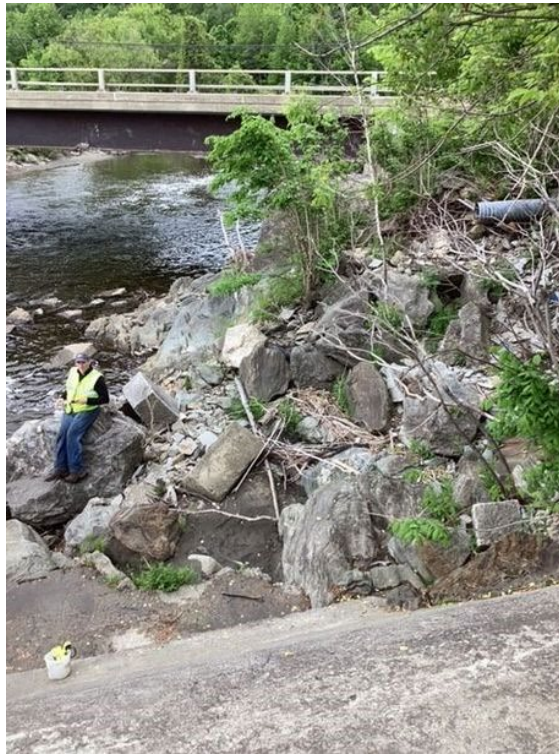
Auxiliary Spillway discharges onto a splash pad that appears to be founded on bedrock.
