Jackson Dam (VT#93.01)

Dam Removal Feasibility Analysis

Caledonia County Natural Resources Conservation District

SLR International Corporation

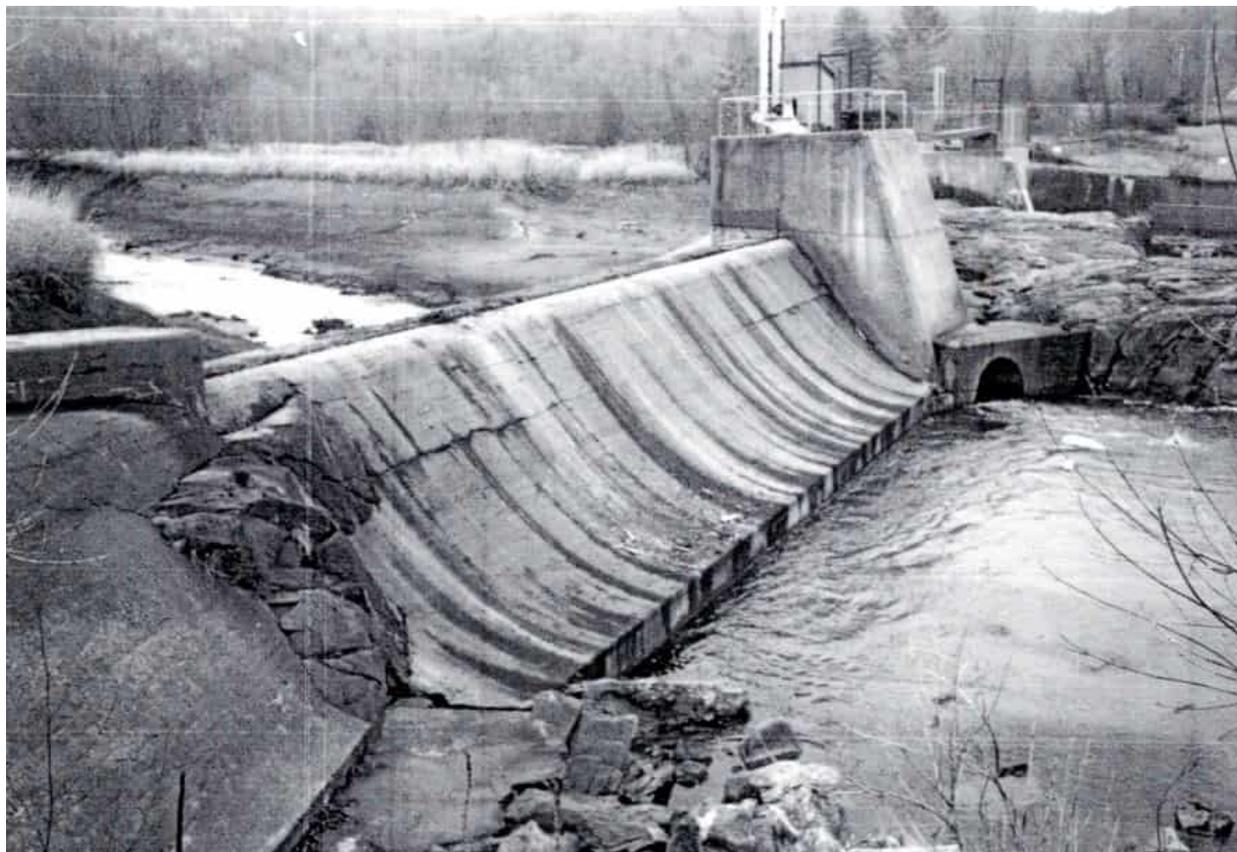
Figure 11: Jackson Dam during winter draw down (Knight, 2001)

Jackson Dam was inspected in November 2001 by Knight Consulting Engineers, Inc. It was reported that a long horizontal crack exists on the upstream and downstream face of the primary spillway and outlet structure (Figure 11; Figure 12). The concrete cap from the 1952 repairs is failing as a result of either settlement of the foundation due to improperly designed footing or the potential undermining of the low-level outlet pier. In addition, there was surface deterioration of

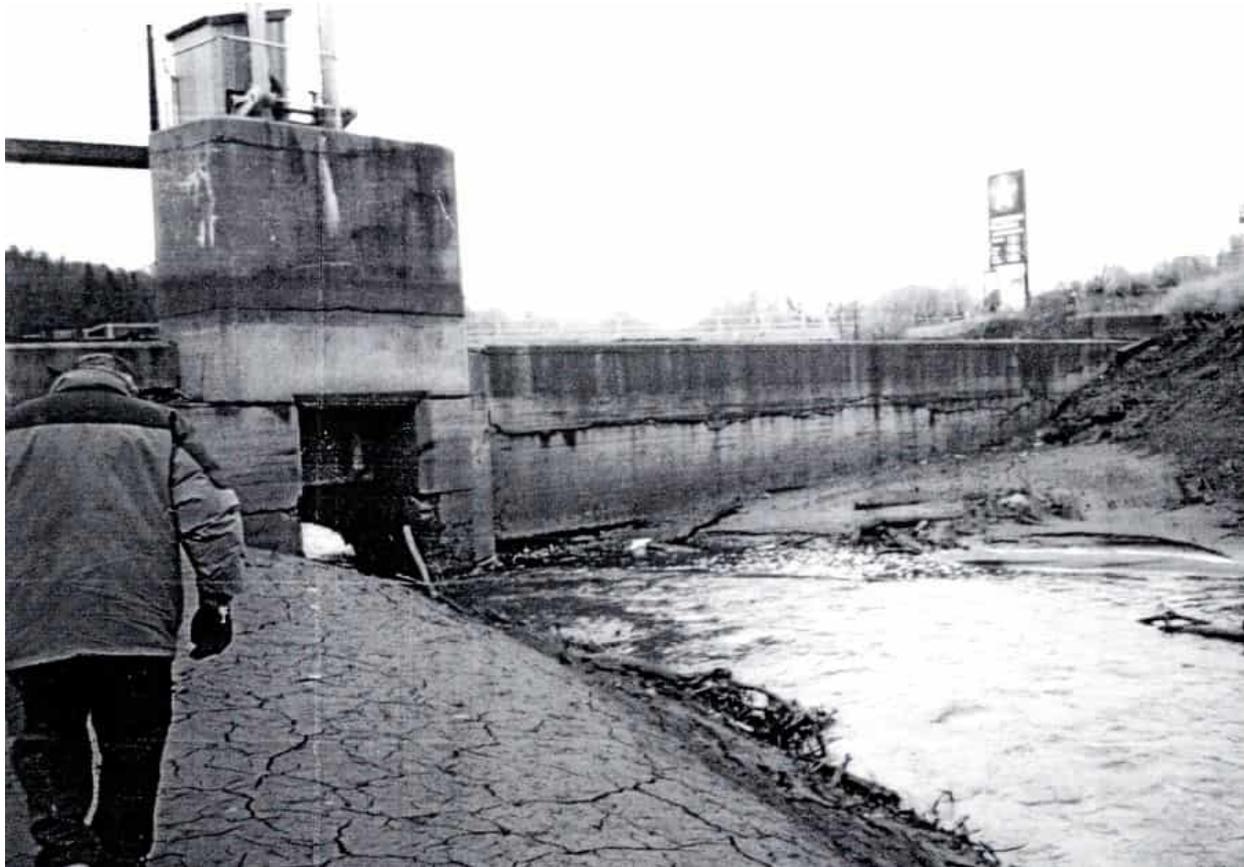
Figure 12: Upstream face of Jackson Dam with large horizontal crack (Knight, 2001)

Engineers at DuBois & King Inc. provided an estimated cost of repair for the dam based on deficiencies identified in the dam inspection. It was recommended to remove the concrete cap and repair the foundation in the main spillway section of the dam. In addition, repairs to the 300-foot non-overflow wall, structural concrete repairs to the mid-level outlet structure and repairs of the outlet gate were recommended. The cost of repairs was estimated to be approximately \$600,000 in 2001 (Tucker, 2002). Repair costs are likely to be significantly higher today due to continued deterioration, inflation, and additional dam safety review and design criteria.

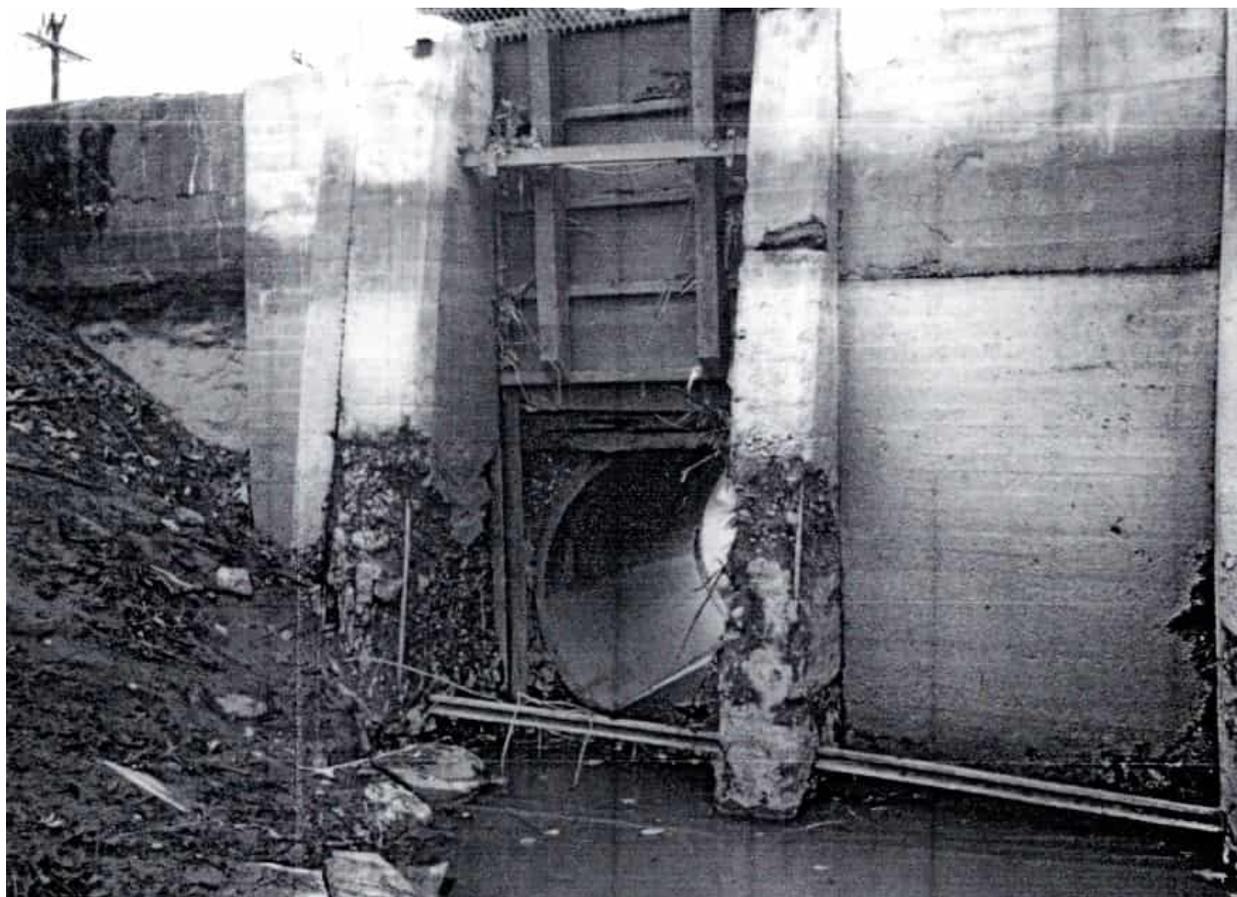
the 300-ft non-overflow wall to the left of the dam. The mid-level outlet structure on the left of the spillway had some cracking and there was undermining to the foundation area (Figure 13) (Knight, 2001) (Tucker, 2002).

Figure 13: Mid-level outlet from upstream of dam (Knight, 2001)

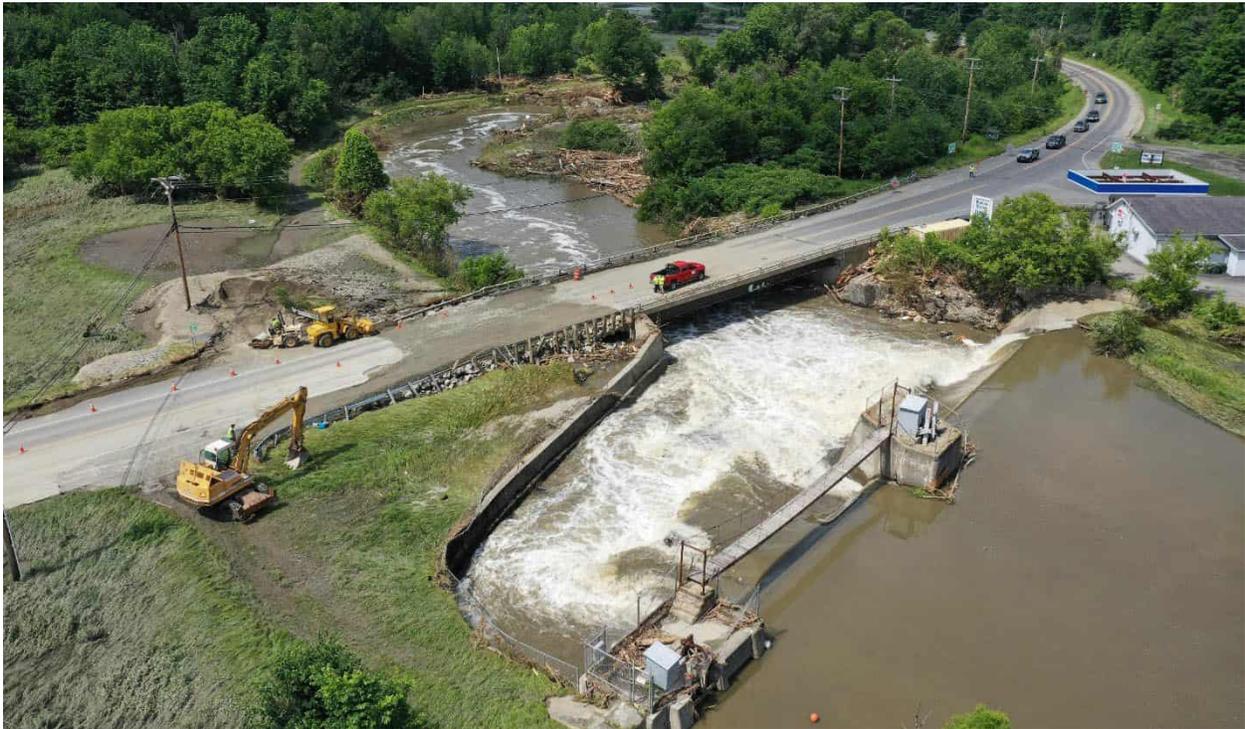
After the July 10, 2023 flooding event a rapid inspection found that the dam had overtopped as a result of the flood event.

Figure 22: Jackson Dam following the July 2023 flood event (AOT, 7/12/2023)

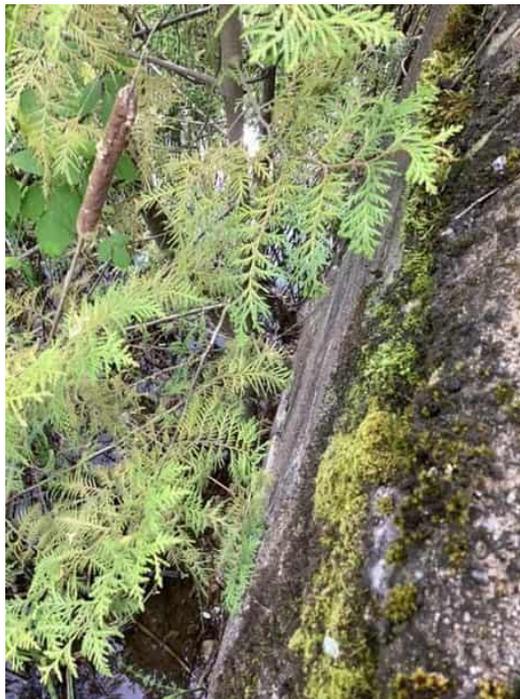
Tree growing out of upstream wall about 150 feet down left wall.

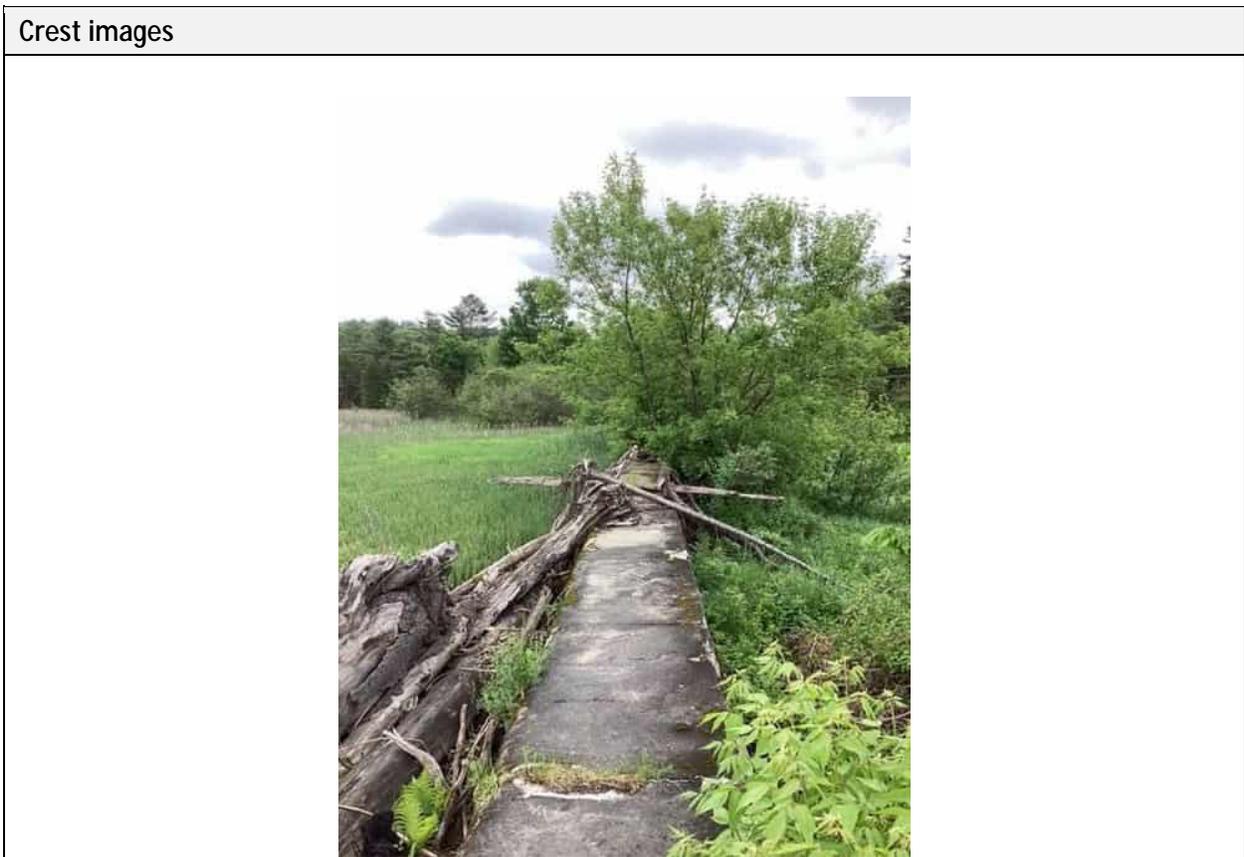
Crest issues	Action
<ul style="list-style-type: none"> • The crest is covered in brush and debris that prevented a thorough inspection. • An area of deteriorated concrete was observed resulting in a low point in the crest. • Just to the left of the structure that contains the two (2) 6-foot diameter outlet pipes, there was a small whirlpool observed on the upstream side and settlement on the crest be indicative of developing issue in this portion of the dam. 	<input type="checkbox"/> None <input type="checkbox"/> Monitor <input checked="" type="checkbox"/> Maintenance <input checked="" type="checkbox"/> Engineer

Debris and tree growth preventing a thorough inspection

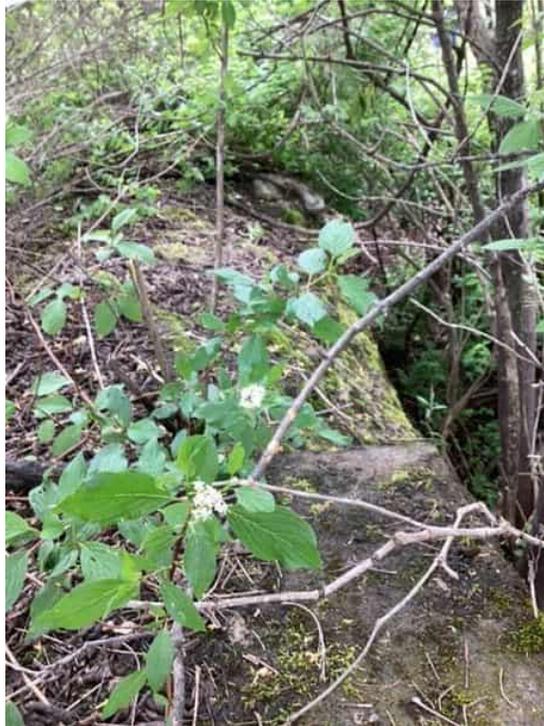
Part of left wall showing visible concrete deterioration and vegetation about 150 feet to the left of the principal spillway. Due to concrete deterioration, the crest elevation is lower than the rest of the wall at this location.

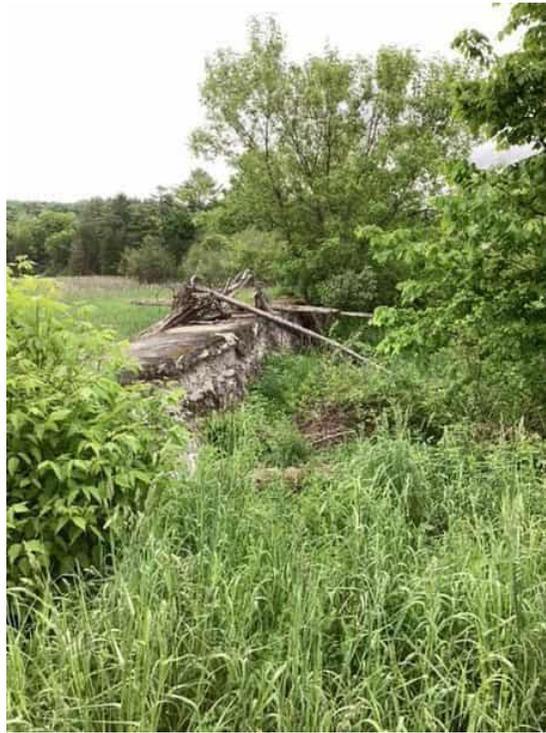
Example of concrete deterioration and delamination on the downstream face.

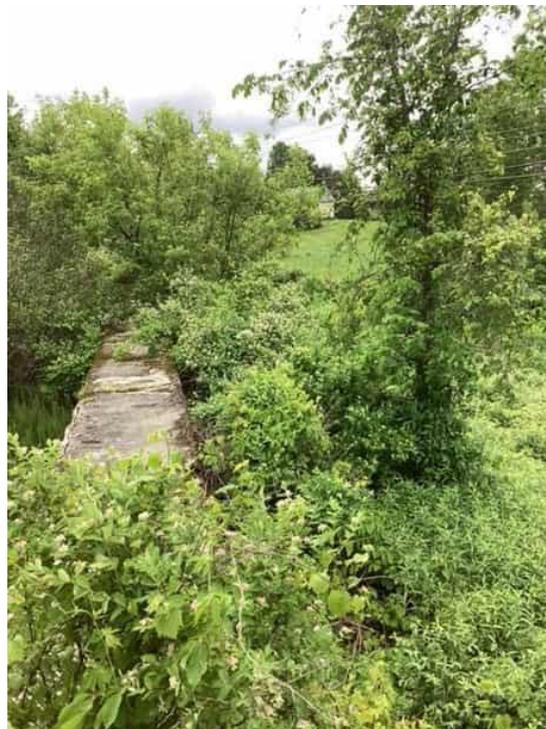
Vegetation obscuring downstream wall face.

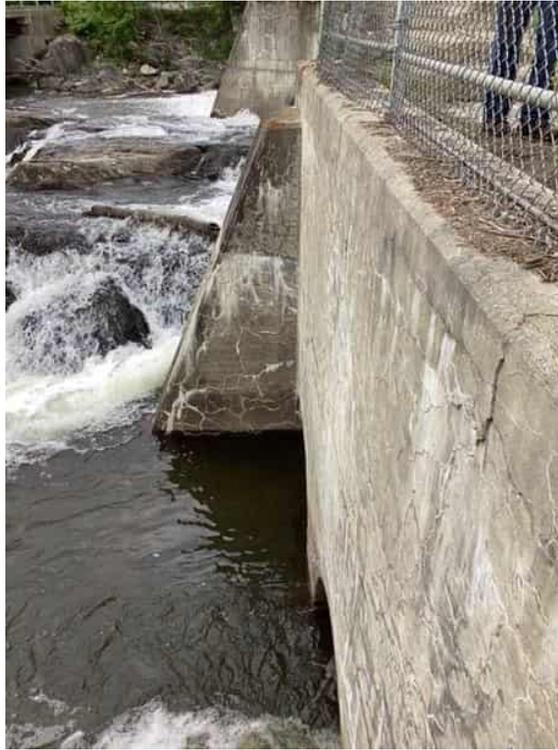
Effervescence and cracks above the two (2) 6-foot-diameter principal spillway outlet structure.

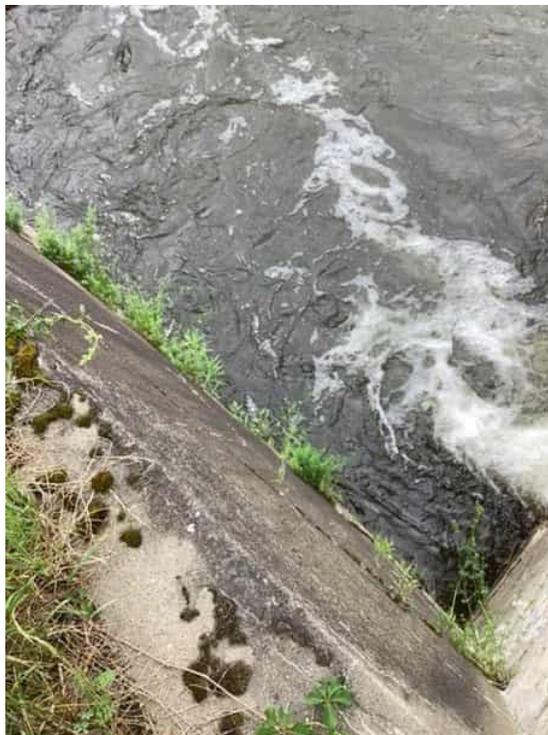
Bulging of the training wall on the left side of where the two (2) 6-foot-diameter principal spillway outlet barrels discharge.

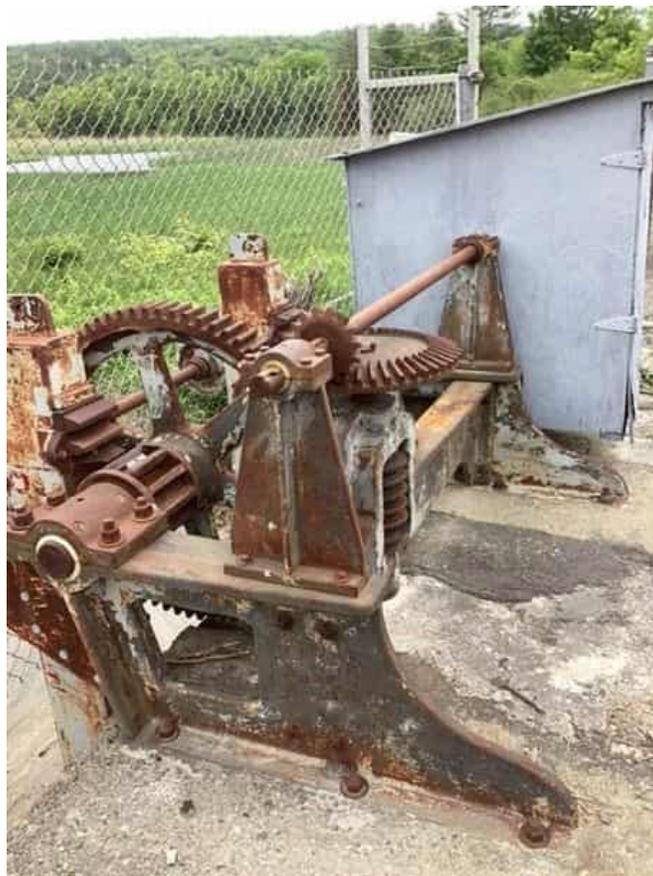
On left gate at the entrance of the spillway. Both gates are closed but are heavily leaking.

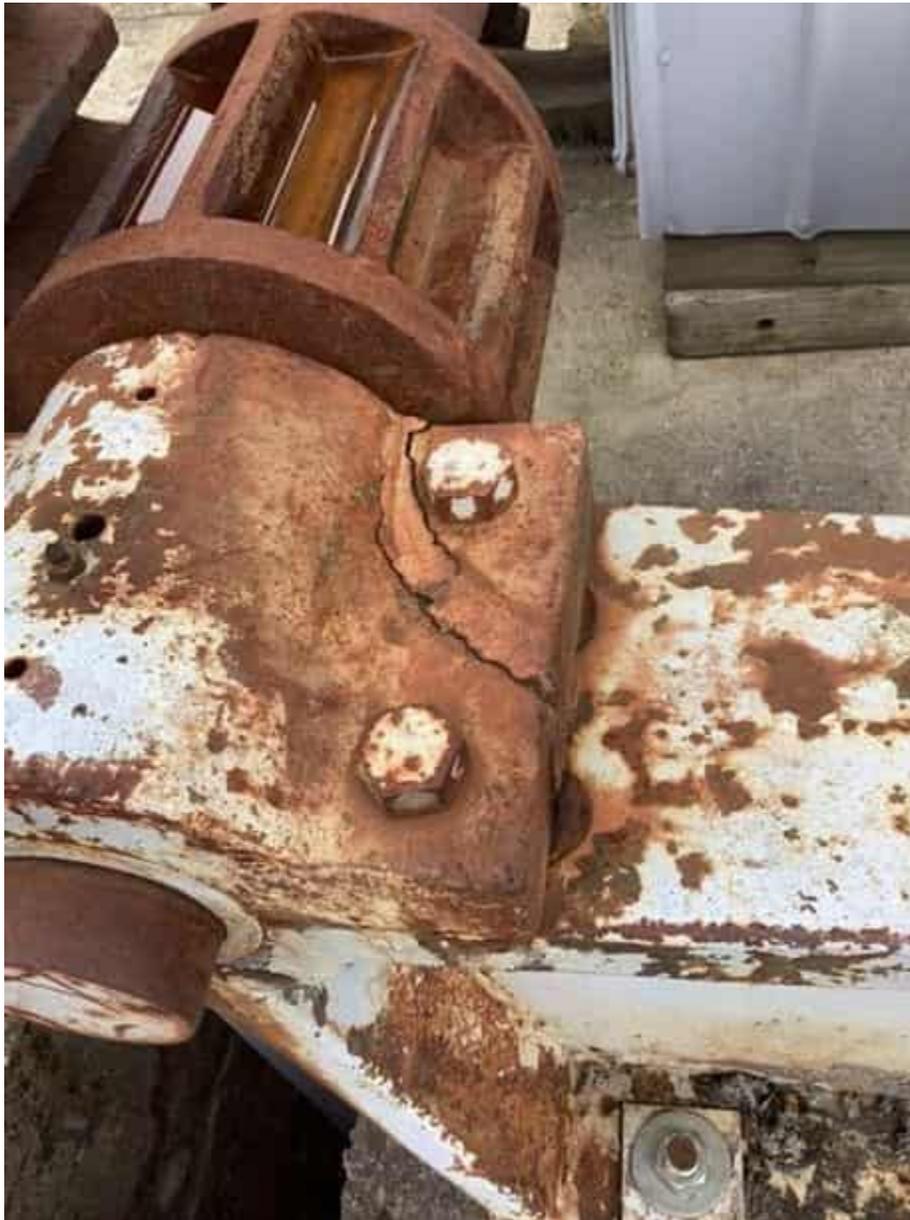
Crack observed in gate support.

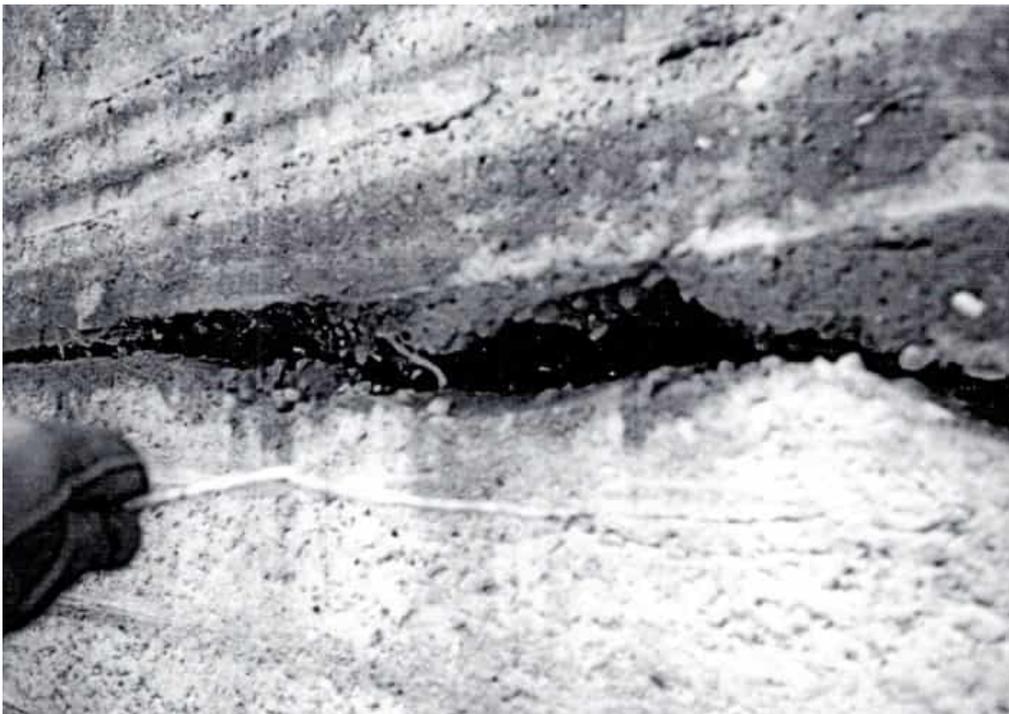
Figure 28: Jackson Dam cracking on upstream face (Knight, 2001)
