# Structural Report

## Structural Assessment of Existing Building

Hardwick, VT Town Garage

| Date of Report: | 10/31/25 |

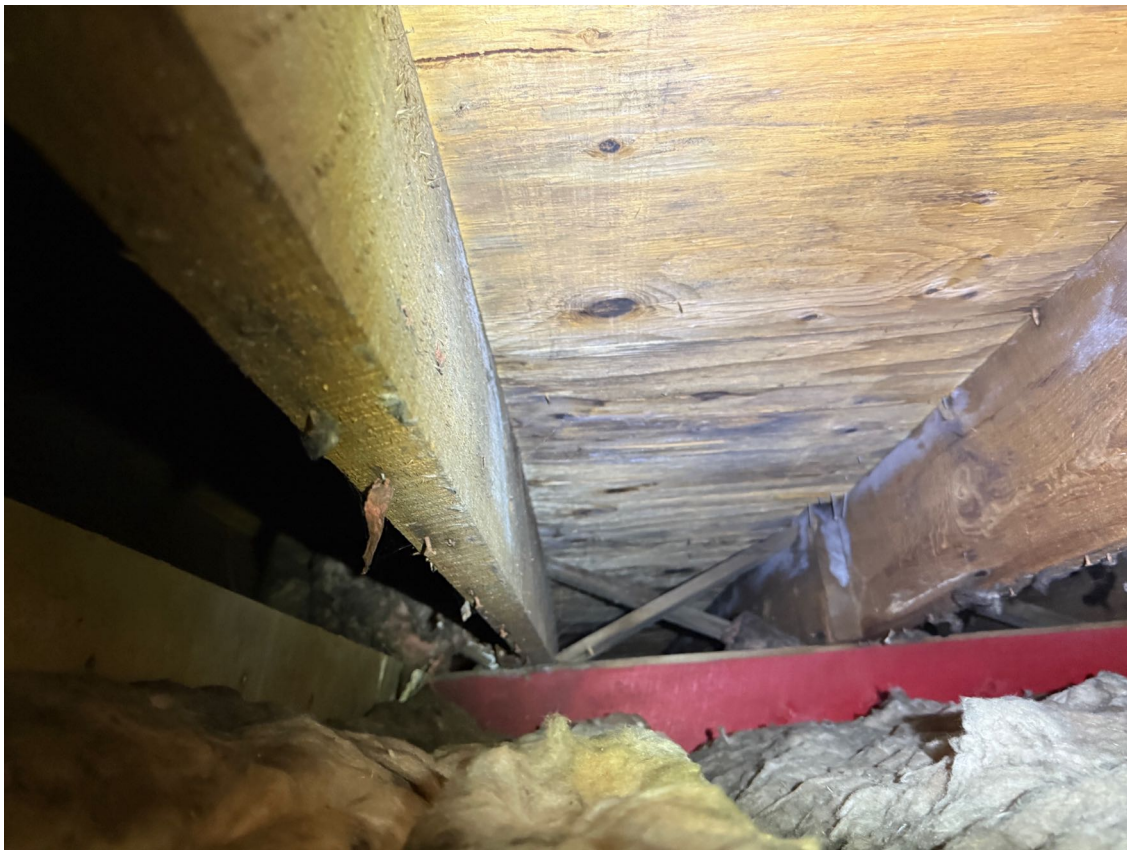
- **Condition:** No generalized roof member distress was observed in accessible areas; however, given deferred maintenance and concealment, the true condition of rafter bearings, beam splices, and connections remains unknown.

*Figure 3: Existing Roof Framing*

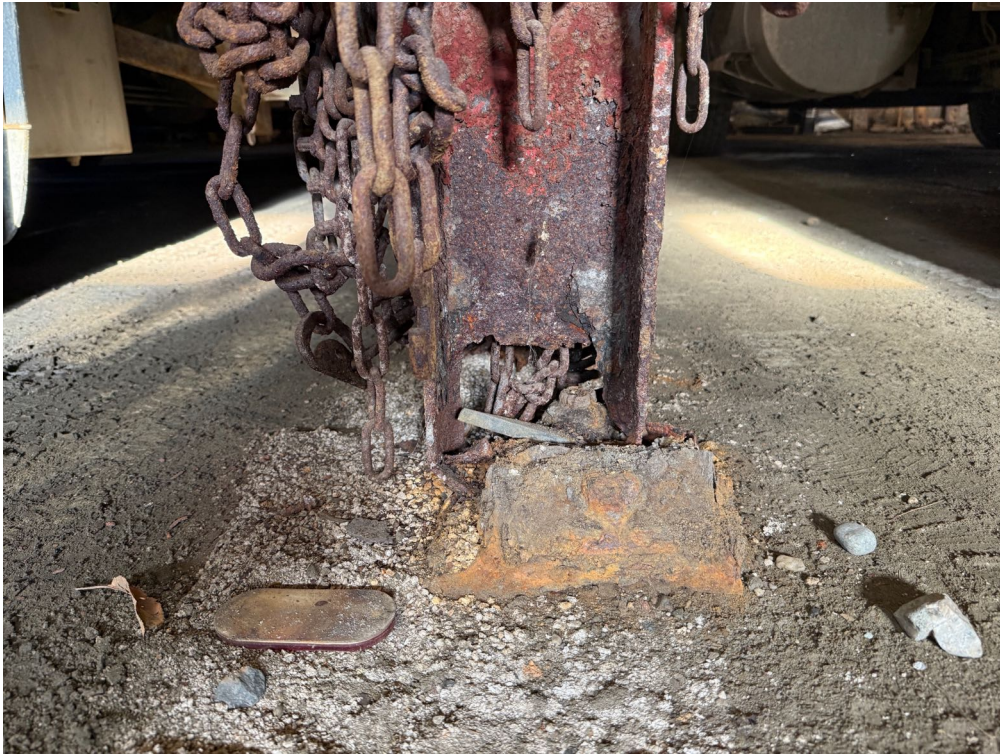
- **General steel corrosion:** W6 interior steel columns show advanced corrosion, particularly at bases where meltwater/track-in and wetting cycles occur. Corrosion and deterioration may be worsened due to any presence of road salts on the slab in winter months. Multiple column bases exhibit section loss and complete or near-complete perforation of flanges/webs at and just above the slab line.

- **Anchorage loss:** Several columns have no visible mechanical anchorage remaining to the concrete slab (baseplates/anchors are either absent, buried in corrosion products, or deteriorated to the point of ineffectiveness) due to rust and corrosion. Other columns show the original anchorage consisted of anchor bolts attaching a base plate below the columns to the top of the slab. It is not known if the slab is thickened at these column bases and/or if there are separate, isolated concrete footings below each of the interior footings.

*Figure 4: Steel Corrosion and Deterioration at Base of Interior Steel Column*

- Cut-back existing steel columns to sound steel above corrosion line; shop-fabricate a replacement lower stub (matching W6 size) with full-penetration weld splice above splash zone.
- Provide new baseplates with (4) adhesive anchors into slab (using a two-part epoxy such as Simpson SET 3G). Grout under baseplate as needed to provide uniform and level bearing of base plate on existing slab; add galvanized sleeve or protective coating at splash zone.
- Optional: Install curb-style concrete pedestals (e.g., 6–8 in high) to elevate the new base above wet slab.

- Form and pour a 1–2 ft high reinforced concrete pier under the base of each column (cut base of steel column to sound steel, new concrete pier to be dimensioned to clear truck/plow geometry), doweled and keyed into the slab. New, elevated base of steel column to have mechanical anchorage to top of new concrete pier. See Figure 16 for a detail of this option.
- **Note:** This option reduces accidental impact risk but still requires sound steel at the top of the concrete pier. Severely wasted steel must be cut out and replaced prior to new concrete piers are installed.

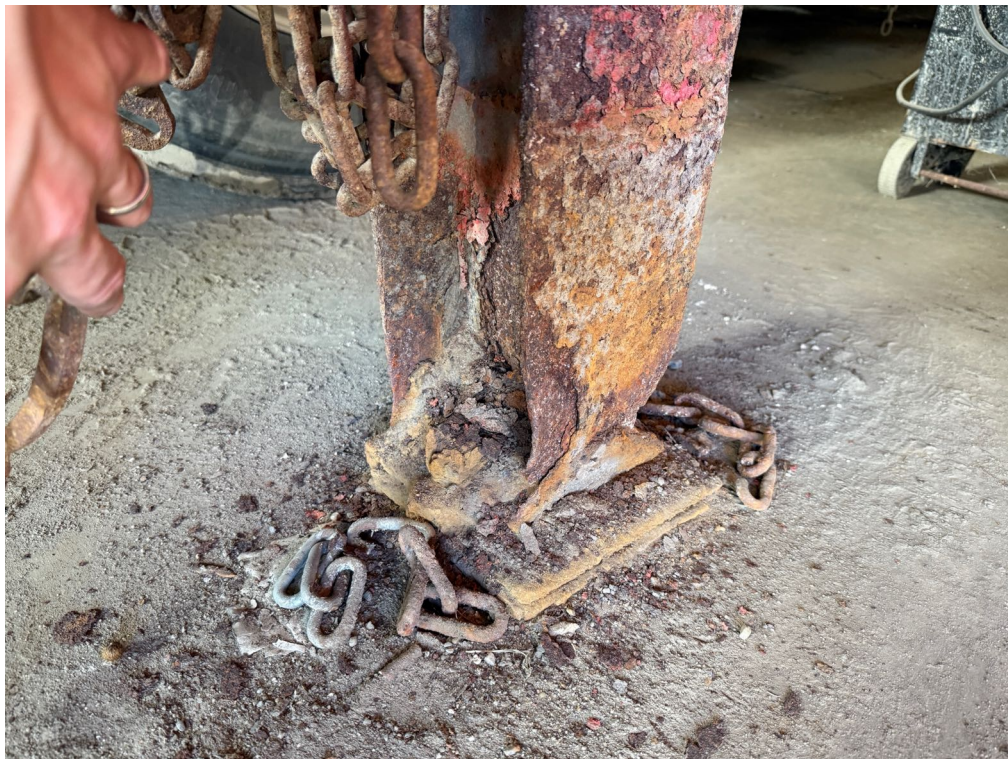
- **Impact damage:** The bases of some columns are twisted/torqued, with local flange/web buckling, consistent with vehicle or vehicle appendage impact in tight bays and misalignment during maneuvering (especially with snowplows attached).

*Figure 5: Steel Corrosion and Impact Warping at Base of Interior Steel Column*

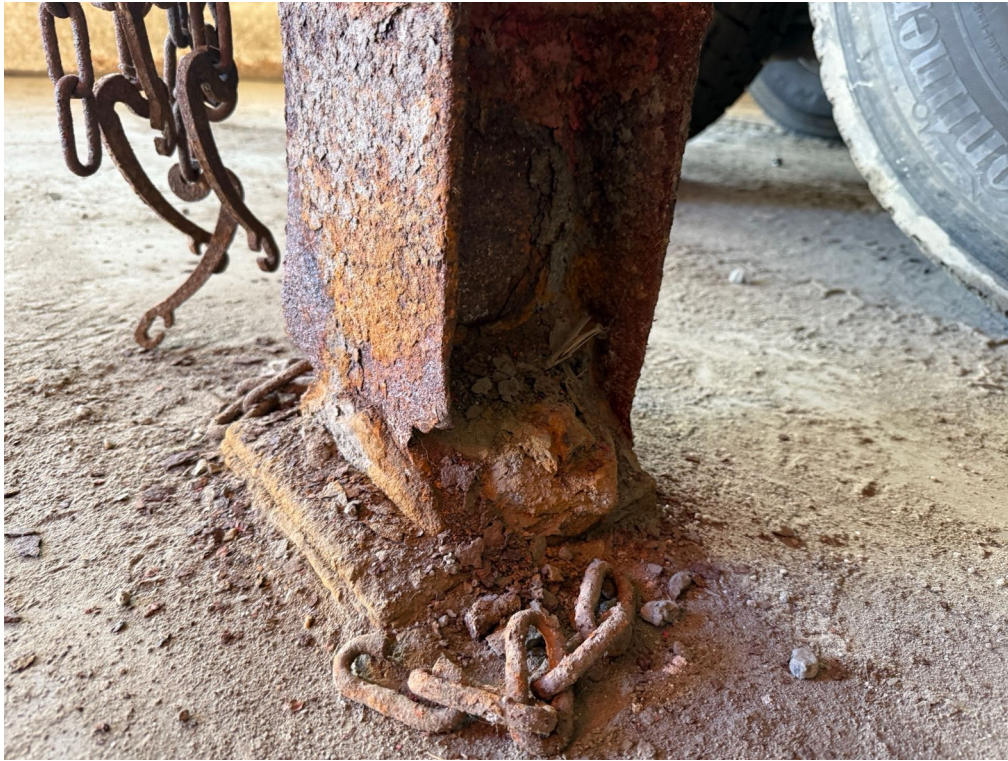
*Figure 6: Steel Corrosion and Deterioration at Base of Interior Steel Column*

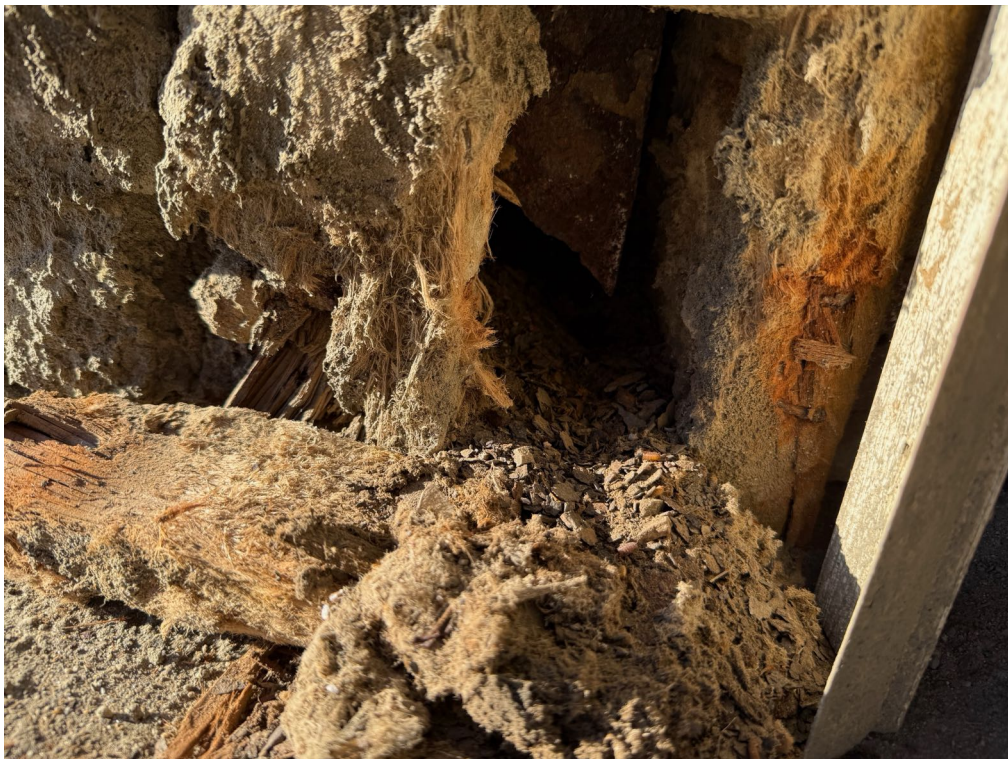
- **Steel columns between overhead doors:** Matching steel columns at overhead-door jambs (centered between doors) likely act as gravity posts for roof beam support and door jamb stiffeners for wind loading support. The one exposed jamb column base was heavily deteriorated (perforated steel; no visible or reliable anchorage to the foundation below). During exposure, accumulated debris (rust scale, sand, organic fines) spilled from the base pocket, indicating moisture trapping against this column base and chronic wetting/drying.

*Figure 7: Steel Corrosion and Debris Accumulation at Base of Steel Column at Overhead Door*

- Repeat the same base repair/anchorage strategy. Where jamb columns share door hardware loads, verify lateral bracing and provide new base connections capable of combined gravity and door loads.

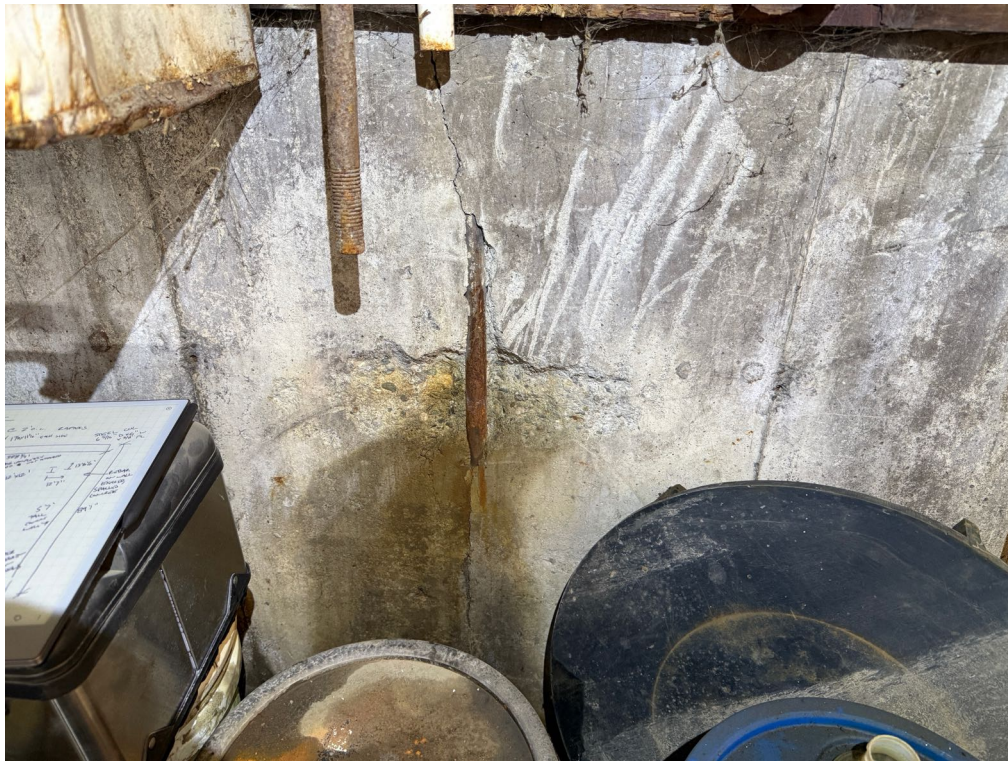
- **Exposed reinforcement:** One region with exposed, corroding rebar and localized spall; corrosion products indicate ongoing moisture ingress and concrete cover distress.

*Figure 8: Spalled Concrete and Exposed/Corroding Reinforcing Steel at Rear Foundation Wall*

- For cracks  $>1/8$  in to  $\sim 7/16$  in: Route-and-seal with semi-rigid epoxy or polyurethane after cleaning
- Exposed rebar/spalls: Remove loose concrete, abrade/rust-convert steel, apply corrosion-inhibiting primer, then patch with polymer-modified structural repair mortar; cure and seal.

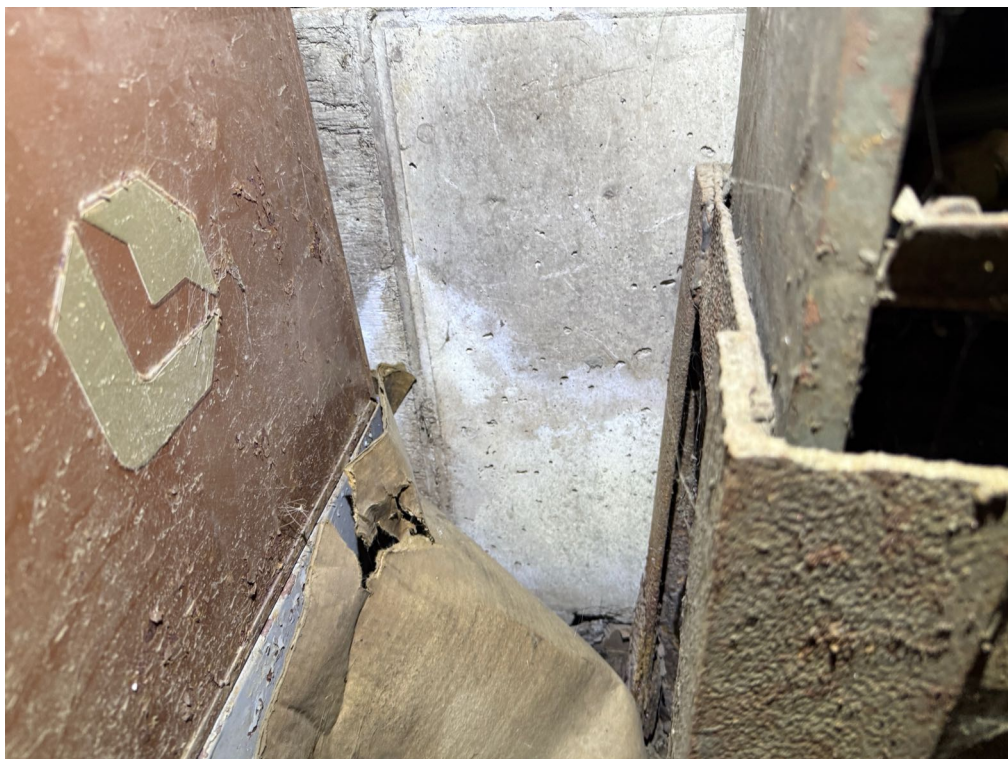
**4.2.1 Moisture infiltration:** Widespread efflorescence on interior faces of side and rear walls; damp areas align with exterior wetting and roof shed toward the rear (low eave). The lack of roof gutters is contributing to the presence of water along this rear foundation wall, and this moisture's detrimental impact on the foundation.

- Efflorescence is a salt residue (white in appearance) left behind when water migrates through the foundation walls and evaporates on the inside surface. This is not merely cosmetic: it is evidence of ongoing moisture intrusion from the surrounding soils.
- Moisture intrusion through the foundation is also an indication that moisture is readily present in the soils on the exterior side of the foundation wall, and that these soils likely do not have a method or diverting the moisture away from the foundation (i.e. drainage plane, footing drain). This creates two potential concerns: hydrostatic pressure and frost action.

*Figure 9: Efflorescence at West Foundation Wall*

- Add continuous gutters at the roof edge with downspouts discharging to grade-away leaders or to daylight; provide splash protection to prevent direct wetting of the wall.
- Regrade the rear swale for positive drainage; avoid winter snow storage piled directly against the rear wall.

- Add exterior insulation (e.g., rigid mineral wool or XPS with protective coating) and waterproofing at the rear wall to reduce freeze–thaw within the section. Seal all patch transitions.

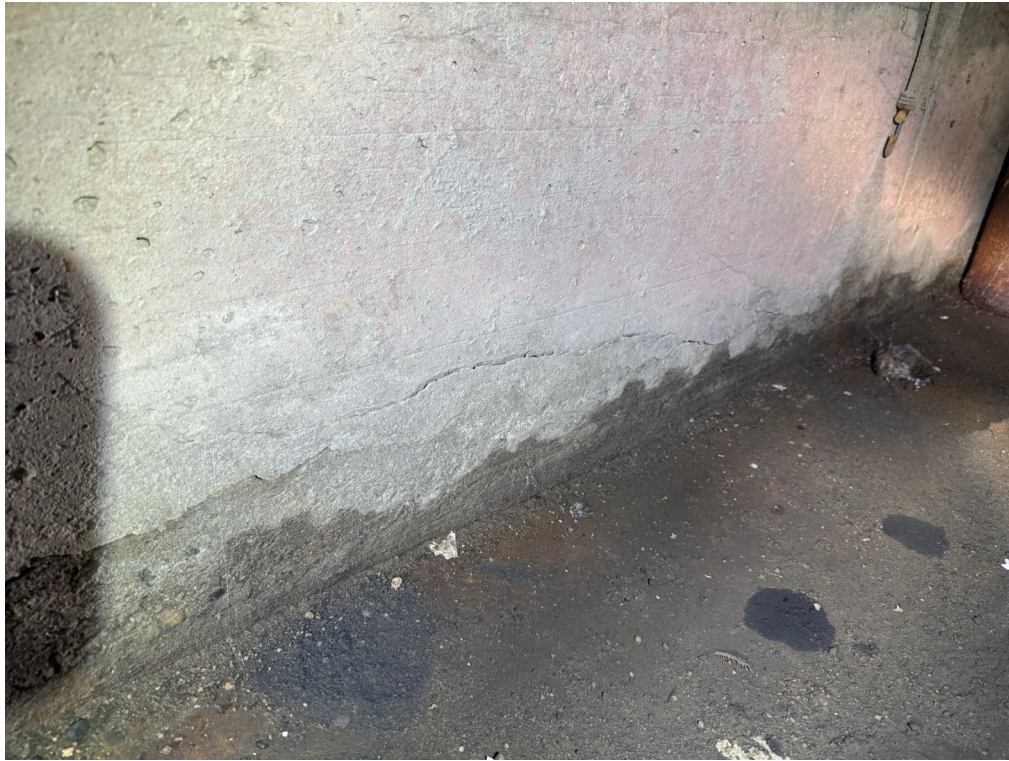
- **Wall Cracking:** At least eight (8) vertical cracks on the rear wall; many originate or terminate at window openings (weakened regions). Typical widths 0.10–0.20 inches; several up to ~7/16 in. Concrete spalling has occurred on both interior and exterior faces at some cracks. Several cracks had loose concrete which could be removed by hand or with limited screwdriver effort during the assessment.

*Figure 10: Active Moisture and Cracking at Rear Foundation Wall*

- Map and number all cracks; record widths.
- For cracks  $\leq 1/8$  in: Epoxy injection to restore continuity and water-tightness.

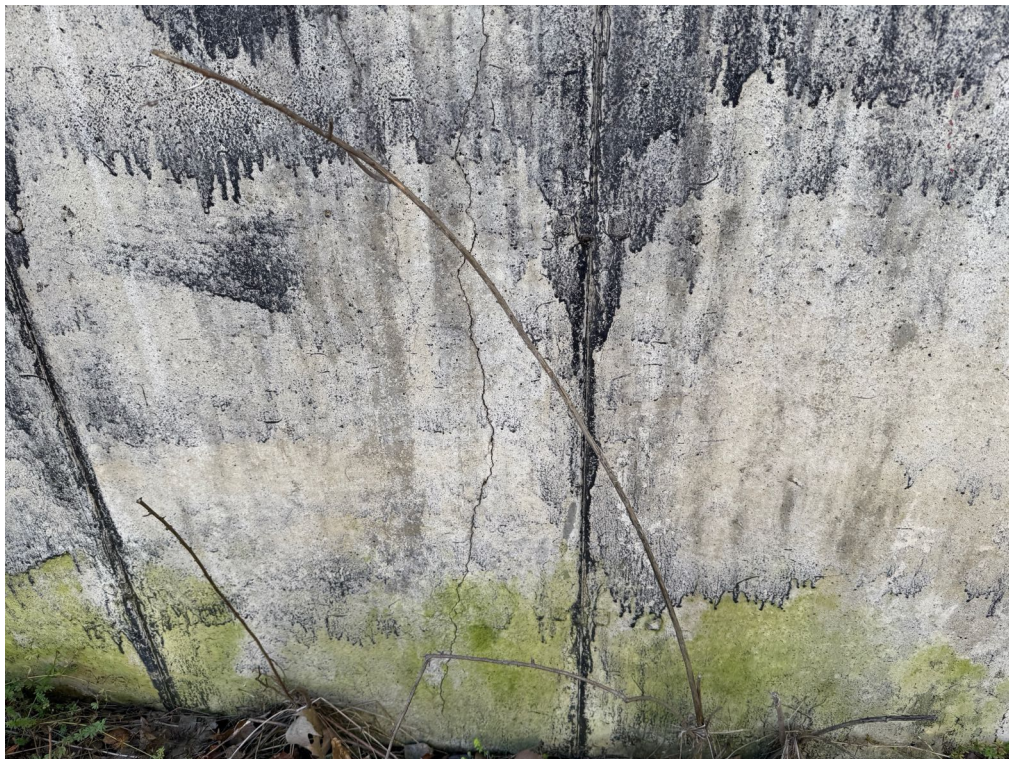
- **Control joints absent:** The ~90-ft long rear foundation wall has no control joints. It appears that the above noted cracking likely started as shrinkage cracking but has expanded and widened with time due to moisture infiltration and freeze-thaw effects. It is typically recommended that foundation walls have control joints at spacings of approximately 20 to 25 feet.

*Figure 11: Vertical Cracking at Rear Foundation Wall*

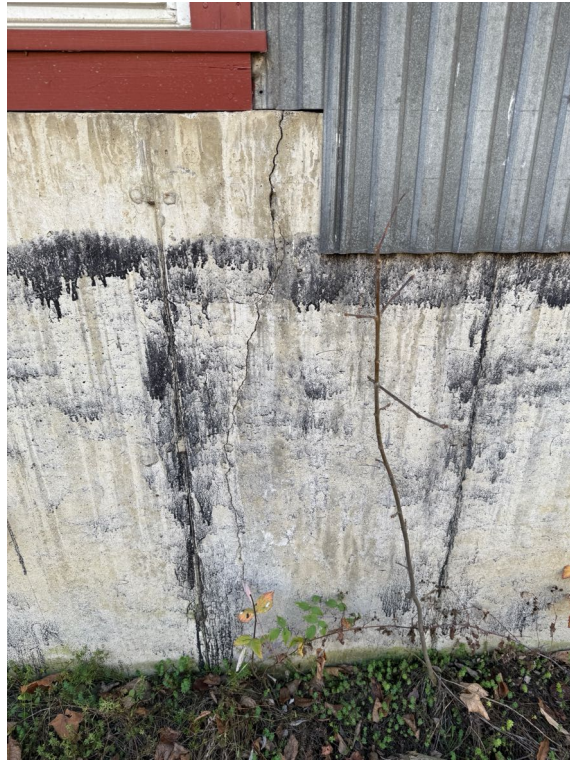
*Figure 12: Vertical Cracking at Rear Foundation Wall*

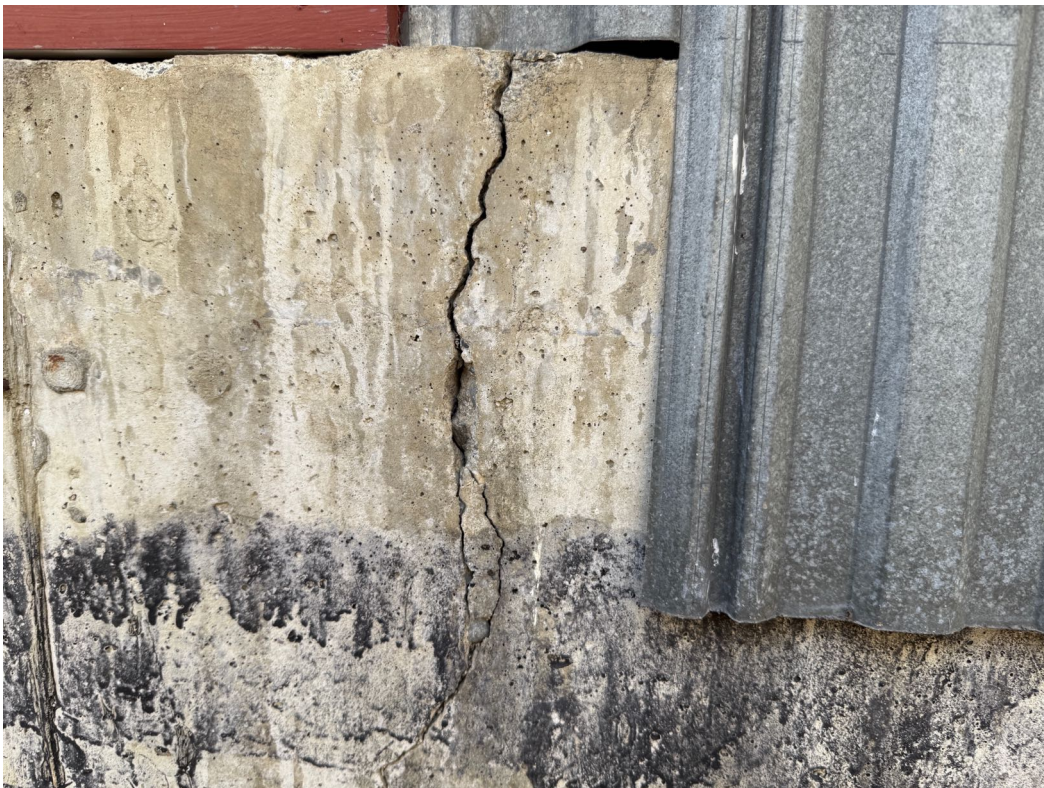
*Figure 13: Vertical Cracking at Rear Foundation Wall*

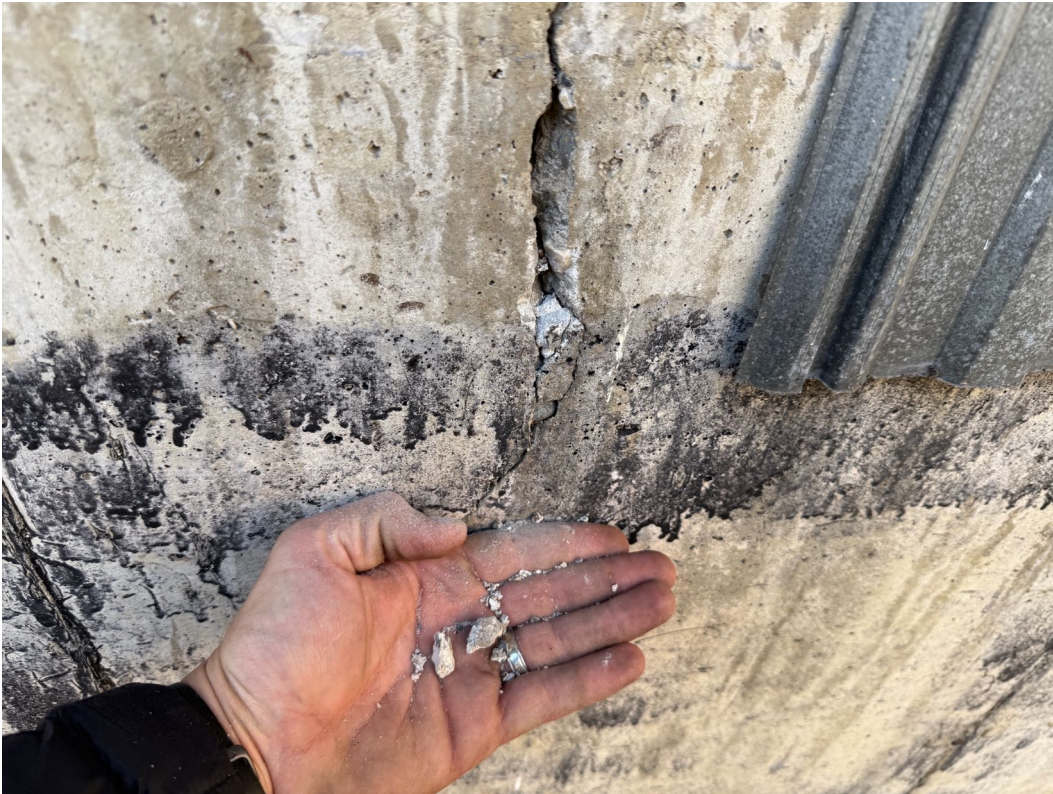
*Figure 14: Vertical Cracking and Spalling at Rear Foundation Wall*

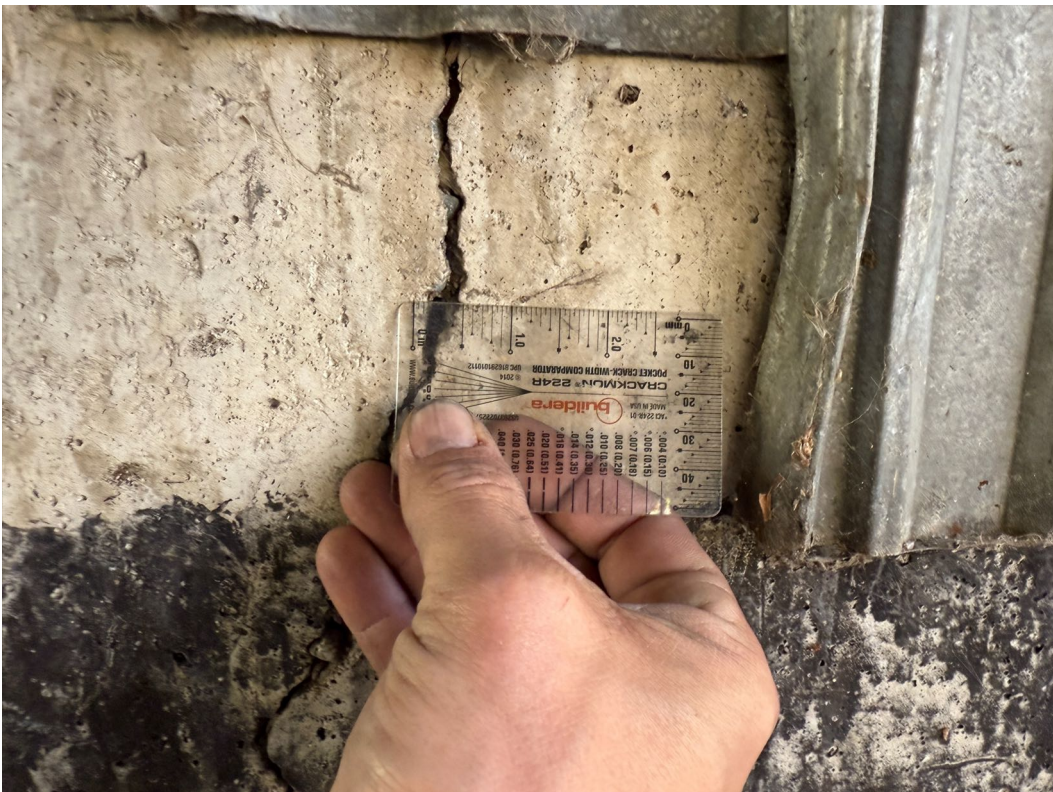
*Figure 15: Vertical Crack Width Measurement (7/16\") at Rear Foundation Wall*
