Revised
DRAFT

Hardwick Village VT 15 Transportation Assessment

Hardwick, Vermont

September 2009

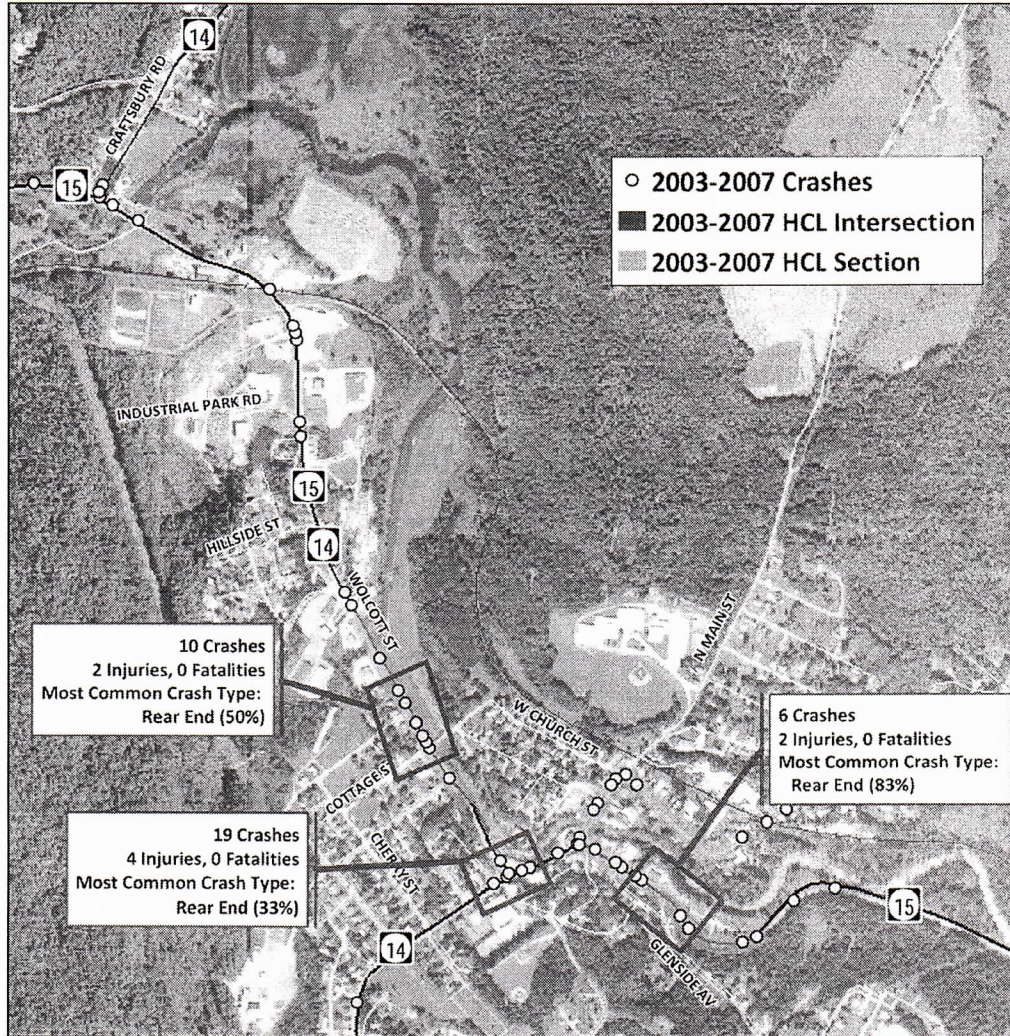
Figure 6: Summary of Reported Crashes and High Crash Locations (2003-2007 data)

The most recent 5-year set of crash data reported by VTrans covers the 2003-2007 period. The crash data from this period are shown in Figure 6 below. The reported crashes, which are depicted with yellow circles, can be seen to cluster in certain locations.

1. VT 15 (Wolcott Street) between the Fire Station and Cottage Street:
This segment of Wolcott Street, which is part of a High Crash Location segment, had 10 reported crashes between 2003 and 2007. The crashes resulted in two injuries. The predominant crash type was a rear-end collision, which represented 5 of the 10 crashes. Of note in this section are large, uncontrolled curb cuts at the Fire Station, the general goods store at the Granite Street intersection, and the auto shop at the Cottage Street intersection. Also of note is a pedestrian crosswalk adjacent to the Cottage Street intersection which does not have appropriate pedestrian crossing warning signs. The combination of uncontrolled access points and unsigned pedestrian crossing may likely be contributing the high crash density in this area.

2. VT 15 / VT 14 / Main Street Intersection:
Although this intersection is not identified as an HCL intersection² or part of an HCL segment, there were a number of crashes that occurred at the intersection during the 2003-2007 period. In particular, there were 19 reported crashes occurring during this period, resulting in 4 injuries. There was a wide range of collision types reported, with rear-end collisions being the most commonly reported (33%) collision type. There are a number of factors likely contributing to the crash rate at this intersection including a confusing horizontal alignment with 3-way stop control, a vertical grade change approaching from the north, a confluence of Vermont State routes with potentially confusing route marker signs, and on-street parking within the operating portion of the intersection.

3. VT 15 / Glenside Avenue Intersection:
This intersection falls within the VT 15 High Crash Location segment and has been identified for years as a potentially unsafe intersection due to poor sight distances for vehicles turning onto VT 15 and the perception of high speed vehicles traveling on VT 15 at the intersection. The crash data from 2003-2007 shows no reported crashes occurring at the intersection, with 6 crashes being reported proximate to the intersection (but likely not directly related to the conditions at the intersection). In addition, a speed count was conducted on VT 15 500 feet west of the

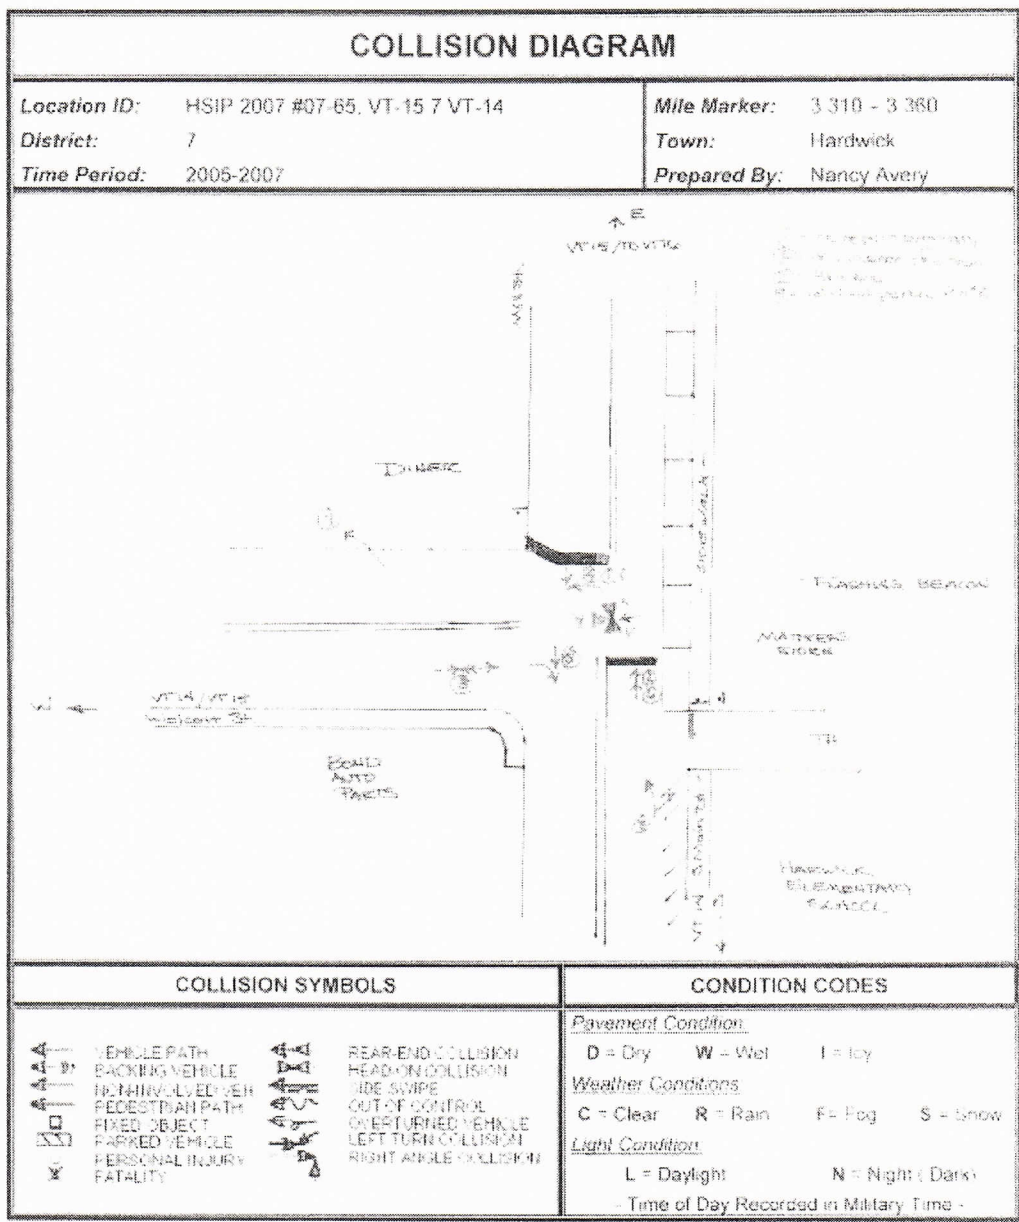
Figure 7: VT 15/VT 14/Main Street Intersection Collision Diagram (VTrans)

- VT 14/VT 15/Main Street Intersection (6 November 2008)
 - A collision diagram for the crashes occurring in the period 2005-2007 is shown below in Figure 7.

- Recommendations included:
 - a. Install LED lens to all beacon heads;
 - b. Eliminate 4 parking spaces within the intersection functional area;
 - c. Upsize "STOP" signs to 36" with a minimum of ASTM Type III sheeting material;

- d. Refresh all pavement markings; and
 - e. Correct and reorganize route marker assemblies for all approaches.

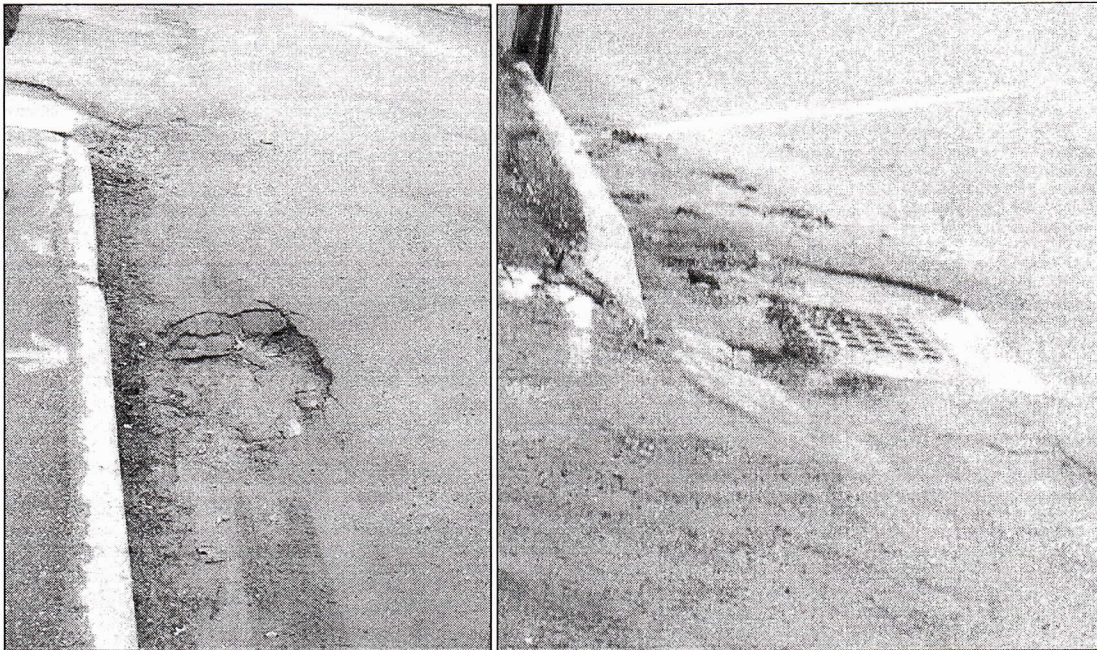
Figure 8: Examples of Deteriorating Catch Basins

The stormwater collection system along VT 15 in Hardwick Village is exhibiting signs of deterioration. At the surface, a number of catch basins were found to be clogged (Figure 8, left). Pavement and subbase material deterioration was found around certain catch basins (Figure 8, both). Additionally, stormwater flows are not currently reaching inlets in some locations due to inadequate road cross-slopes and/or inlets not located adjacent to a vertical curb (Figure 8, right), witnessed by “pools” of silt deposits.

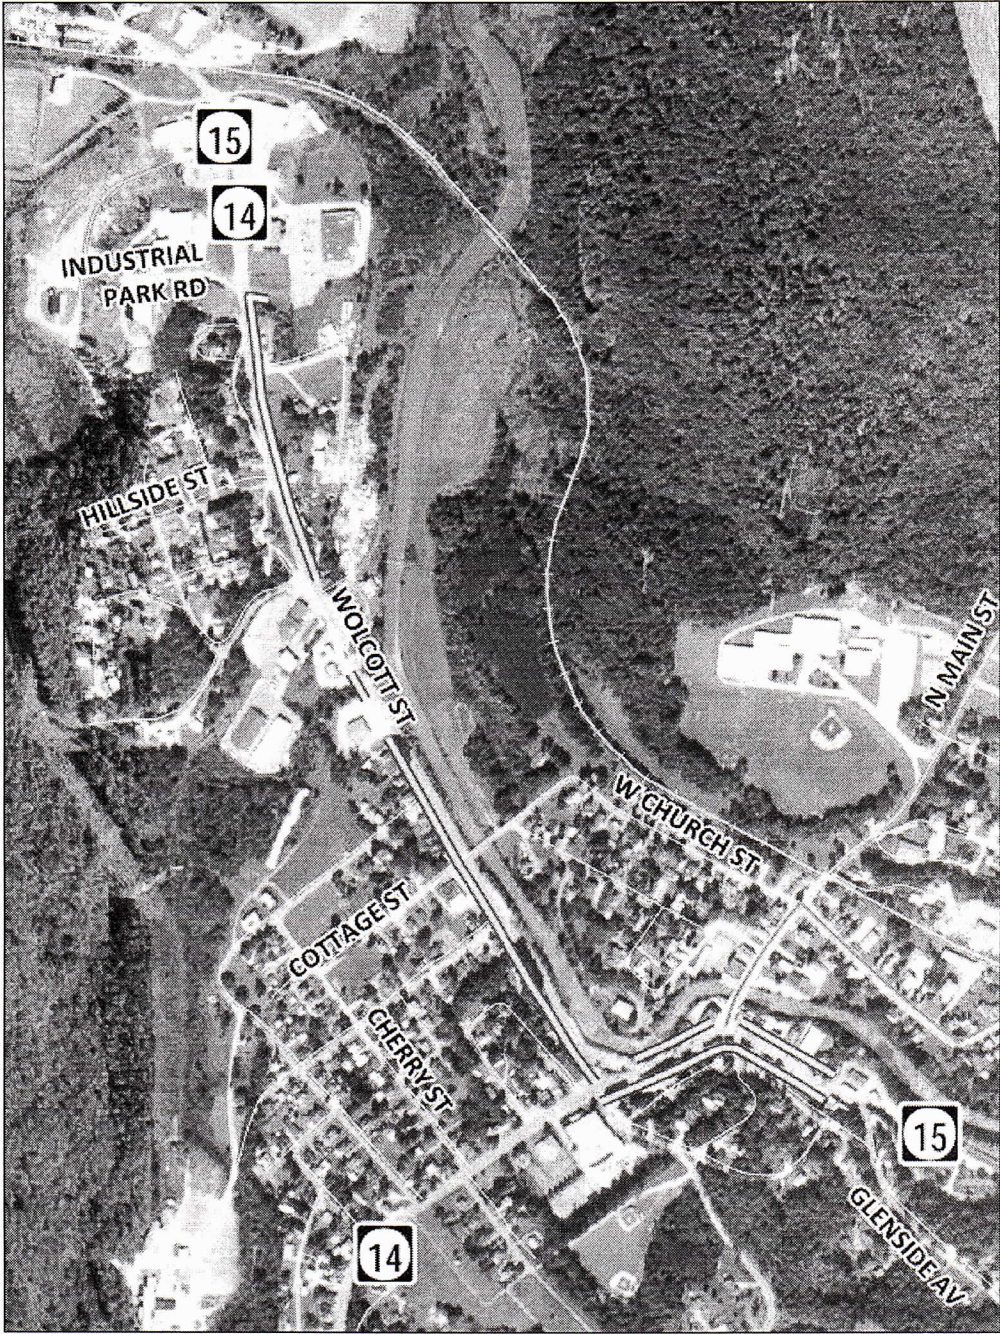
Figure 9: Existing Sidewalks along VT 15 in the Project Area

Figure 9 below shows the existing sidewalk infrastructure along VT 15 in the project area. The existing sidewalks vary widely in condition, width, and materials. Many sections of the existing sidewalks are in poor condition and do not have vertical curb separation from the roadway. Sections of the sidewalk network in the village center are in good condition with adequate width and vertical curb separation.

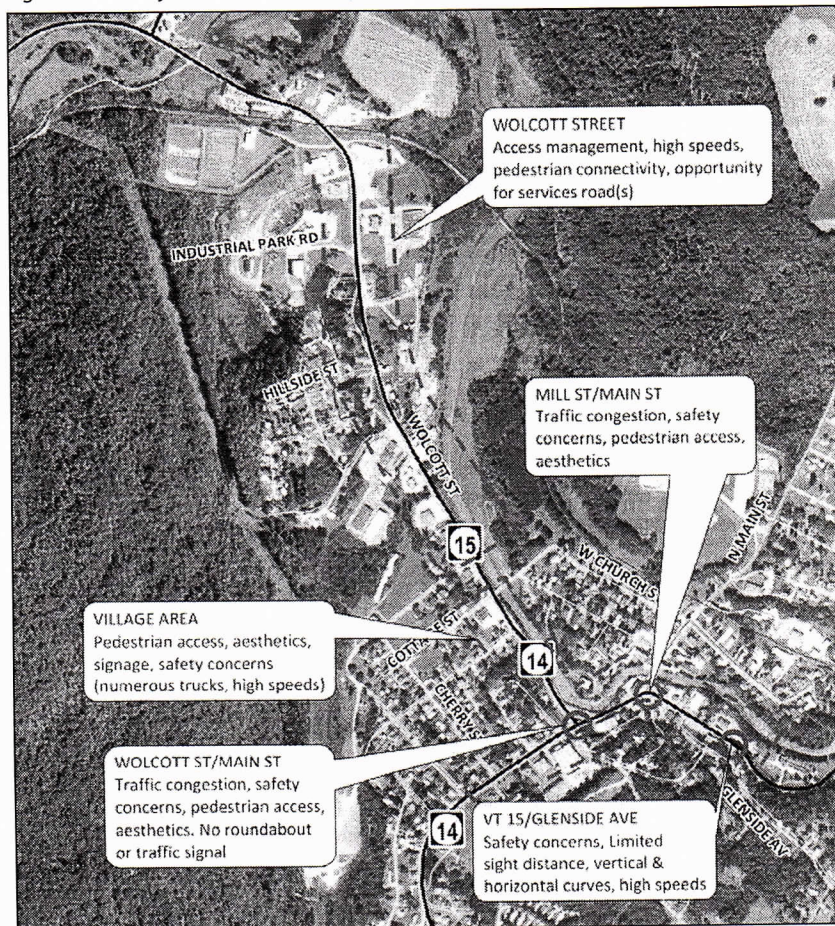
Figure 14: Identified Issues in the Project Area

A graphical summary of location-specific issues is illustrated in Figure 14 below.

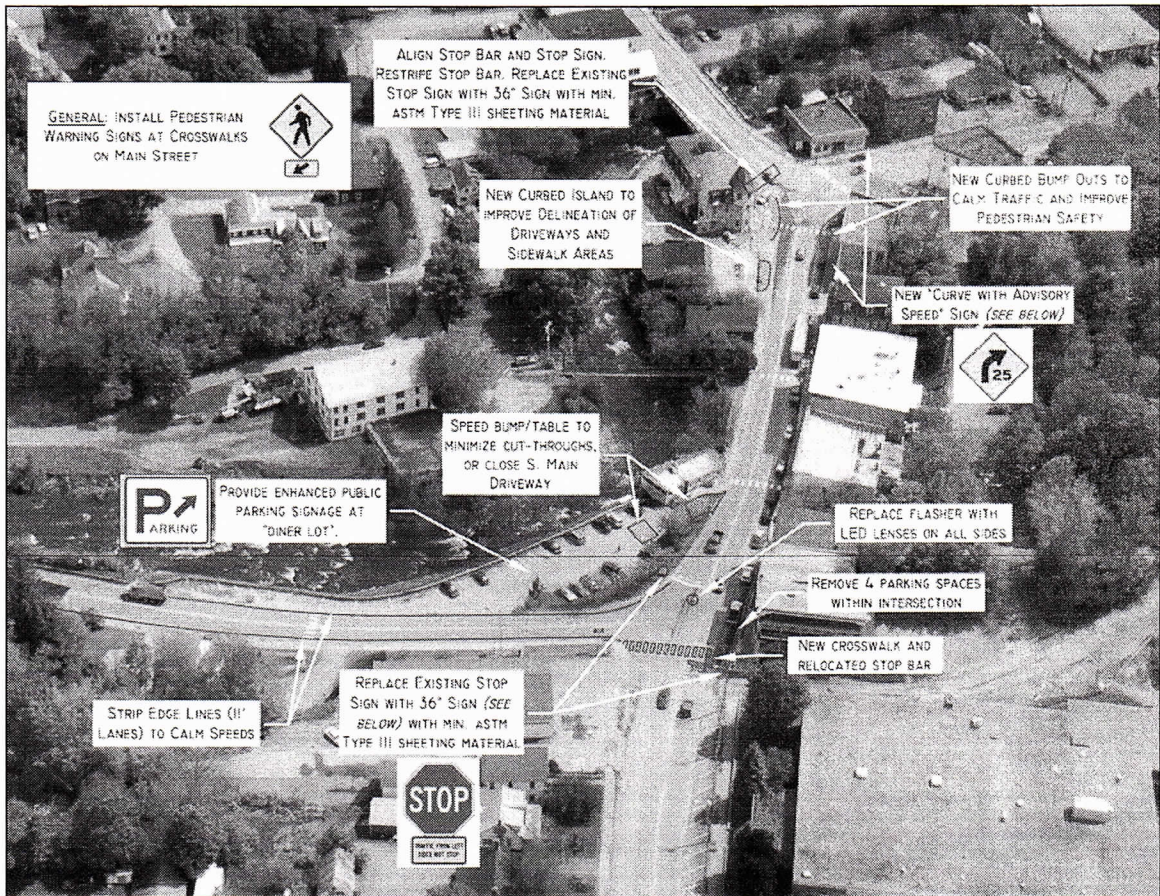
Figure 17: Village Focus Area Short-Term Recommendations

This focus area includes the Village area of VT 15 from VT 14 to North Main Street. The primary concerns raised in this area include the high crash rate, traffic operational confusion, lack of public parking signage, and inadequately signed crosswalks.

- Re-stripe edge lines to define 11 foot travel lanes along VT 15 to calm speeds approaching and exiting the VT 15/VT 14 intersection.
- Provide Public Parking signage at the accesses to the municipal lot to clarify the intended use of the lot.

- To discourage cut-through traffic through the municipal parking lot, either construct a speed bump/table within the lot or close the access to the lot from South Main Street adjacent to the diner.

- Replace the existing STOP signs at both the South Main Street and VT 14 approaches to the VT 15/VT 14 intersection with a larger 36 inch sign with a minimum ASTM type III sheeting material for enhanced visibility and reflectivity. Supplement the STOP signs with “Traffic From Right/Left Does Not Stop” plaque, to clarify that the intersection is not all-way stop-controlled.

- Stripe a new crosswalk across the VT 14 approach and relocate the stop bar behind the crosswalk, per VTrans standards.
- Remove the four on-street parking spaces within the functional area of the VT 15/VT 14 intersection, to remove potential conflicting movements from the operational area of the intersection.

- Replace the existing flashing beacon at the VT 15/VT 14 intersection with LED lenses in all directions.
- Install new Curve with Advisory Speed sign for both VT 15 approaches to the VT 15/North Main Street intersection.

- Install new curbed bump-outs at the mid-block crosswalk adjacent to the VT 15/North Main Street intersection to calm traffic speeds and reduce the pedestrian crossing distance.

- Align stop bar and STOP sign at North Main Street approach to VT 15/North Main Street intersection.
- Install pedestrian warning signs at the mid-block crosswalks along South Main Street.

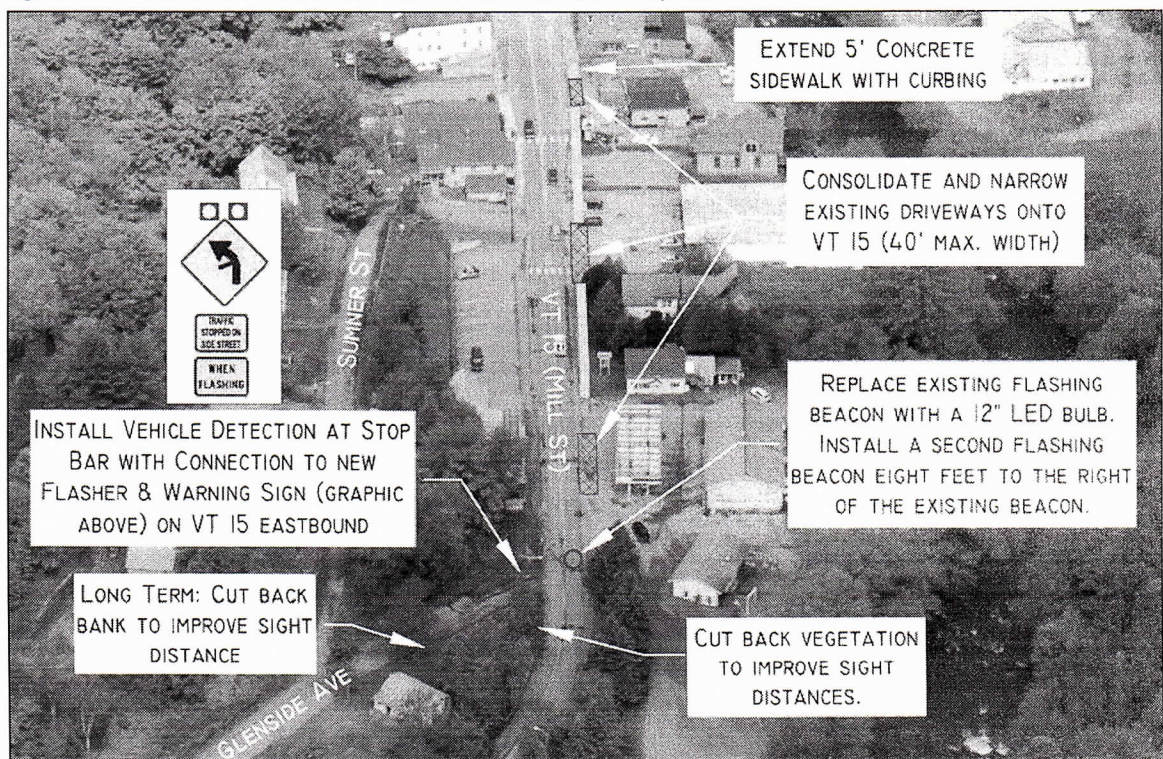
Figure 19: VT 15/Glenside Avenue Intersection - Focus Area Preliminary Recommendations

This focus area includes the area in the vicinity of the VT 15/Glenside Avenue intersection. This section of VT 15 is characterized by a transition from a rural arterial into a village setting. The primary concerns raised in this area include the safety concerns related to the poor intersection sight distance (both for vehicles exiting Glenside Avenue and vehicles approach the intersection on VT 15 from the east), excessively wide curb cuts, and the lack of pedestrian facilities in the area.

- Cut back and maintain the vegetation on the west side of VT 15 to improve sight distances for vehicles approaching on VT 15 from the east.
- Replace the existing flashing beacon with a 12 inch LED lens in all directions and install a second flasher eight feet to the right of the current beacon to increase visibility.

- Install an inductance loop vehicle detector at the Glenside Avenue approach to detect vehicles waiting to turn onto VT 15. Connect detector to new sign on VT 15 east of the intersection to warn approaching vehicles that traffic may be entering intersection when flashing.

- Extend sidewalk along north side of VT 15 from village to Halls Market and gas station.
- Narrow and consolidate multiple access points on north side of VT 15 with a maximum width of 40 feet at the edge of the right-of-way, per VTrans Access Management Standards. These reconfigurations should be considered during site plan review for any improvements to the sites.

- As a long term consideration, cut back bank on the southeast corner of the VT 15/Glenside Avenue intersection to improve intersection sight distance.
