Stormwater Master Plan Town of Hardwick, Vermont

PROJECT NO. PREPARED FOR:

16-138

Amy Macrellis / Water Resources Scientist
Stone Environmental, Inc.
535 Stone Cutters Way
Montpelier, VT 05602
amacrellis@stone-env.com
802.229.1884

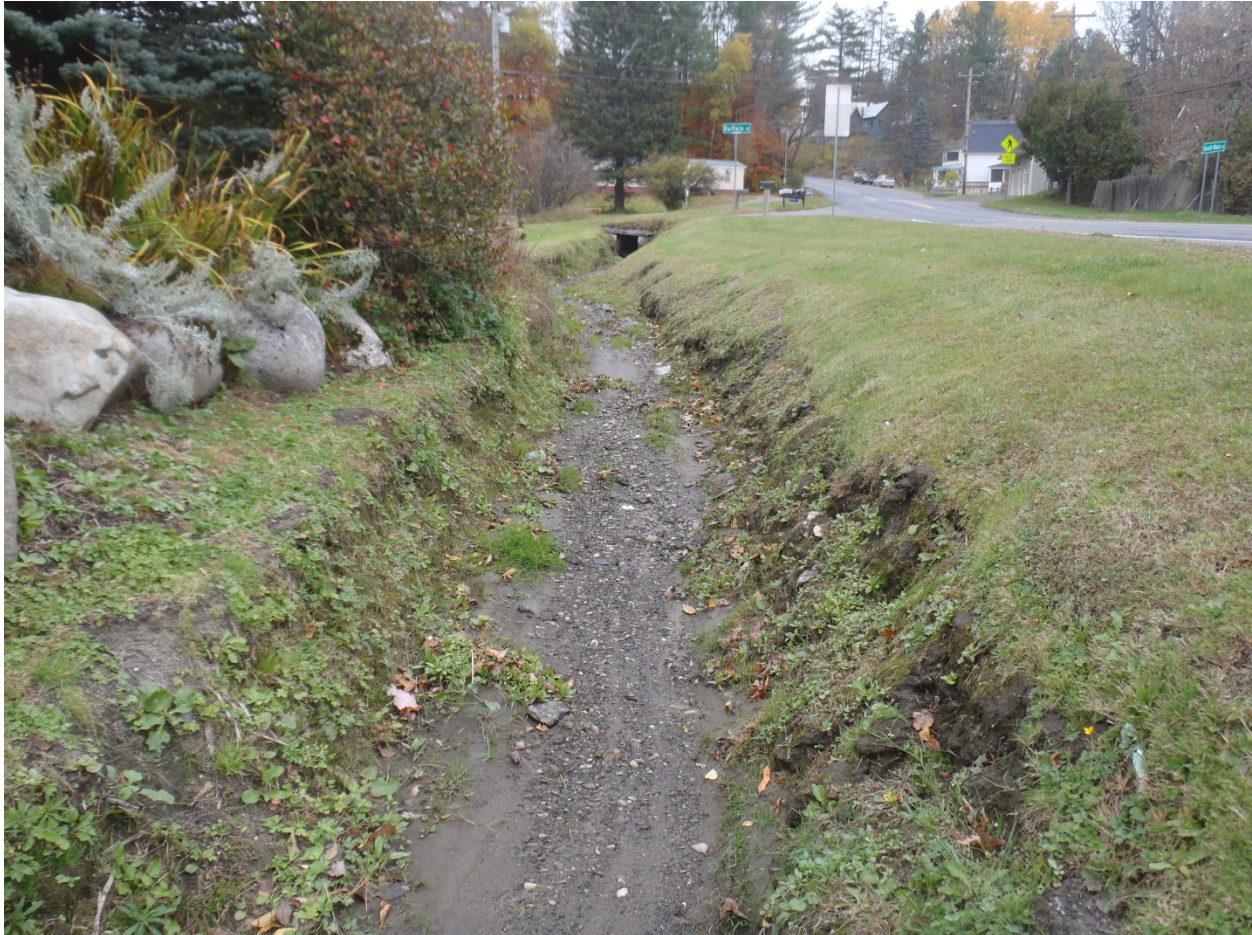
also subject to regular ditching and re-shaping by either the Town or VTtrans, roughly once every 2-4 years. It is suspected that the channel is in adjustment due to the increased impervious area upstream, meaning that the channel is adjusting its cross sectional area to accommodate the increase in flows and stream power conveyed during storm events. The severity of sediment transport and active erosion can be observed in the photo below.

The proposed restoration is based on accelerating the channel evolution process and bringing the channel to stage V of the CEM, where a new 'inset' floodplain exists and channel bed and banks have re-stabilized. Restoration includes a revised stream channel sized to accommodate the 1.5 year storm event, floodplain benches to accommodate flows for larger storm events (i.e. the 2 through 100 year events), side slopes graded between 2:1 and 3:1 up to existing grade, and planting of native vegetation along benches and slopes. Also proposed is a pool and step on the upstream end to serve as a sediment forebay, and upsizing of the downstream existing culvert. The end result is lower channel velocities, higher channel roughness, less

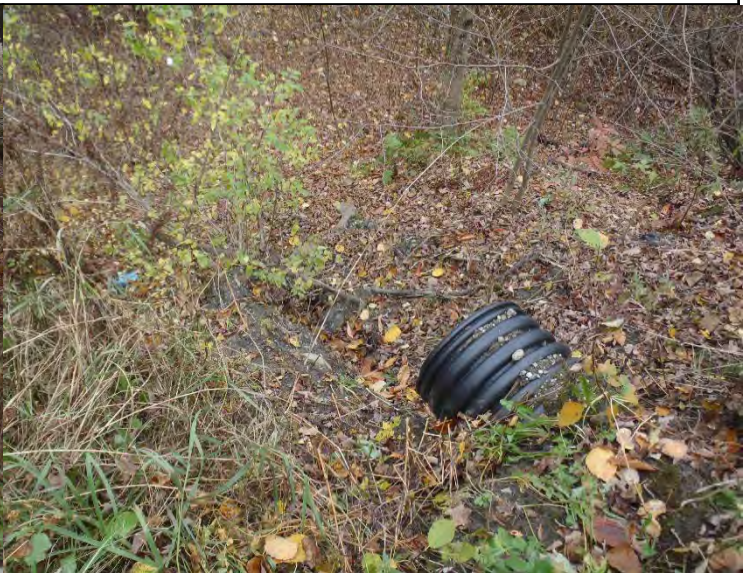
Photo 2. Elevated and eroding culvert outlet

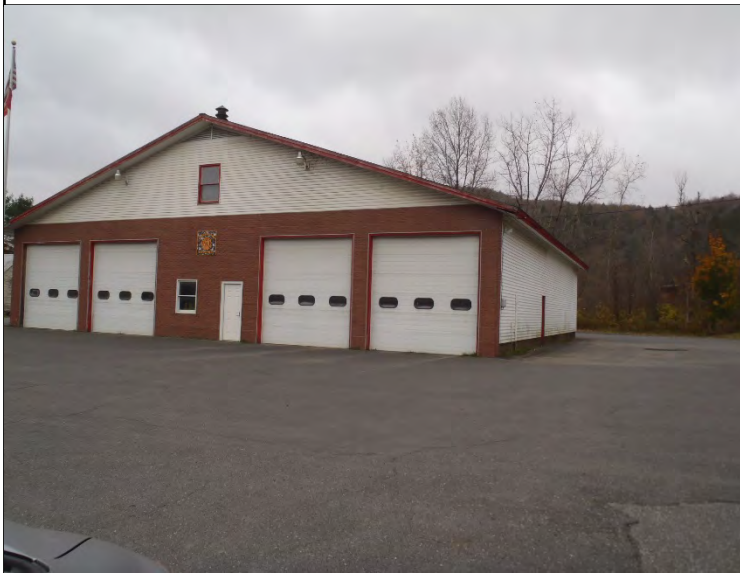
Photo 1. Catch basin appears to capture all site drainage

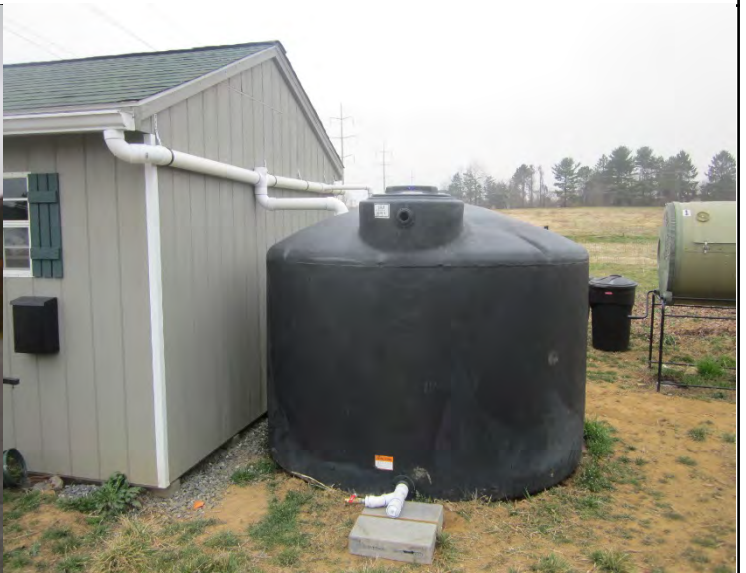
Photo 2. Example of a cistern used to collect roof runoff

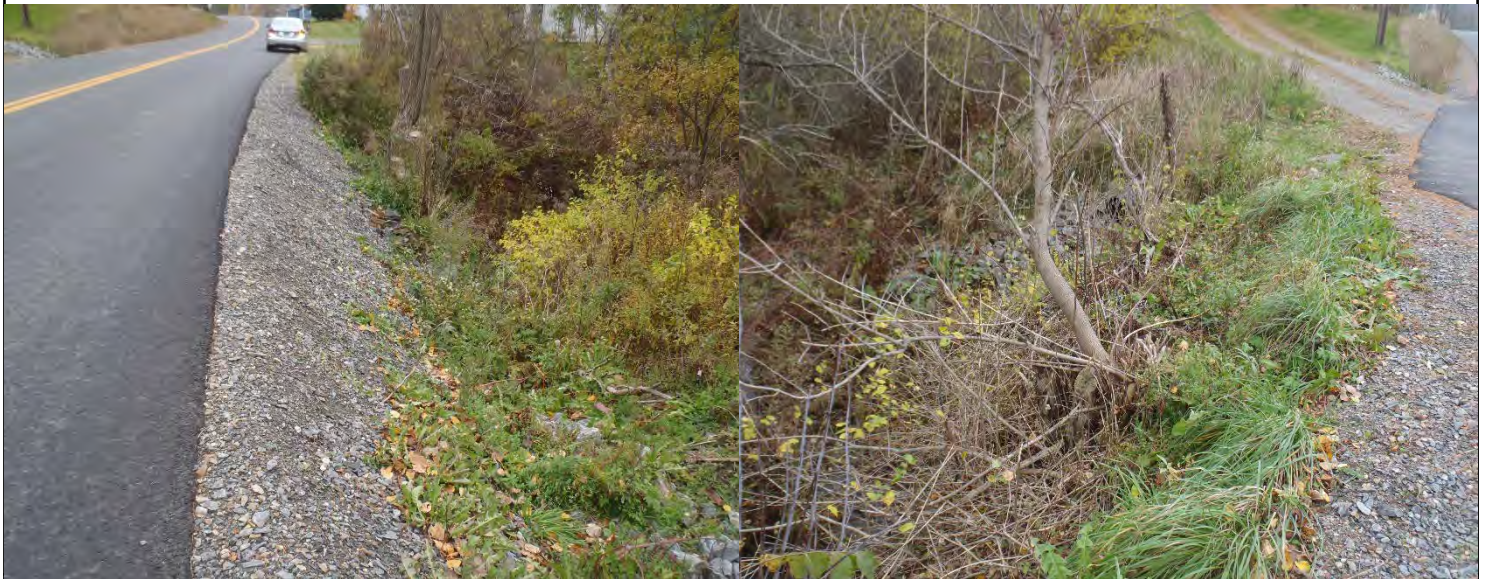
Photo 1. West edge of Mackville Road

Photo 2. East edge of Mackville Road

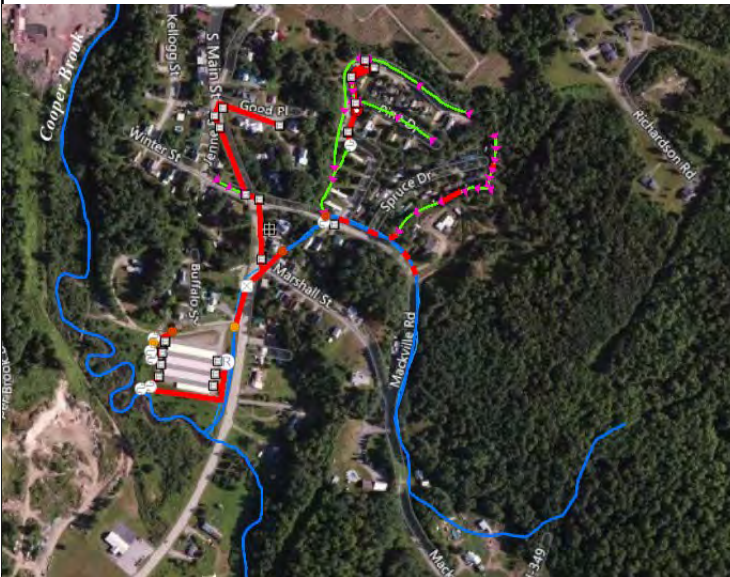
Photo 1. Conveyance feeding the eroded drainage channel

A large area (approximately 73 acres) is directed to this swale via stormwater infrastructure from the north and northeast, as well as a seasonal stream originating from the east. The existing channel should be cleaned, the sideslopes laid back to a 1:3 if space is available. The channel could also incorporate check dams to facilitate slowing of flow and promote sediment deposition, or it could be converted to a bioswale promoting infiltration, depending on soil type and groundwater conditions.

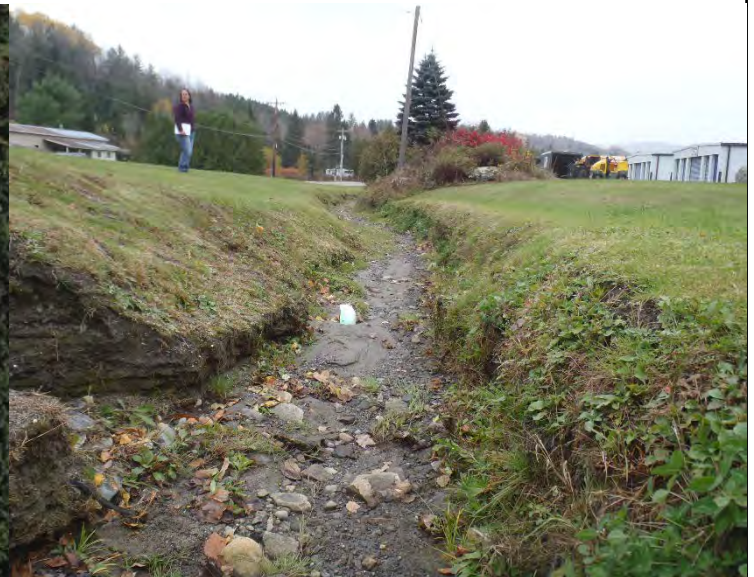
Photo 2. Erosion within drainage channel

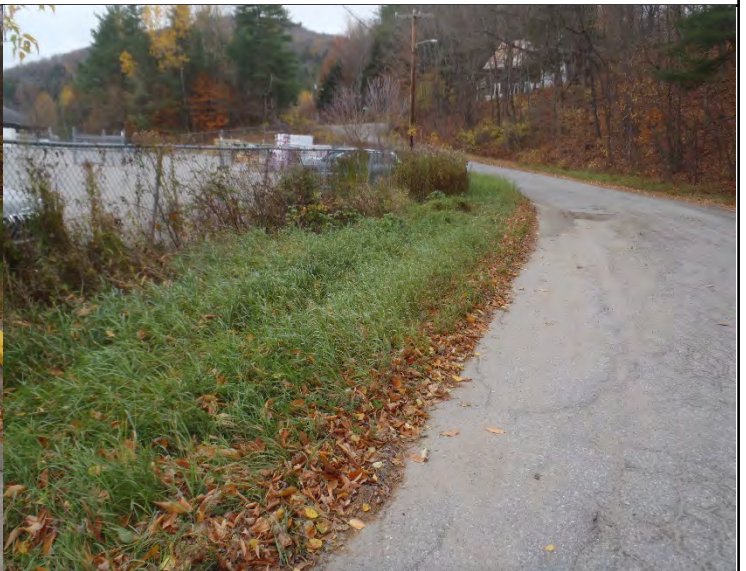
Photo 2. Green space available for capture and treatment between fence and Union Street

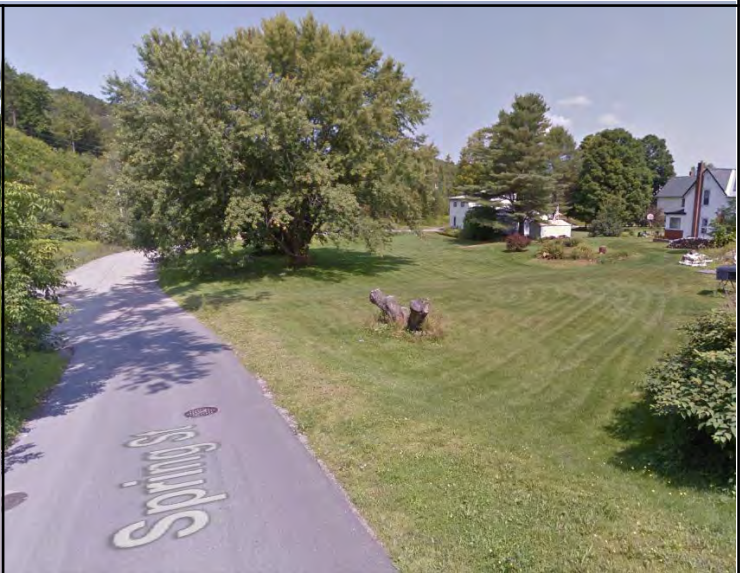
Photo 1. Potential treatment area, looking southeast from Granite Street. (Photo from Google Street View, Aug. 2014)

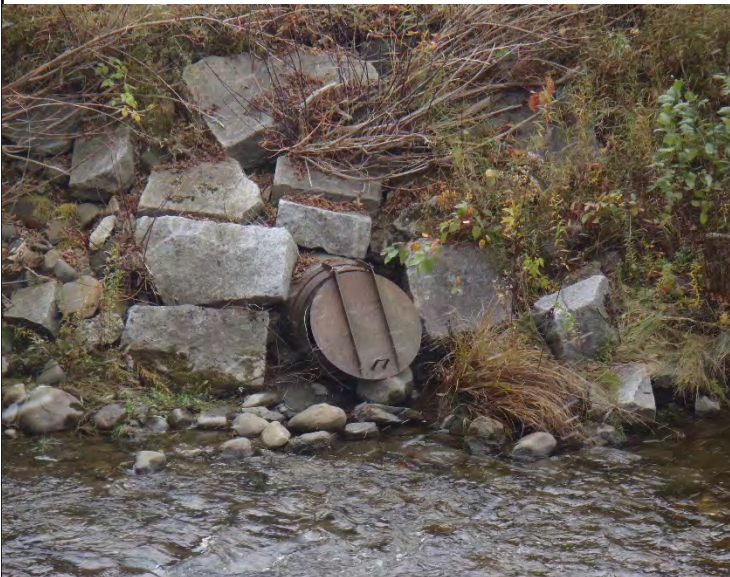
The Town has indicated that the current “trash can” style outlet cover does not adequately protect against backwater. This culvert, and ultimately the pipe system connected to it backs up during seasonal high water. This outlet structure could be replaced with a “duck bill” outlet structure, or similar device, as shown in Photo 2 below.

Photo 1. Existing culvert outlet with trash can style outlet structure

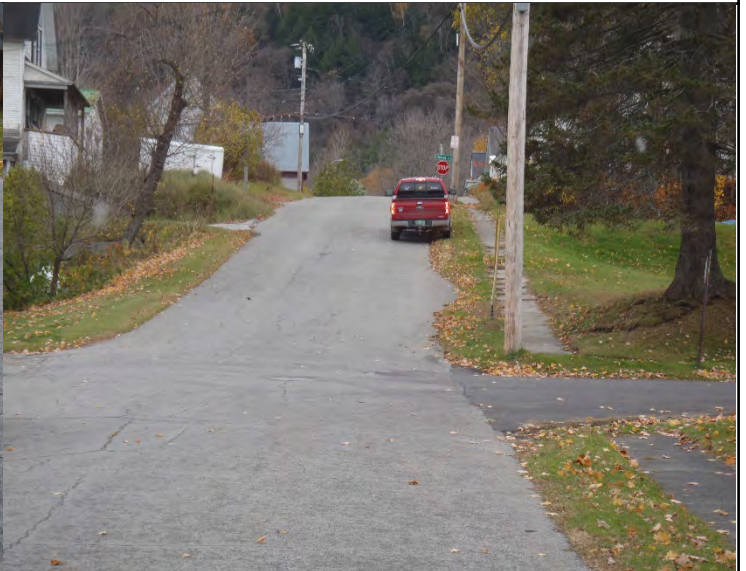
Photo 1. Green space available for stormwater capture and treatment

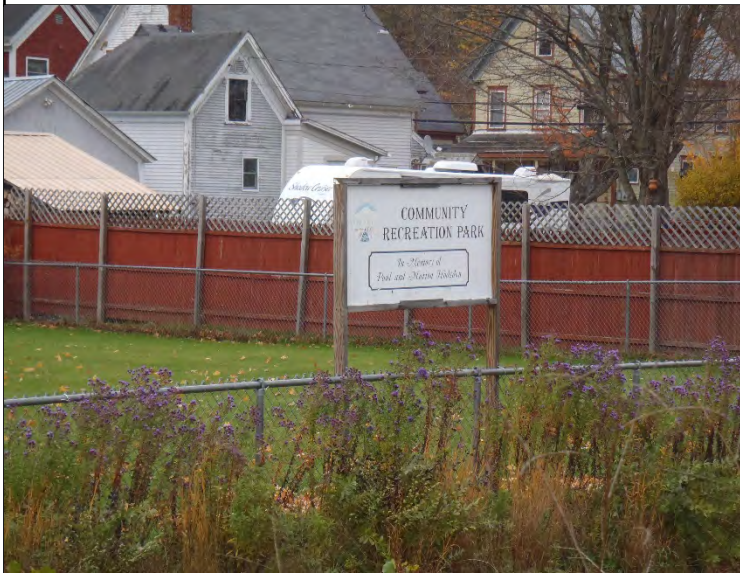
Photo 1. Community Recreation Park

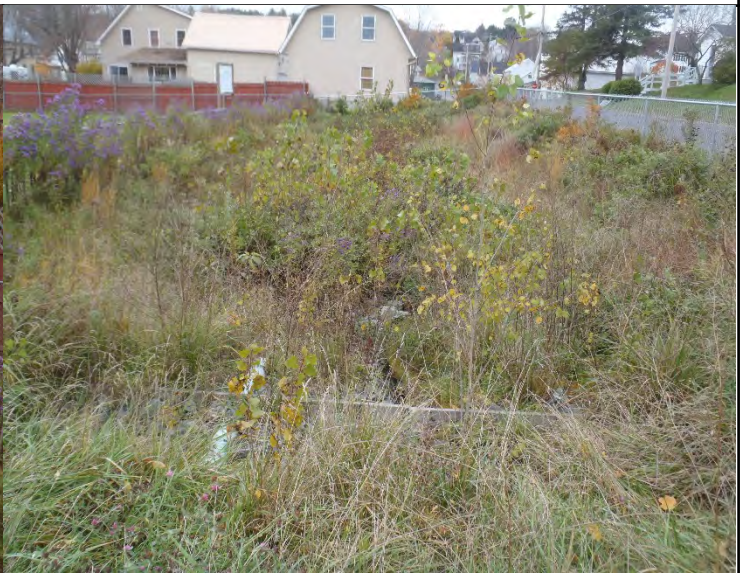
Photo 2. Bioretention area at Community Recreation Park in need of maintenance

Future Maintenance	<ul style="list-style-type: none"> Follow an Operations and Maintenance plan that includes should include bi-annual cleaning of the bioretention area. Bi-annual cleaning should include removing sediment, and mowing or trimming vegetation as necessary. 	
Improve Winter Maintenance	<ul style="list-style-type: none"> The Town may use the bioretention area for snow storage in winter months. Doing so will allow snow melt to infiltrate and capture sediment. If the bioretention area is used for winter snow storage, sediment must be removed every spring after all the snow has melted. This will ensure adequate permeability is maintained within the bioretention area. 	
Additional Design/Permitting Requirements:		
<ul style="list-style-type: none"> Additional engineering support includes one day to create an Operations and Maintenance Plan, and one half-day to perform inspection and offer suggestions after initial maintenance has taken place.

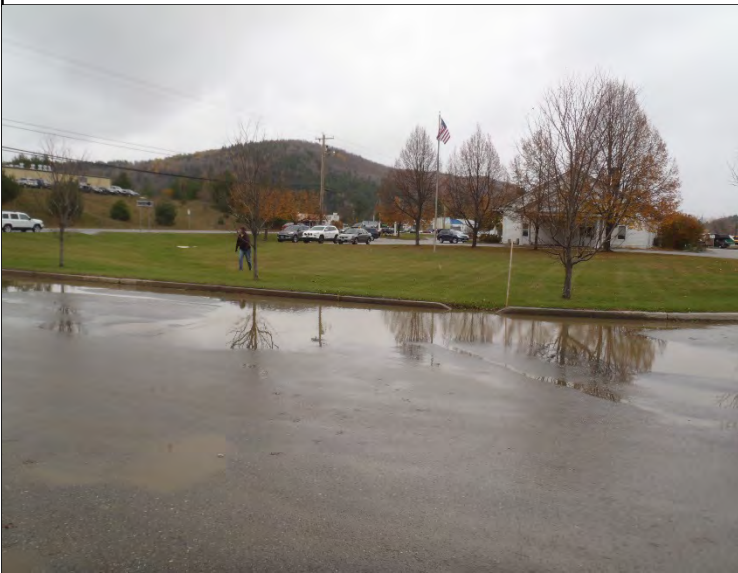
Photo 1. Ponding water due to settling and/or plugged or damaged drainage infrastructure

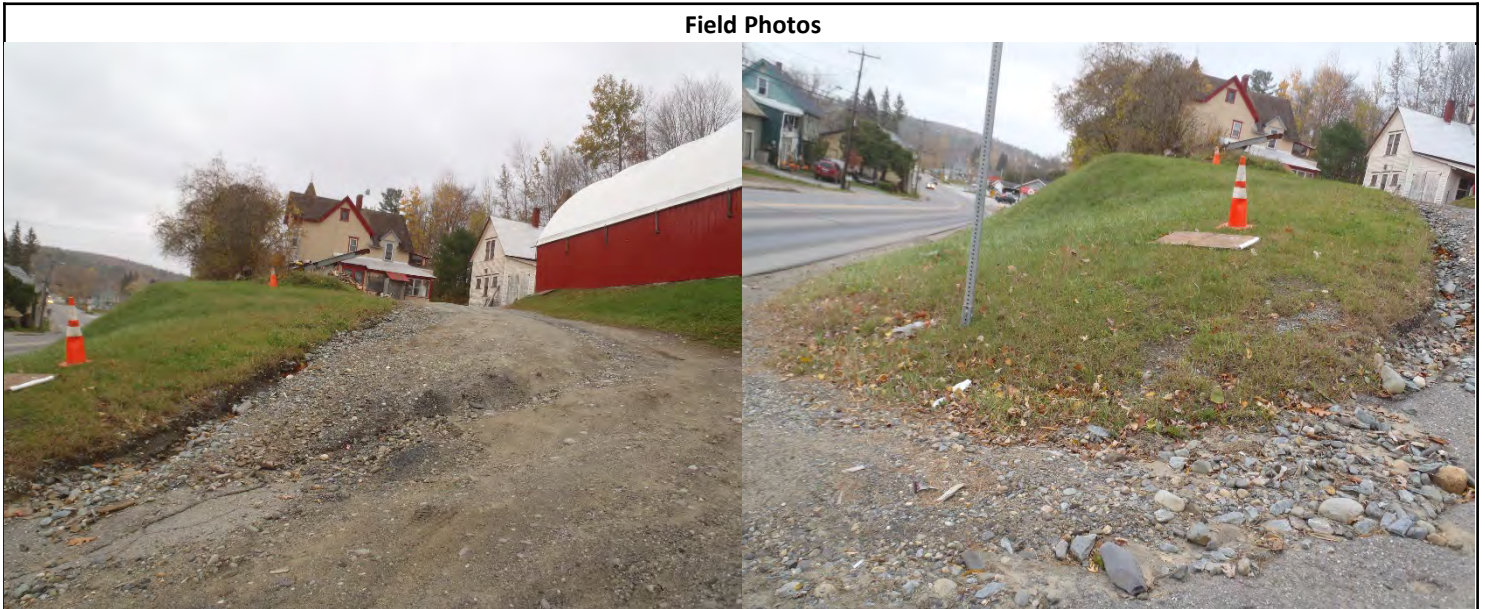
Lower Prospect Street is eroding into intersection of Hillside Street, Lower Prospect Street, and Wolcott Street. It appears that the cause of the erosion is primarily runoff from the barn roof to the southwest.

Photo 1. Driveway erosion at the home on the south corner of Hillside Street and Wolcott Street

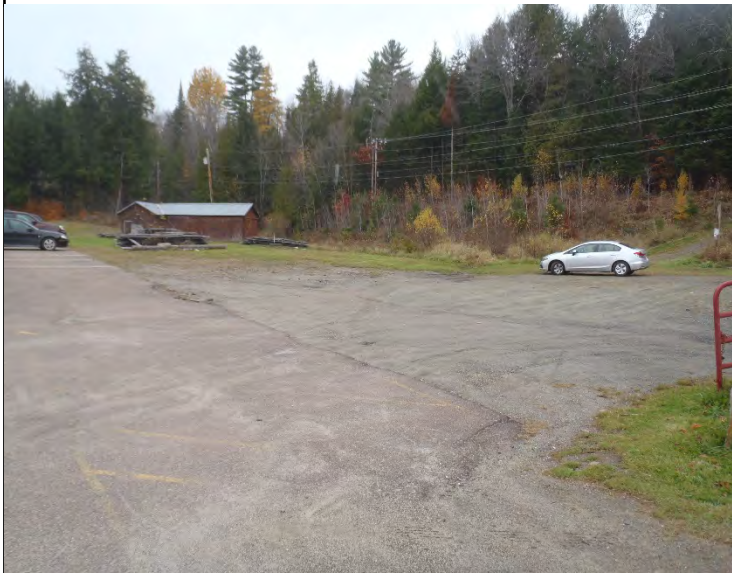
Runoff from the parking lot and uphill area to the east gravel area near Hardwick Trails. The runoff could be routed to the existing green space where it could be captured and treated. Ideally the existing green space could be used to infiltrate, pending soil investigations.

Photo 1. Existing drainage and green space with retrofit potential

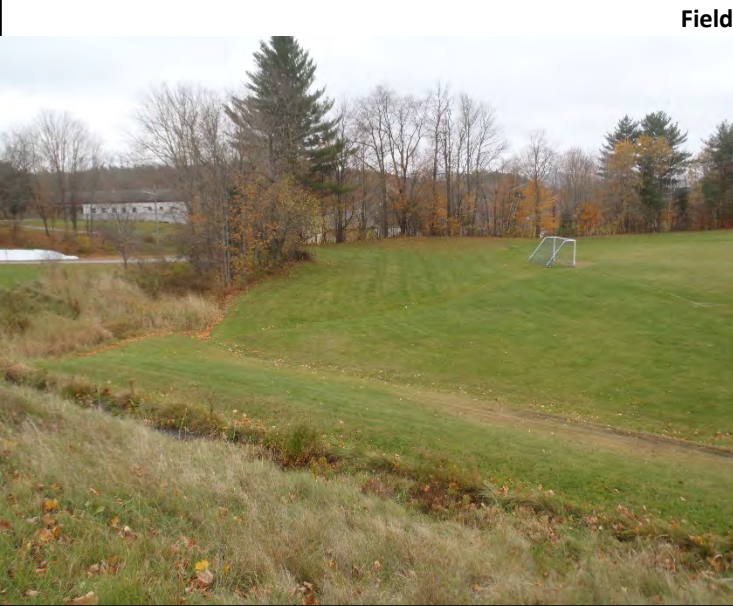
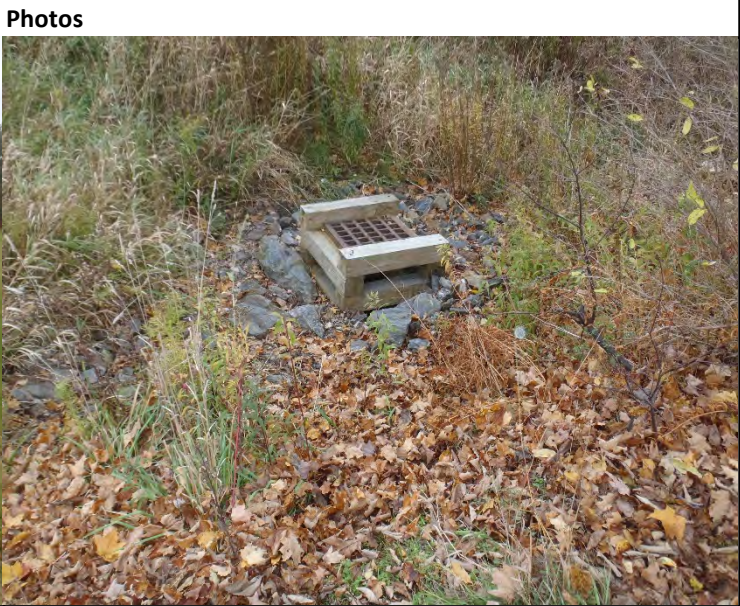
<p>Photo 1. Potential retrofit location south east of school</p>	<p>Photo 2. Existing detention basin outlet structure</p>

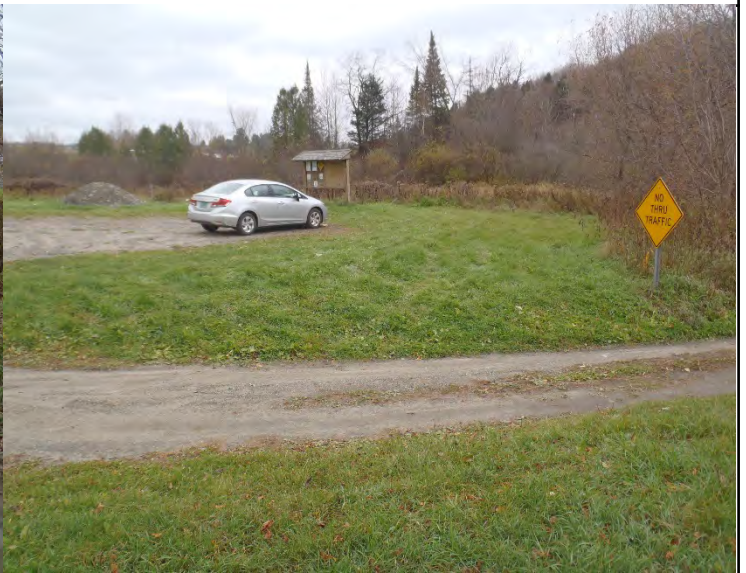
Photo 1. Sediment transport from VT Route 15 onto Wright Farm Road

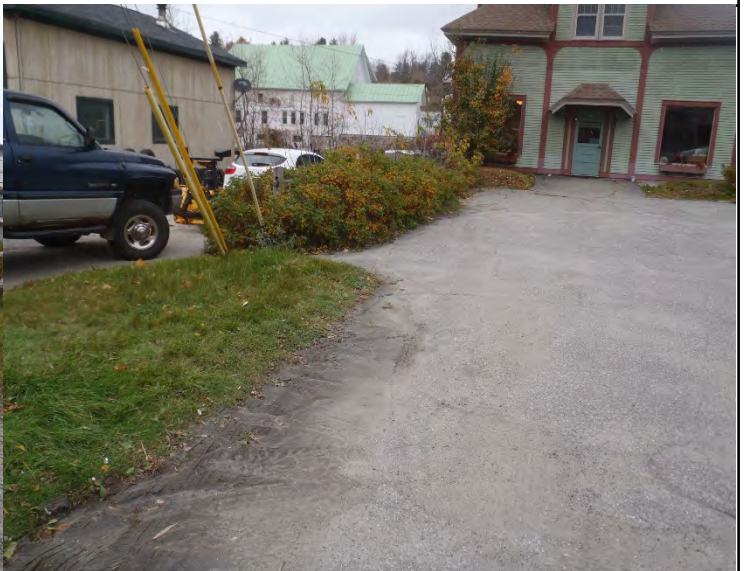
Photo 1. Available green space between Hardwick Village Market and GRACE

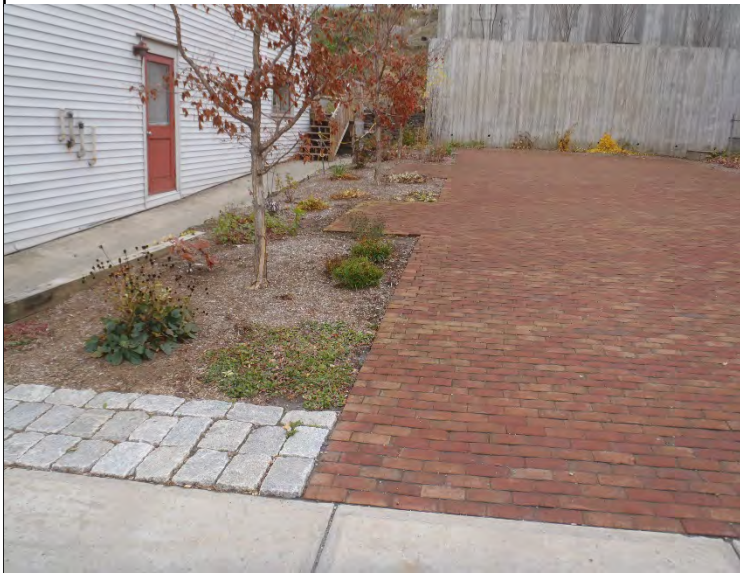
Photo 1. East edge of the park

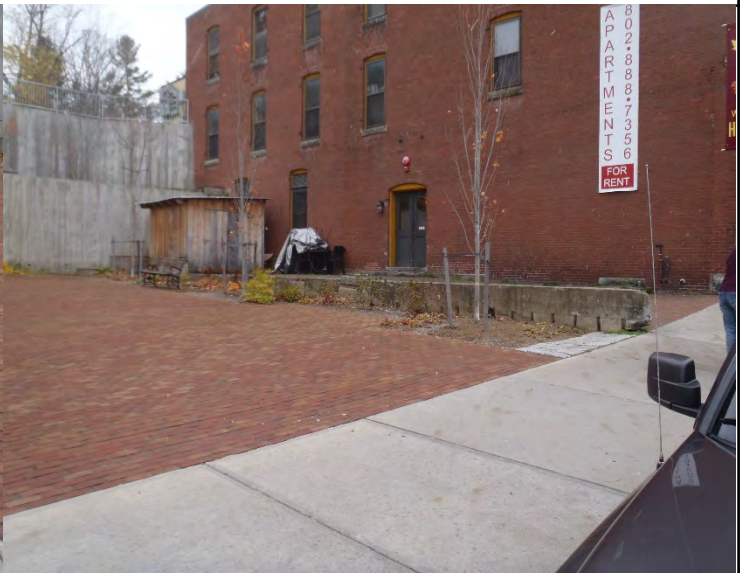
Photo 2. West edge of the park

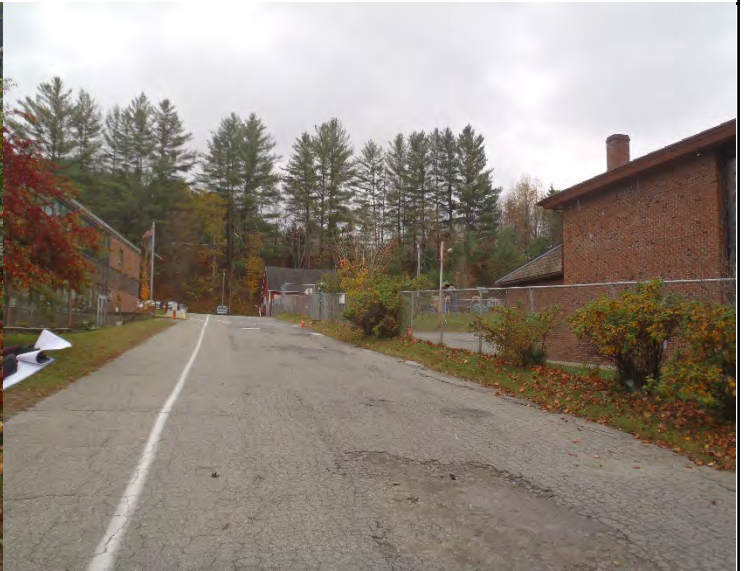
Photo 1. Green space available for linear stormwater retrofit

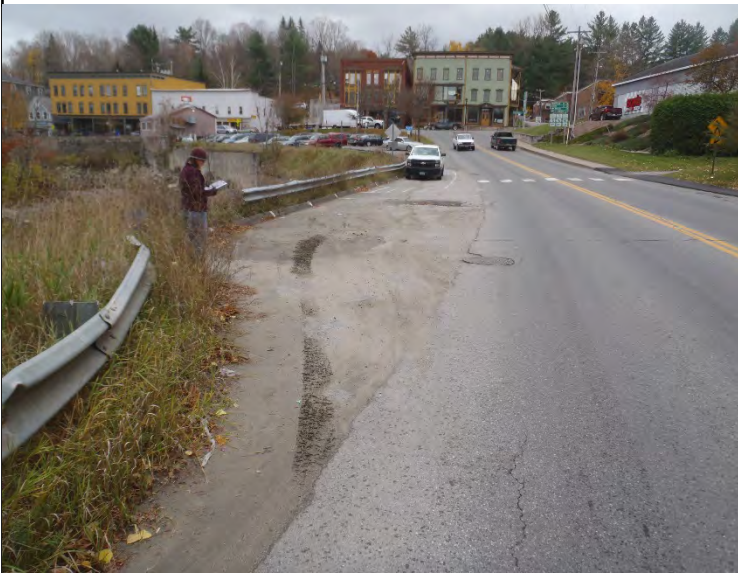
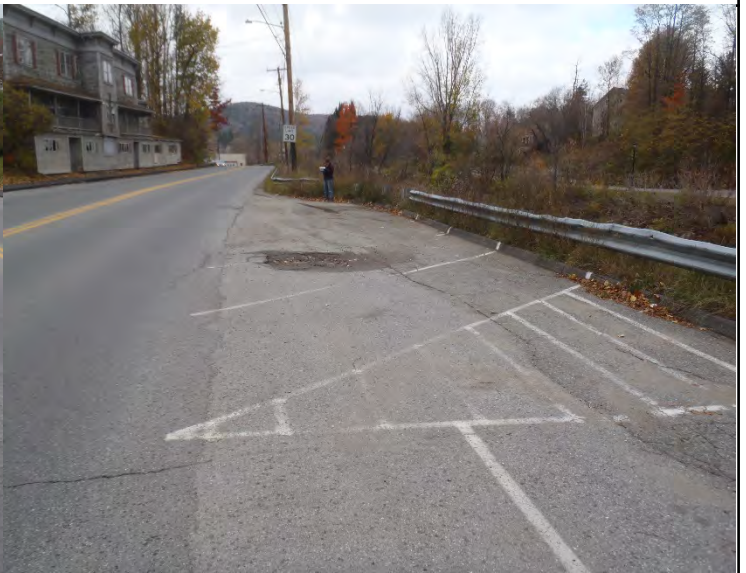
Photo 1. Existing conditions in the location of a potential sedimentation basin

Photo 2. Existing conditions in the location of a potential sedimentation basin

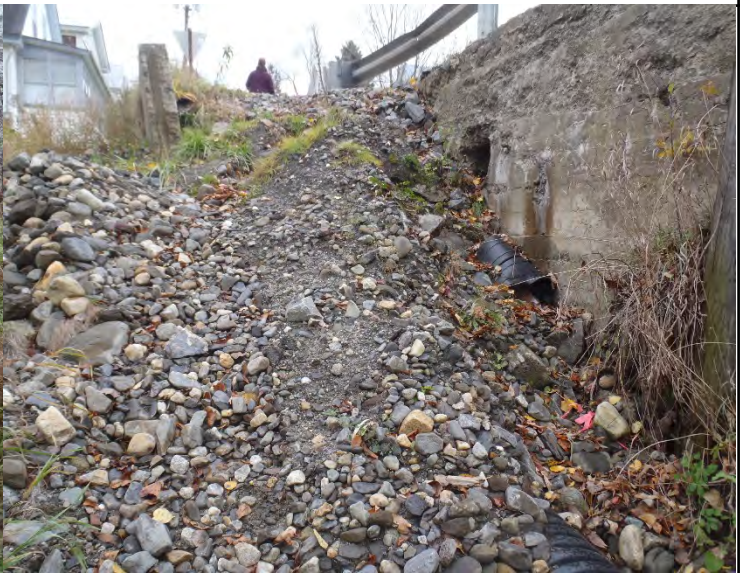
Photo 1. Marginal erosion on the northwest corner of the bridge
