Jackson Dam

Dam Removal Feasibility Analysis

Hardwick, Vermont

March 26, 2026

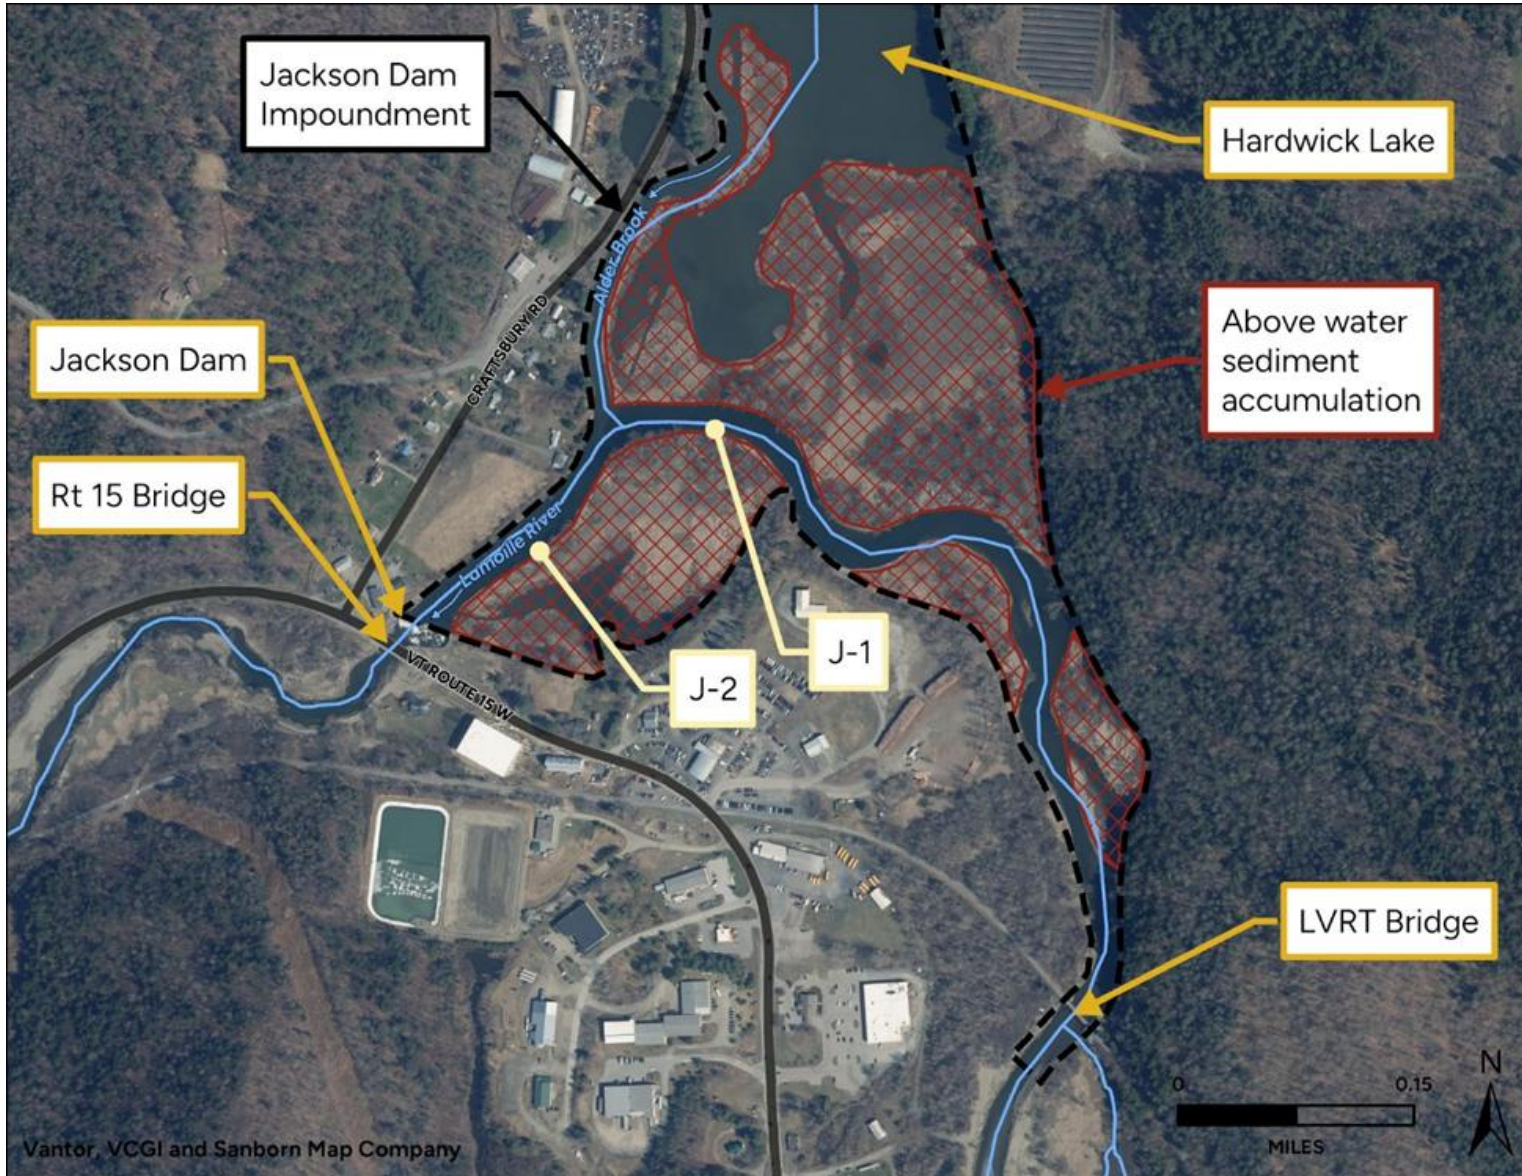
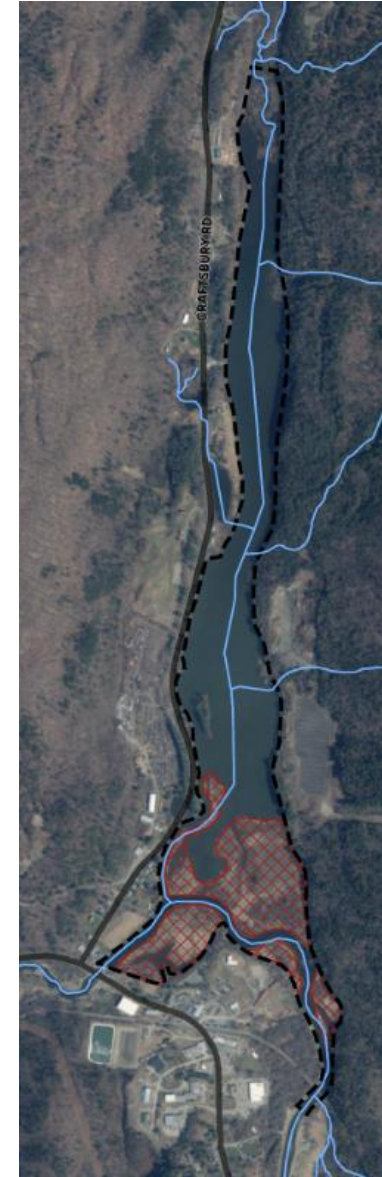
- Extensive sediment deposition
- Deep sediment-filled channel on the Lamoille
- Lake has a max depth of ~7 feet

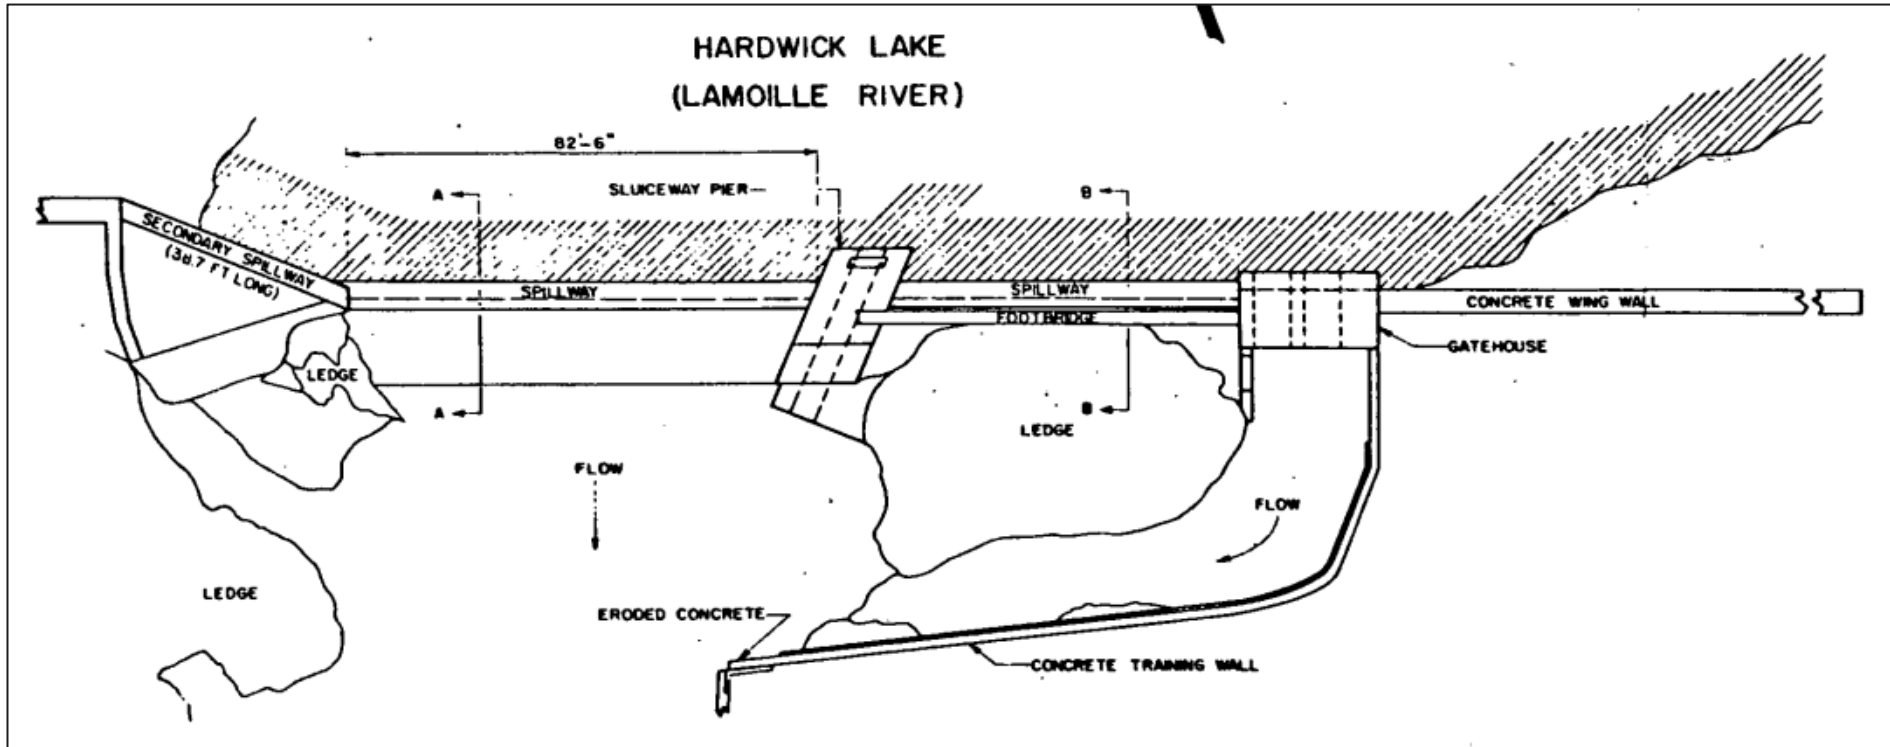
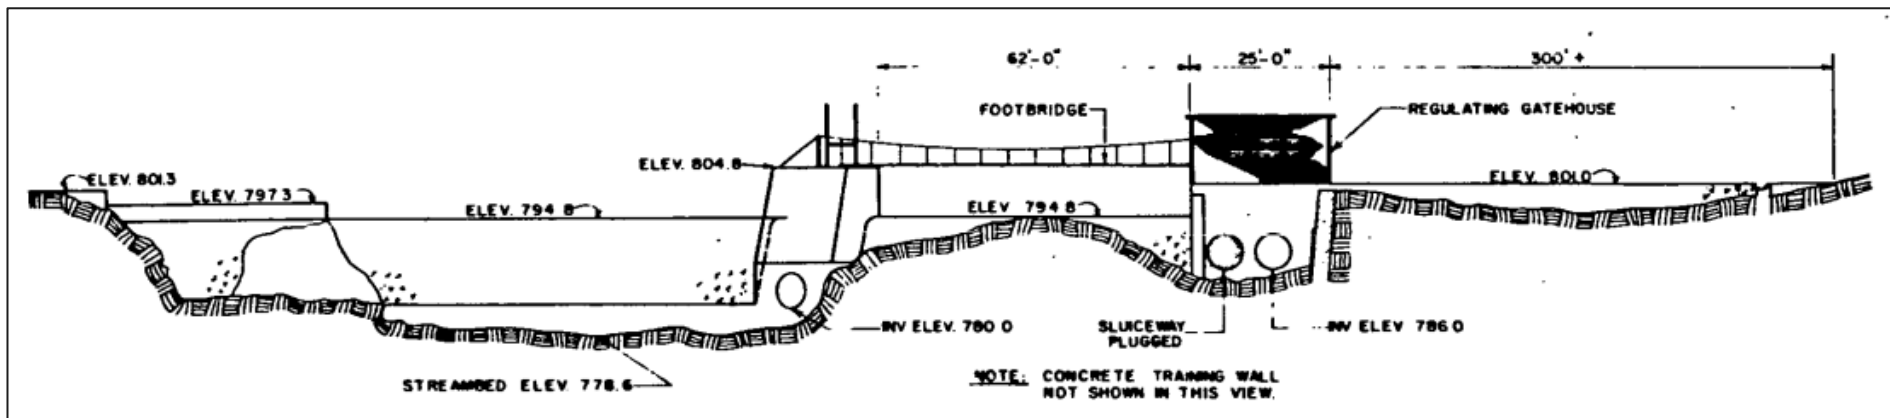
USACE, 1980 from the 1952 repairs

- Total length ~523 feet
- Max height ~23 feet

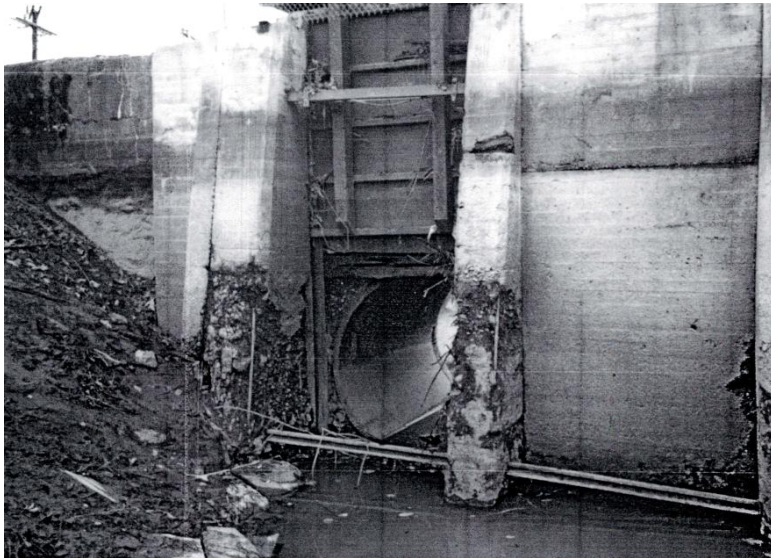
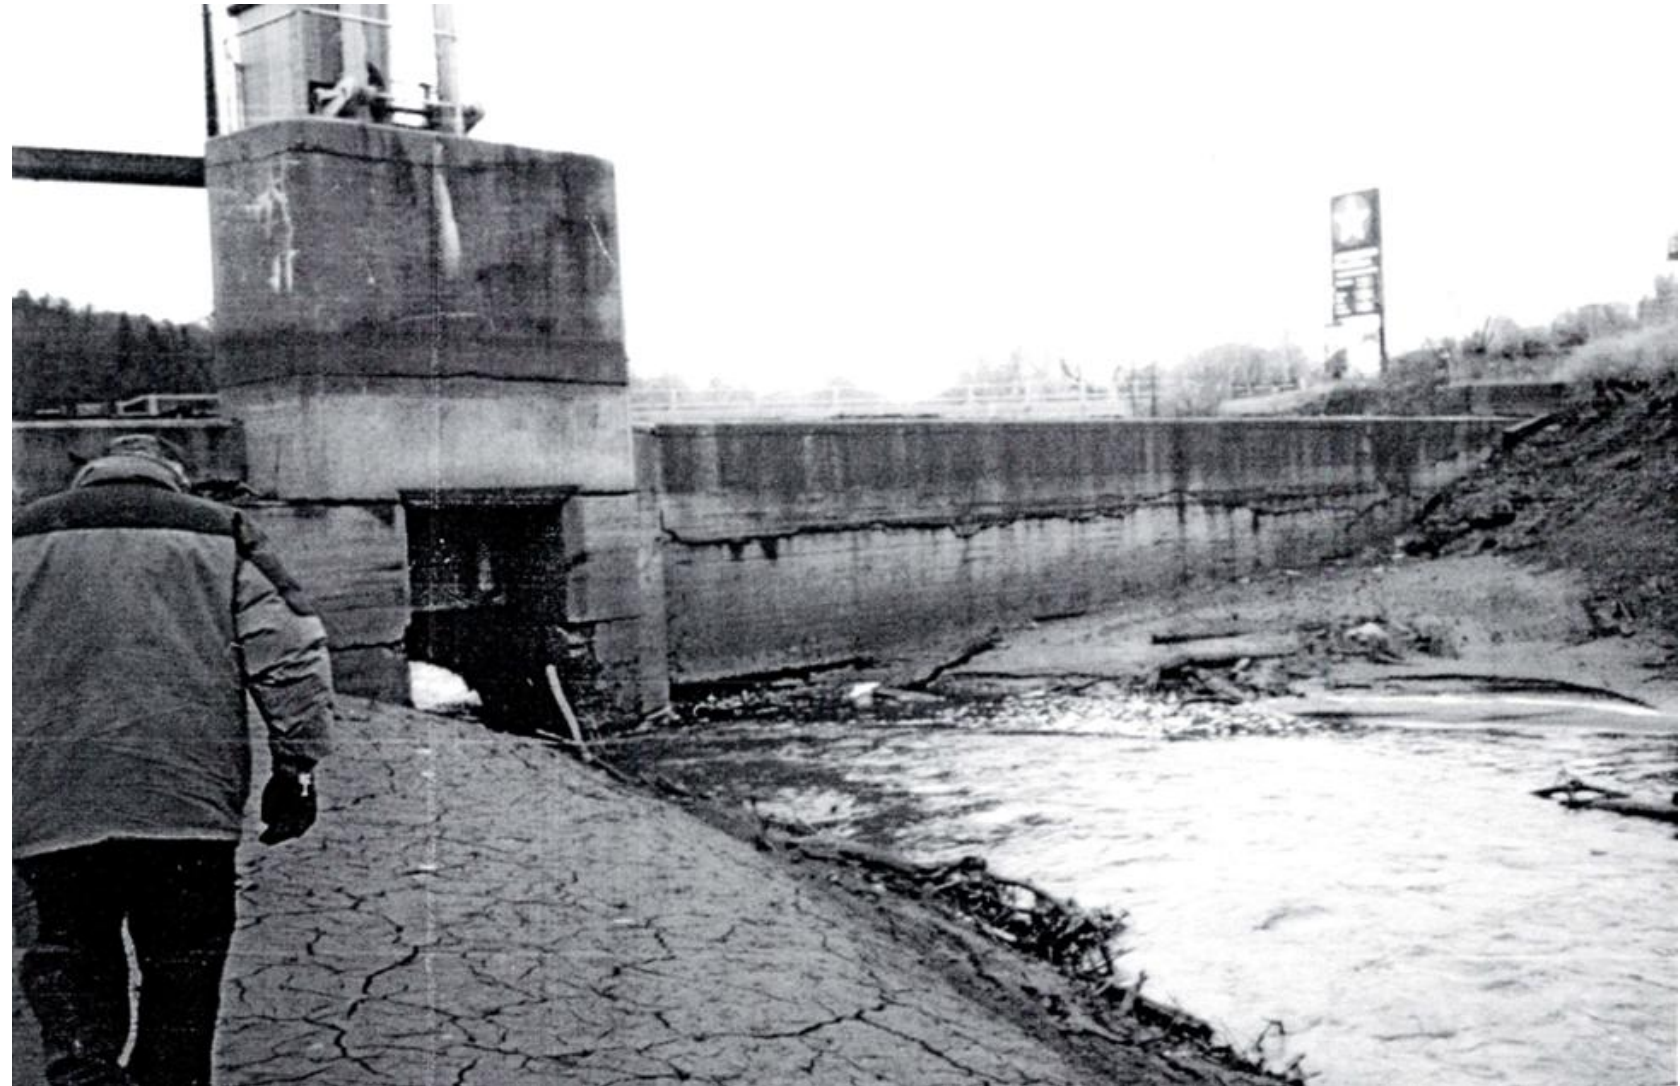
- Dam inspection in 2001
- Horizontal crack on US and DS face
- Concrete cap from 1952 repairs is failing
- Surface deterioration
- Undermining to the foundation in certain areas

- Engineers at DuBois & King Inc. recommended repair of the dam based on deficiencies identified in the dam inspection
- Repairs include:
 - Remove the concrete cap and repair the foundation in the main spillway
 - Repairs to the 300-foot non-overflow wall
 - Structural concrete repairs to the mid-level outlet structure
 - Repairs of the outlet gate

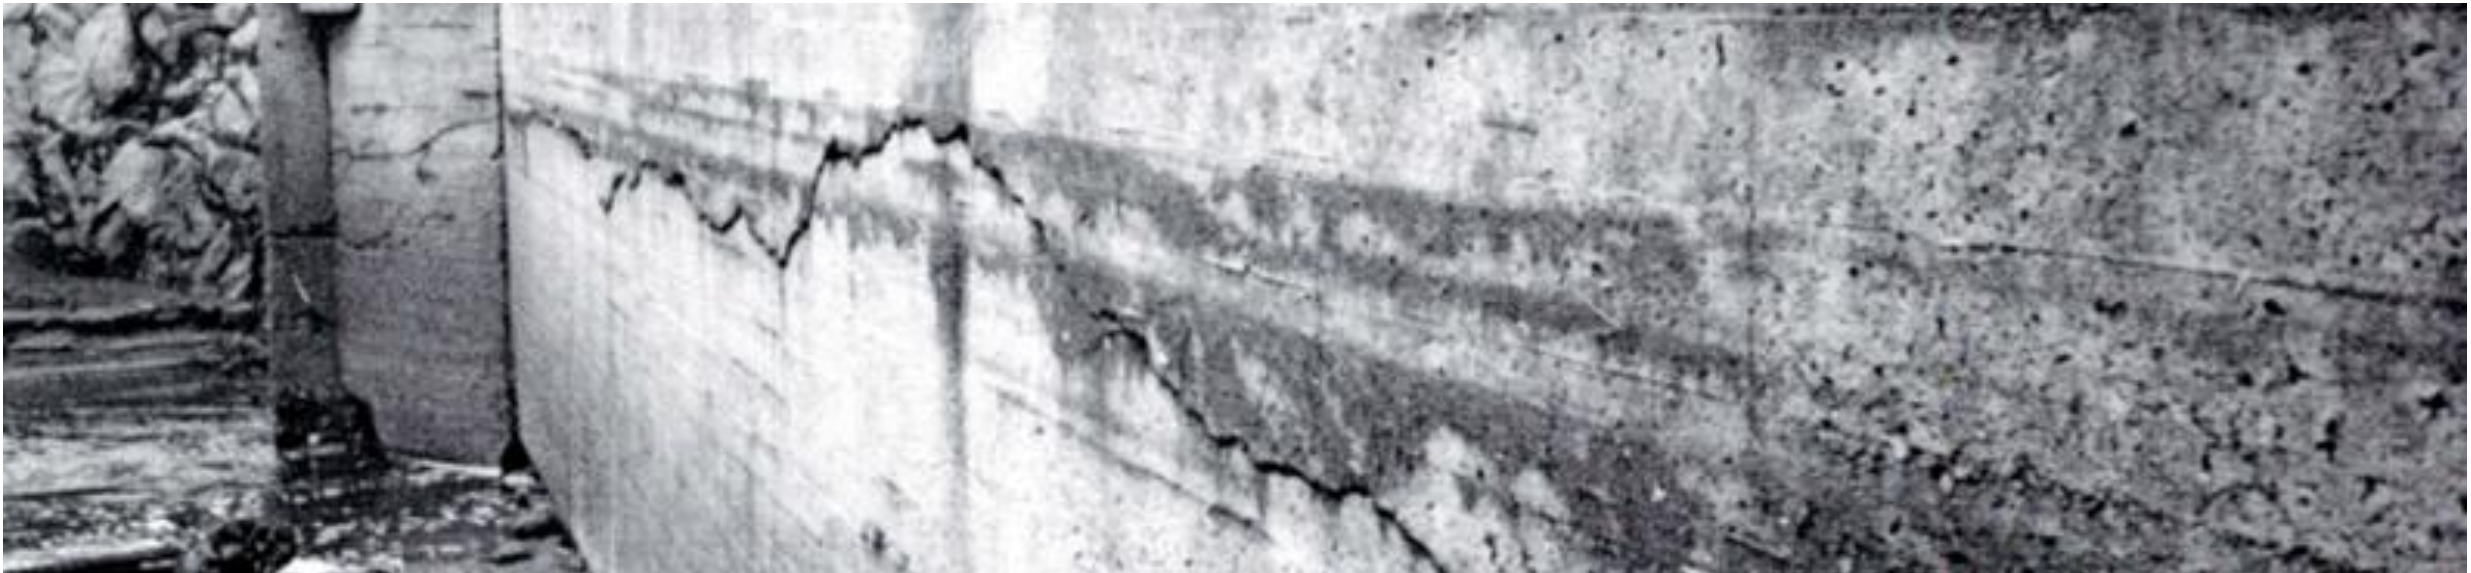
Knight, 2001

- Classified as a **Significant Hazard Dam**
 - Dam failure = property losses and damage to downstream infrastructure
- Dam rated as **POOR** in dam safety inspections in 2010, 2011, 2015, 2019, 2023, and 2024
- **Significant repairs and modifications** are required to restore dam to safe operating conditions and to meet dam safety requirements
- Operation at the lower-level year-round was recommended for consideration **until a permanent solution can be pursued**

Based on the studies and analysis recommended above, repair, rehabilitate, or replace the dam to bring it into compliance with current dam safety rules and guidance. Alternatively, consider pursuing dam removal.
