## AARP Community Walk Audit location:

Wolcott Street, Hardwick – from the Hardwick Fire Station to the 3-way intersection.

Date: 9/23/24 Started at 10 am and finished at 11 am

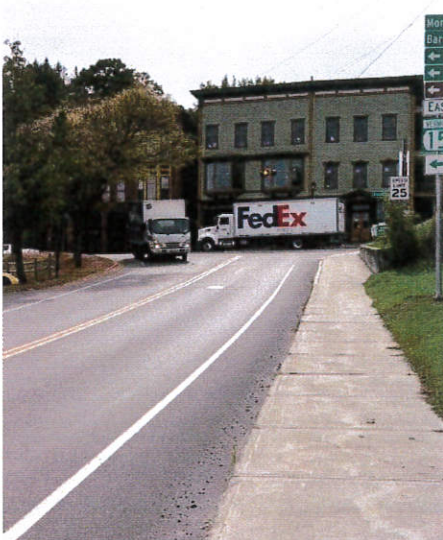
View to the 3-way Intersection from Wolcott Street – improved sidewalk and 25 mph sign for Main Street.

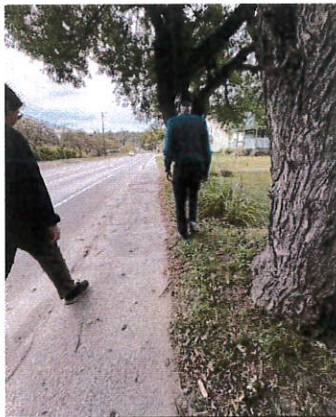
Near Granite Street – no separation from Wolcott Street

Intersection and ends beyond the Hardwick Fire Station. The upper (near Main Street) and lower (beyond the Hardwick Fire Station) sections were improved last year and have limited issues with curbs or cracking. However, the middle section of the Wolcott St sidewalk has eroded and poses multiple safety issues including a lack of separation from the street.

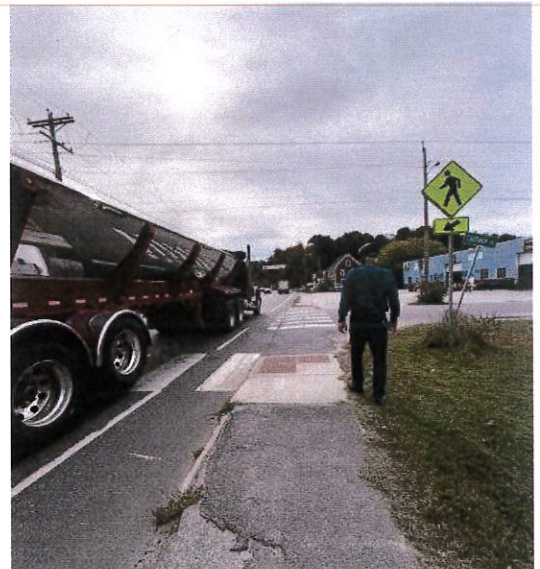
Near Cottage Street – no separation and a cracking, crumbling sidewalk.

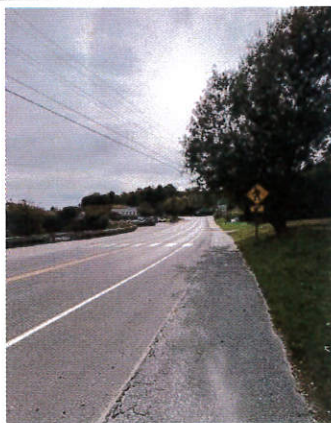
Above Elm Street – no separation from Wolcott Street

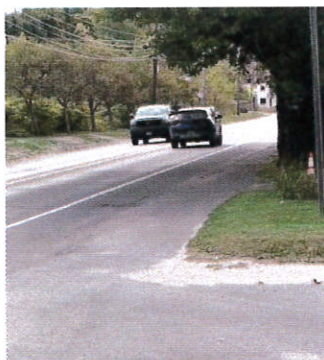
Near Granite Street – no separation from Wolcott Street

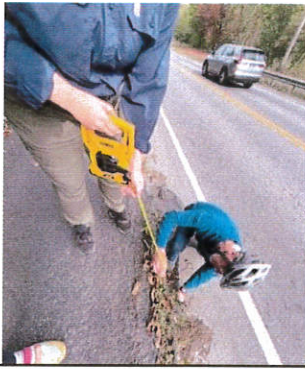
- 2) The most concerning section is between Elm Street and Main Street. The sidewalk is identified as a school route (by sign) and was busy with pedestrian traffic. However, the section is narrow, has overhanging vegetation, and a large vertical drop to

26 inches from the sidewalk to the roadway – between Elm Street and Main Street

Wolcott Street. The change varies between 15 inches to 26 inches. The sidewalk is sloped, cracking, and eroding. Vehicles travel at 30 mph or more.

The entire location could be improved by sidewalk repairs, a storm water review, installation of better drainage, better speed sign installation, and access management on the street. **The section identified between Elm Street and Main Street should be studied and improved as soon as fiscally possible.** Any review of potential Wolcott Street improvements should include an examination of the Lamoille River side for bicycle safety. See the second map on the next page.

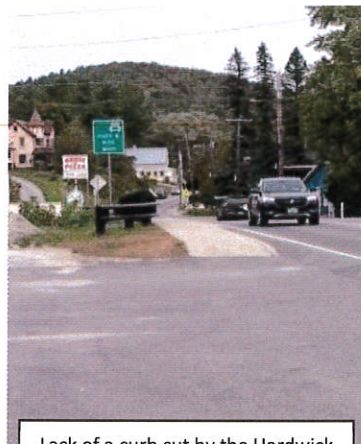
- 3) The Hardwick Fire Station, Rite Way Sports and Northeast Service Station have parking areas with no curb cuts. The sidewalk virtually disappears past these potentially busy areas.

Lack of a curb cut by the Hardwick Fire Station

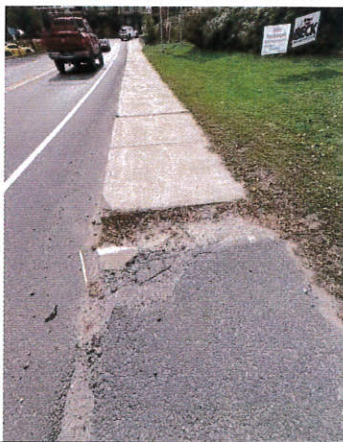
- 4) The Wolcott Street sidewalk is continuous and no segments are missing. However, the sidewalk has a variety of slopes and elevations which make the sidewalk difficult to be used by a wheelchair or other form of mobility assistance.

Sections have gaps and are crumbling.

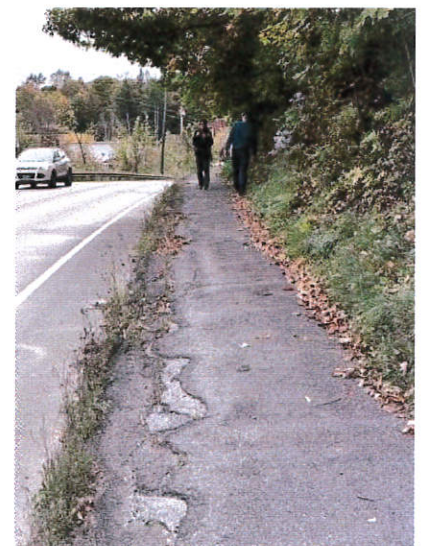
- 5) The existing sidewalk is often not wide enough for two people to walk side by side (between 4 ½ feet to 8 feet in width). The sidewalk is too narrow for two people to pass each other, especially if a wheelchair or other form of mobility assistance is being utilized.

East sidewalk is not adequate in places for a wheelchair or other forms of mobility assistance.

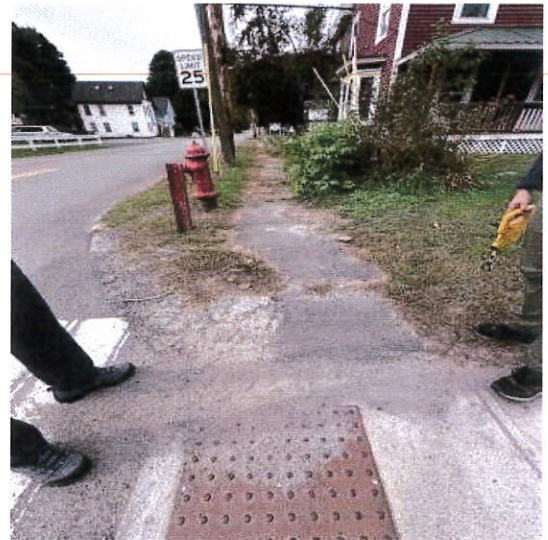
Intersection of Wolcott Street and Elm Street

- 9) Drainage does not appear to be adequate for increased capacity rain events. Water drains off of the Main Street and collects or erodes on the east side of Wolcott Street. Drainage is also inadequate in the Granite Street Historic District. Excess water travels down Granite Street, Cottage Street, and Elm Street and collects on Wolcott Street.
