**AARP Community Walk Audit location:
South Main Street from 3-way Intersection to Alpine Heights,
Hardwick**

Date: 5/28/24 Started at 10 am and finished by 11 am
Posted Speed Limit: 25 mph

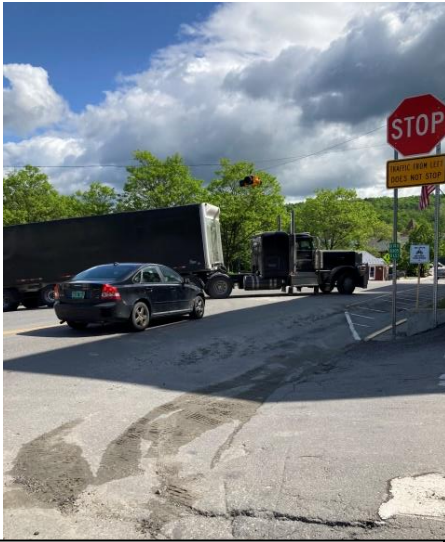
3-way Intersection – looking toward the Hardwick Downtown

10) The 3-way Intersection does not have a crosswalk that enables pedestrians to cross from the west side to the east side (where the shops and restaurants are located). The wear patterns in the grass next to the public parking indicate that people are not traveling to the existing crosswalk but are walking up the grassy bank (around the fence) and across the intersection. Within the span of 10 minutes, the Planning Commission observed 5+ pedestrians crossing through the 3-way Intersection.

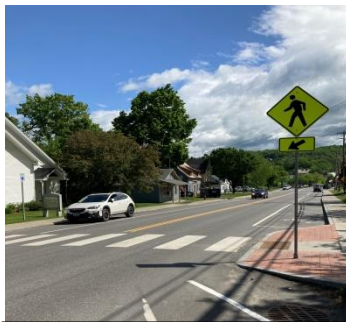
Crosswalk near Lower/Upper Cherry St.

at Lower/Upper Cherry Street were improved last year and have limited issues with separation and curbs. The east sidewalk on South Main Street has curbs which are typically sufficient to separate pedestrians from the road. However, there are sections of the east sidewalk near the Main Street Cemetery which have been eroded and pose a safety issue with the current drop to the traveled lane. The west sidewalk ends at Lower Cherry Street . No separation from the traffic is provided. Over the span of 10 minutes, 4-10 heavy and/or large trucks traveled west through the downtown and were precariously close to the pedestrians on the side. Drivers honked at the Planning Commission members as they walked along the west side of South Main Street.

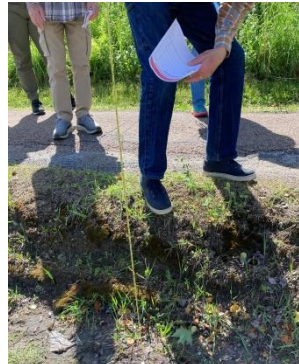
Curb erosion near the east sidewalk on South Main St.

The location could be improved by sidewalk repairs, a storm water review and installation of better drainage, sidewalk installation on the west side, and access management on the western side of the street. A new crosswalk is necessary near Summer Street.

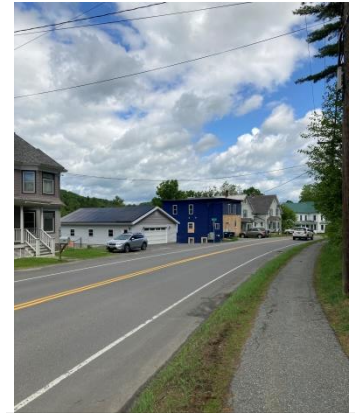
Entering South Main Street – near Alpine Heights - east sidewalk

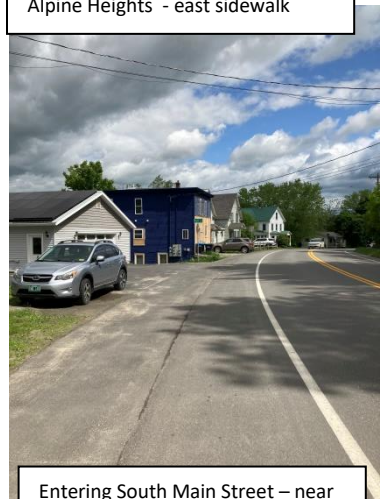
Entering South Main Street – near Alpine Heights - west side. No sidewalk available.

2) The east sidewalk has multiple obstacles after Upper Cherry Street. The east sidewalk is cracked, broken, uneven, and undulating (sloped) and difficult to navigate at times. The west sidewalk beyond Upper Cherry is nonexistent. Tenants and owners park in the path of pedestrian or bicycle access on the west side of South Main Street.

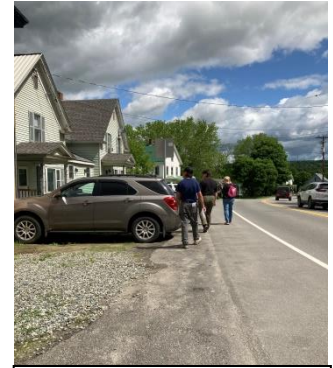
After Lower Cherry Street, the west sidewalk of South Main Street is nonexistent.

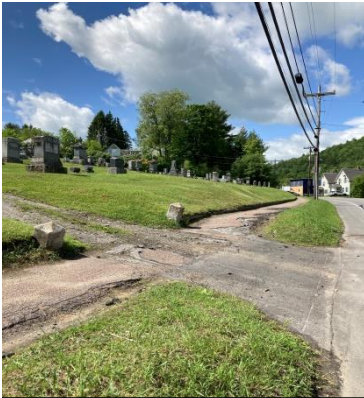
3) The east sidewalk is continuous – no segments are missing. However, the east sidewalk after Upper Cherry Street has a variety of slopes and elevations which make the sidewalk difficult to be utilized by a wheelchair or other form of mobility assistance. The west sidewalk after Lower Cherry Street is nonexistent but the expanse is well-paved and flat.

Sloping sidewalk on east side of South Main Street

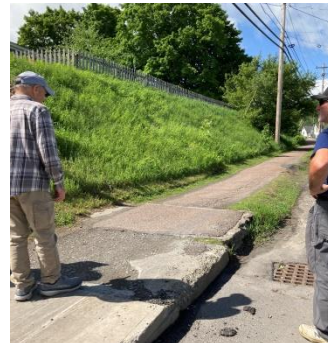
East sidewalk is not adequate in places for a wheelchair or other forms of mobility assistance.

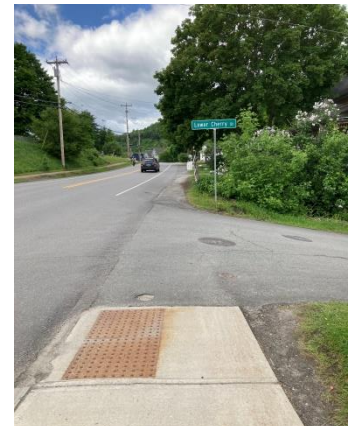
West sidewalk at Lower Cherry St

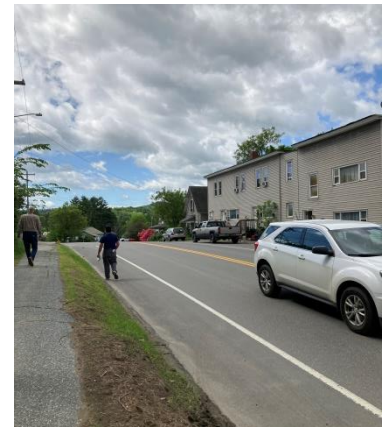
4) The existing sidewalks are wide enough for two people to walk side by side (between 4 ½ feet to 8 feet in width) before Upper and Lower Cherry Street. After Upper Cherry Street, the east sidewalk is too narrow for two people to pass each other, especially if a wheelchair or other form of mobility assistance is being utilized.

East sidewalk becomes too narrow for two people.

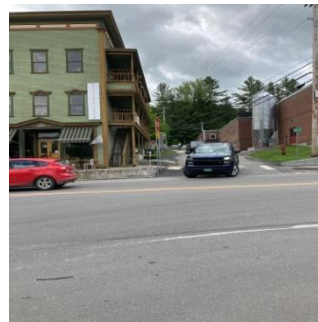
5) There are raised indicators so that users with vision impairments will know when there is a crosswalk across South Main Street. These indicators have not been installed at the intersections of the various side streets that connect with South Main Street.

Intersection of South Main Street and Holton Hill

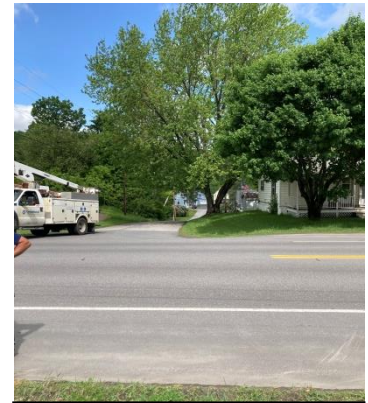
7) There are two main crosswalks across South Main Street. Each existing crosswalk has signs indicating a pedestrian crosswalk and bump-outs to ensure safe crossing. **There is a serious need for an additional crosswalk near Summer Street to allow for safe commute to the elementary school. This crosswalk will need traffic calming elements as well as pedestrian signs due to the high volume of traffic on South Main Street.**

Possible location for a new crosswalk near Summer Street.

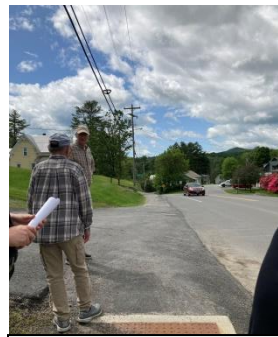
8) The crosswalks and walking areas that traverse the side streets on the east side of

South Main Street are slanted and sloped to a degree that walking becomes difficult. When the surface is wet due to rain, snow or ice, the crossings are slippery and hard to navigate.

Intersection of South Main Street and Alpine Heights.

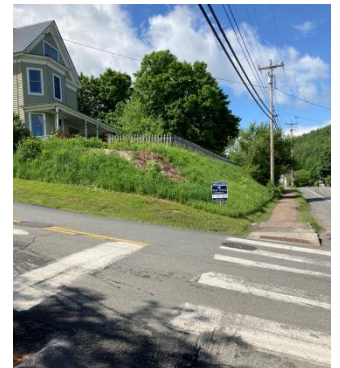
Crosswalk across Upper Cherry Street.

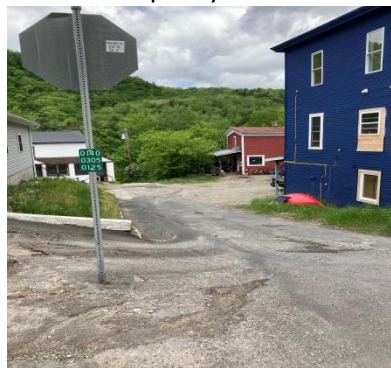
9) Drainage does not appear to be adequate for increased capacity rain events. Water drains off of the east side and collects or erodes on the west side of South Main Street.

Intersection of South Main Street and Farr Street – after a minimal rain event.

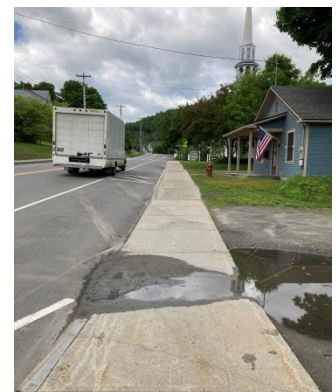
Prior to Lower Cherry Street, after a minimal rain event.

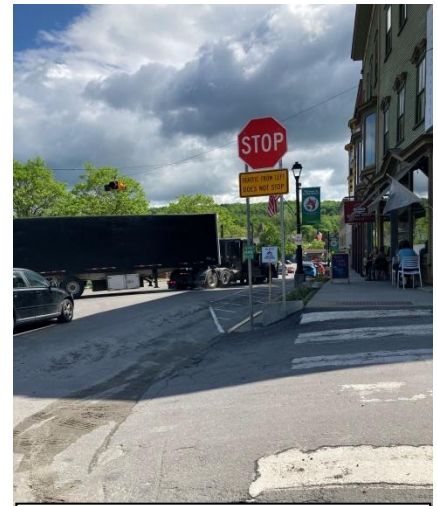
3-way Intersection from Holton Hill vantage point
