Lamoille River Modeling and Alternatives Analysis

Hardwick Flood Mitigation

December 3, 2025

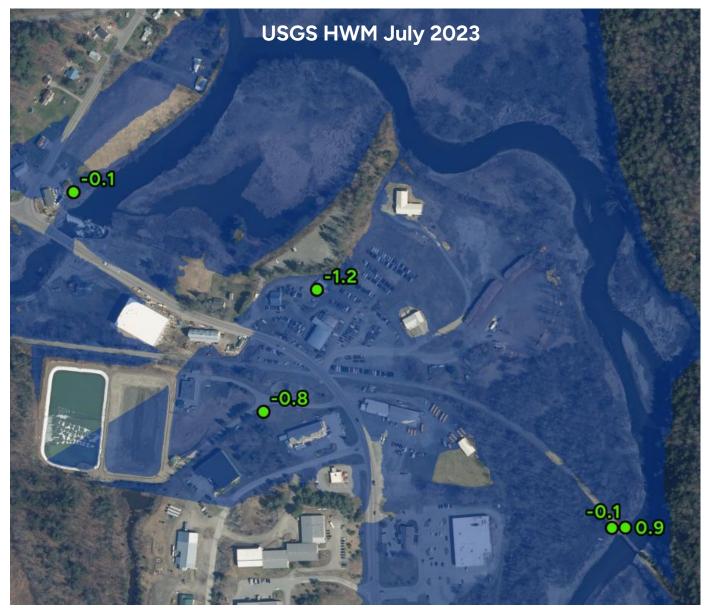
How Accurate is it?

Calibration / Validation:

- High Water Marks (HWMs)
- Accuracy is within 1 ft
- Good for comparing alternatives

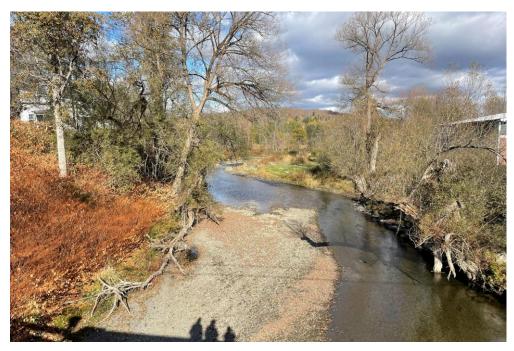
East Church Street Bridge and Floodplain

Problems

- Buyouts
- Erosion

- Bridge Replacement
- Floodplain restoration
- Slope stabilization

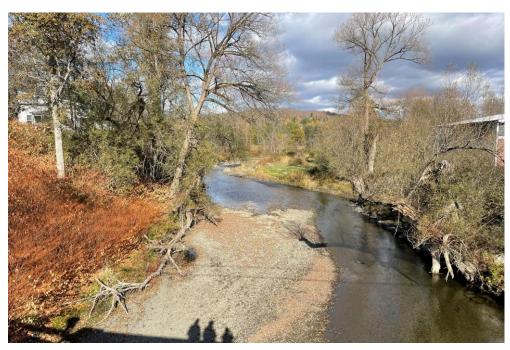
East Church Street Bridge and Floodplain

Problems

- Buyouts
- Erosion

- Bridge Replacement
- Floodplain restoration
- Slope stabilization

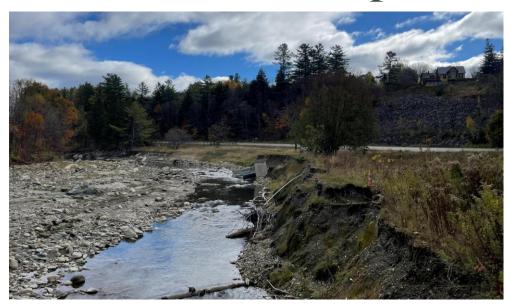
Mill Street Floodplain

Problems

- Eroding bank
- Buyout

- Slope stabilization/bank armouring
- Floodplain restoration
 - Space for Debris and Ice Shedding

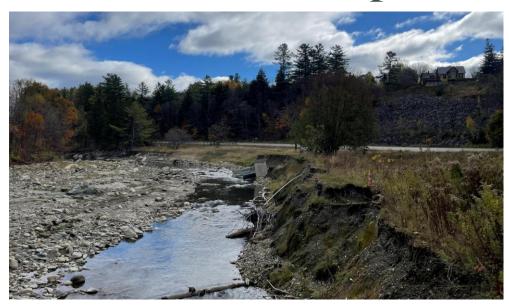
Mill Street Floodplain

Problems

- Eroding bank
- Buyout

- Slope stabilization/bank armouring
- Floodplain restoration
 - Space for Debris and Ice Shedding

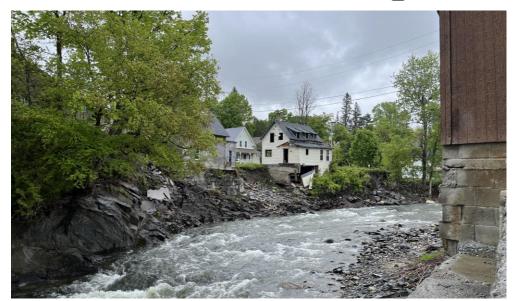
Downtown Floodplains - Buyouts

Problems

- Eroding banks
- Potential Buyouts

- Slope stabilization/bank armouring
- Floodplain restoration

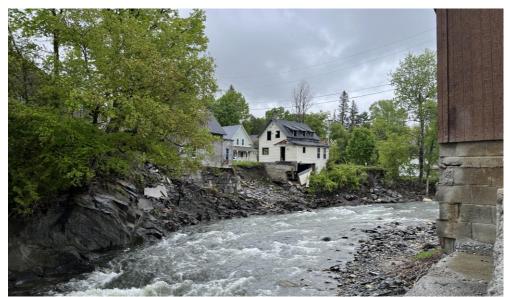
Downtown Floodplains - Buyouts

Problems

- Eroding banks
- Potential Buyouts

- Slope stabilization/bank armouring
- Floodplain restoration

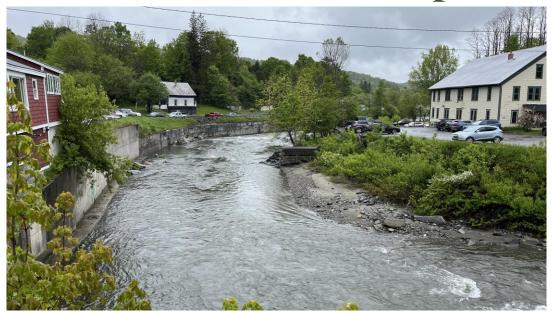
Downtown Floodplains - Constrictions

Problems

- Constrictions
- Eroding banks

- Slope stabilization/bank armouring
- Floodplain restoration

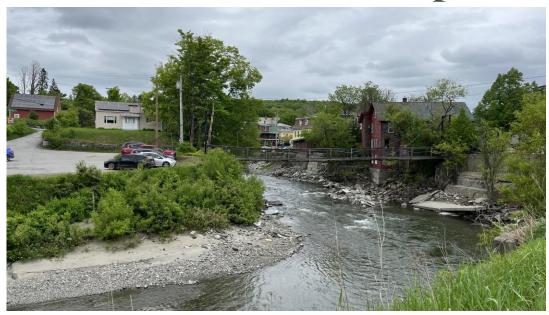
Downtown Floodplains - Constrictions

Problems

- Constrictions
- Eroding banks

- Slope stabilization/bank armouring
- Floodplain restoration

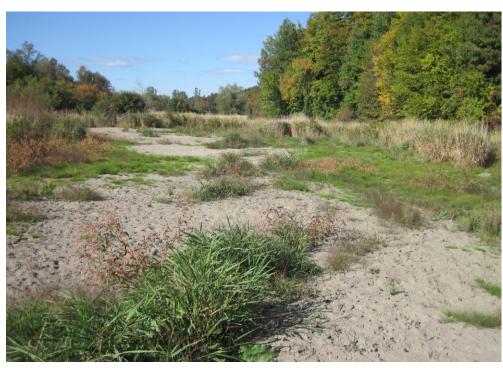
Wolcott Street and Sawmill Lane Floodplains

Problems

- Sediment deposition
- Inundation flooding
- Possible buyouts

Possible Solutions

Floodplain restoration opportunity

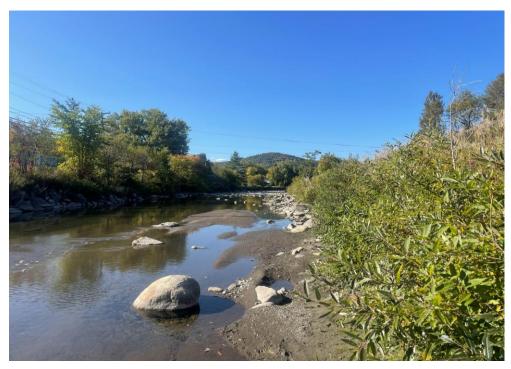
Wolcott Street and Sawmill Lane Floodplains

Problems

- Sediment deposition
- Inundation flooding
- Possible buyouts

Possible Solutions

Floodplain restoration opportunity

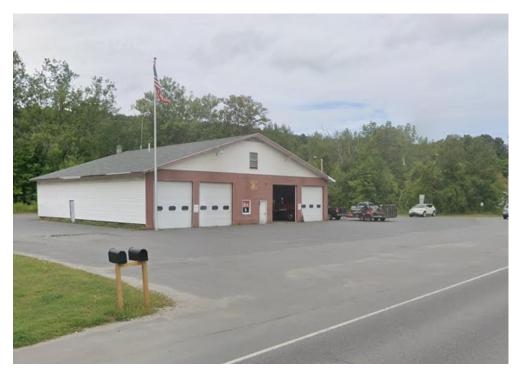
Hardwick Fire Station

Problems

- Inundation Flooding
- Impact to emergency services

Possible Solutions

- Elevate ~4 ft (increases WSE ~0.01 ft)
- Relocation

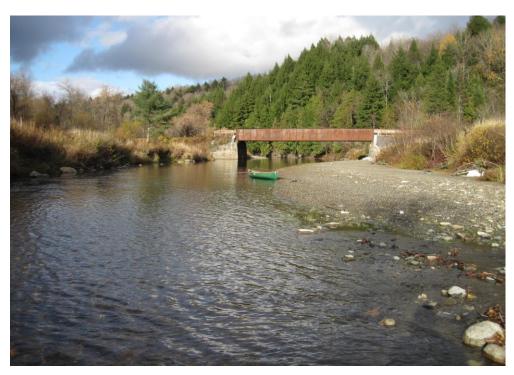
LVRT Embankment

Problems

- LVRT Bridge is a constriction and backs up flow
- Embankment fully blocks floodplain

Possible Solutions

- Lower Embankment / Planned Overflow
- Widen Bridge

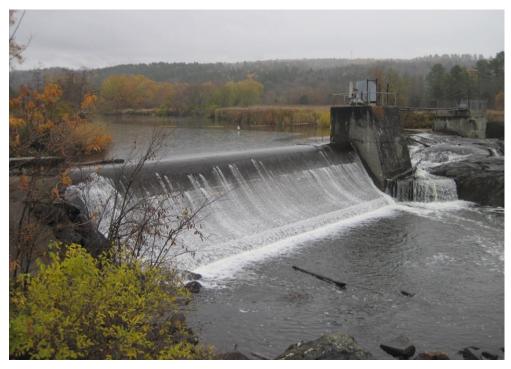
Jackson Dam

Problems

Barrier in River

Possible Solutions

- Dam removal
- Permanent drawdown

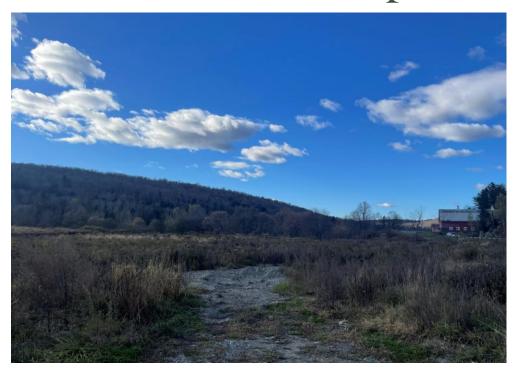
Town Line Floodplain

Floodplain restoration (~10 ac)

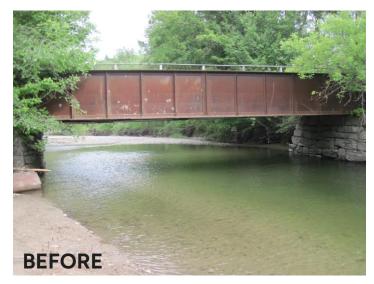
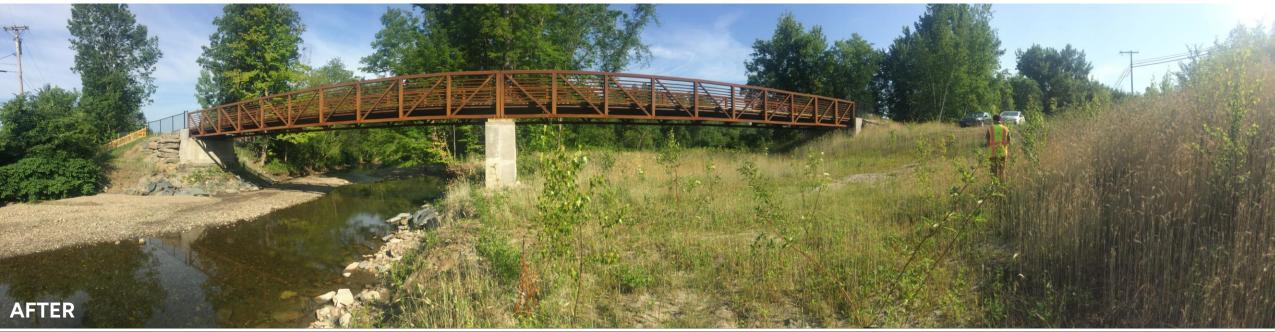
Greenway Trail Bridge Replacement- Jeffersonville

Removed constriction

- An undersized bridge and unused abutments were removed
- Larger bridge installed
- Opened up floodplain under bridge

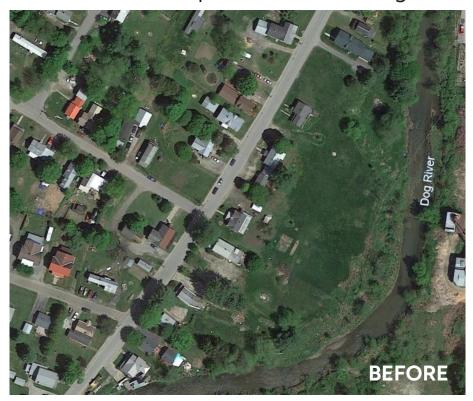
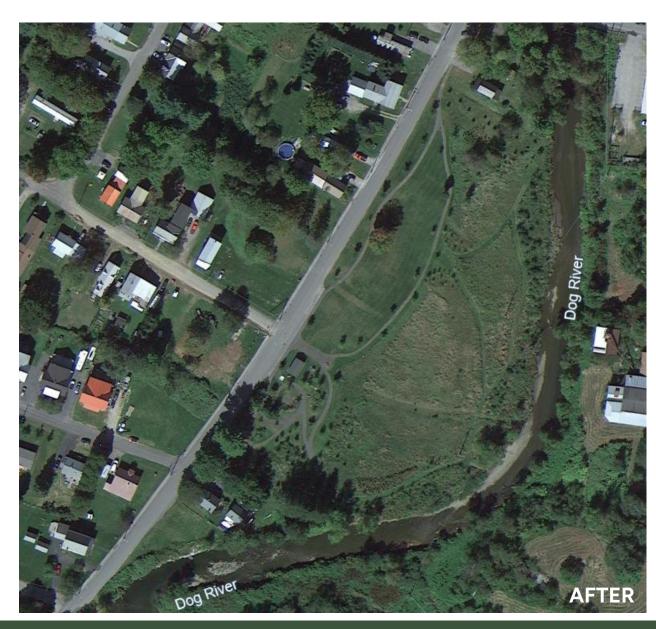
Dog River Floodplain Restoration - Northfield

Removing buildings, people, & infrastructure from vulnerable locations

- Remove 7 damaged homes
- Remove 9,000 CY fill in floodplain & lower land average 4 feet over 3 acres
- Remove berm
- Plant restored floodplain with native vegetation

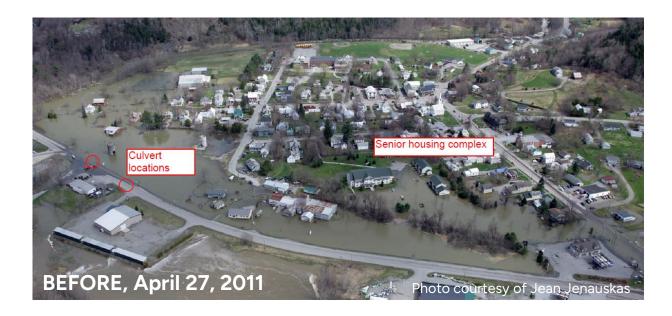
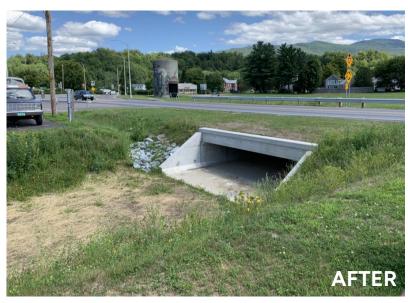
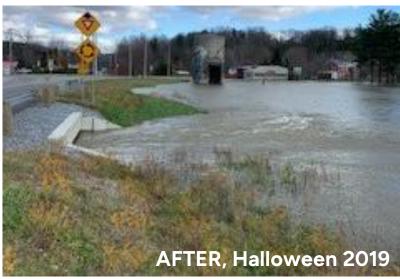
Provide additional capacity under highway embankment

- Large culvert installed under road
- Floodwater trapped behind road embankment can flow out of village
- Road overtops less
- Buildings flooded less
