| STATE OF VERMONT<br>Division for Historic Preservation<br><br>VERMONT ARCHITECTURAL<br>RESOURCE INVENTORY<br><br>Individual Property Survey Form | SURVEY NUMBER:<br>(Assigned by VDHP) |
| | PRESENT FORMAL NAME: Quonset Hut / Town Garage |
| | ORIGINAL FORMAL NAME:<br>U.S. Navy Steel Arch Rib Utility Building |
| ADDRESS: Creamery Street, Town Garage Complex | ARCHITECT/ENGINEER: U.S. Navy Department<br>Bureau Yards and Docks |

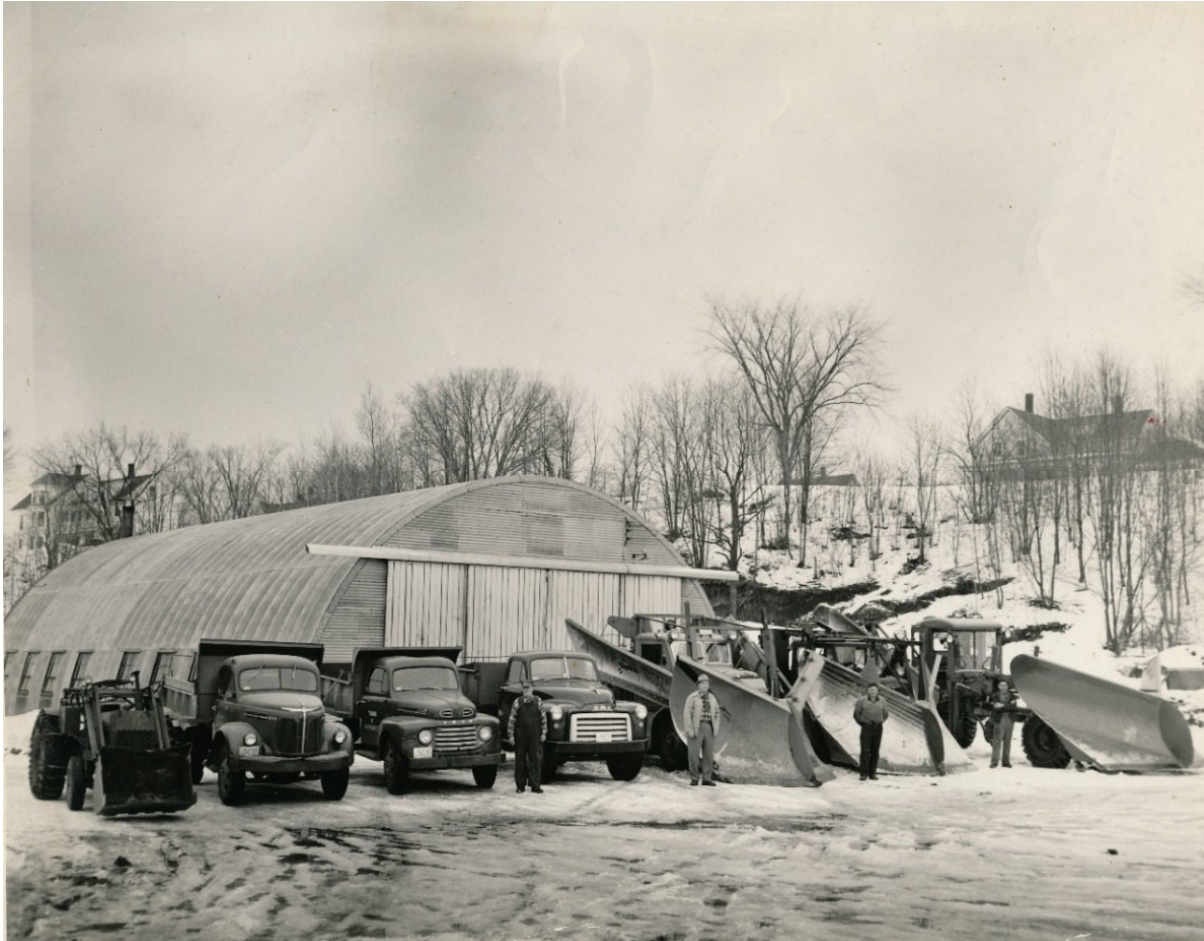
A historic photo taken c. 1952-53 (based on the model years of the trucks in the photo) shows an earlier and likely the original appearance of the Utility Building. The east bulkhead featured a double-wide garage bay opening filled with four sliding wooden doors. The doors were held on a wall-mounted track that extended out beyond the 40' wide elevation. Otherwise, the east elevation was solid, without a man door or louver. The south elevation has not been altered.

Photo 1. . View NW, c. 1952-53, showing the east bulkhead and south elevations. Photo courtesy of the Hardwick Historical Society.

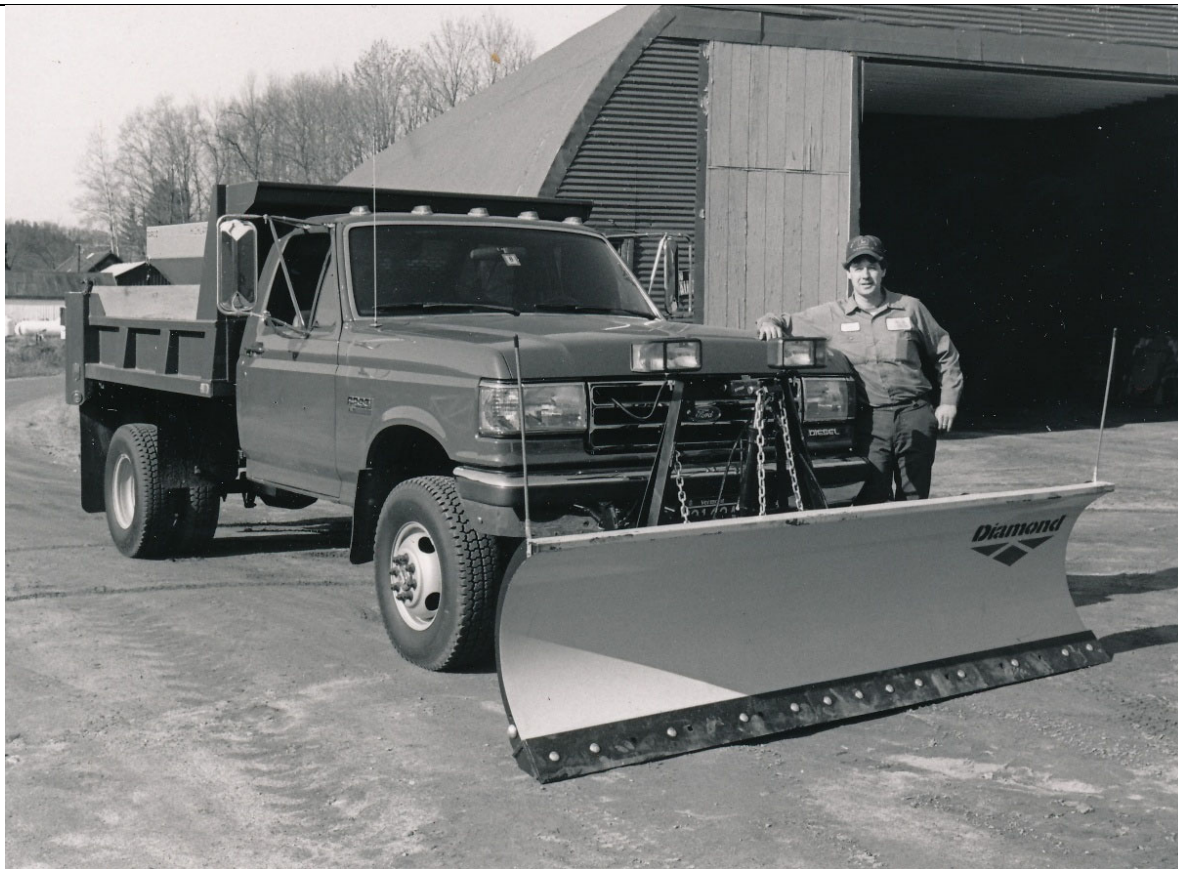
The alterations that resulted in the current appearance of the east bulkhead were made prior to 1993. A photo taken c.1993 shows that the width of the wide garage bay had been reduced by the construction of wooden stud walls sided with vertical boarding on both sides of the original opening. The track that held the four sliding doors was also removed.

Photo 2. . View NW, c. 1993. The opening on the east bulkhead has been reduced in width by the construction of wooden stud walls sheathed with vertical boarding. The opening is now filled with an overhead garage door. The upper corner of the added man door is also visible in the photo. The date of the added louver is unknown. Photo courtesy of the Hardwick Historical Society.

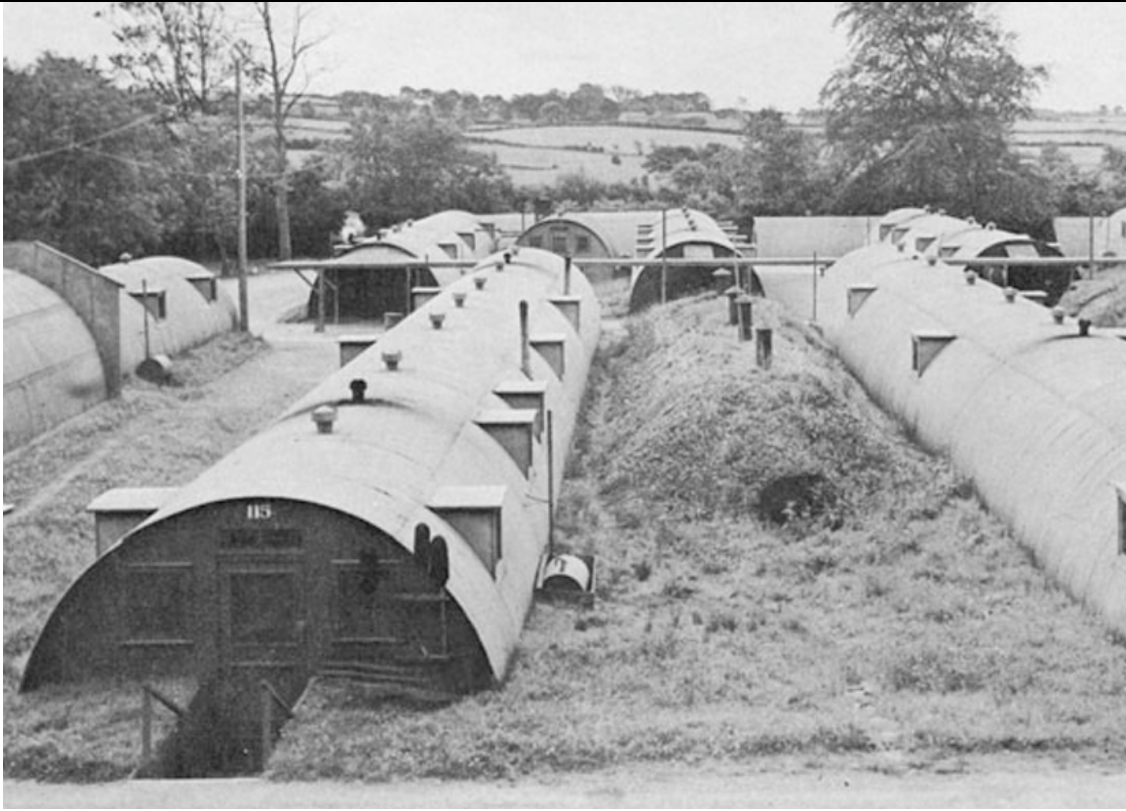
Photo from the website *U.S. Navy Quonset Hut, Weapons of Mass Construction*. Several of the Utility Buildings in the second row of the photo appear to have very wide bulkhead openings.

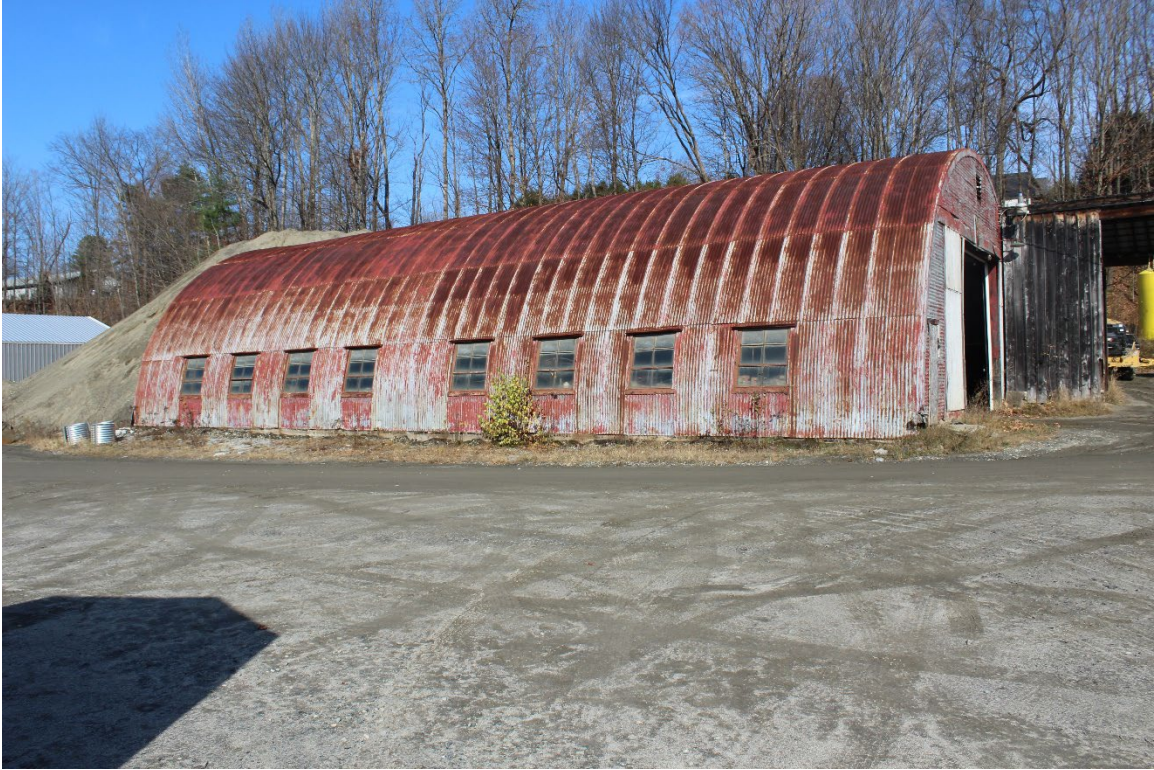
Photo 1. Hardwick Quonset Hut/Hardwick Town Garage. View NW, showing the south and east bulkhead elevations. Available architectural plans for a Quonset Hut refer to the vertical, end elevations as bulkheads. The 8 windows in the south elevation are grouped so that 4 are centered in each half of the elevation.

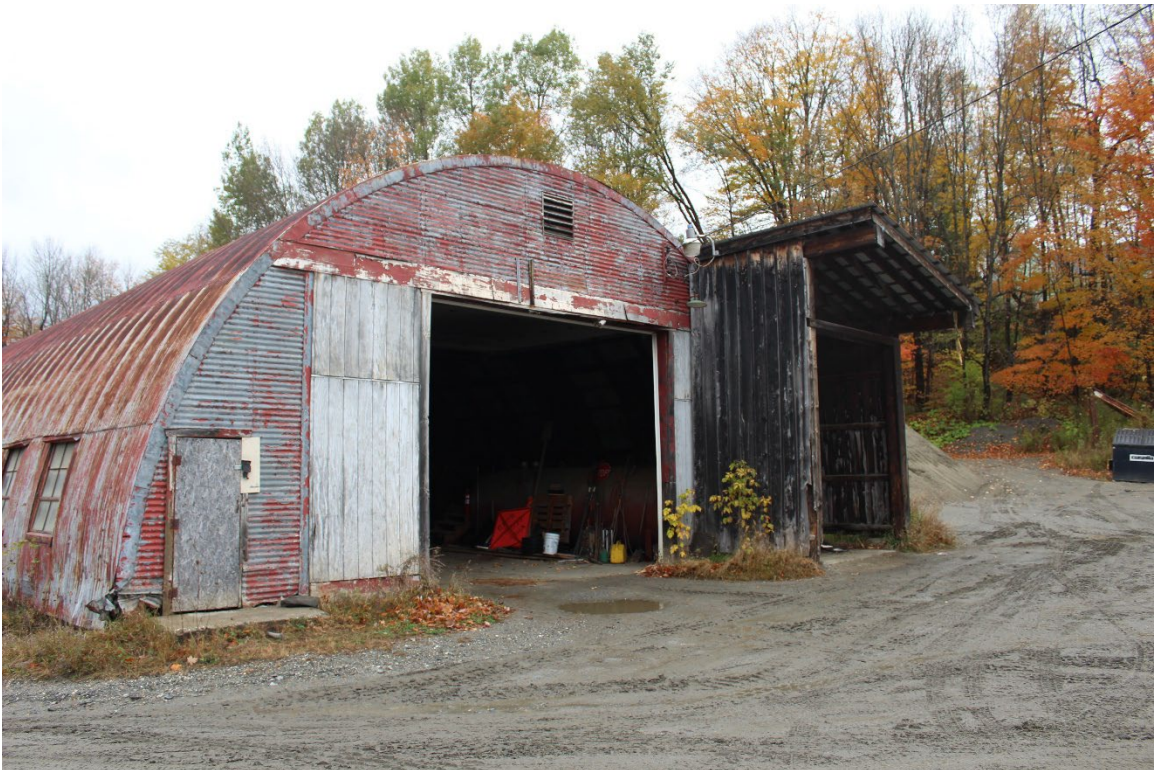
Photo 2. New NW, showing the east bulkhead. The centered garage bay opening is flanked by narrow sections of wall sided with vertical boarding rather than horizontally-oriented corrugated metal. The man door in the south corner of the bulkhead is made of single piece of fiberboard. The non-historic shed-roofed structure north of the garage bay door covers the Town Garage gasoline pump and is not structurally attached to the Quonset Hut.

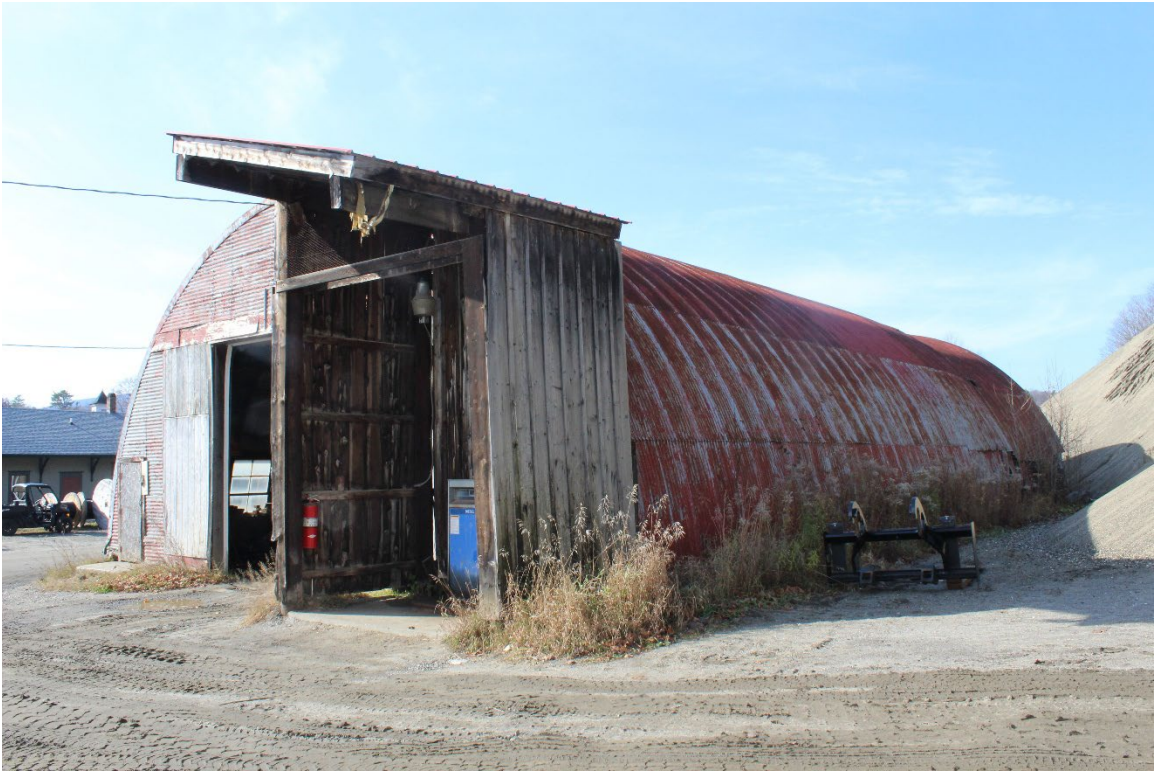
The 80' long north elevation is solid. Several arched ribs and pieces of corrugated sheathing have been bent and/or detached at the west end of the elevation. This damage was reportedly caused when road sand, which is stored behind the Utility Building, was dumped against the building.

Photo 3. View SW, showing the solid north elevation. Some of the corrugated sheathing and associated framing at the west end of the elevation is bent and damaged, reportedly by road sand that had been piled against the building. The shed over the gas tank is not structurally attached to the Quonset Hut.

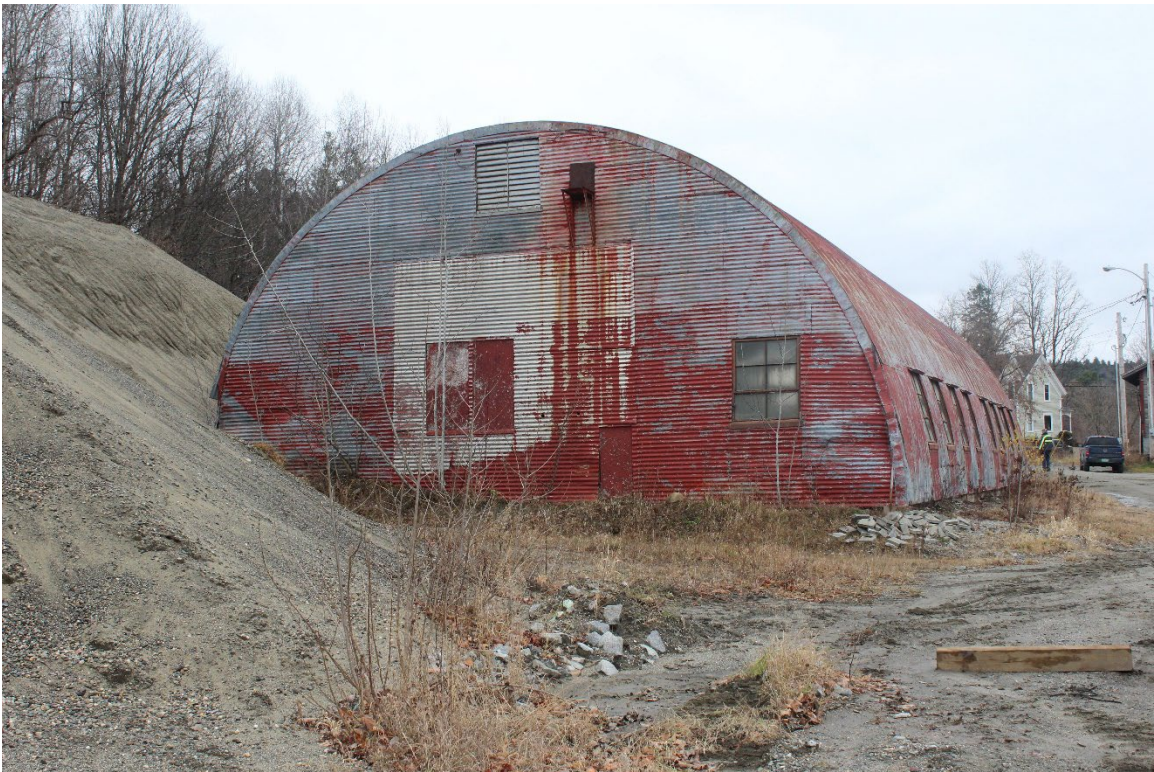
Photo 4. View NE, showing the west bulkhead and the south elevation. The original wide opening in the west bulkhead has been infilled with sheet metal. The single window in the south corner matches the windows on the south elevation but is located higher in the wall. The louver at the top of the wall is larger than the east bulkhead louver and may be original because it matches a louver style shown in several Quonset Hut Manuals (US Navy Seabees Museum). Note the close proximity of the sandpile to the Quonset Hut.

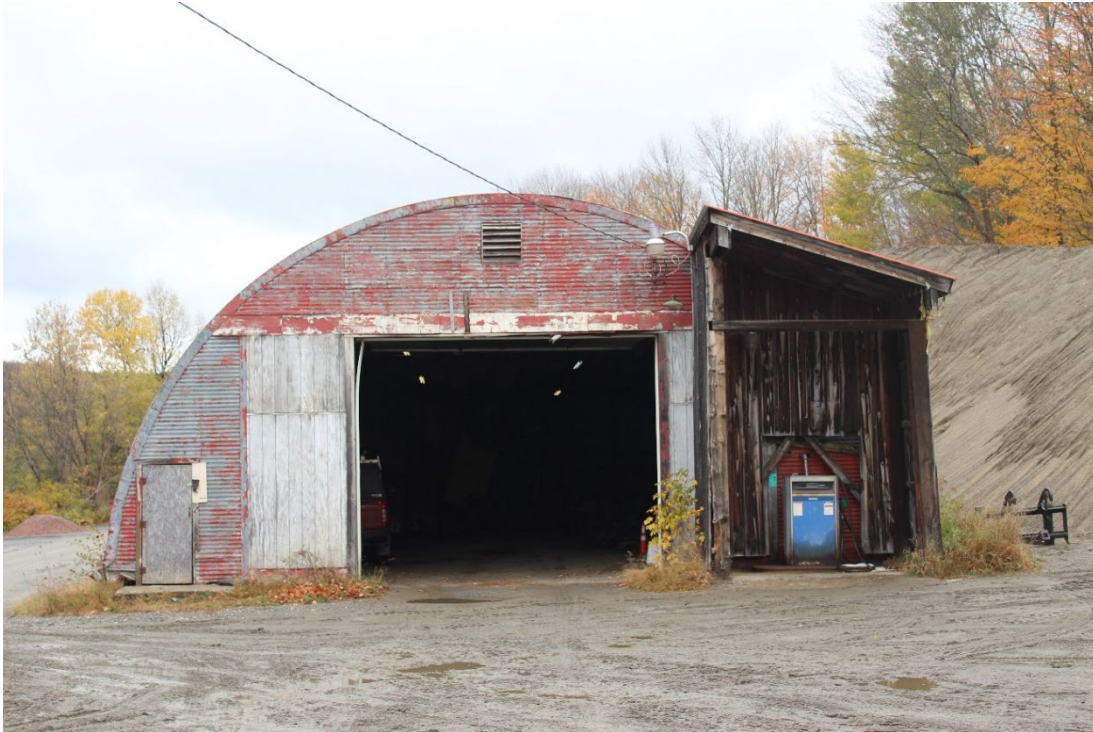
Photo 5. View W, showing the east bulkhead. Wooden stud walls sided with vertical boarding were constructed to reduce the width of the original opening. The originally opening included a wall-mounted track which extended out beyond the 40' width of the elevation and supported 4 sliding wooden doors. The doors and track were removed when opening was altered. Sheet metal flashing that now overs the track area is tucked under the historic crimped flashing.

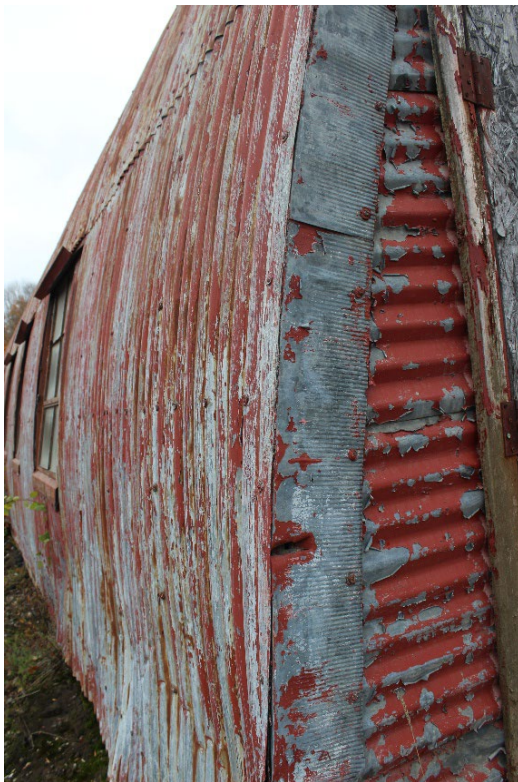
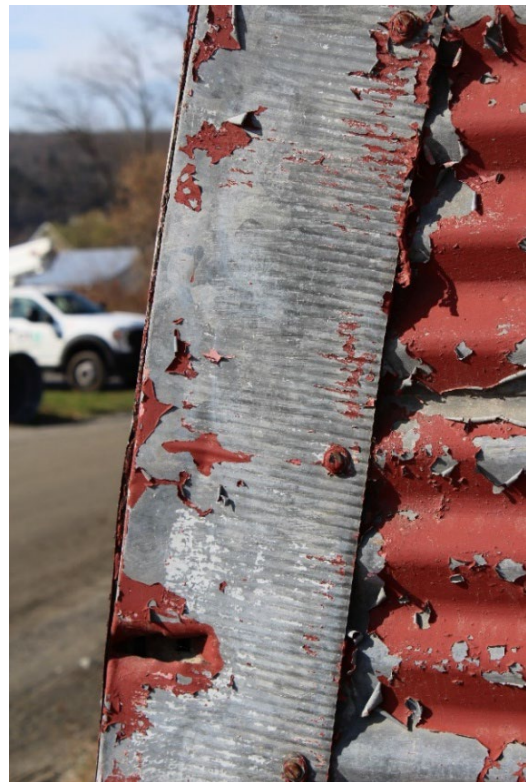
PPHotos 6 and 7. View west, showing the crimped end wall flashing at the southeast building corner. The end wall flashing extends around the perimeter of the east and west bulkhead elevations and is tucked beneath the corrugated metal sheathing on the north and south elevations.

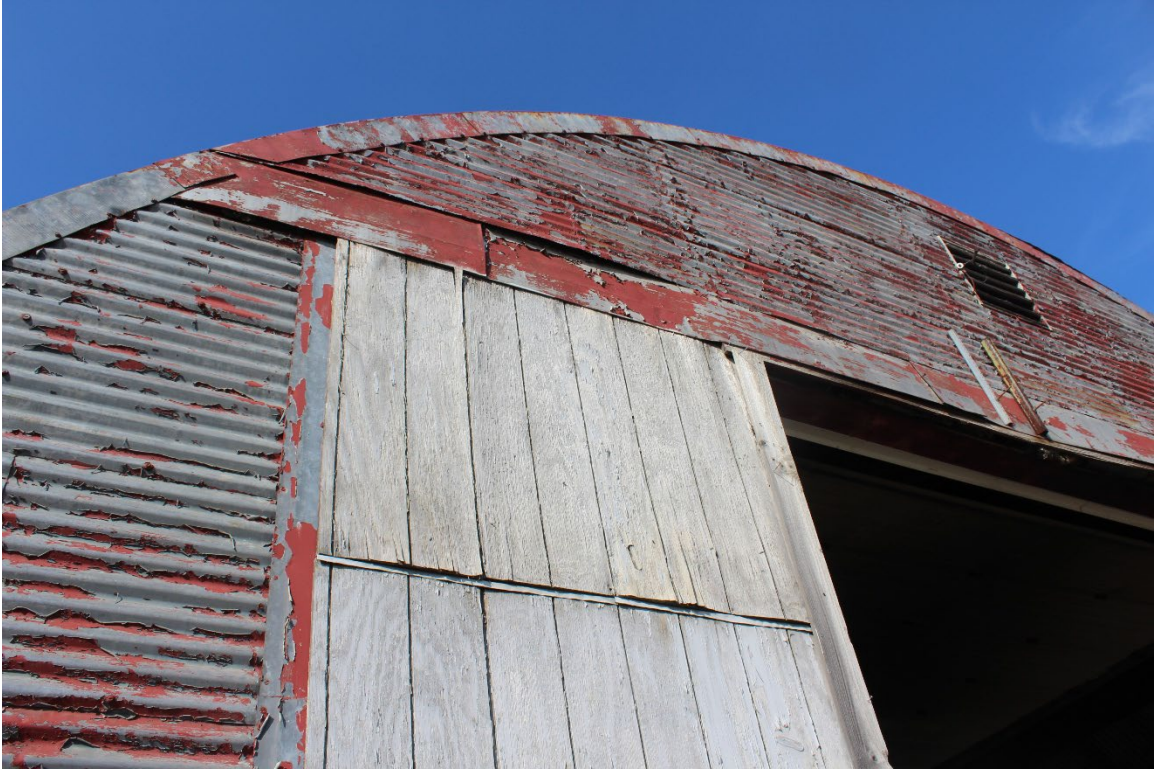
Photo 8. View W. The wall mounted track that held the 4 original sliding wooden garage doors was removed. Wide flashing was installed over the area of track attachment. The added flashing is tucked under the historic crimped flashing the overs the joint between the bulkhead and the arched rib framing.

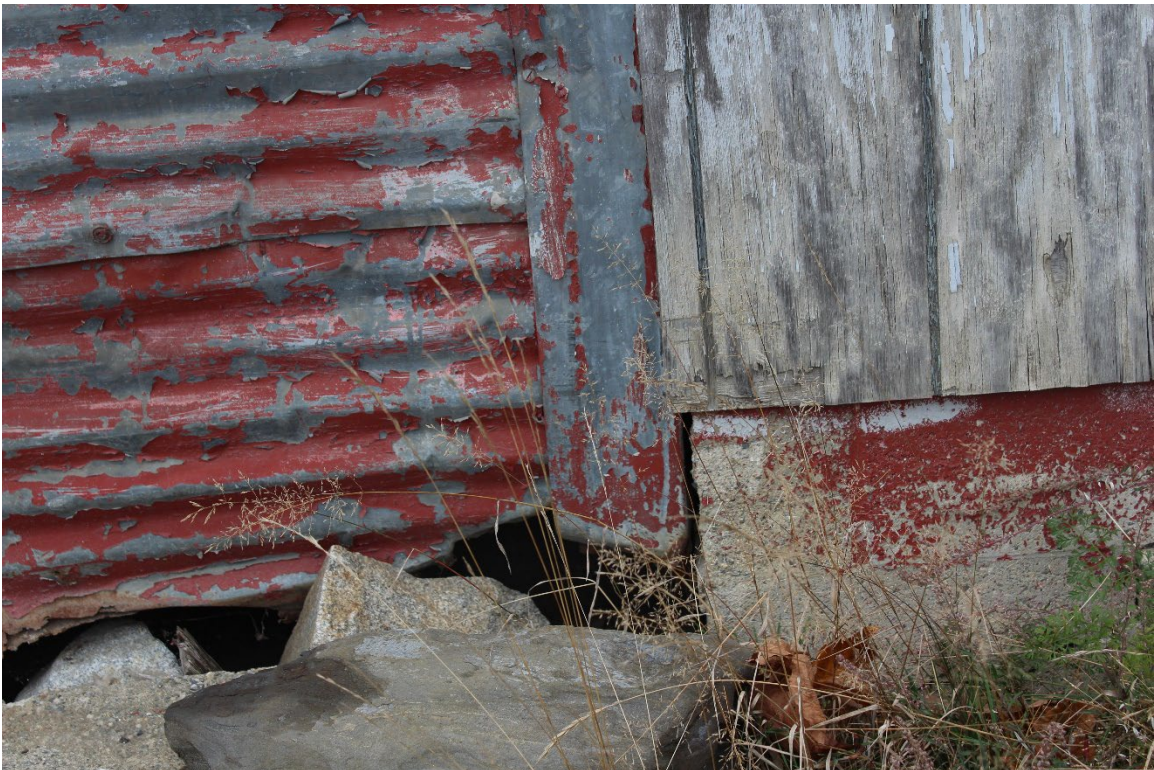
Photo 9. Two courses of concrete block were added to increase the height of the original poured concrete wall under the added, wooden stud-framed sections. Note that the original concrete wall is broken and heaved.

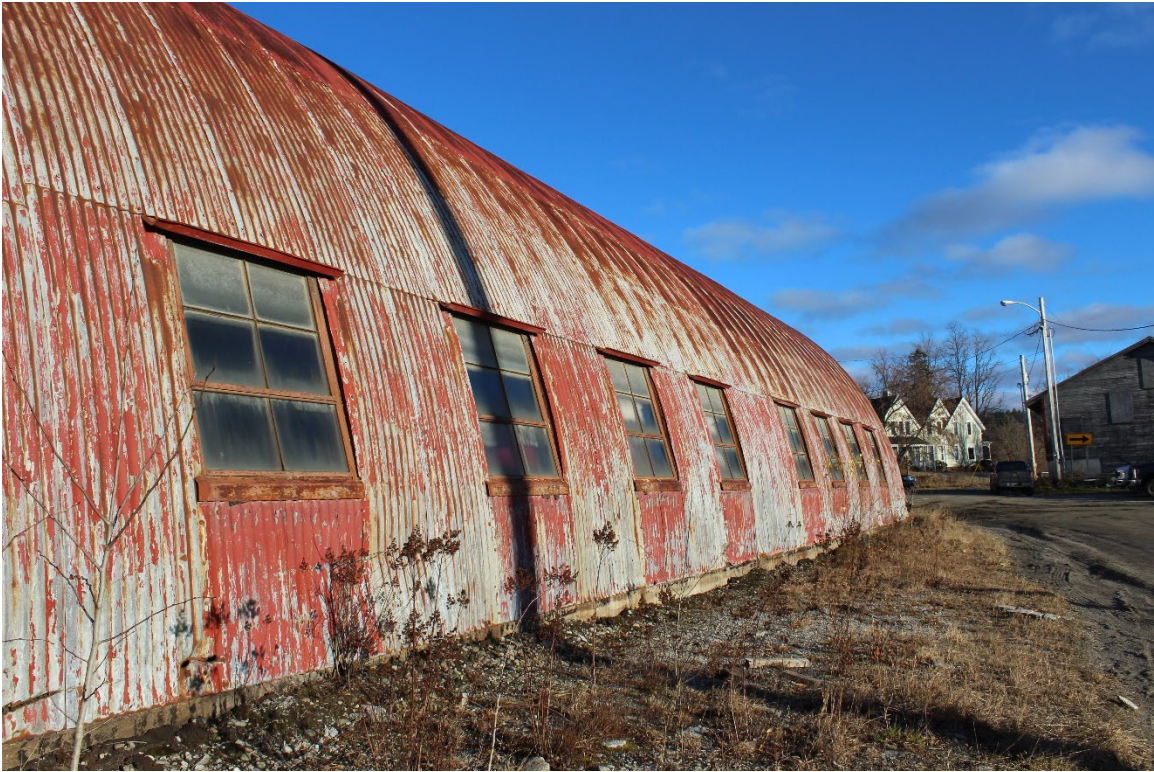
Photo 10. View NE, showing the eight, 3'-1" x 4"-7" window openings in the south elevation. The openings are spaced so that four are centered in each half of the elevation. There are two solid structural bays in the center and at each end of the elevation and single bays between each window opening. Note the short poured concrete foundation wall. The depth of the wall is unknown

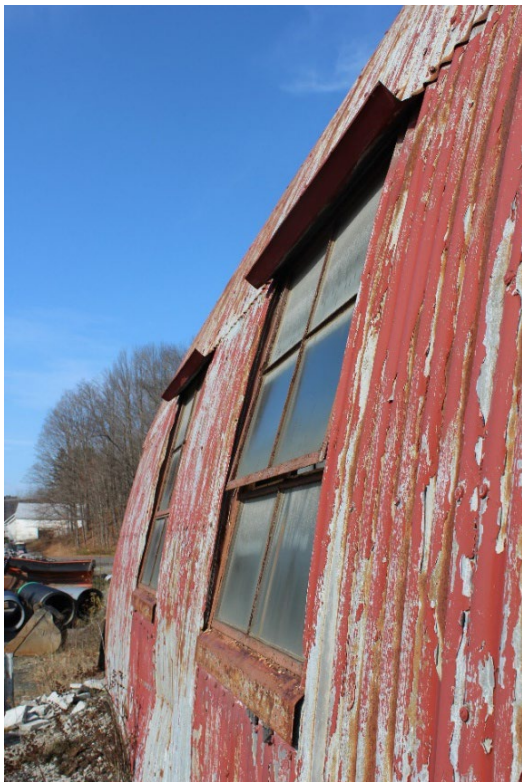
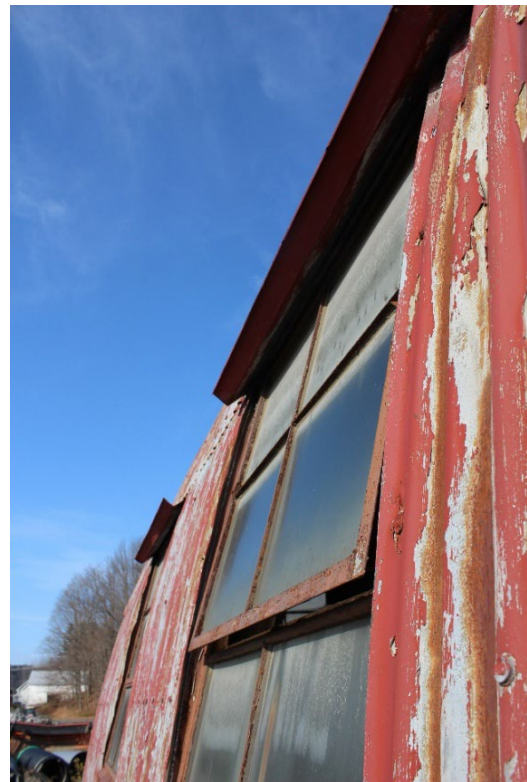
Photos 11 and 12. View west showing a typical four-light over-two light metal window. The four-light top windows are side-hinged to operate as louvers. The bottom two-light windows are fixed. The individual lights are horizontally-oriented. The flat window units are mounted into the arch-shaped south elevation.

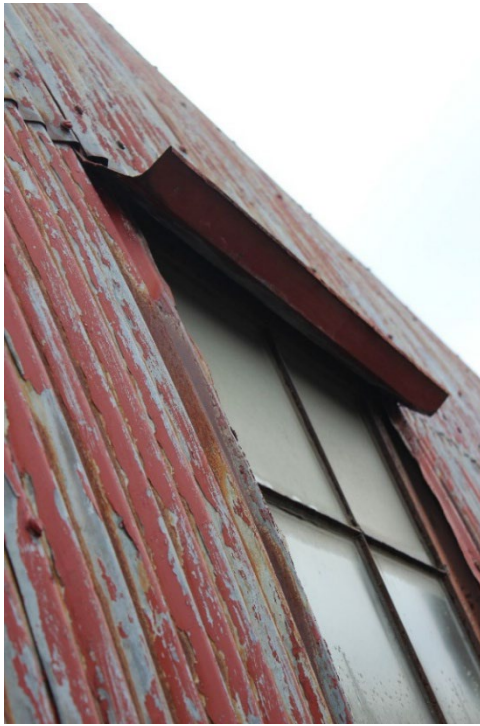
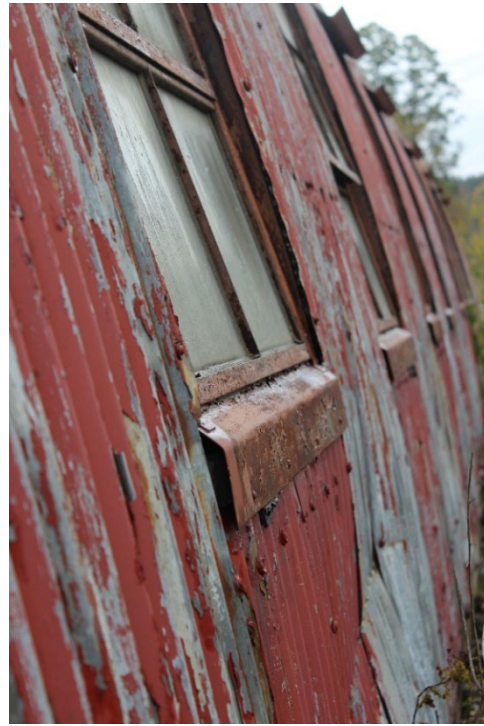
Photos 13 and 14. View NE showing the sheet metal window header and sill flashing. The header flashing is tucked under the corrugated sheet metal and has been formed to provide a narrow shade above the windows. The sill flashing protects the wooden sills. The fenestration pattern is enhanced by the juxtaposition of the flat window units and the arch shape of the south elevation.

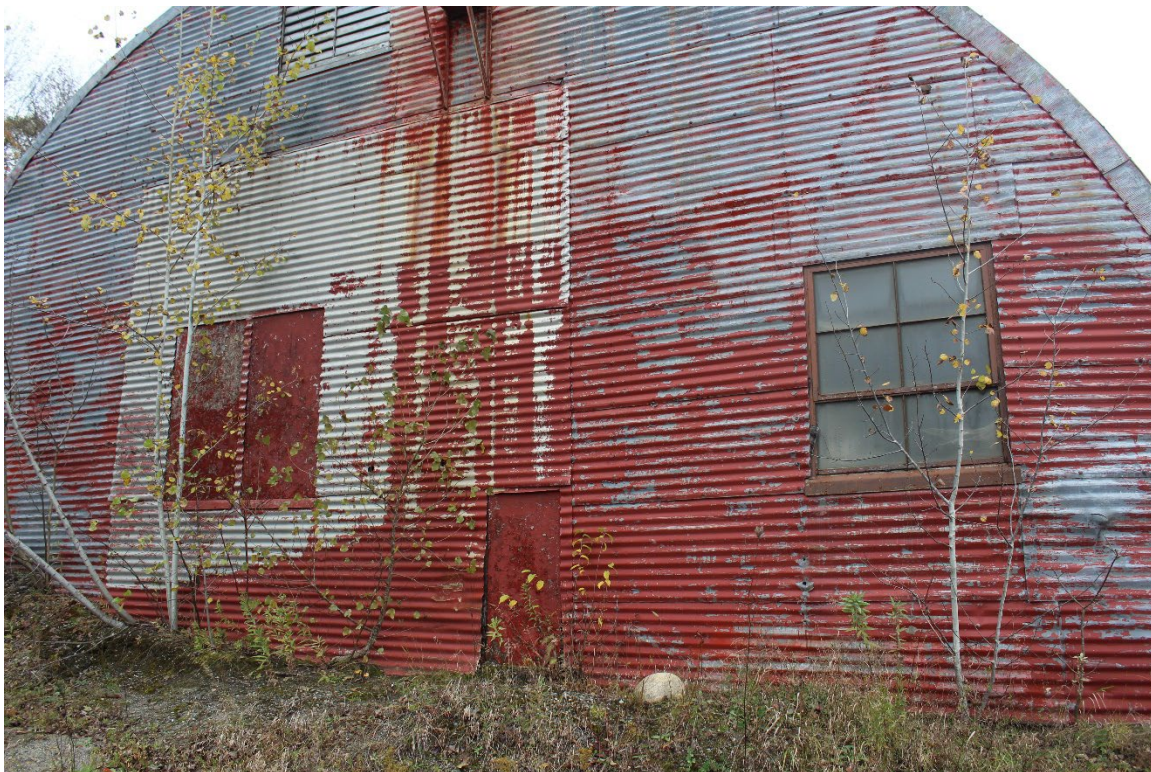
Photo 15. View NE, west bulkhead. The now infilled wide, centered opening appears to have been the same height as the opening in the east bulkhead. The added paired window openings in the patched area are taller and narrower than the original windows; the sill flashing has been retained but is narrower than the sill flashing associated with the original windows.

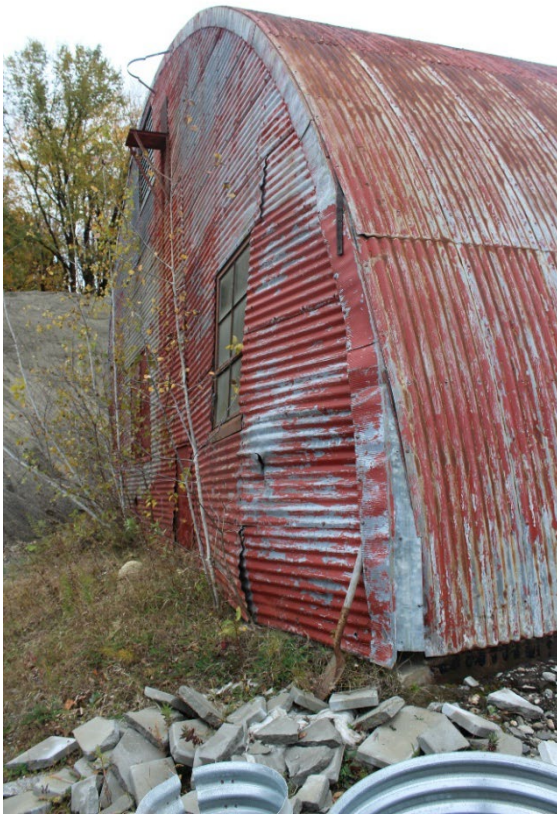
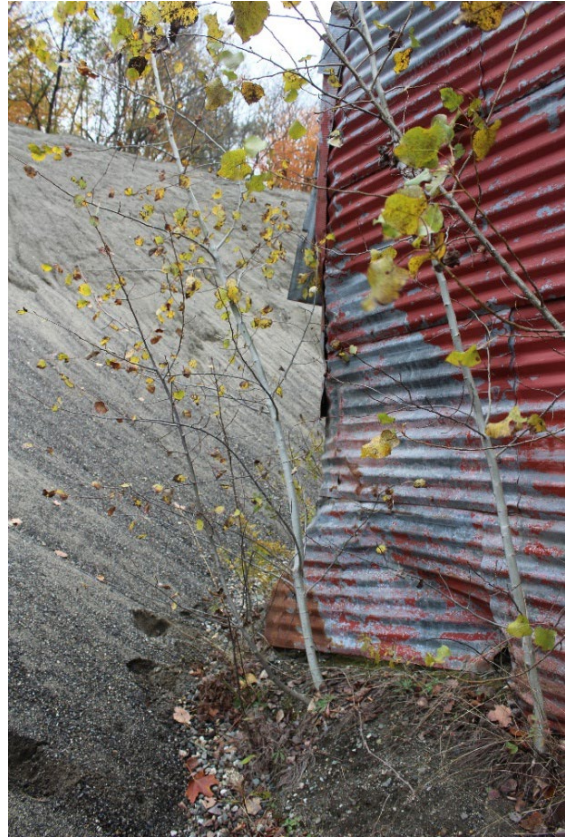
original because it matches a louver style shown in several Erection Manuals (U.S. Navy Seabees Museum). The north and south corners of the west bulkhead have been damaged by apparent impacts.

Photos 16 and 17. View NE, showing damage to the SW (left) and NW corners of the west bulkhead. Note the crimped end wall flashing around the perimeter of the west bulkhead.

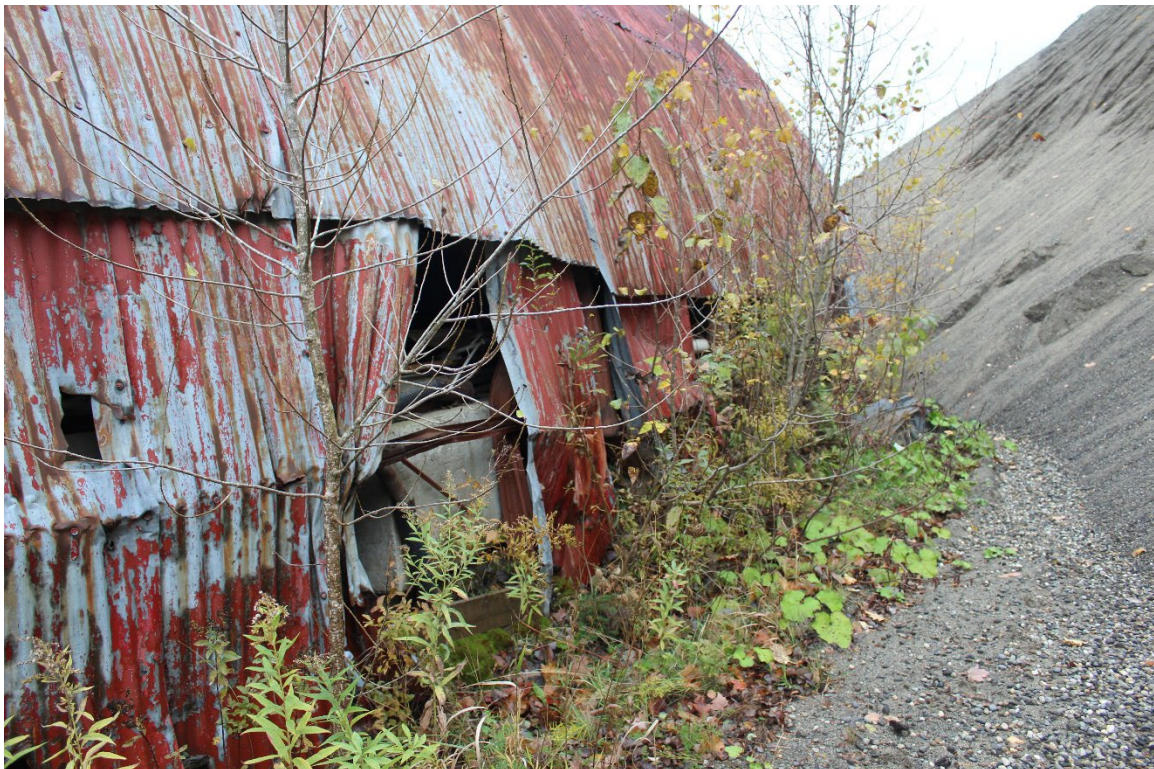
Photo 18. View SW, showing the unfortunate damaged west end of the north elevation.

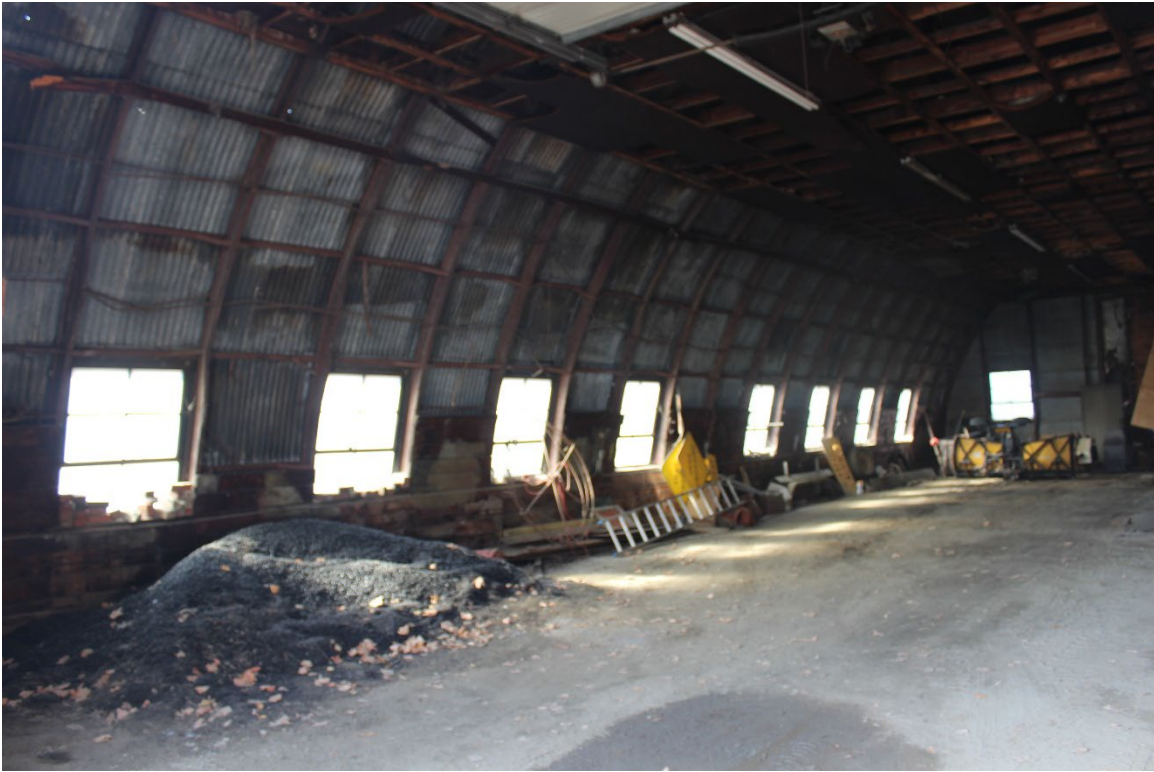
Photo 19. View SW, showing the south elevation, steel arch rib framing and the 8 windows. The windows are located so that four are centered in each half of the elevation. There are two solid structural bays in the center and at each end of the elevation and single bays between each window opening. The floor is dirt. Various materials and supplies are stored near or against the bottom of the wall.

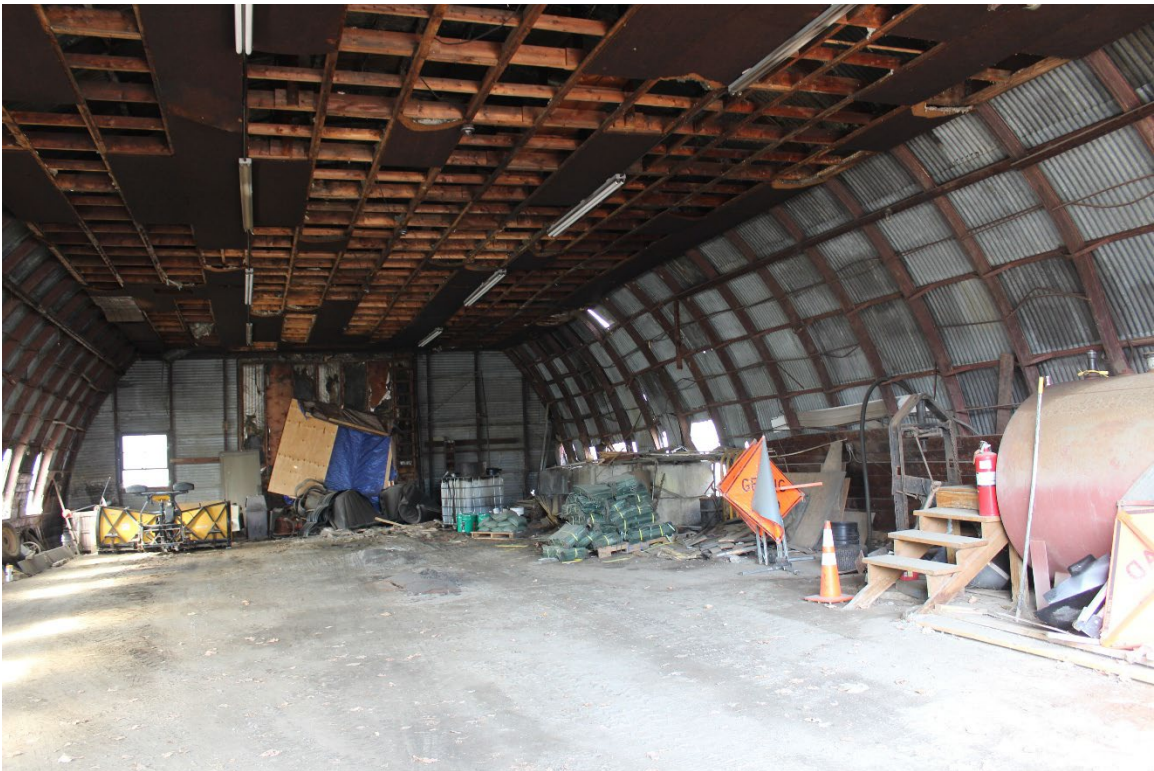
Photo 20. View NW, showing the metal stud-wall-framed west bulkhead and a portion of the arch-rib-framed north elevation. Some of the corrugated Sheathing and rib framing at the west end of the north elevation is damaged, broken or missing. An added wood frame suspended above the floor extends the length of the building and obscures the view of the upper third of the arched rib frame.

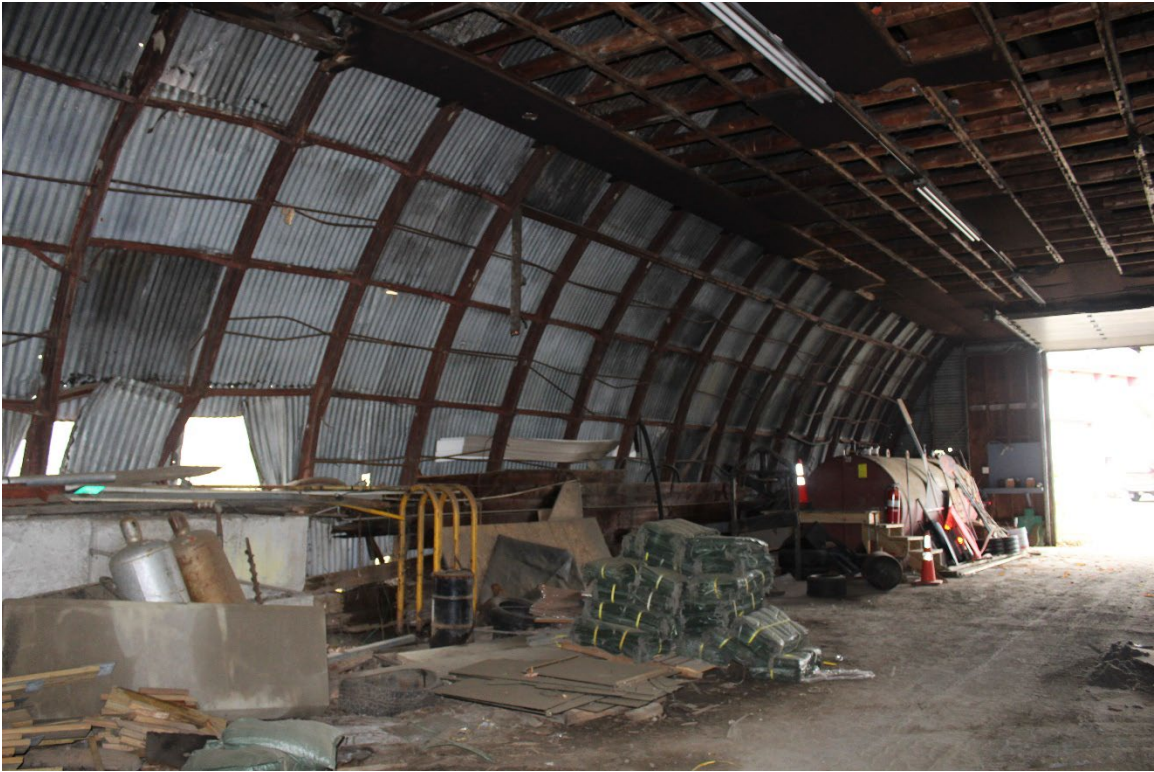
Photo 21. View NE showing the eastern portion of the north elevation and the east bulkhead. The added wood frame is supported on the header above the existing east bulkhead opening and on the header of the now infilled west bulkhead door. The large tank in the NE corner of the Quonset Gut contains gasoline.

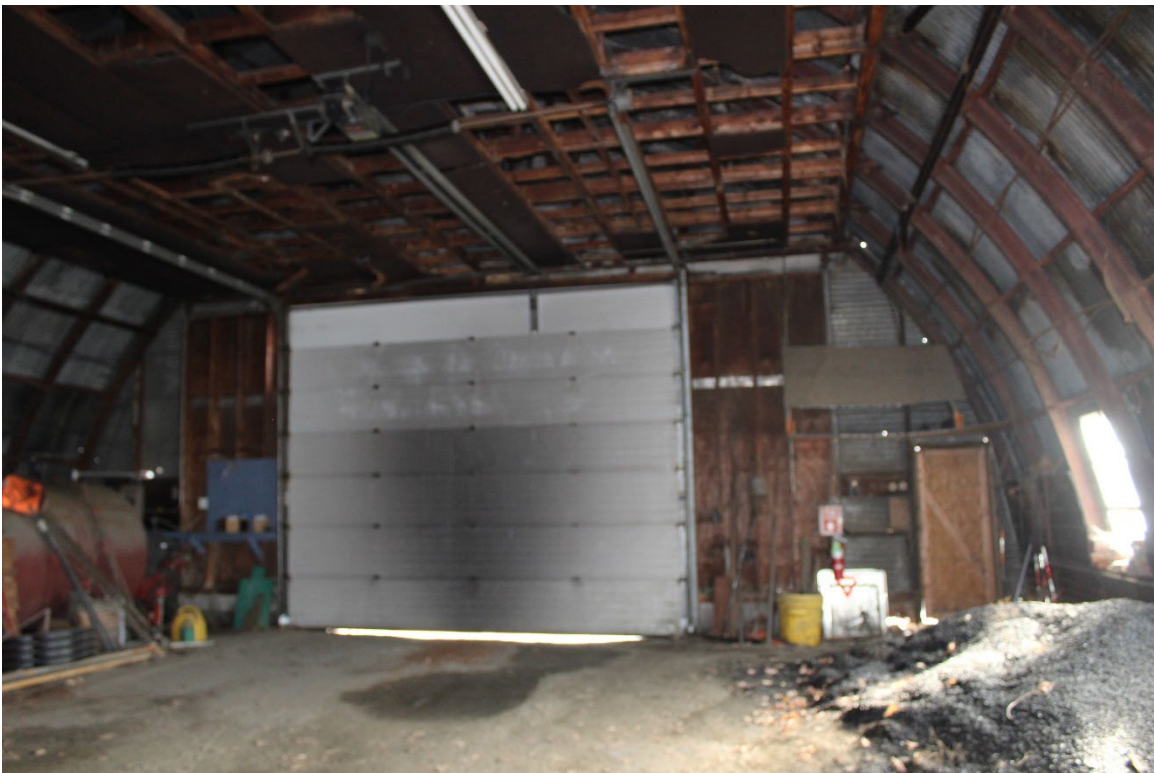
Photo 22. View NE showing the interior of the east bulkhead. The width of the original opening was reduced by the construction of wood stud walls inboard of the historic metal stud framing. The added man door was let into the metal stud-framed SE corner. . Note that the added suspended wood frame spans the width of the original opening.

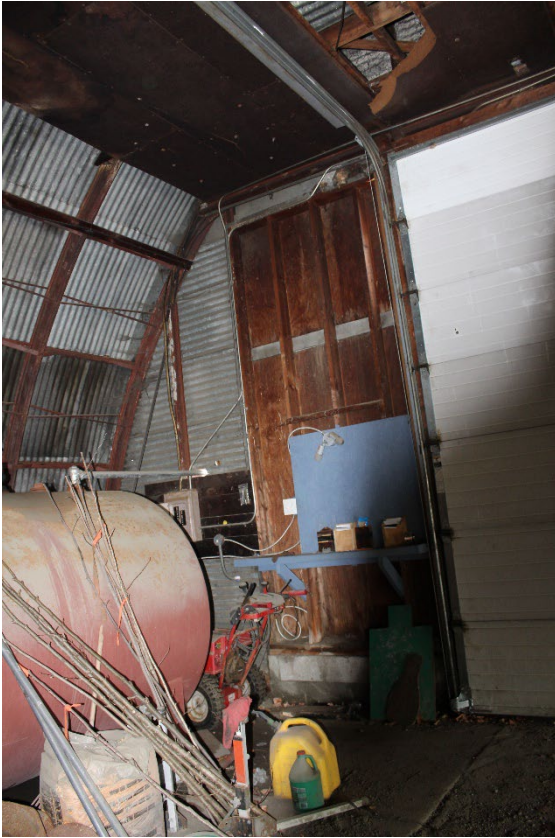
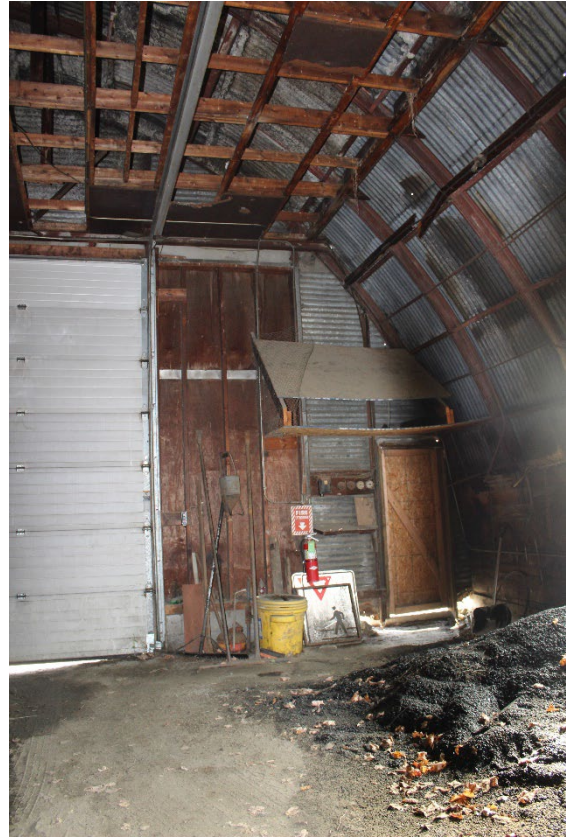
Photos 23 and 24. View east showing the added wooden stud walls north of the existing bulkhead opening (left) and south of the opening. The metal stud walls that flank the original opening each contain two structural bays. The wooden studs are butted up against the interior metal studs. The tracks for the overhead garage door are mounted to the underside of the suspended wooden frame.

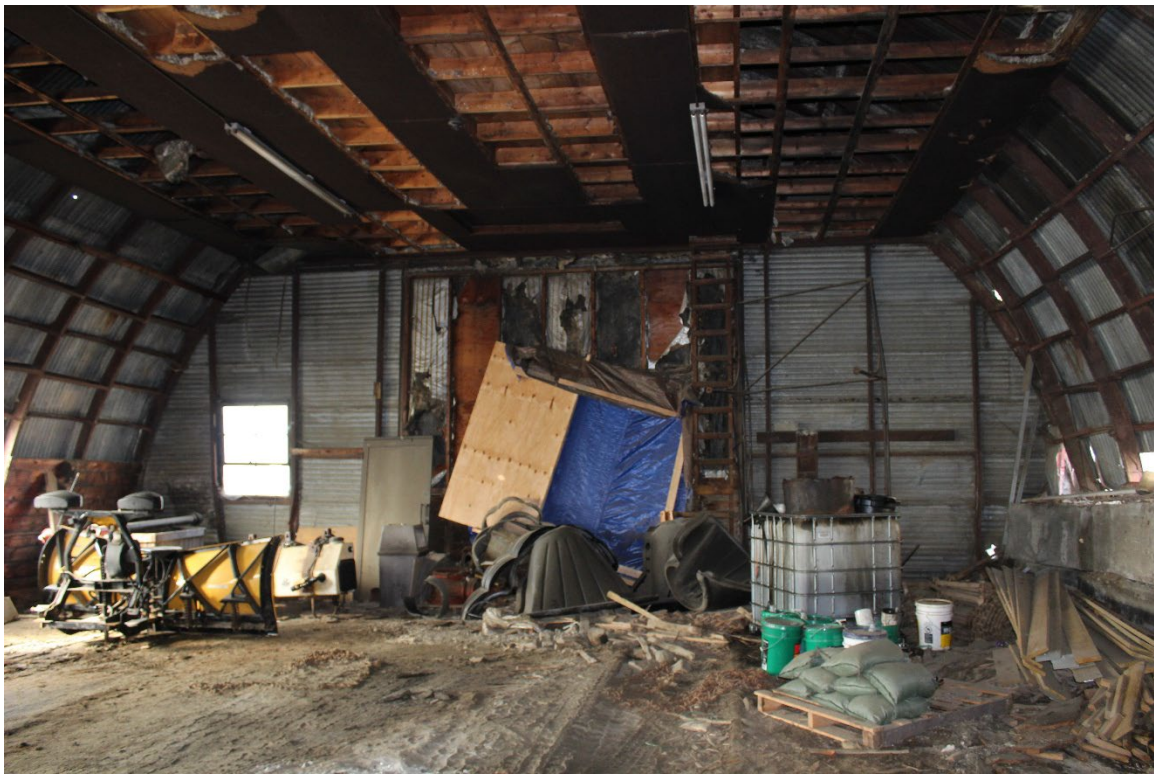
Photo 25. View W, showing the west bulkhead. The wide opening has been infilled but its original width does not appear to have been altered. The metal stud walls that flank the opening are each four bays wide. The stud bays immediately adjacent to the original opening are significantly narrower than the other bays.
