| STATE OF VERMONT<br>Division for Historic Preservation<br><br>VERMONT ARCHITECTURAL<br>RESOURCE INVENTORY<br><br>Individual Property Survey Form | SURVEY NUMBER:<br>(Assigned by VDHP) |
| | PRESENT FORMAL NAME: Quonset Hut / Town Garage |
| | ORIGINAL FORMAL NAME:<br>U.S. Navy Steel Arch Rib Utility Building |
| ADDRESS: Creamery Street, Town Garage Complex | ARCHITECT/ENGINEER: U.S. Navy Department<br>Bureau Yards and Docks |

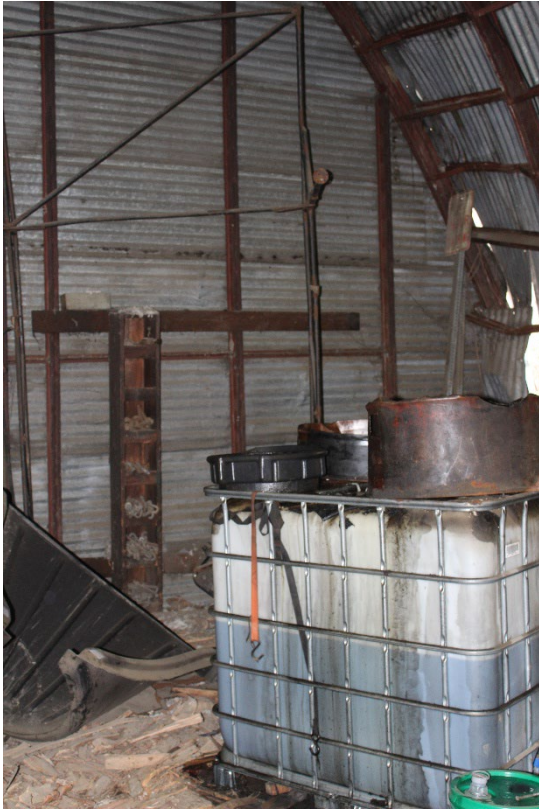
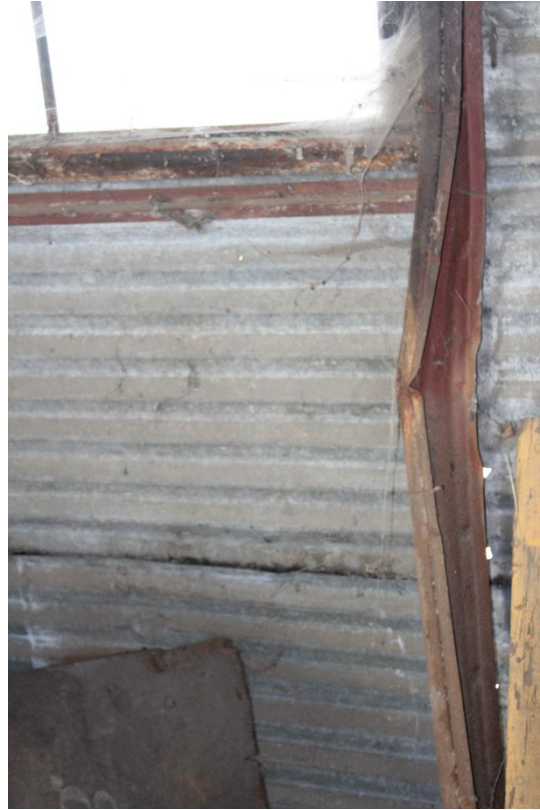
Photo 26, left. View NW showing the stud wall north of the former west bulkhead door. The I-section wall studs are slightly smaller than the I-section arch ribs. Photo 27, right. View SW, showing a damaged I-section Stud in the west bulkhead. The I-section ribs, purlins and studs are made of 2 channels joined back to back. Note the groove or joint in the center of the flange on the I-section stud.

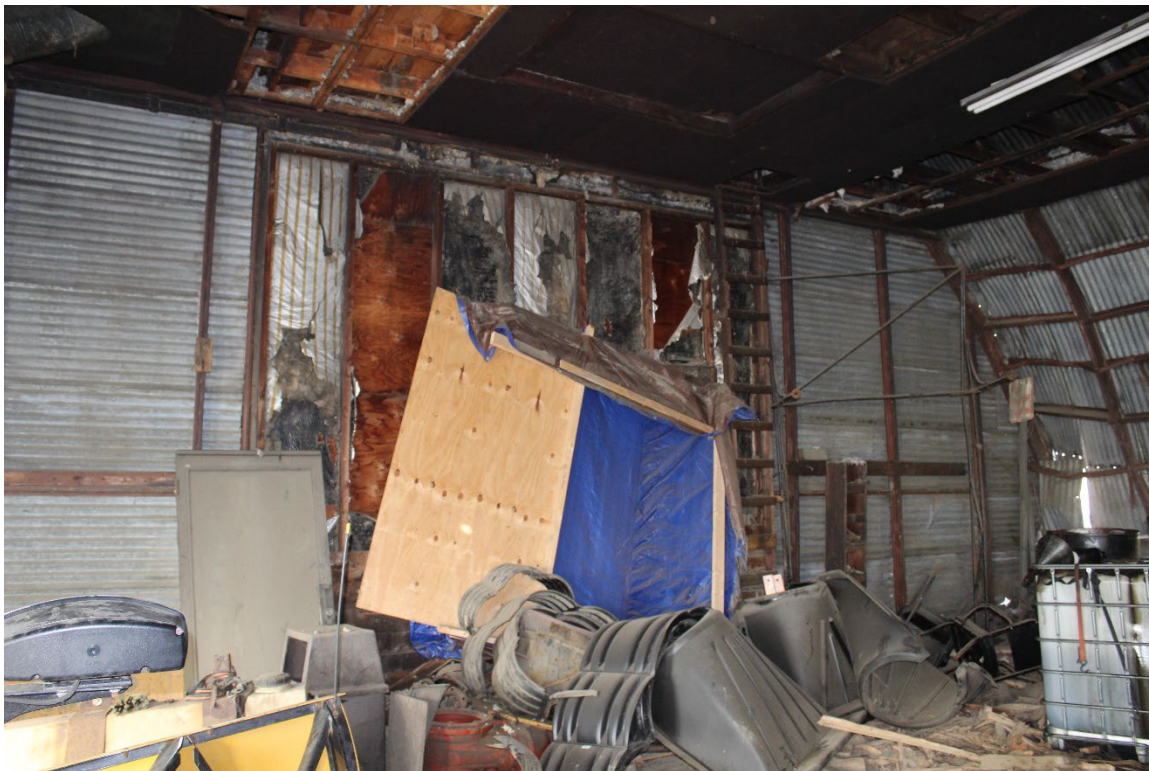
Photo 28. View NW. The stud walls on both sides of the former opening in the west bulkhead are each four bays wide; the interior bays that flank the opening are quite narrow. A wooden frame has been added within the original opening. The wood posts are attached directly to the metal studs that framed the opening. The wood header is several inches below the original channel plate. The wood frame may have been added to provide a nailing surface when the west opening was infilled.

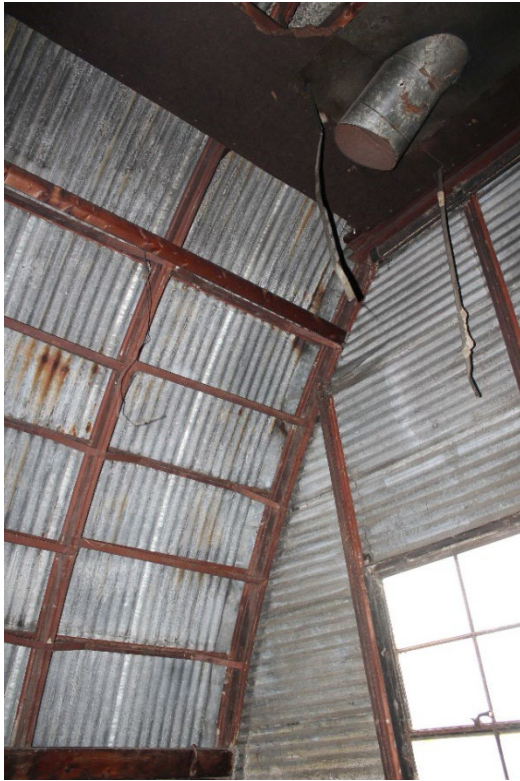
Photo 29, left, view SW showing the junction of the south arch rib framing and the west stud wall framing. The I-section studs are smaller than the I-section ribs. The added boarding that carries the electrical conduit is adjacent to the purlin immediately below the added wood frame. Photo 30, right. The added wood frame makes it difficult to see the ribs and purlins above. The suspended frame is supported along its length by 2 x 4s that are nailed to the wood frame and to each steel rib above

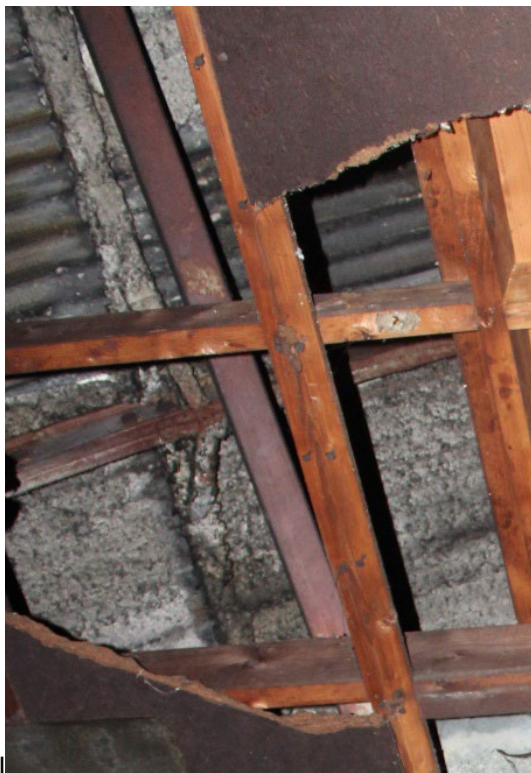
Photo 31, left, view SW. A splice plate that joins 2 sections of an arch rib is visible on the left side of the photo, just below the north/south oriented framing member. Photo 32, right, view east. A splice plate in the third furthest rib is barely visible above the wood frame.

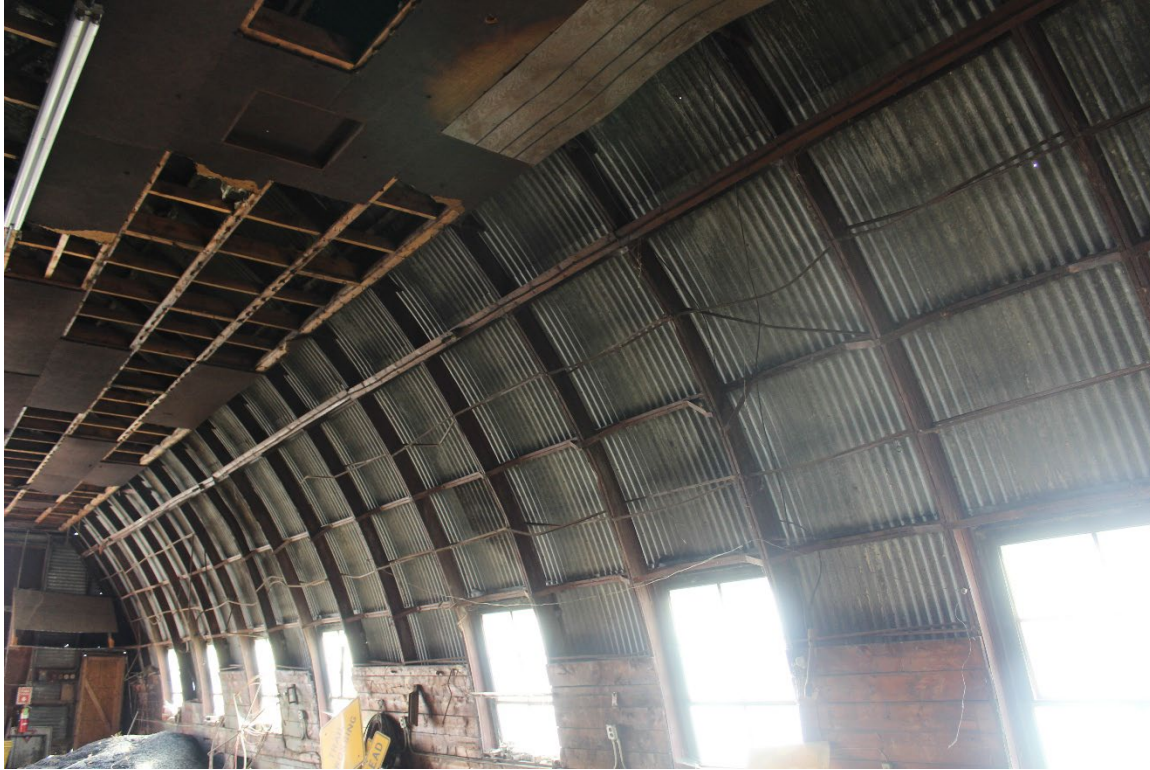
The steel arch rib frame of the north and south elevations incorporates twenty-one 6", I-section ribs that are screwed to a 6" channel plate at 4' on center. The 21 ribs enclose twenty structural bays. Each rib is apparently assembled from three sections but the splice plates are nearly impossible to decipher because of they occur above the added framing associated with the overhead garage door. One splice plate is visible on the second or third rib in the southwest corner of the building, another is visible in the middle of the south elevation. The arch frame also includes 2- 5/16" I-section purlins which run horizontally for the length of the building, resting on each rib and presumably screwed to the outside or top flange. The number of purlins is unknown because the added wood framing blocks the view of the upper third of the steel arch frame. There are four evenly-spaced purlins on the visible portions of the north and south elevations; it is likely that there are also purlins at the bottom of these elevations, now hidden by the added boarding and the accumulation of material.

Photo 33. View SE. The steel arch rib framing consists of twenty-one 6", I-section ribs spaced 4' on center that enclose 20 structural bays. Each rib is apparently assembled from three spliced sections. The arch frame also includes 2- 5/16" I-section purlins which run horizontally for the length of the building and are screwed to the outside or top flange of the ribs. The frame also incorporates standard cross bridging which is centered between the purlins and provides lateral stability.

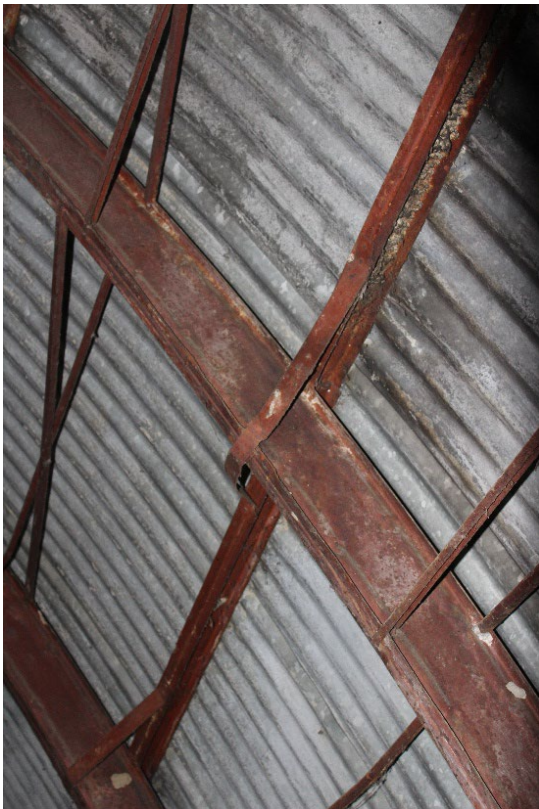
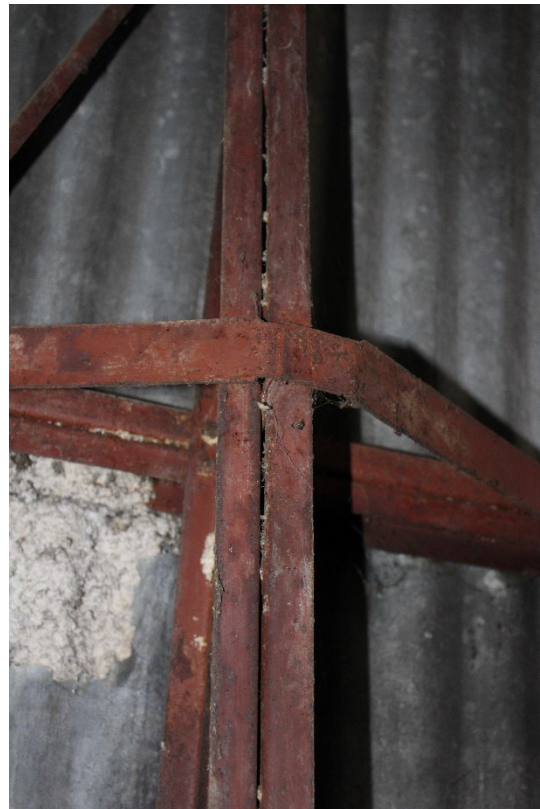
Each purlin/rib connection is stabilized by two pieces of 1" plate steel that appear to wrap around the arch rib. In fact, each piece is nailed into the groove between the purlin channels and into the inside or bottom groove between the rib channels. The steel arch rib frame also incorporates standard cross bridging which is centered between the purlins and provides lateral stability. The cross bridging, which is made of 1" angles, is generally nailed into the grooves between the rib channels, although some of the bridging appears to be nailed to a flange.

Photo 34 and 35. Detail of the intersection of a 6" I-section rib and a 2 and 5/16" I-section purlin. The ribs and purlins are made of 2 channels that are welded together back to back. The joint between the 2 channels creates a very clear groove in the middle of each flange that runs the length of the member. Each purlin/rib connection is stabilized by two pieces of 1" plate steel, each of which is nailed into the groove between the 2 channels in the I-section purlin and into the groove between the 2 channels of the I-section rib.

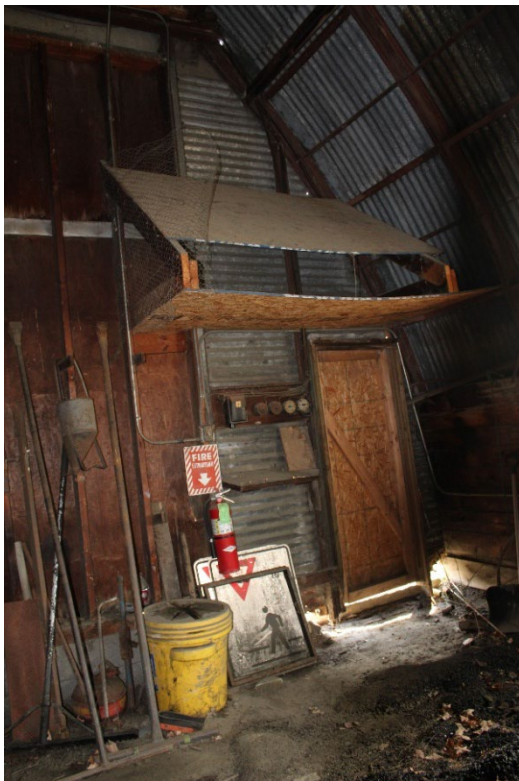
Photos 38, left. View SE showing the electrical breaker box on the east bulkhead wall. Conduit runs from the box up along the metal stud to the right of the box. Photo 39, right, showing a lighting fixture mounted on the boarding that carries the conduit.

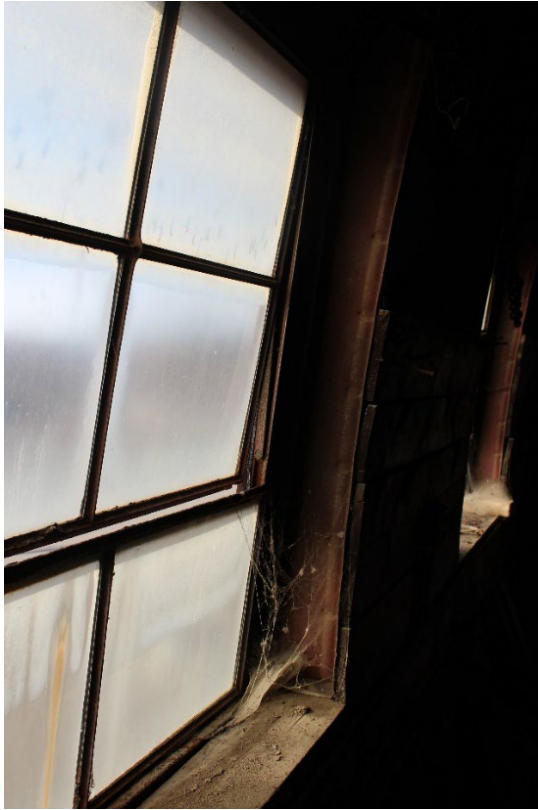
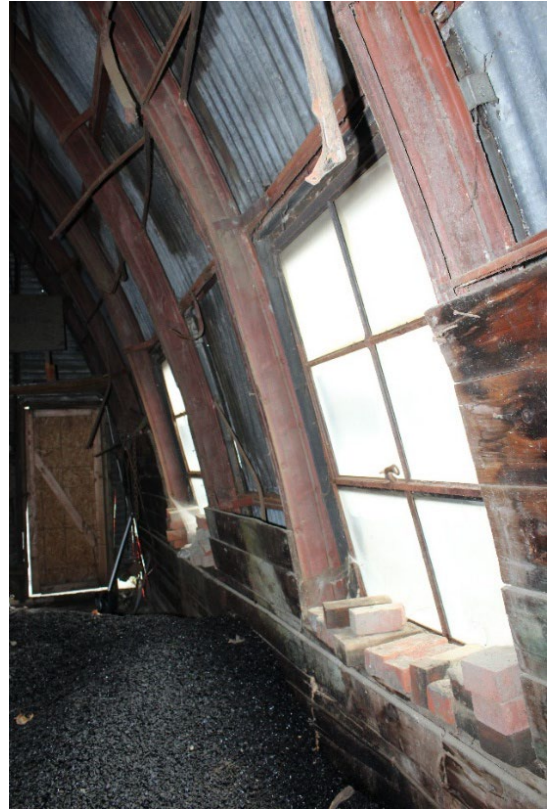
Photo 40. View west (left) and Photo 41. View east. The four-light upper windows are side-hinged to open as louvers. The bottom two-light windows are fixed. Each flat window unit spans the width of a structural bay. Each bay is defined by 2 of the 21 steel arch ribs. Window sills are wooden.
