Stormwater Master Plan Town of Hardwick, Vermont

PROJECT NO. PREPARED FOR:

16-138

Amy Macrellis / Water Resources Scientist
Stone Environmental, Inc.
535 Stone Cutters Way
Montpelier, VT 05602
amacrellis@stone-env.com
802.229.1884

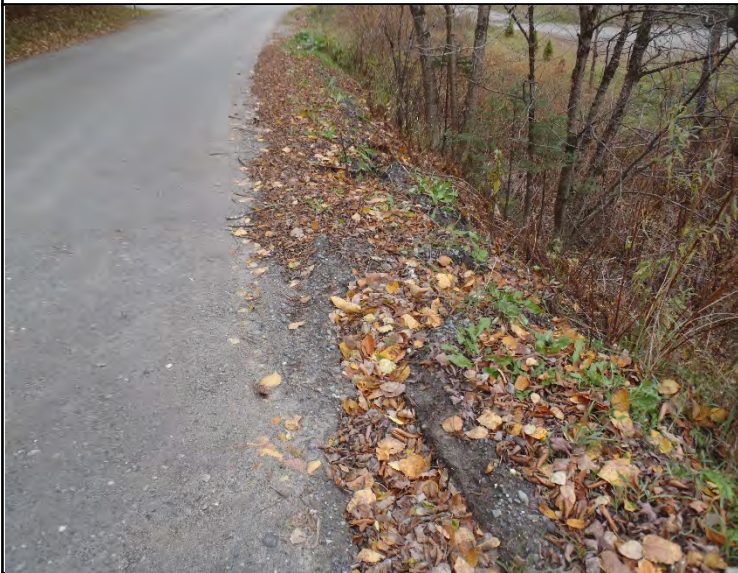
There is moderate erosion along the north edge of Dix Road. A significant berm exists along the edge of road and a moderate gully created by stormwater breaking through the berm is actively eroding. It appears that the roadway is graded steeply towards to the north – the problem may be alleviated by regrading along the north edge to promote sheet flow. A culvert crossing from Dix Road under Carey Road has an elevated outlet that is creating scour and gully erosion on the embankment. Stabilizing the outfall (e.g., installing a stone splash pad) would substantially slow erosion processes. It should be noted that the water draining over the north edge does not appear to conveyed to any further point – it looks as if the water infiltrates at the toe of slope.

Photo 1. Shoulder berm/erosion and gully formation

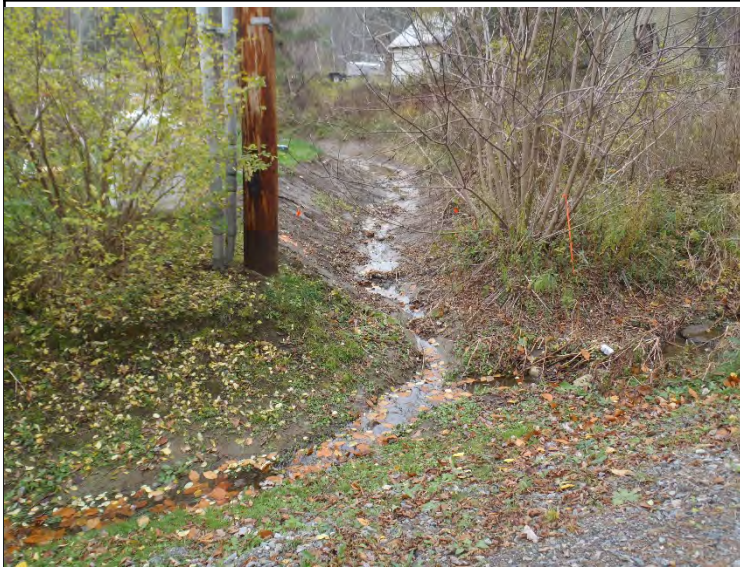
Photo 1. Destabilized open ditch lacking erosion control

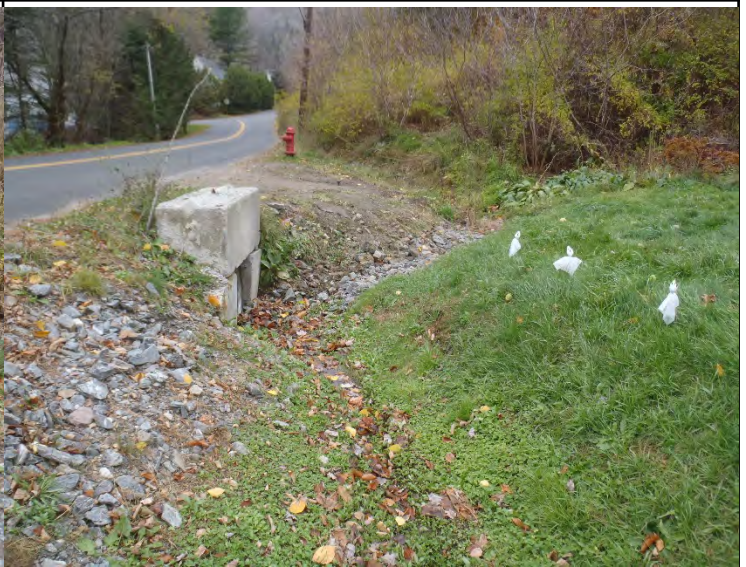
CB-04: The fire hydrant access is slumping and eroding into the ditch line plugging up the stone and contributing to sediment transport. The slope could be stabilized by installing stone and leveling the access.

Photo 2. Slumping fire hydrant access and concrete headwall

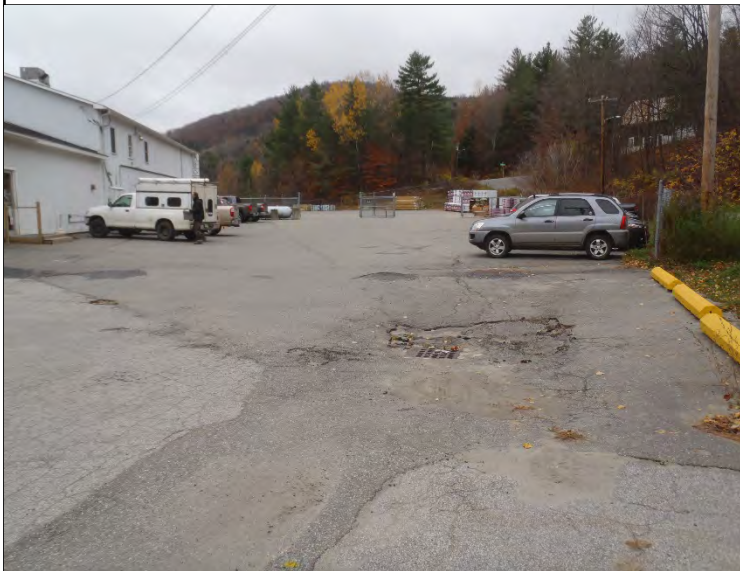
The site appears to drain to a single catch basin near the northernmost corner of the lot. The existing green space between Union Street and the Poulin Lumber fence could be utilized for stormwater capture and treatment. Further investigation regarding elevations in the area is needed to assess the viability of conveying runoff to this location.

Photo 1. Catch basin appears to capture all site drainage

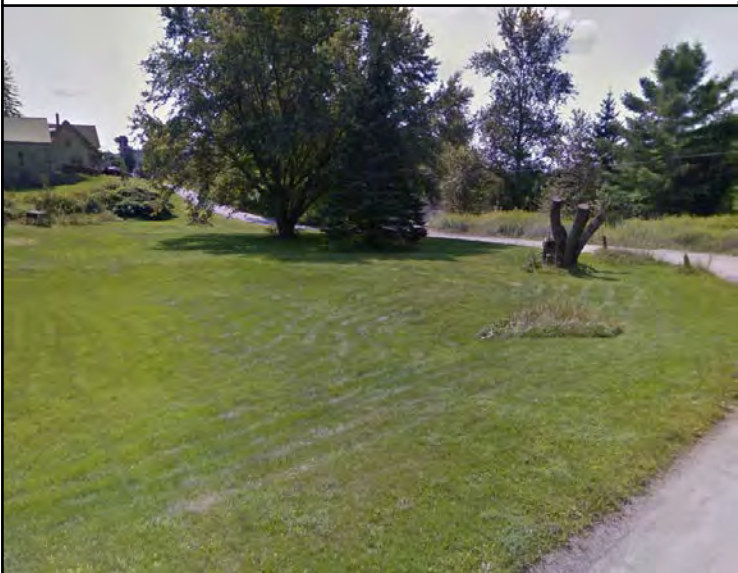
The closed drainage system that drains Spring, Summer, and Dewey Streets outfalls into Cooper Brook just north-west of the Spring Street-Granite Street intersection. The existing green space east of that intersection could be utilized for stormwater volume capture and water quality treatment. Any stormwater treatment retrofit practices here, however, would be located in the brook's 100-year floodplain.

Photo 1. Potential treatment area, looking southeast from Granite Street. (Photo from Google Street View, Aug. 2014)

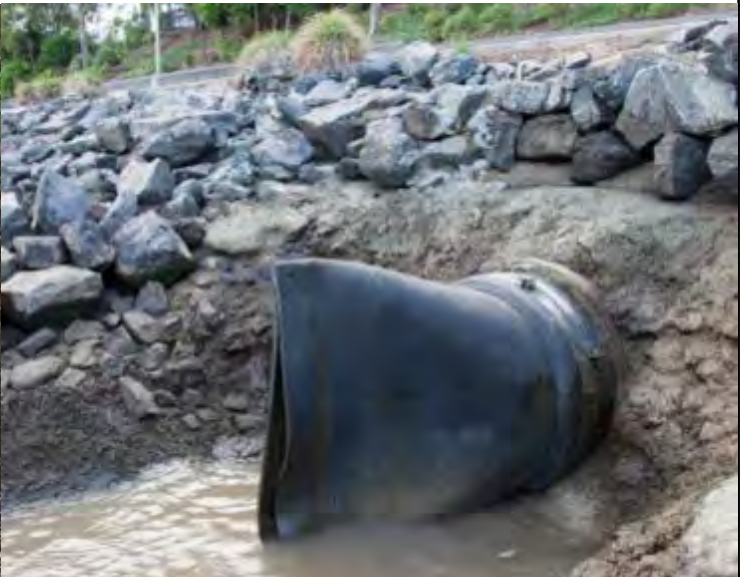
Photo 2. Example of a duck bill outlet structure

The Town has indicated that the current “trash can” style outlet cover does not adequately protect against backwater. This culvert, and ultimately the pipe system connected to it backs up during seasonal high water. This outlet structure could be replaced with a “duck bill” outlet structure, or similar device, as shown in Photo 2 below.

<ul style="list-style-type: none"> • “Duck bill” outlet structure installation will prevent backwater conditions when the river elevation is above the outlet.

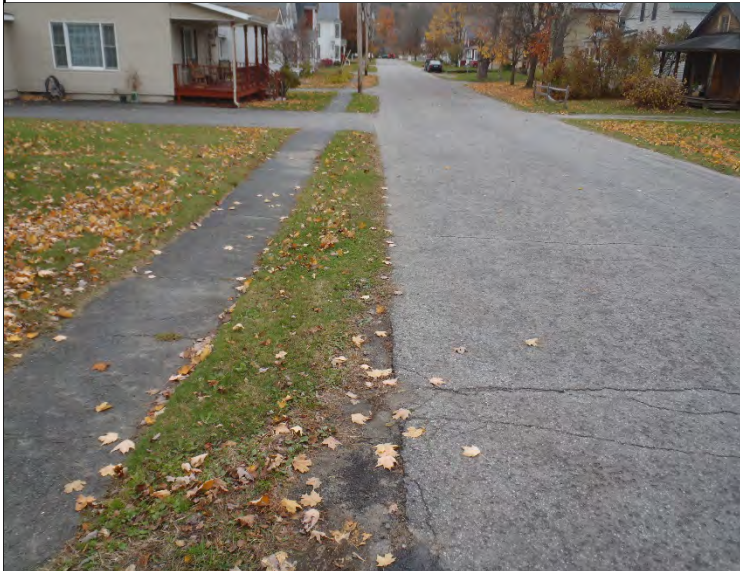
There is green space available between Elm Street and the sidewalk along the north edge of the road that could be utilized to capture and treat roadway runoff. There may also be available green space along the south edge between Elm Street and private fences that could be utilized for capture and treatment as well.

Photo 1. Green space available for stormwater capture and treatment

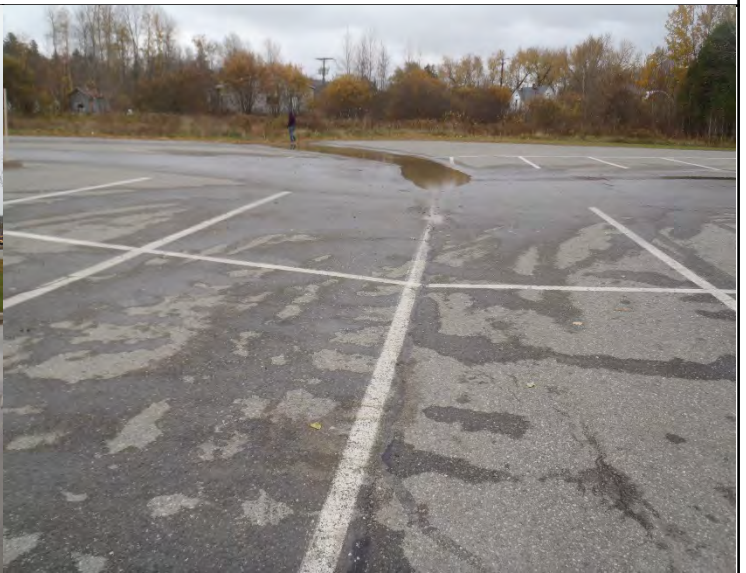
Much, if not all, of the stormwater from the site appears to drain to the center of the parking lot and flow south where it enters a stone channel. The stone has become plugged and the banks are eroded. The parking lot also looks to have settled in locations causing ponding. The existing drainage pattern could be reestablished, and a portion of the parking lot to the south, that appears to be mostly unused, could be converted to a stormwater practice to capture and treat runoff from approximately 3 acres of impervious surface.

Photo 2. Parking lot drainage pattern with ponding water and potential stormwater practice location

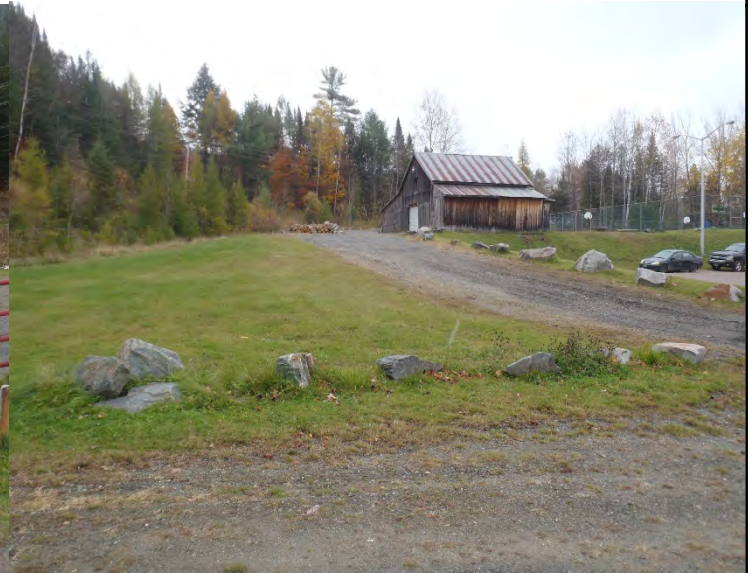
Runoff from the parking lot and uphill area to the east gravel area near Hardwick Trails. The runoff could be routed to the existing green space where it could be captured and treated. Ideally the existing green space could be used to infiltrate, pending soil investigations.

Photo 2. Uphill area that drains towards Hardwick Trails

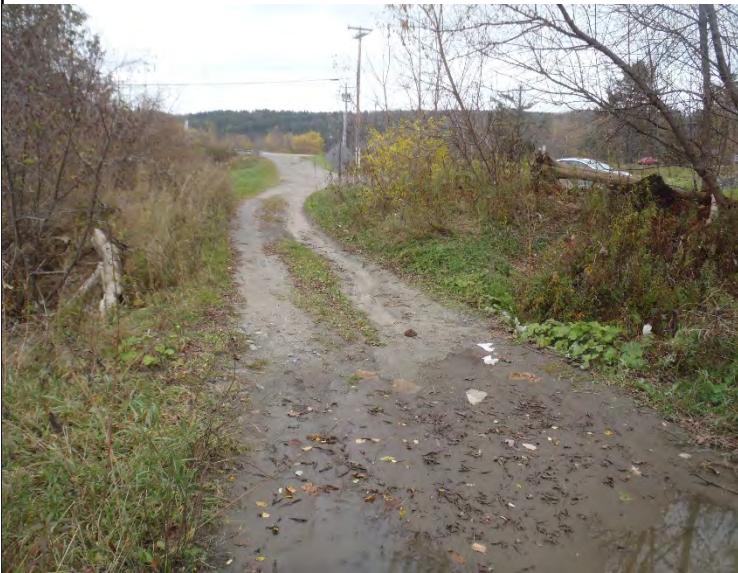
Road runoff as well as runoff from the CATT/VASA trail deposits large amounts of sediment in a small tributary immediately above its confluence with the Lamoille River. A stormwater retrofit could be installed within the green space to the south of the parking area. Ideally the treatment practice would incorporate a sediment basin that could be easily cleaned and maintained. *Wright Farm Road is a Class IV road maintained by Greensboro Garage.*

Photo 1. Sediment transport from VT Route 15 onto Wright Farm Road

LR-08	Wright Farm Road	Retrofit opportunity	Route runoff from VT Route 15 to the existing green space and install an infiltration basin with sediment bay that can be easily cleaned/maintained (pending soil investigations).	B/D	3	4	2	2	11		C	M	Y (partial)	M		
LR-09	GRACE	Retrofit opportunities	Two green strips exist between the buildings of Hardwick Village Market, GRACE, and Brochu Auto Service. These strips can be used for linear bioretention areas to capture, treat, and infiltrate runoff from Mill Street, parking areas, and roofs.	NR (Urban) Adams / Nicholville	4	4	2	2	12	0.5	A	M	Y (partial)	M	Yes	
LR-10	Positive Pie and Yummy Wok park	Retrofit opportunity	Promote infiltration and reestablish plantings within the existing park.	NR (Urban) Adams / Nicholville	1	4	2	2	9		A	L	Y (partial)	L		
LR-11	Hardwick Elementary School	Retrofit opportunity	There is a vegetated green strip between Hardwick Elementary School and Saint Norbert's Catholic Church. Install a linear bioretention area at that location. This could be implemented in conjunction with a repaving/regrading project. Parking lot reconstruction was completed in summer/fall 2017; parking is now graded to the closed drainage system and treatment in the green space is no longer feasible.	NR (Urban) Adams / Nicholville	3	4	3	3	13		A	MH	Y (partial)	M

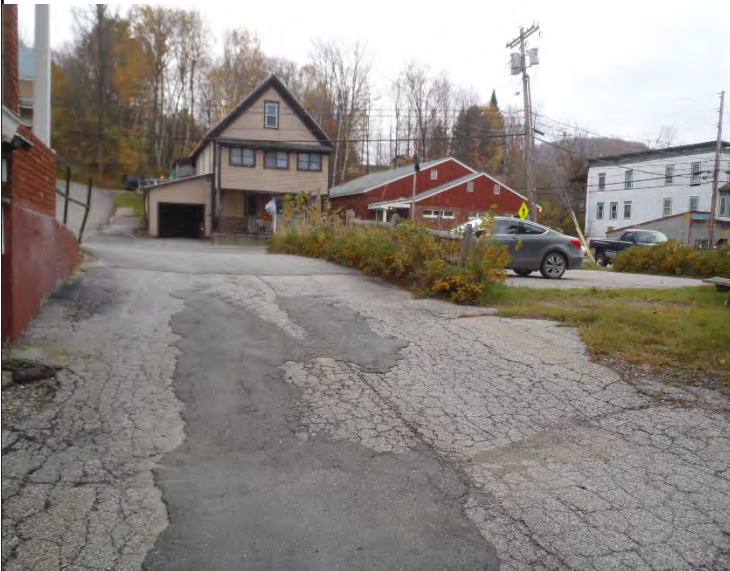
There is available green space between the parking lots of Hardwick Village Market, GRACE, and Brochu Auto Service that could be utilized for roadway, parking lot, and rooftop runoff capture and treatment. Narrow linear bioretention swales could be developed in these areas.

Photo 1. Available green space between Hardwick Village Market and GRACE

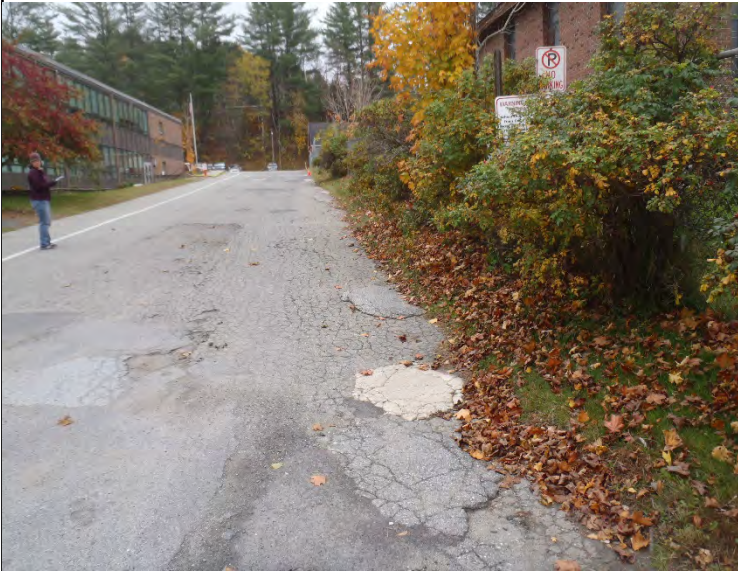
There is a vegetated green strip between Hardwick Elementary School and St. Norbert's Catholic Church available to implement a linear stormwater retrofit to capture and treat stormwater from parking area and rooftops. Further investigation into current site drainage would be required to assess how much of an impact such a retrofit would have.

Photo 1. Green space available for linear stormwater retrofit

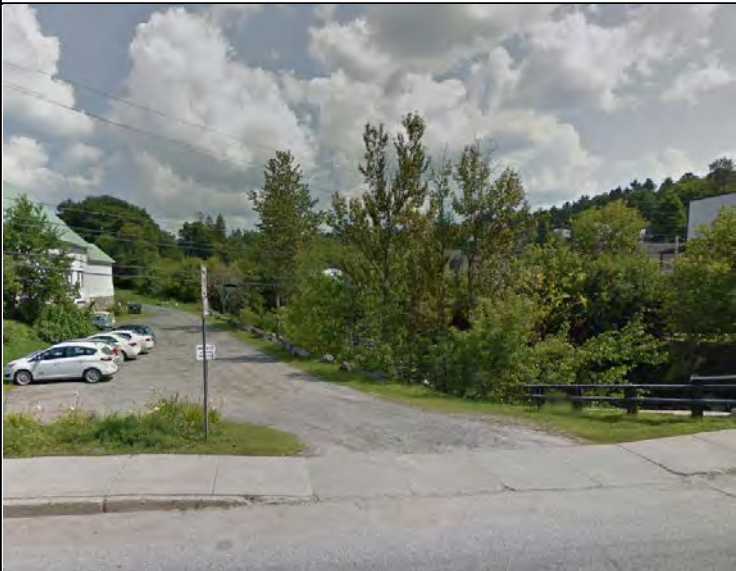
There is a vegetated green strip between the veterinary clinic's southern gravel parking lot and the north bank of the Lamoille River. The strip is narrow and adjacent to a retaining wall at the river's north bank, so there is not sufficient space for a bioswale between the parking lot and the river, but the mowed lawn area could be enhanced with perennials or shrubs to slow down and/or evapotranspire runoff from the gravel lot and nearby up-slope structures.

Photo 1. Green space available for additional vegetative buffer plantings (photo from Google Street View, Aug. 2014)

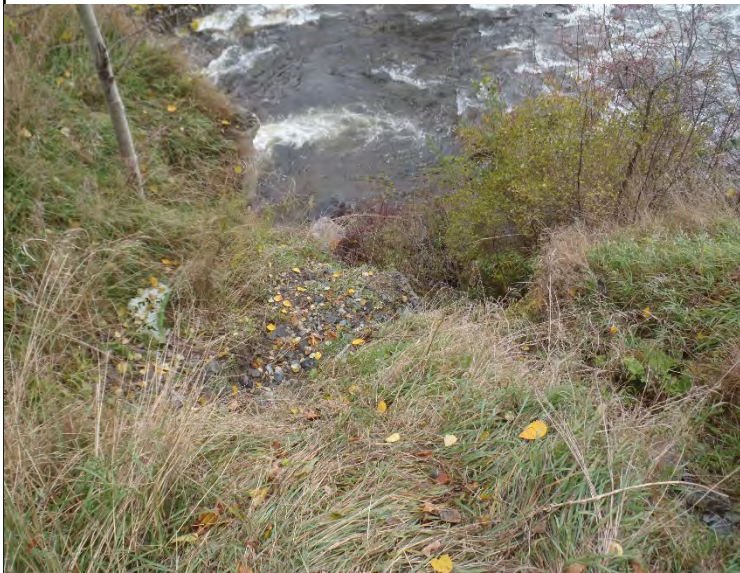
Overland stormwater runoff from Main Street is causing significant erosion at the southeast corner of the bridge. Marginal erosion created by overland runoff from Brickhouse Road is also present at the northwest corner of the bridge. Both areas would benefit from the installation of step-pools and/or large stone to slow water and reduce erosion. A retaining wall on private property on the southeast corner may need to be relocated to achieve proper conveyance.

Photo 1. Marginal erosion on the northwest corner of the bridge

Photo 2. Substantial erosion on the southeast corner of the bridge

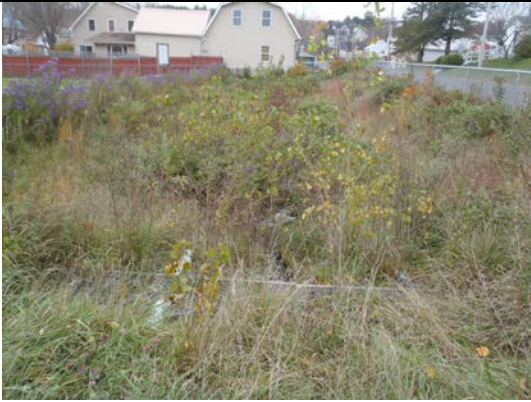
Project: LR-03**Hardwick VT SWMP, Site Restoration Plan**

Latitude:	44.505053 N	
Longitude:	-72.372303 W	
Land Ownership:	Town of Hardwick	
Drainage Area (acres)	24.5	
Impervious (acres)	7.8	
Site Description:		
<ul style="list-style-type: none"> A previously established bioretention area is in need of maintenance. The forebay should be cleaned of sediment. Small trees, invasive species, and dead vegetation should be removed. Creation of a simple Operations & Maintenance plan will ensure sustainable maintenance in the future. 		
Proposed Scope of Work		
Improve Site Drainage	<ul style="list-style-type: none"> The site appears to drain adequately. 	
Restore BMP	<ul style="list-style-type: none"> The forebay should be cleaned of sediment. Small trees, invasive species, and dead vegetation should be removed. Creation of a simple Operations & Maintenance plan will ensure sustainable maintenance in the future.

Future Maintenance	<ul style="list-style-type: none"> Follow an Operations and Maintenance plan that includes should include bi-annual cleaning of the bioretention area. Bi-annual cleaning should include removing sediment, and mowing or trimming vegetation as necessary. 	
Improve Winter Maintenance	<ul style="list-style-type: none"> The Town may use the bioretention area for snow storage in winter months. Doing so will allow snow melt to infiltrate and capture sediment. If the bioretention area is used for winter snow storage, sediment must be removed every spring after all the snow has melted. This will ensure adequate permeability is maintained within the bioretention area. 	
Additional Design/Permitting Requirements:		
<ul style="list-style-type: none"> Additional engineering support includes one day to create an Operations and Maintenance Plan, and one half-day to perform inspection and offer suggestions after initial maintenance has taken place.

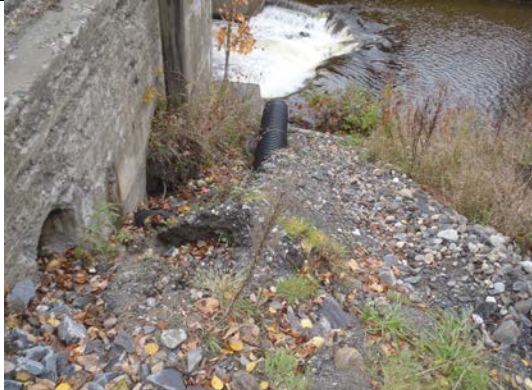
Project: LR-14 **Hardwick VT SWMP, Site Restoration Plan**

Site Description:
 Overland stormwater runoff from Main Street is causing significant erosion at the southeast corner of the bridge. Marginal erosion created by overland runoff from Brickhouse Road is also present at the northwest corner of the bridge. Both areas would benefit from the installation of step-pools and/or large stone to slow water and reduce erosion. A retaining wall on private property on the southeast corner may need to be relocated to achieve proper conveyance. Moderate erosion also exists at the east edge of Church Street, northeast of the bridge. Overall, erosion in this drainage area is caused by high velocity overland flow and by active outlet scour at storm drain outlets.

- This project would mitigate erosion and reduce infrastructure damage, as well as reduce pollutant loading to the river. Installation of drainage improvements and water quality treatment practices will reduce pollutant loading from Main Street and Brickhouse Road, while reducing runoff velocity.
- This project would lengthen the effective lifespan of the bridge by ensuring damaging stormwater flows do not continue to erode the bank and abutments.

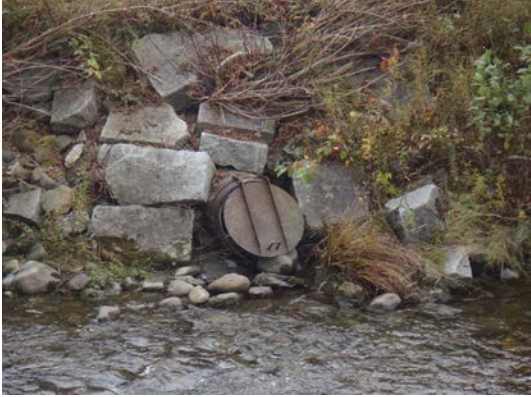
Project: LR-01**Hardwick VT SWMP, Design Build Plan**

Latitude:	44.50658 N	
Longitude:	-72.37008 W	
Land Ownership:	Town of Hardwick	
Drainage Area (acres)	32.0	
Impervious (acres)	9.43	
Site Description: The Town has indicated that the current “trash can” style outlet cover does not adequately protect against backwater. This culvert, and ultimately the pipe system connected to it, backs up during seasonal high water. This outlet structure could be replaced with a “duck bill” outlet structure, or similar device.		
Proposed Scope of Work		
Install BMPs	<ul style="list-style-type: none"> • Install a “duck bill” outlet structure or in-line backflow prevention valve installation to improve drainage through the closed stormwater drainage system by providing protection against backwater conditions within the system. • Tideflex TF-2 Curved Bill Check Valve or similar recommended for installation at the outfall (see attached cut sheet)

Stabilize Overflow / Flow Path	<ul style="list-style-type: none"> • The existing outfall is stable; no additional improvements are necessary. 	
Additional Design/Permitting Requirements:		
<ul style="list-style-type: none"> • The check valves are individually manufactured based on line pressure, backpressure, and the outside diameter of the existing pipe, so hydrologic/hydraulic modeling is required for check valve design and sizing. • Additional engineering support includes approximately one half-week for hydrologic modeling, and one half-day for final construction inspection (~15-20% of total project cost). 		
Next Steps:		
<ul style="list-style-type: none"> • Confirm project support from the Town of Hardwick, other project stakeholders. • Complete additional modeling with support from local distributor (New England Environmental Equipment, Bedford, MA (http://www.ne3inc.com)). 		
Project Benefits:
