Jackson Dam (VT#93.01)

Dam Removal Feasibility Analysis

Caledonia County Natural Resources Conservation District

SLR International Corporation

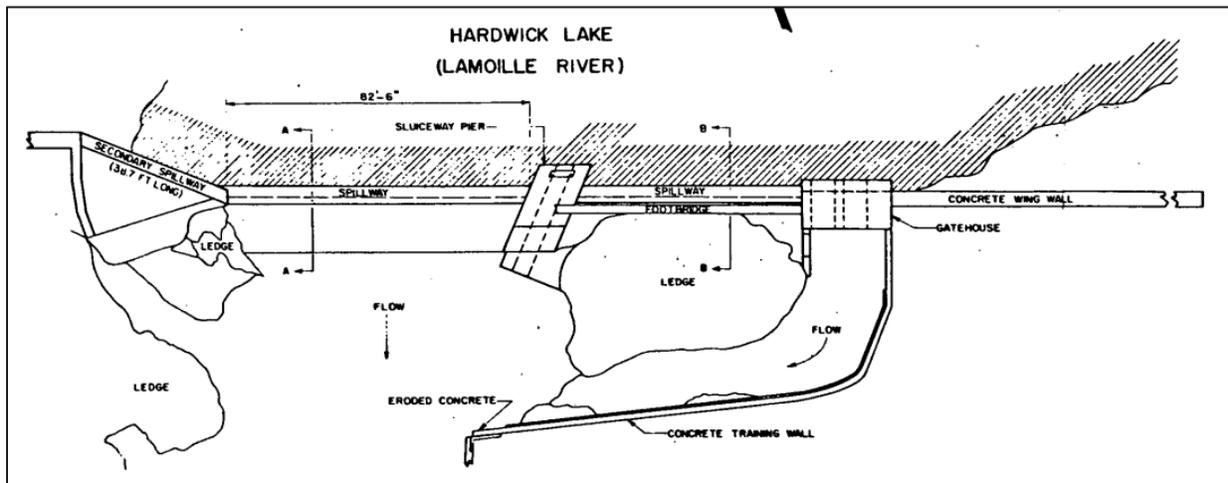
Figure 8: Jackson Dam plan adapted from reconstruction plans in 1952 and modified by field observations (USACE, 1980)

Jackson Dam is a concrete gravity dam with a principal spillway, auxiliary spillway and outlet works founded on bedrock with a total length of 523 feet (Figure 8; Figure 9). There is an emergency spillway to the river right side of the principal spillway that is 38 feet. The principal spillway has a total length of 144 feet and is divided by a 17 feet wide structure that contains the gate operated low-level outlet which has a diameter of 6 feet. The right section of the spillway is an ogee weir that is 82 feet wide. The left section of the spillway is formed around a bedrock ledge. Both sections of the spillway are fitted with slots and receivers for flashboards, although these have not been used in many years. On the left side of the spillway is a structure with gate operated mid-level outlets both with diameters of 6 feet, although the right outlet has been plugged and abandoned. A non-overflow concrete wall extends from the left side of the structure approximately 300 feet. A training wall extends from the mid-level outlets to the left abutment of the Rt 14 Bridge (Green, 2024).

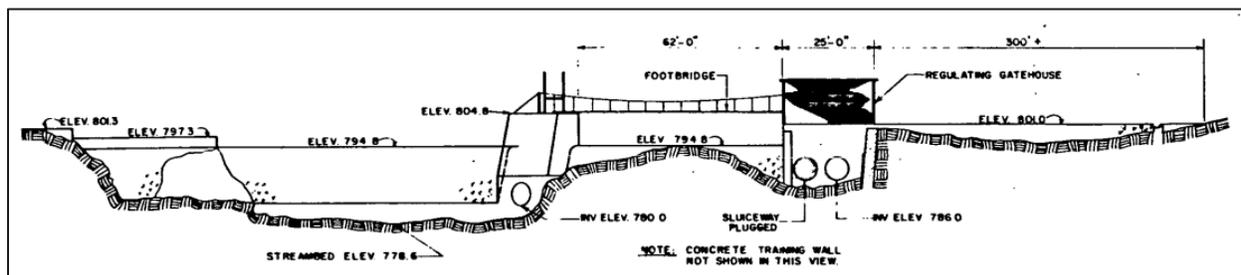
Figure 10: Jackson Dam plan cross section (USACE, 1980)

Jackson Dam has a maximum height of 23 feet (Figure 10). The top of the principal spillway is 16.2 feet above the downstream streambed. There is a footbridge that extends over the left spillway that provides access to the gate operated low-level outlet. Based on plans from the 1952 repair, the downstream streambed has an elevation of 778.6 feet, and the low-level and mid-level outlets have inverts of 780 and 786 feet respectively. When the dam is drained during the annual winter drawdown, the elevation of the low-level outlet is only 1.4 feet above the natural streambed elevation (Figure 11).

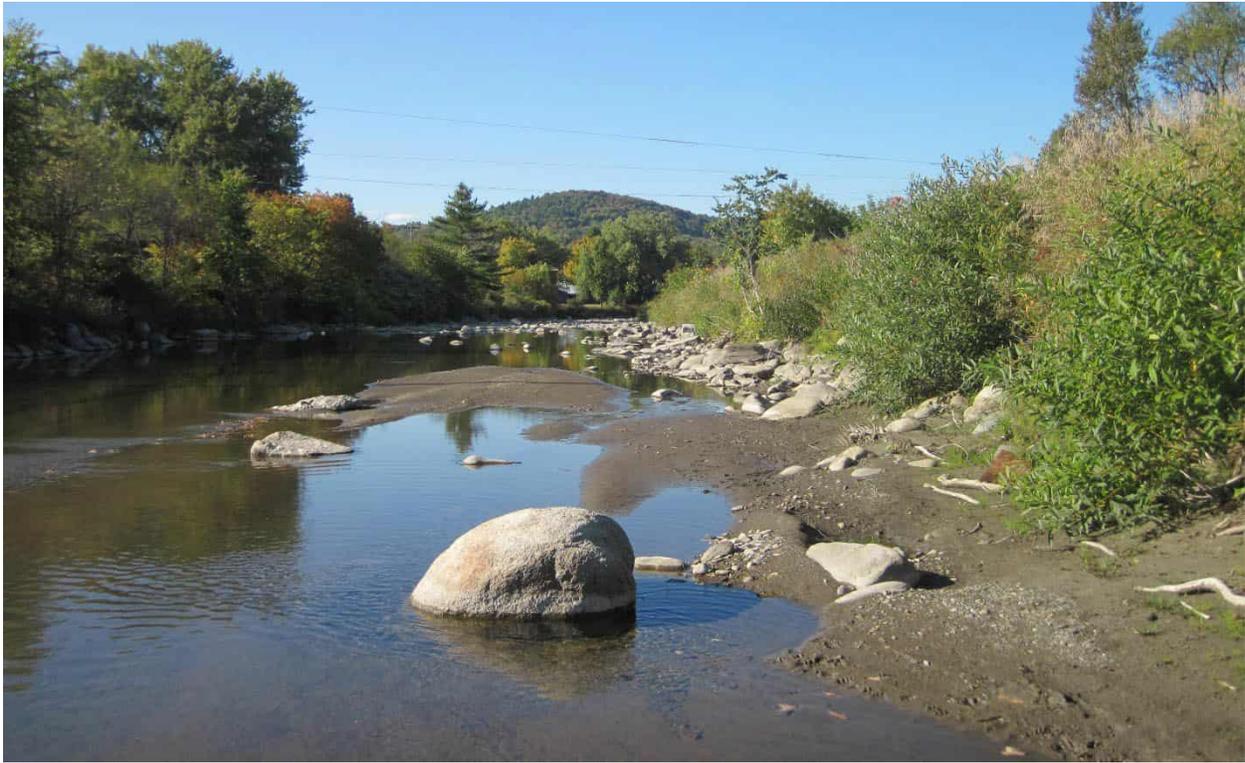
Figure 14: Lamoille River upstream of Jackson Dam and the LVRT Bridge looking downstream

The upstream reach, which spans from the Main St Bridge in Hardwick to the LVRT bridge upstream of the dam, is cobble dominated, has a moderate incision ratio (1.35), and the extensive bank armoring indicates stage II channel evolution and stream bed degradation (Figure 14) (O’Brien, 2009). The downstream reach, which spans from Jackson Dam to the Rt 15 crossing in Wolcott, is incised (1.5), the numerous sediment bars indicate stage III channel evolution and major channel adjustment, and the disruption in sediment transport from the dam upstream may be associated with the historic channel degradation through the reach (Figure 15) (Bear Creek Environmental, 2010). Alder Brook reaches have not been assessed.

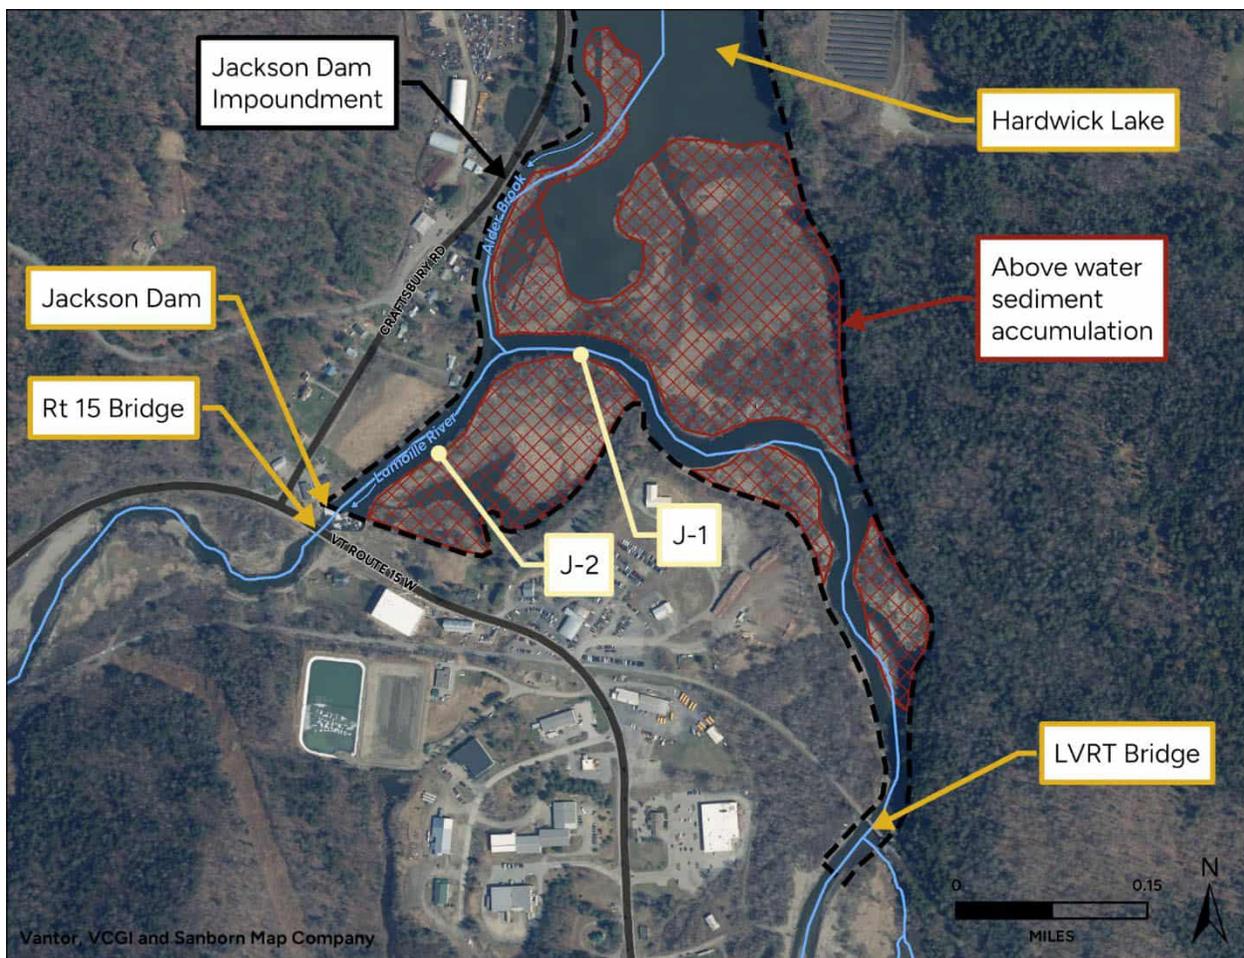
Figure 16: Jackson Dam impoundment area on the Lamoille River, above water sediment deposition, and sediment sampling locations

Jackson Dam impounds approximately 0.9 miles of the Lamoille River up to the upstream LVRT bridge. Directly upstream of the dam, the channel is deep, and the riverbed is filled in with fine sediment. There is a large area of wetlands on river left that appears to be previously open water that has filled in with sediment over time (Figure 16). Similarly, between the confluence with Alder Brook and the eastern slope of Hardwick Lake, the right bank of Lamoille River has likely filled overtime through sediment deposition from both the Lamoille River and Alder Brook. Further upstream near the LVRT bridge, the channel has some free-flowing areas, yet soft sediment exists indicating the dam is still influencing the channel. Approximately 400 feet upstream of the LVRT bridge there is a stable riffle which appears to be outside the influence of the dam at low flow. During flood conditions, the backwater from the dam extends up to the Cottage Street Bridge.

SLR collected sediment samples, J-1 and J-2, at different locations within the Lamoille River section of the impoundment on a site visit in October 2025 (see Figure 16). SLR contracted Endyne Inc. Environmental Laboratories to perform analyses for metals, PAHs, Pesticides, PCBs, and VOCs. The results of this analysis were found that both sediment samples were below the Vermont Human Exposure Thresholds (Appendix D). Additional sampling is recommended once sediment removal areas have been determined.

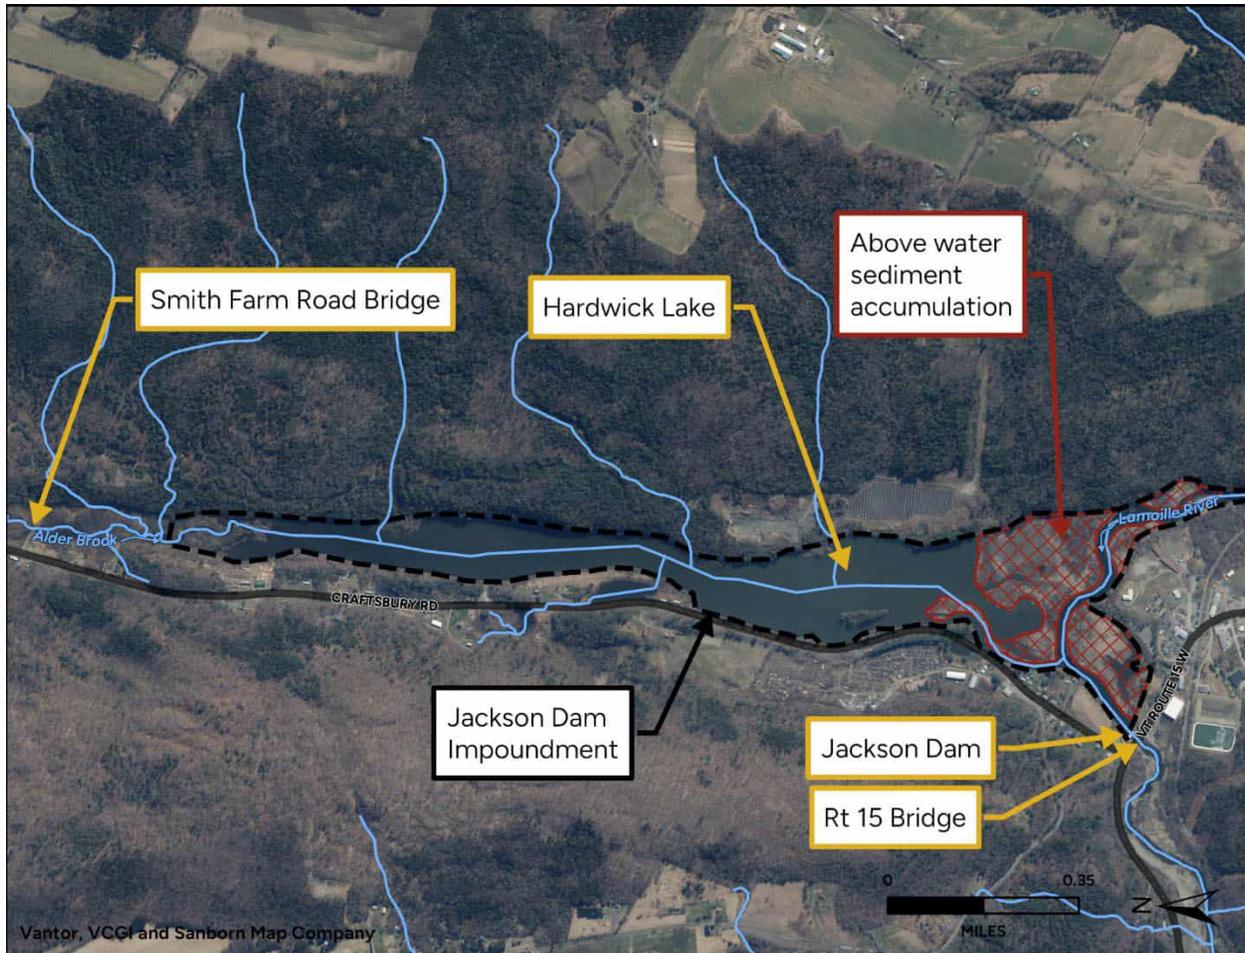
Figure 17: Jackson Dam impoundment area on Alder Brook and above water sediment deposition

Jackson Dam impounds approximately 1.8 miles of Alder Brook creating Hardwick Lake. As described above, the southern end of the lake is filled in with sediment, creating a wetland area (Figure 17). Moving north, the lake widens to a maximum width of approximately 0.2 miles before narrowing to about 0.1 miles in the northern section of open water. There is a stable wetland complex with active beaver presence at the northern end of the lake extending 0.4

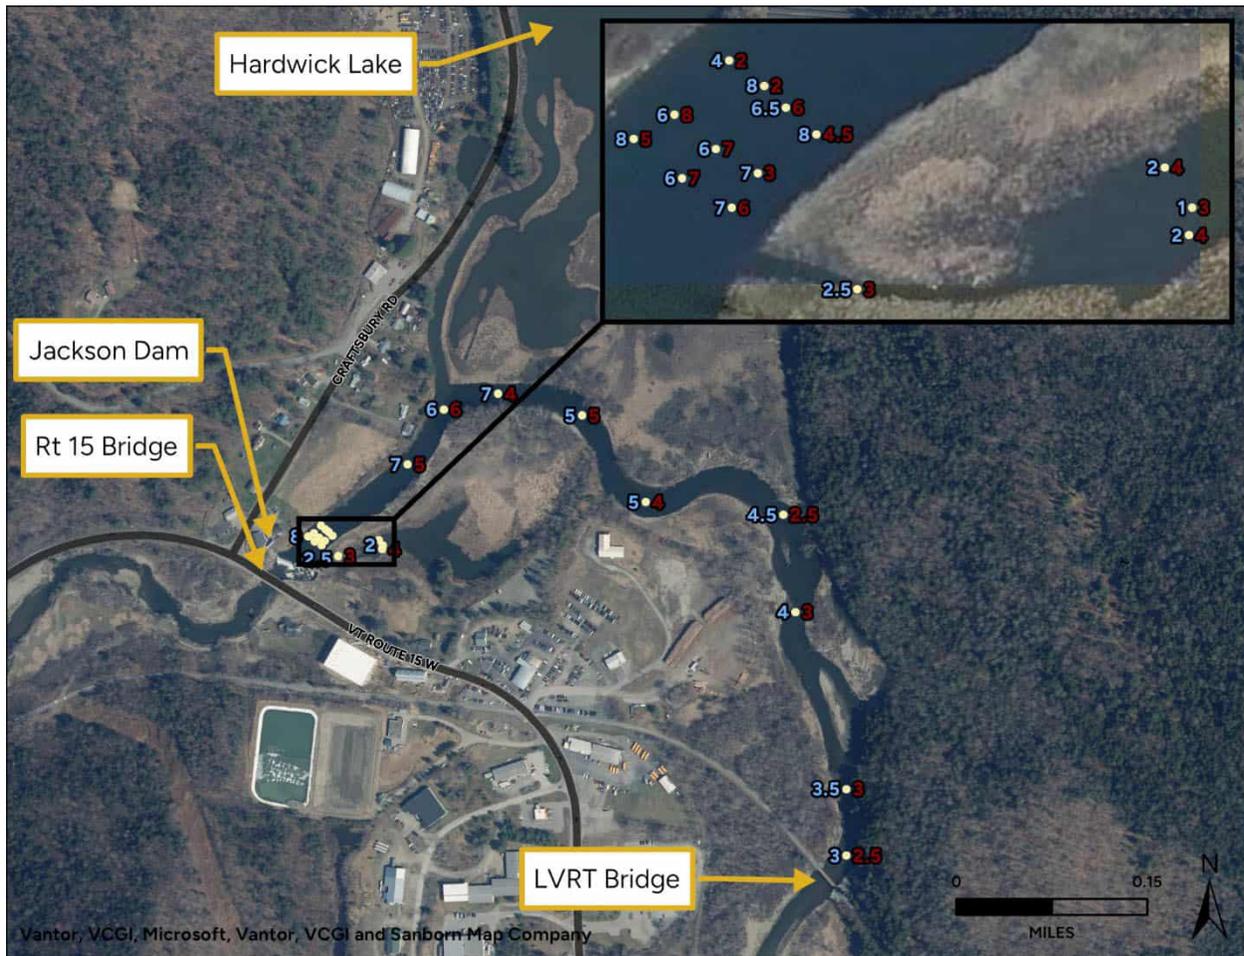
Figure 19: Sediment probing locations on the Lamoille with water (blue, left) and sediment (red, right) depths in feet

SLR performed limited sediment probing with a 14-foot rebar rod upstream of the dam. The rod was pushed by hand into the bed until encountering firm, coarse substrate that felt like either bedrock, cobble, or gravel. Closer to the dam, the sediment was either too deep for the 14-foot rod to hit refusal, or the sediment was too consolidated to allow for deeper probing. As a result, measurements that did not hit refusal are potentially underestimating the depth of sediment in the area. Probing was concentrated to the impoundment on the Lamoille River and did not extend upstream through Alder Brook and Hardwick Lake (Figure 19).

The water depth varied from 1 to 8 feet and sediment thickness varied from 2 to 8 feet (Table 3, Appendix B). On the Lamoille, sediment was thickest at the downstream end of the impoundment, closer to the dam. Sediment depths at the dam are around seven feet and taper moving upstream to 2.5 feet deep near the LVRT bridge.

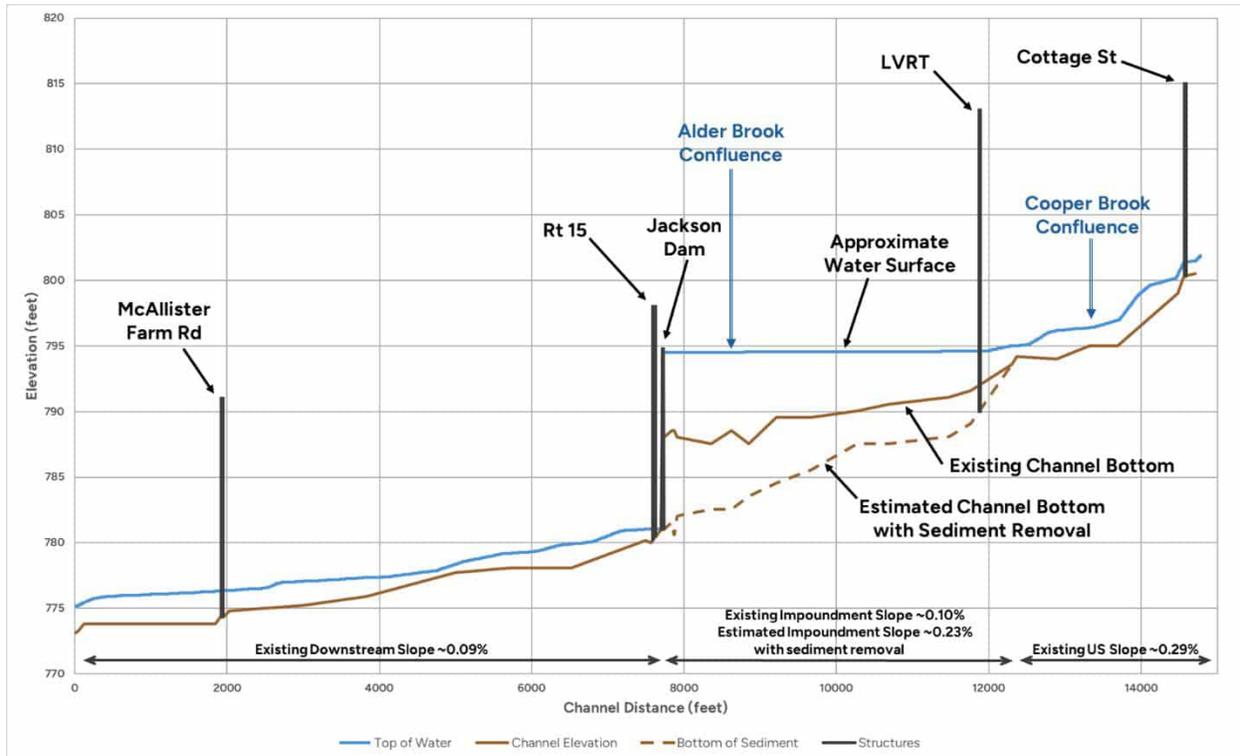
Figure 20: Jackson Dam and Lamoille River Estimated Channel Profile

An approximate channel profile along the centerline of the Lamoille River includes the normal water surface, top of sediment, and probed channel bottom spanning from the McAllister Farm Road Bridge upstream to the Cottage Street Bridge (Figure 20). The surface water elevation is derived from Vermont 2023 LiDAR data. In the impoundment, sediment and channel elevations were estimated relative to the surveyed water and sediment depths. Upstream and downstream of the impoundment, channel elevations were derived from handheld GPS survey or from the FEMA FIS profile of the Lamoille River.

The channel slope is flat downstream of the dam (0.09%) and is steeper upstream of the impoundment area (0.29%). In the impoundment area, the existing channel bottom has a flat slope (0.10%) and the channel if all the sediment was removed would be steeper (0.23%).

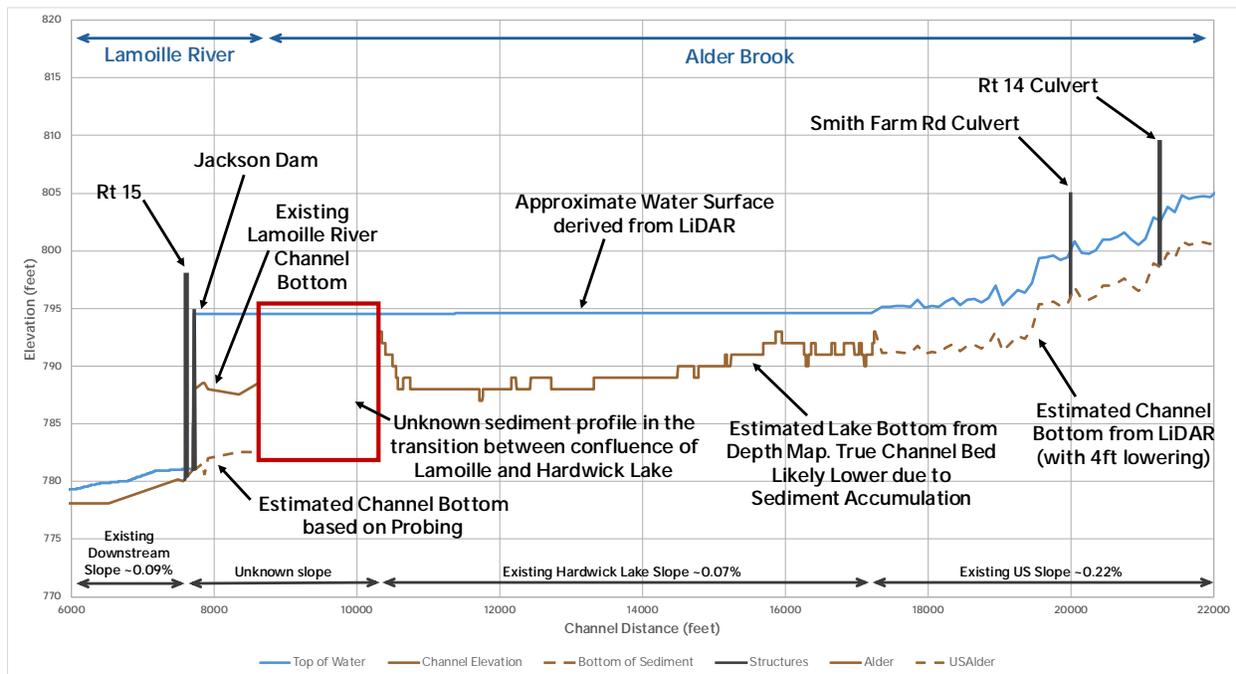
Figure 21: Jackson Dam and Alder Brook Estimated Channel Profile

A channel profile along the approximate centerline of Alder Brook as it flows through Hardwick Lake includes the normal water surface and estimated channel bottom spanning from the Rt 15 Bridge downstream of Jackson Dam to upstream of the Rt 14 Culvert (Figure 21). The surface water elevation is derived from Vermont 2023 LiDAR data. Just upstream of the dam, the sediment and channel elevations were estimated relative to the surveyed water and sediment depths from probing. In Hardwick Lake, the depths were estimated from an existing depth map of the lake from 2018. The depth map represents the surface of the lakebed, and below this there may be additional accumulated sediment within the extent of Hardwick Lake. Upstream of the lake, channel depths were estimated by adjusting the surface LiDAR elevation by 4 feet based on an observed water depth at the Smith Farm Road Culvert. Between the confluence of the Lamoille River and where Alder Brook opens up into Hardwick Lake, the channel and sediment profile in this transition zone is undetermined as sediment probing was not conducted in this area. Further probing in this region will be essential to understanding the transition between Alder Brook and the Lamoille if the dam is removed.

The channel slope on the Lamoille River is shallow downstream of the dam (0.09%), on Alder Brook the slope is unknown in the transition area between the confluence and Hardwick Lake, within Hardwick Lake the slope is shallow (0.07%), and upstream in the wetland complex the slope is moderate (0.22%).

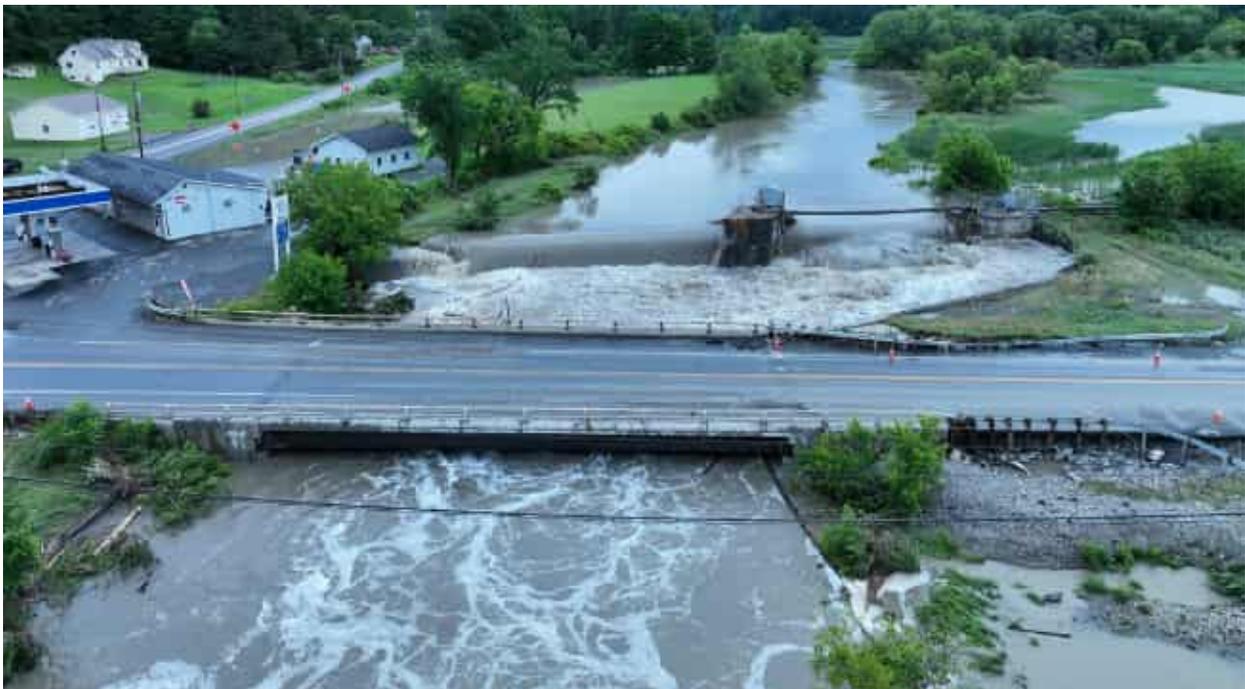
Figure 23: High water on the Lamoille River following the July 2024 flood event (AOT, 7/11/2024)

In addition to ice jam flooding, the Lamoille River in Hardwick has also experienced four significant flood events in the past 15 years (Figure 22; Figure 23). The dam reportedly

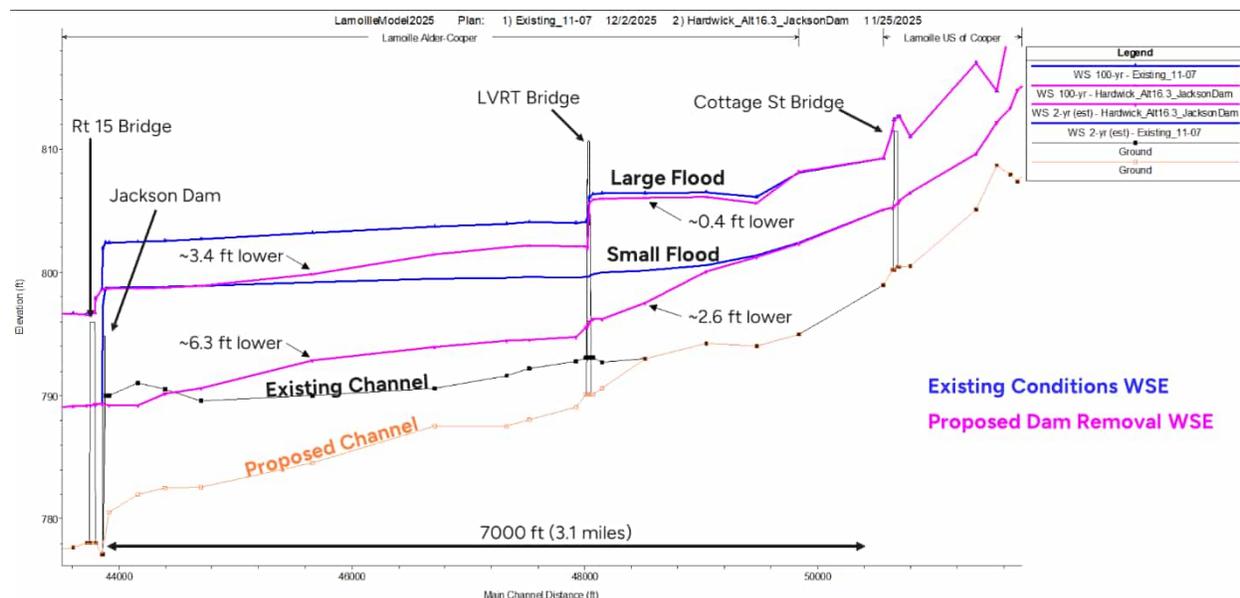
Figure 24: Lamoille River profile of existing conditions and proposed dam removal with channel lowering with WSE of a large, medium, and small flood

This section of the Lamoille River in Hardwick was included in a one-dimensional (1D) steady flow hydraulic model that was developed in 2025 by SLR to evaluate flood impacts and mitigation strategies in the Lamoille River and seven tributaries. Selected sections of the report that relate to Jackson Dam are included in Appendix F. One of the flood mitigation alternatives tested in Hardwick was the removal of Jackson Dam. This alternative included removing accumulated sediment in the channel based on depths of preliminary probing and restoring floodplains in the river corridor upstream of the dam by removing accumulated sediment so that the river is not incised and can access its floodplains. The results show significant reduction in water surface elevations extending approximately 3.1 miles upstream of the dam (Figure 24). If the dam is removed, water levels on the Lamoille are expected to decrease in both large and small floods which would provide significant benefits to upstream buildings and infrastructure as they will experience lower flood levels or not be inundated at all. A variation of this alternative was modeled where only the channel was excavated and no sediment was removed from the floodplains, and while this did lower water surface elevations, an additional foot of flood reduction can be achieved with sediment removal on the floodplain.

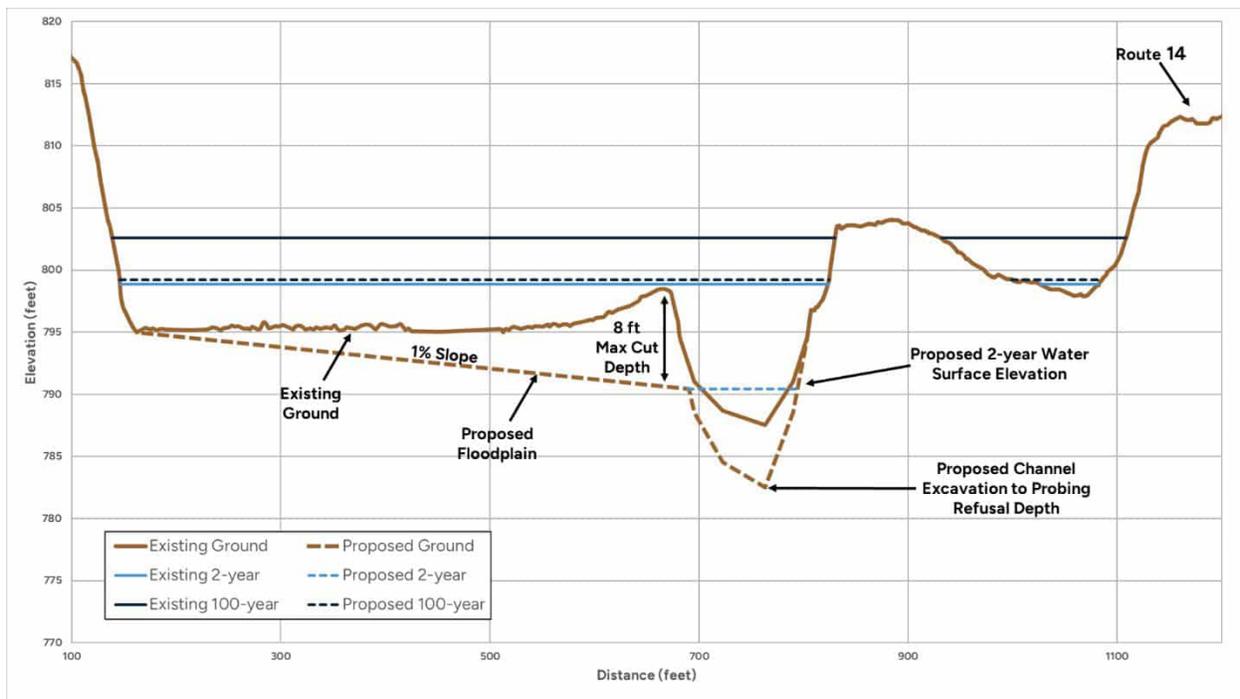
Figure 25: Cross section 500 feet upstream of the dam of Lamoille River and floodplain with existing and proposed conditions (model cross section 11.19)

The sediment under the majority of the footprint of Lake Hardwick would be vegetated in place. The sediment recommended for removal in the channel of the Lamoille River between the LVRT bridge and the dam and in the channel of on Alder Brook upstream of the confluence has an estimated volume of 63,400 CY. In addition, some sediment removal in the river corridor is recommended to create accessible floodplains, up to 123,500 CY. The sediment removal volume in the floodplain was based on lowering areas along the rivers to the 2-year water surface elevation and tying in the floodplain to the existing ground at a 1% slope (Figure 25). This volume could be adjusted based on desired floodplain connectivity – vertically and laterally. It is recommended that the sediment be removed from the channel and floodplain and be relocated to another area on the project site outside of the river corridor against the valley wall.

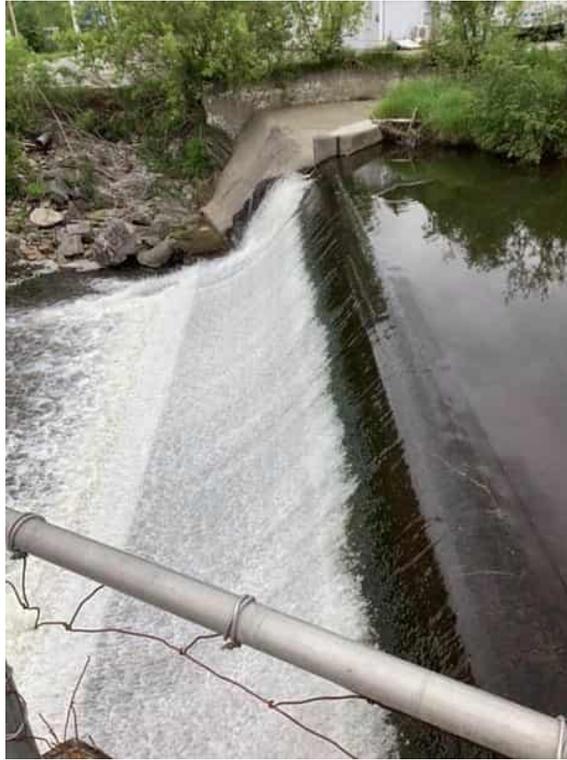
Principal spillway issues	Action
Deteriorating concrete	
Issues:	
<input type="checkbox"/> Bug holes	<input type="checkbox"/> None
<input checked="" type="checkbox"/> Hairline crack	<input type="checkbox"/> Monitor
<input checked="" type="checkbox"/> Efflorescence	<input checked="" type="checkbox"/> Maintenance
<input type="checkbox"/> Spalling	<input checked="" type="checkbox"/> Engineer
Impacted area: Throughout	
Location: Entire Surface

Ogee weir section on right side of dam.

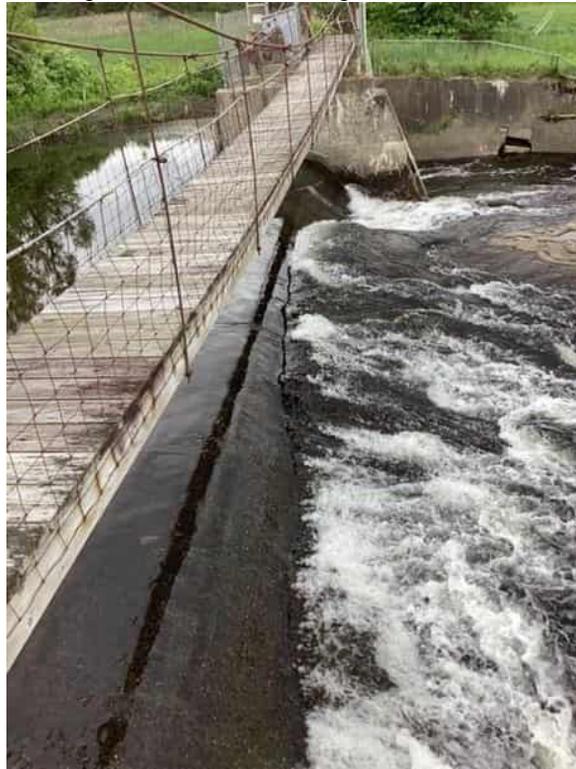
Weir section on left side.

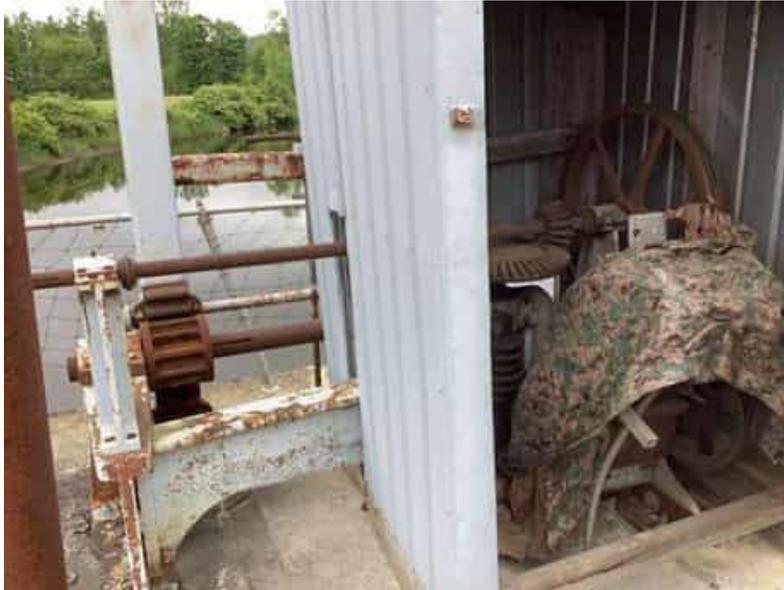
Main Principal Outlet Structure	
Elevation: El. 786.0 (feet)	Location: Left side of principal spillway.
Drain size and configuration: Two (2) 6-foot-diameter outlet barrels with a manually operated gate. Left of the two outlet pipes is nonfunctional and reportedly abandoned.	Access: Good.
Additional comments: Outlet was not operated during inspection. The lake is reportedly lowered using this outlet works in the winter. Leakage through this gate was observable.	
Main Principal Outlet Structure Issues	Action
The mechanism and visible condition of the gate operator appears poor. The condition of the gate itself could not be determined.	<input type="checkbox"/> None <input type="checkbox"/> Monitor <input checked="" type="checkbox"/> Maintenance <input checked="" type="checkbox"/> Engineer

Gate across wooden spillway cable bridge.

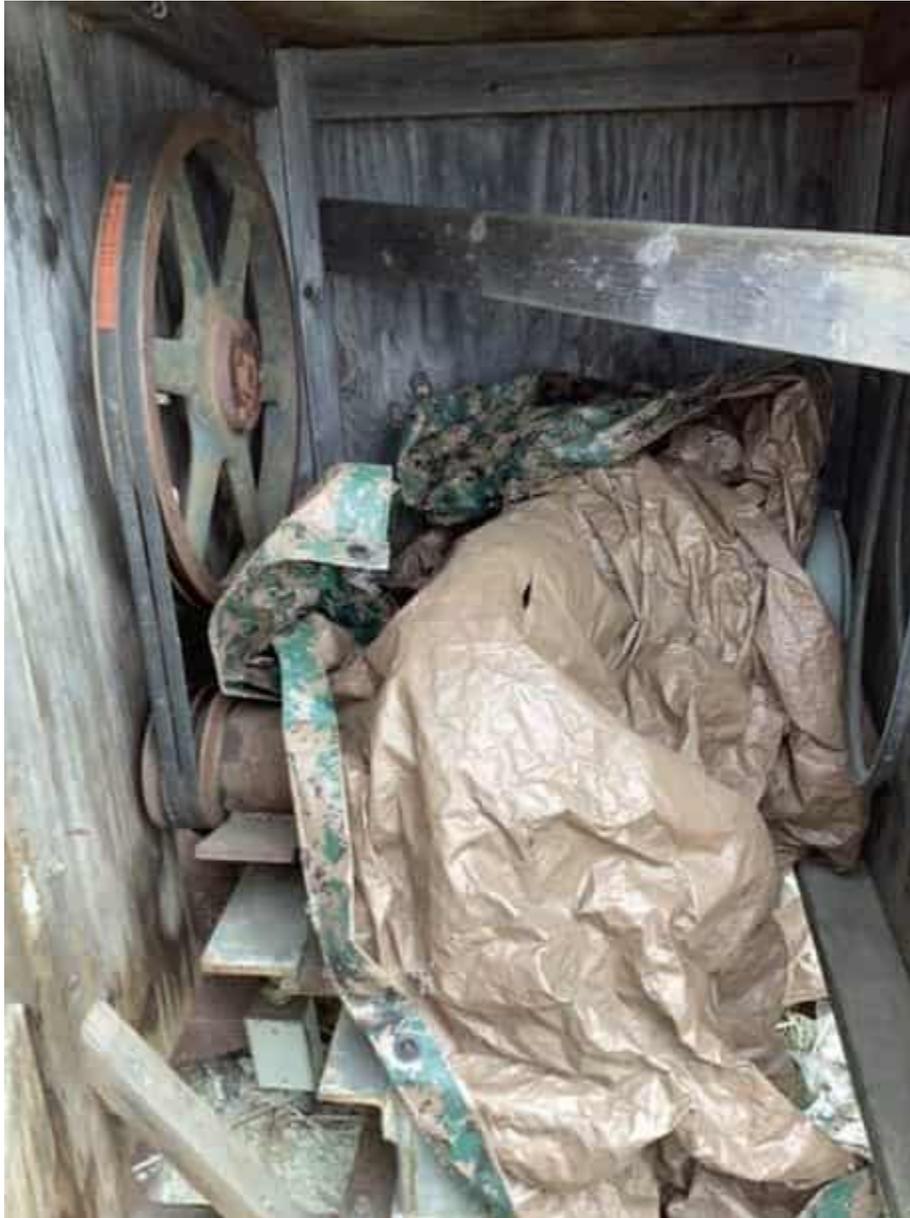
Inside of the housing where the gate operator is located for the left main gate.

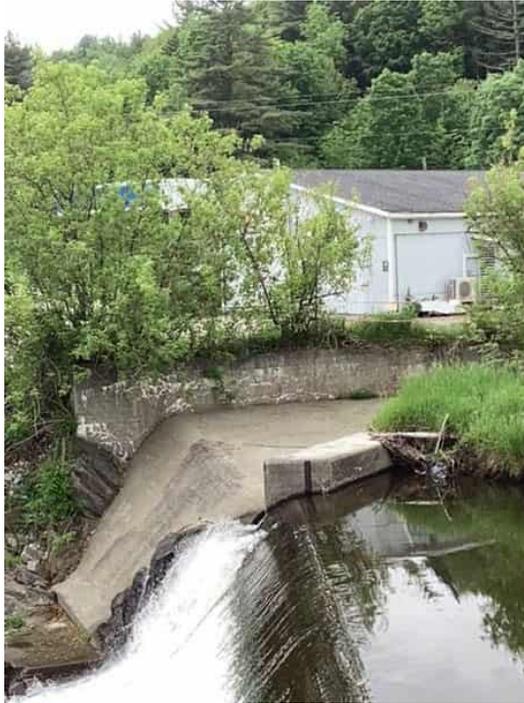
Auxiliary spillway at the right abutment.

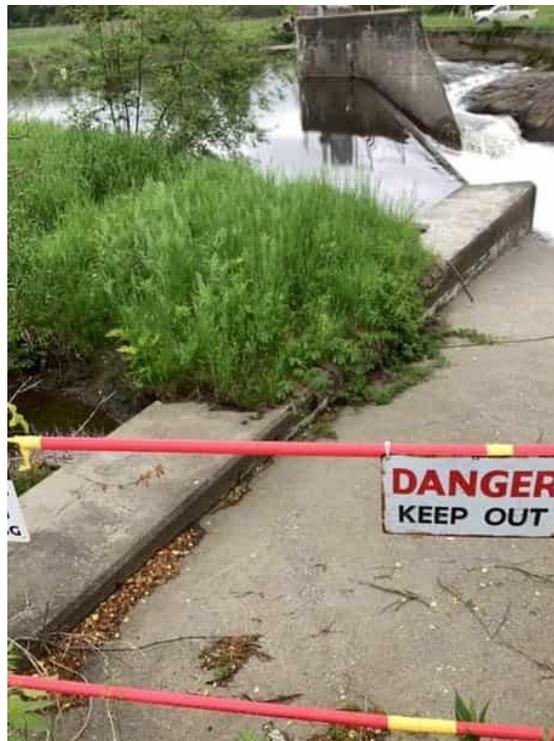
Broad crested auxiliary spillway weir from right abutment.

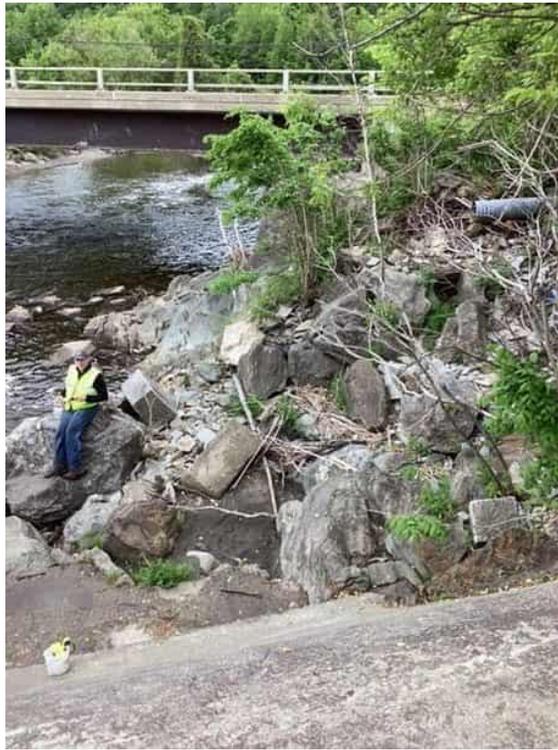
Auxiliary Spillway discharges onto a splash pad that appears to be founded on bedrock.

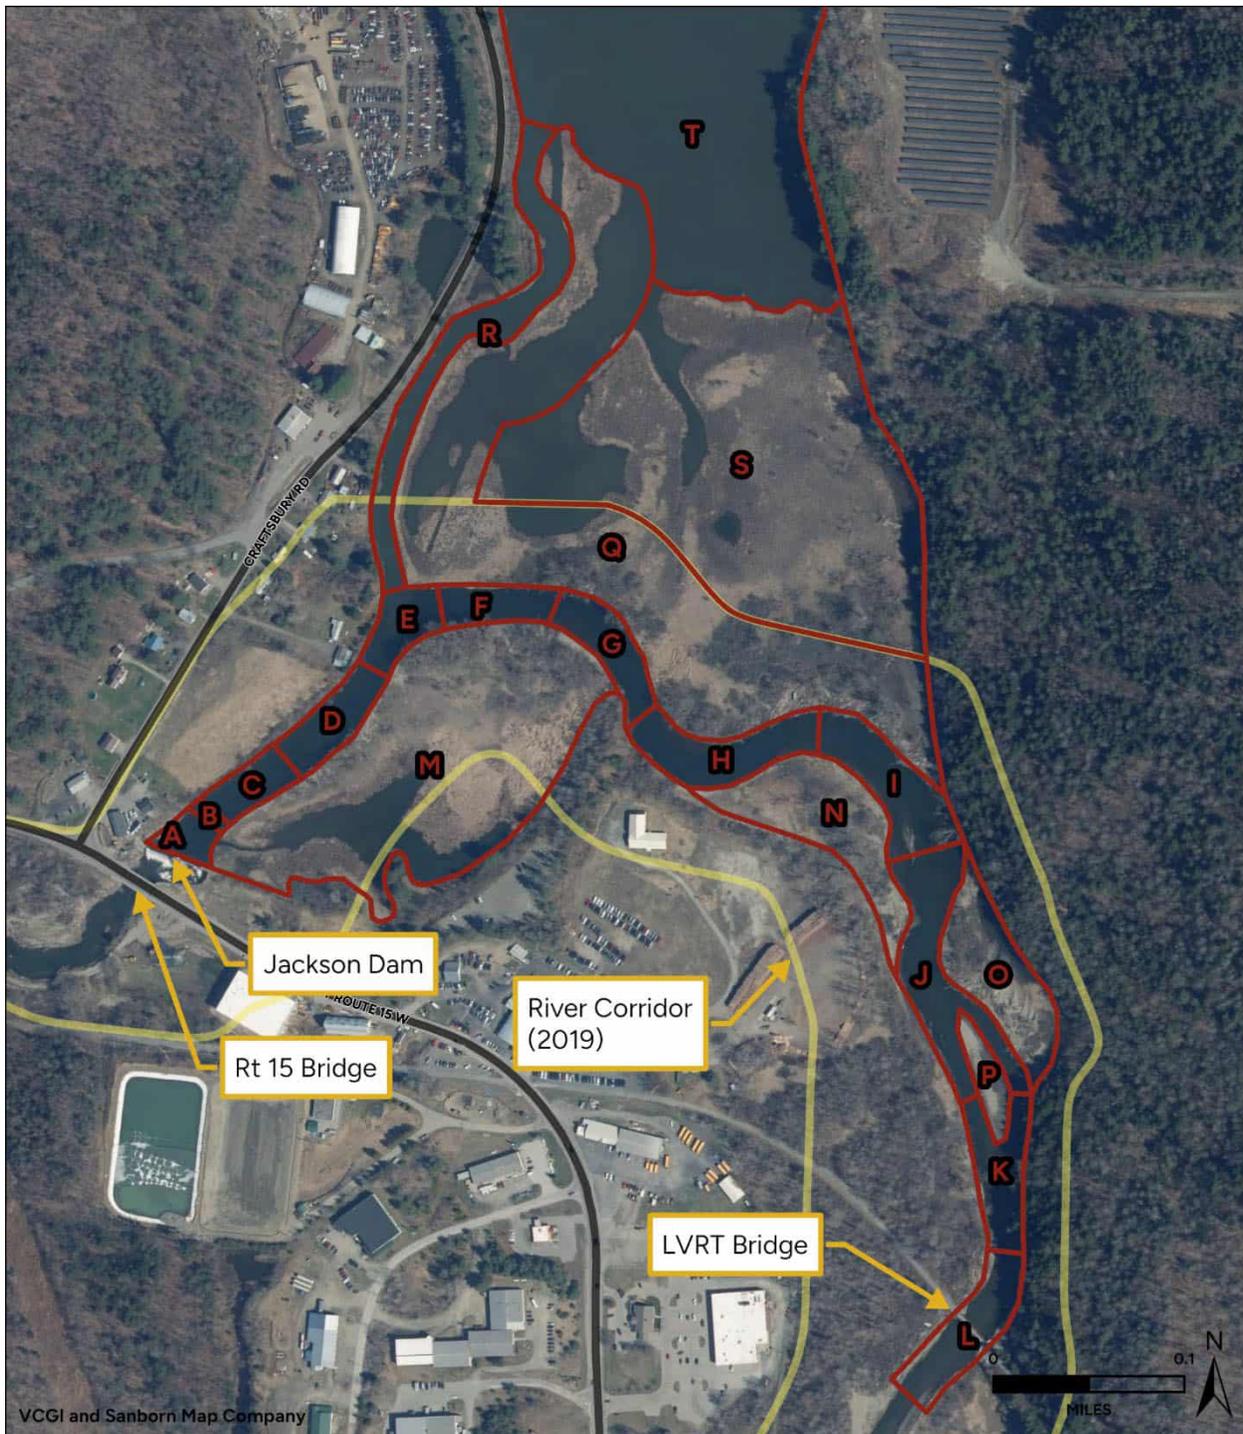
Figure 26: Impoundment areas with similar attributes used to estimate sediment volume

Impoundment ID	Approximate Sediment Depth (feet)	Area (feet ²)	Volume (feet ³)	Volume (cy)
A	6	17,000	102,000	3,800
B	6	4,000	24,000	900
C	3.6	28,000	100,800	3,700
D	5	41,000	205,000	7,600
E	6	34,000	204,000	7,600
F	4	33,000	132,000	4,900
G	5	44,000	220,000	8,100
H	4	66,000	264,000	9,800
I	2.5	72,000	180,000	6,700
J	3	98,000	294,000	10,900
K	3	52,000	156,000	5,800
L	2.5	61,000	152,500	5,600
M	8.5	469,000	3,986,500	147,600
N	7.5	115,000	862,500	31,900
O	5.5	92,000	506,000	18,700
P	2.5	24,000	60,000	2,200
Q	6.5	689,000	4,478,500	165,900
R	4	108,000	432,000	16,000
S	6.5	741,000	4,816,500	178,400
T	~	4,600,000	~	~
Total			17,180,000	640,000
Total in river corridor (M, N, O, P, Q)			9,894,000	370,000
Total in channel (A, B, C, D, E, F, G, H, I, J, K, L, R)			2,466,000	90,000

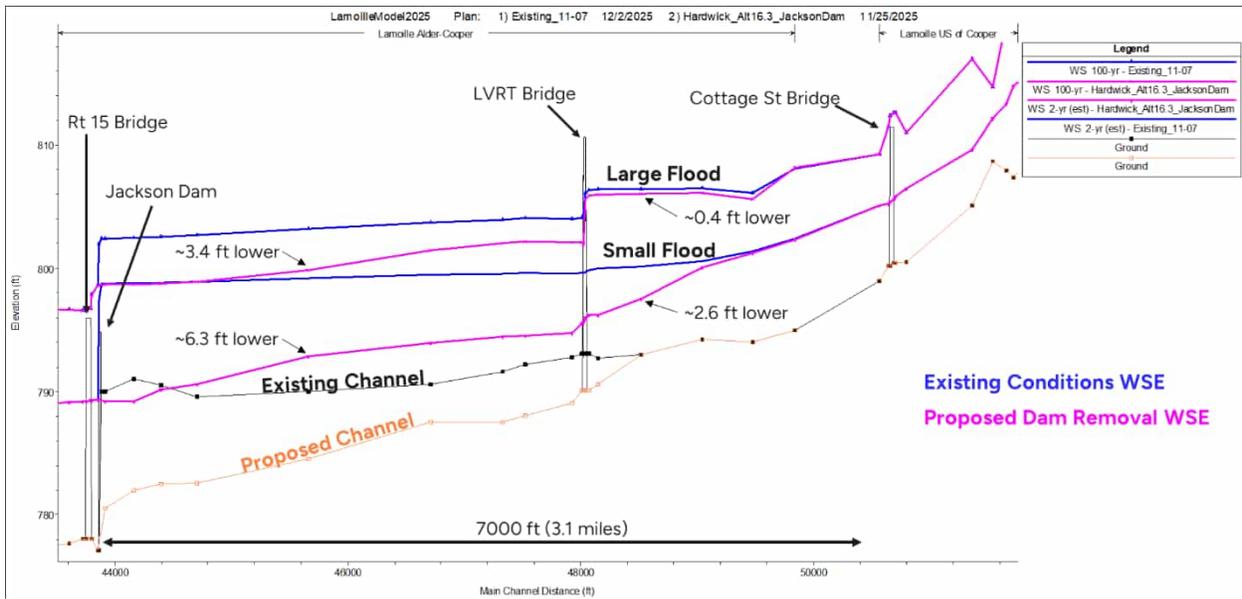
This alternative involves removing the dam and excavating sediment built up behind the dam up through the LVRT Bridge (Figure 44). In addition, floodplains next to the river would be lowered so the river is not incised and can access the floodplains. The flood reduction benefits extend 3.1 miles upstream of the dam. Large flood water surface elevations are lowered 3.4 feet just upstream of the dam and 0.4 feet upstream of the LVRT Bridge. Small flood water surface elevations are lowered 6.3 feet just upstream of the dam and 2.6 feet upstream of the LVRT Bridge.

Figure 44: Profile of existing conditions and proposed dam removal with channel lowering with WSE of a large, medium, and small flood

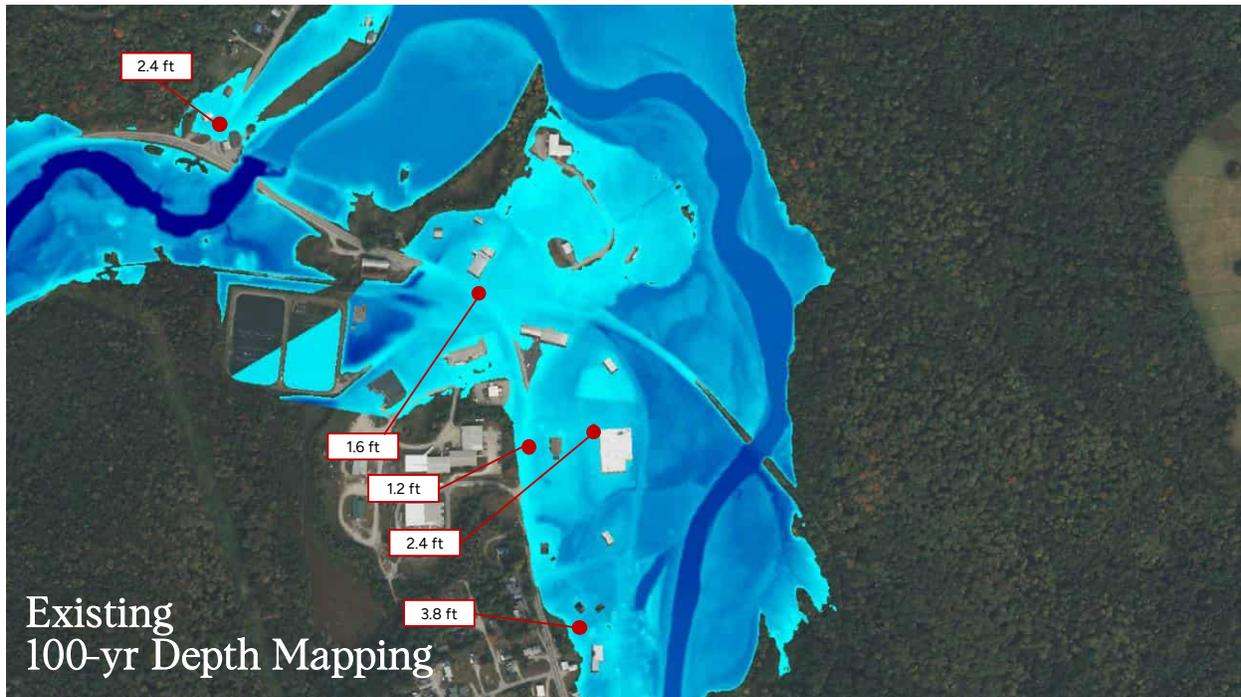
Mapping of the existing and proposed flood depths for the 100-year flood show flood reduction benefits from removing Jackson Dam (Figure 45, Figure 46). These results highlight how run-of-river dam removal would reduce inundation extent across Route 14/15 and reduce impacts to nearby businesses.

Figure 45: Depth mapping of existing conditions for a large flood

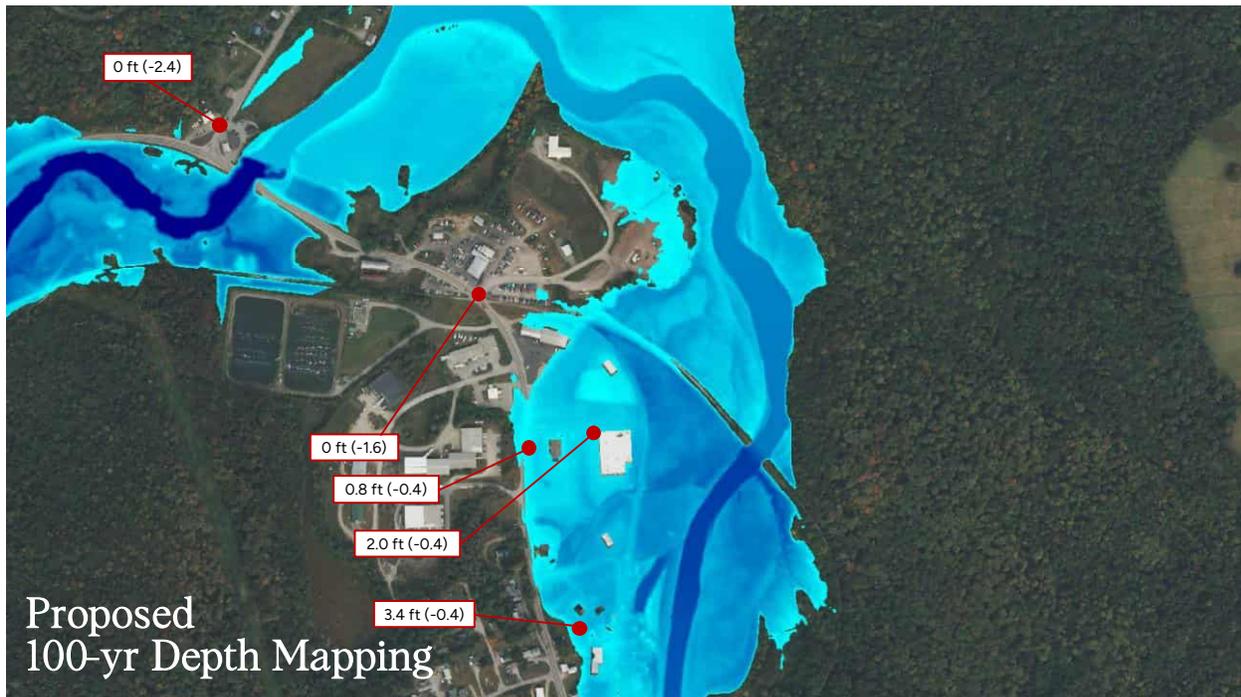
Figure 46: Depth mapping of proposed dam removal for a large flood

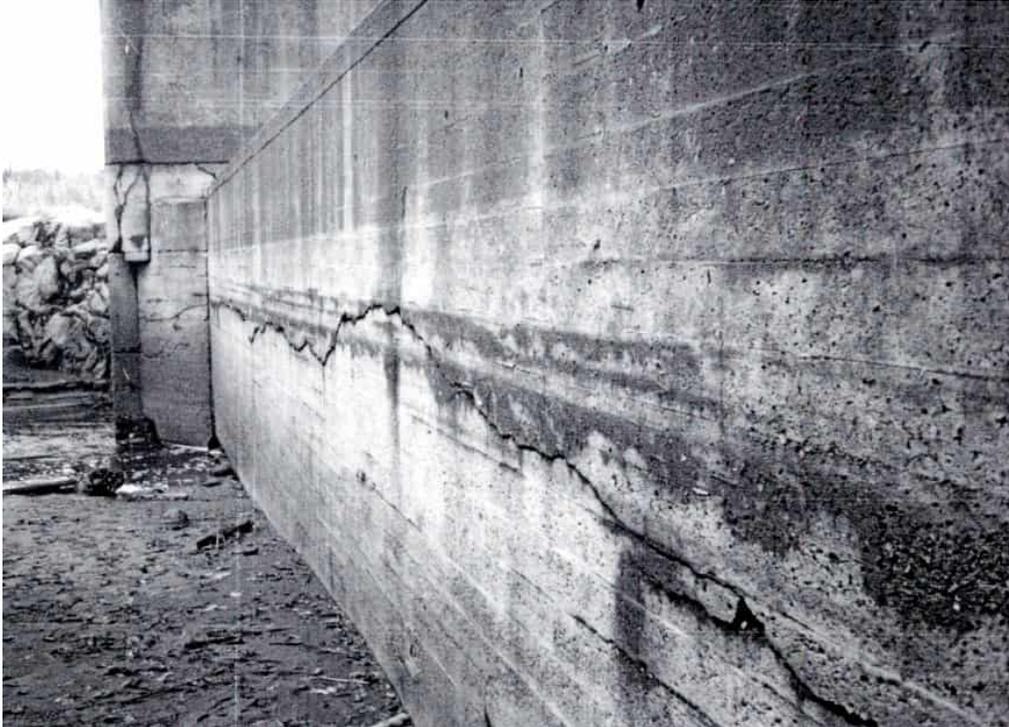
Figure 27: Jackson Dam upstream face during winter draw down (Knight, 2001)
