Jackson Dam (VT#93.01)

Dam Removal Feasibility Analysis

Caledonia County Natural Resources Conservation District

SLR International Corporation

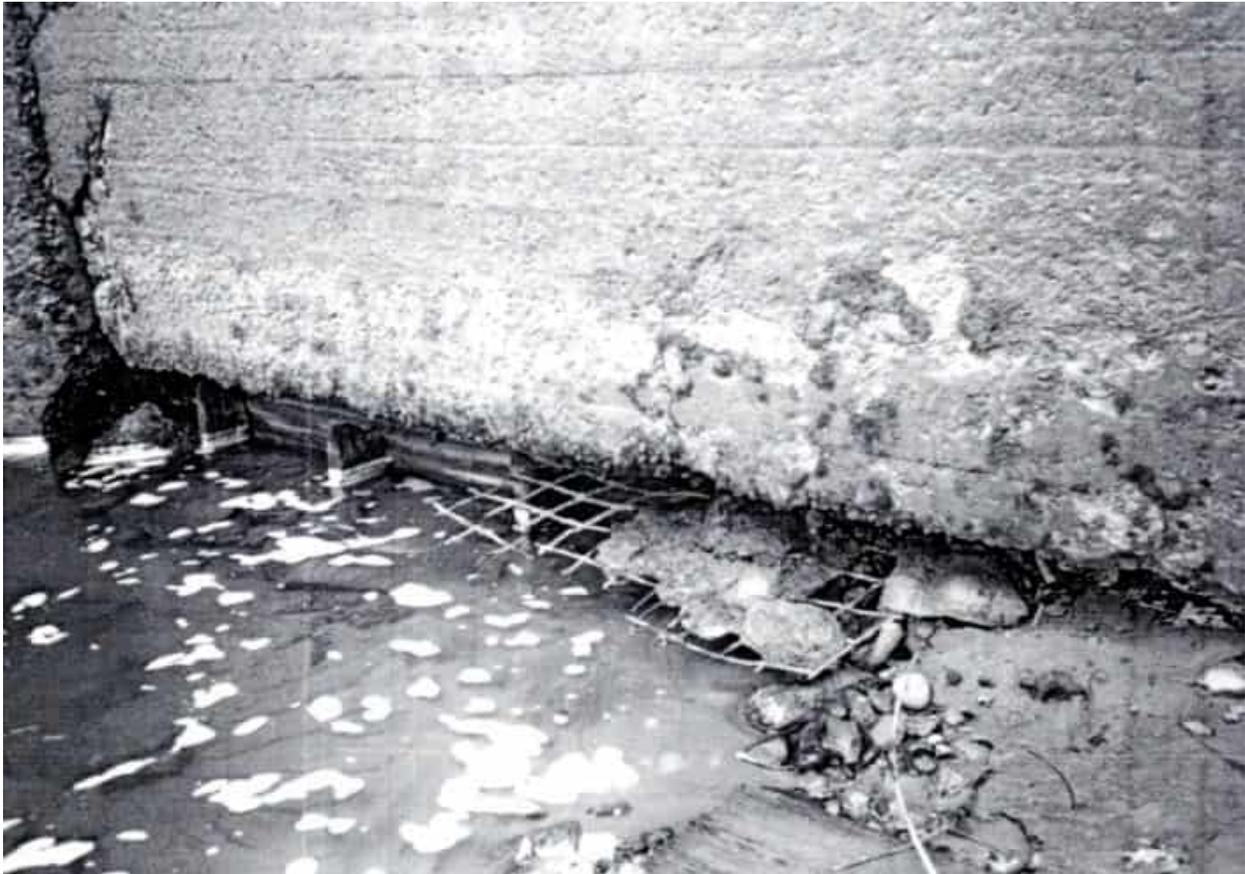
Figure 29: Jackson Dam during winter draw down (Knight, 2001)
