Errors and Omissions Request

April 2023

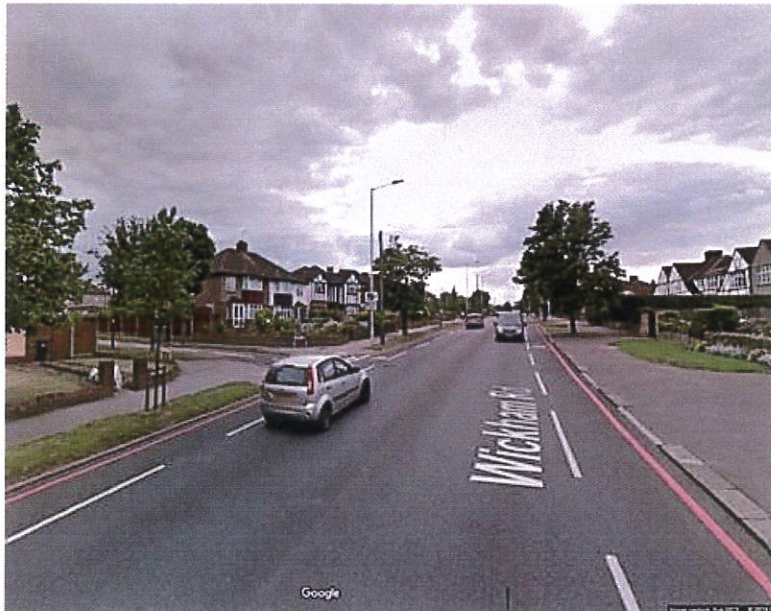
1. Remove the centerline from North Main Street. *Time Sensitive.*

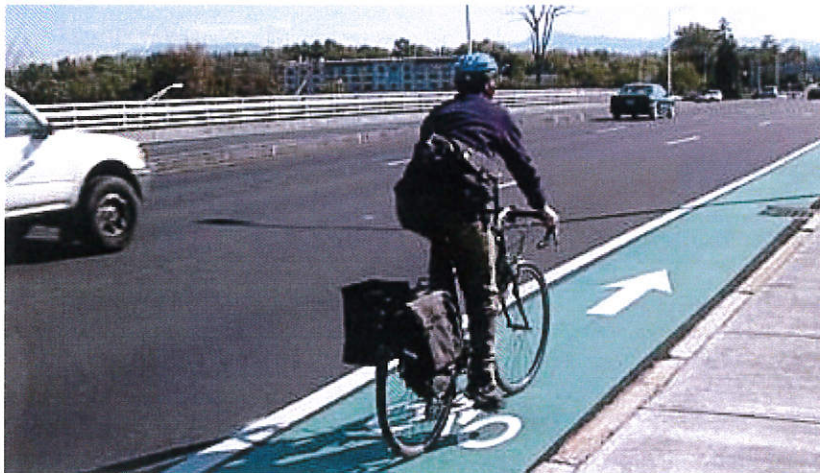
2. Create a bike lane in the uphill direction on North Main Street – from the Route 15 intersection to the LVRT crossing.

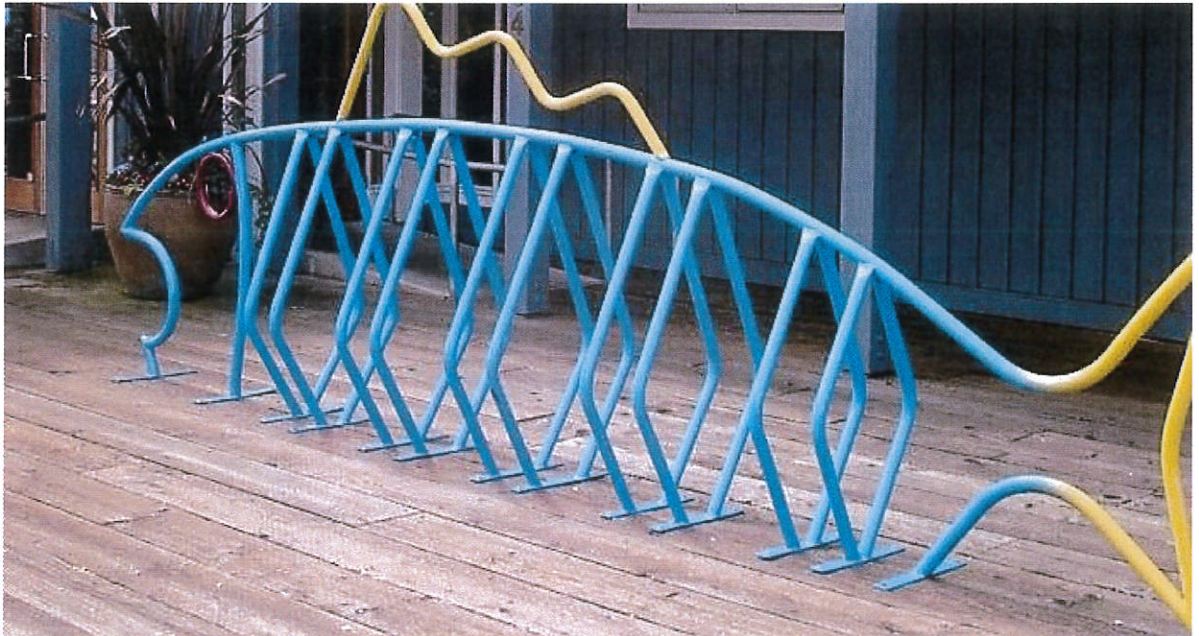
3. Create ample bike parking at the pause park next to the Memorial Park. Encourage bikers to leave their bikes and walk to the downtown. Story walk? Bike racks?

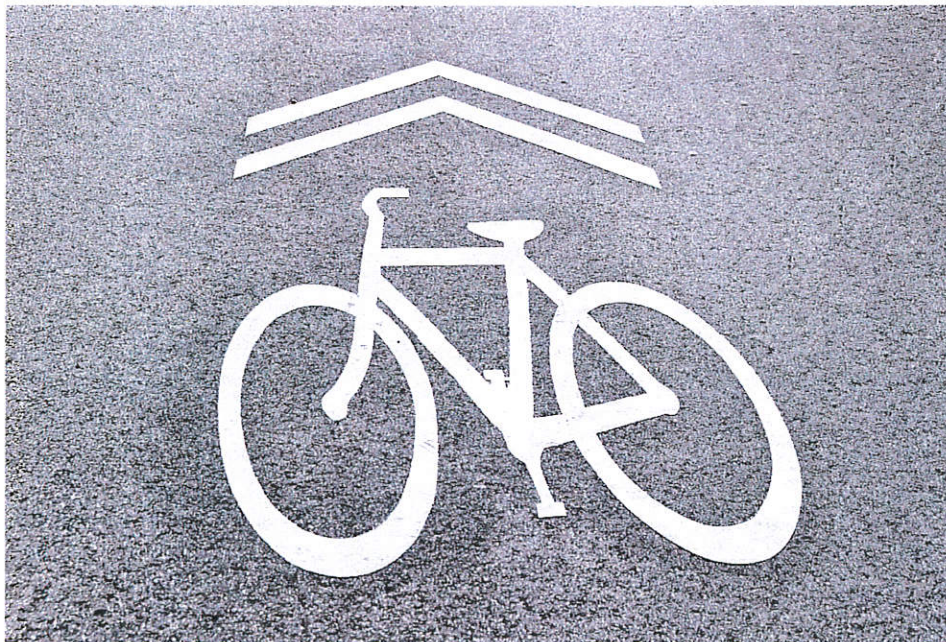
4. Create and install signage on the LVRT and in the Downtown area directing bikers to the best routes to downtown, bike racks, local businesses, etc.
5. Install sharrows on the downhill lane of North Main Street from the LVRT crossing to the Route 15 intersection.

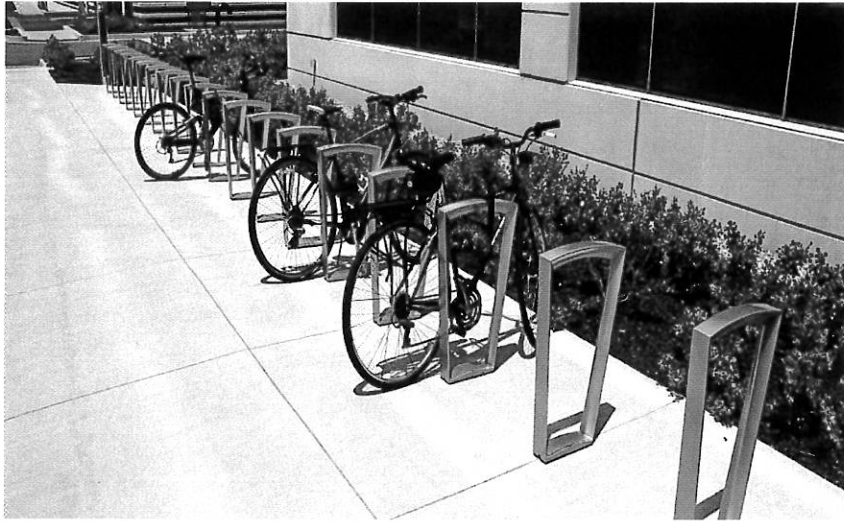
6. Install bike racks in the Peace Park, adjacent to the Civic Standard.
