Lamoille River Watershed Updated Water Quality/Aquatic Habitat Assessment Report February 2016

Vermont Agency of Natural Resources
Department of Environmental Conservation
Watershed Management Division
Monitoring, Assessment, and Planning Program

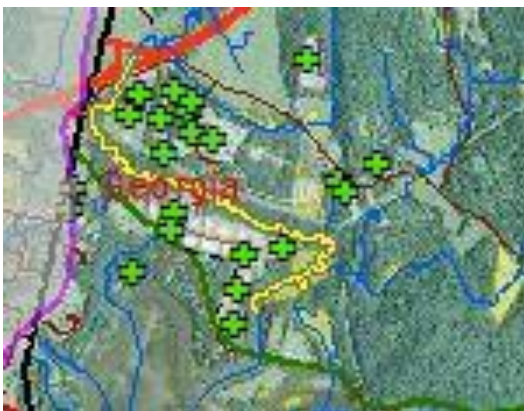
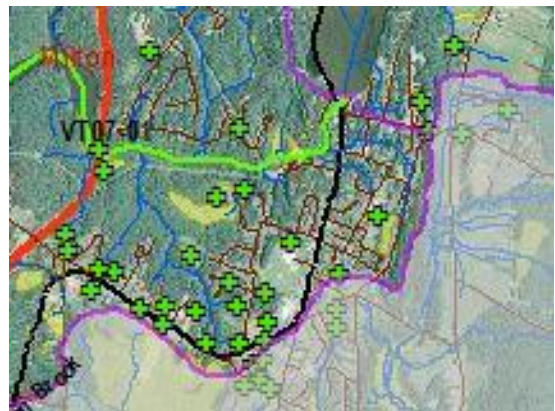
Two areas in the Lower Lamoille watershed have high concentrations of stormwater permits. One area is that around the impaired Deer Brook (yellow stretch below) and the other is the area south of the Lamoille mainstem just downstream from Arrowhead Reservoir. (The green crosses are issued stormwater permits.)
