# Lamoille River Modeling and Alternatives Analysis

Hardwick Flood Mitigation

December 4, 2025

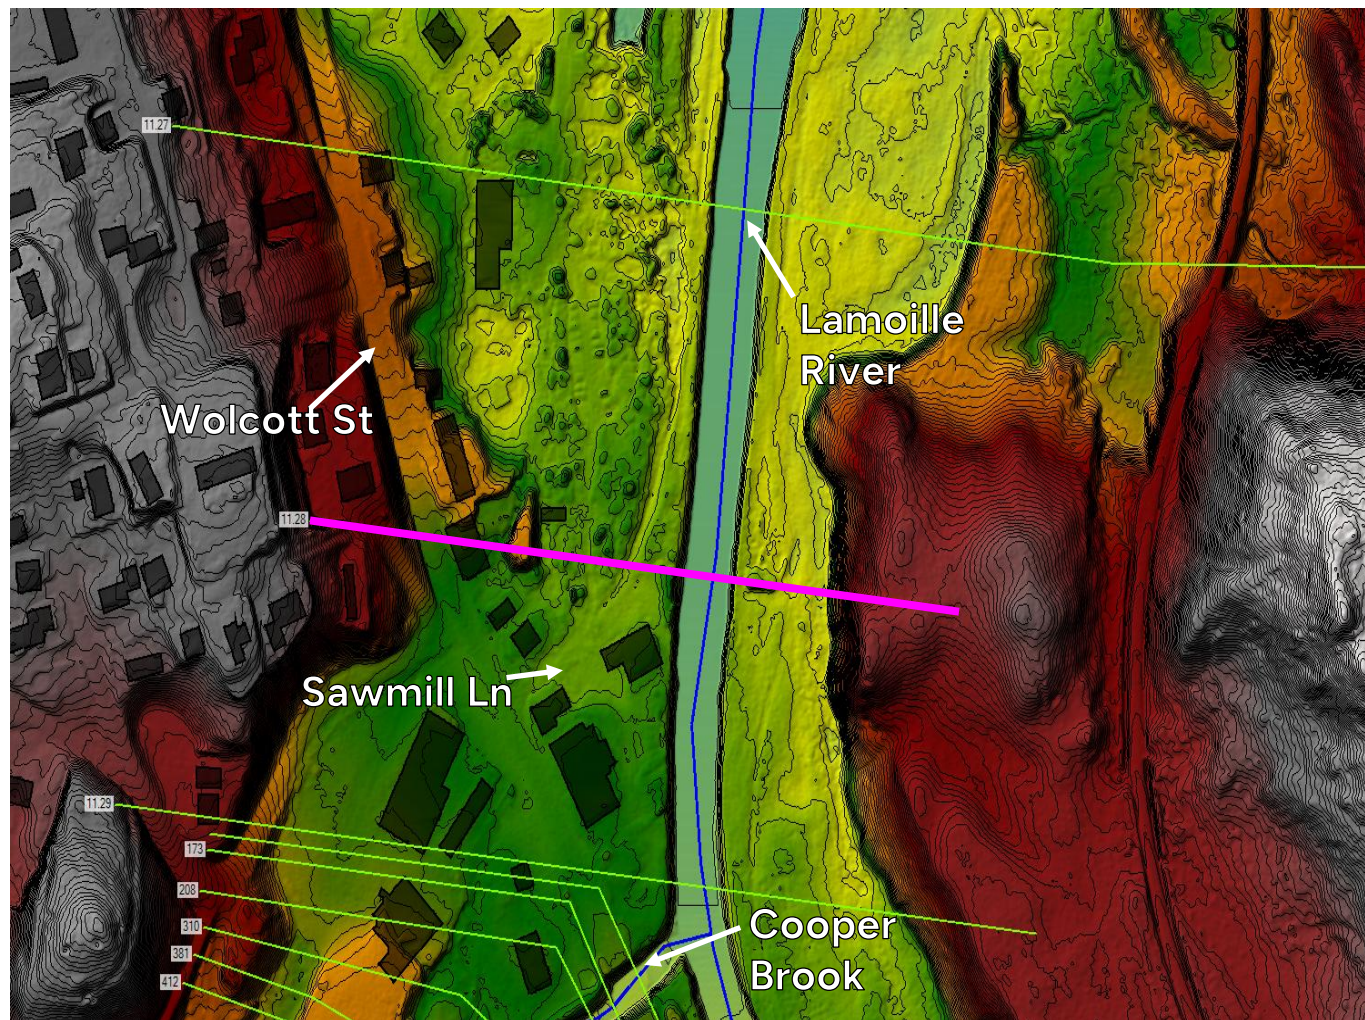
# Model Creation & Inputs

- Elevation Data
  - LiDAR – 2023
  - Survey
  - UAV
  - FEMA prior points (below water)
- Landuse for Roughness
- Buildings
- Bridge, Culvert, and Dam Plans
- Field Observations and Measurements

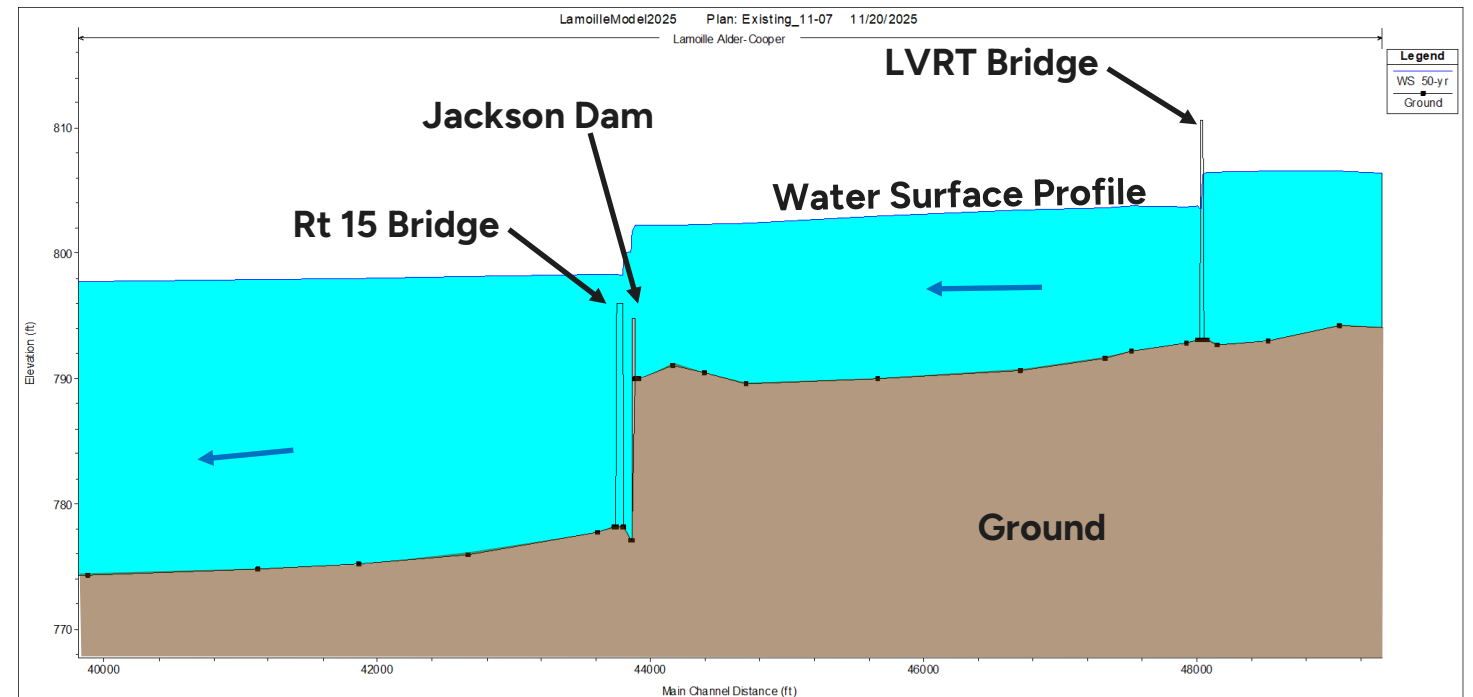
- Water Surface Elevation
- Floodplain Mapping
- Flow Characteristics
  - Velocity
  - Depth
- **Channel and Water profiles**
- Dam, Bridge, and Culvert Impacts
  - Backwatering
  - Overtopping
  - Scour

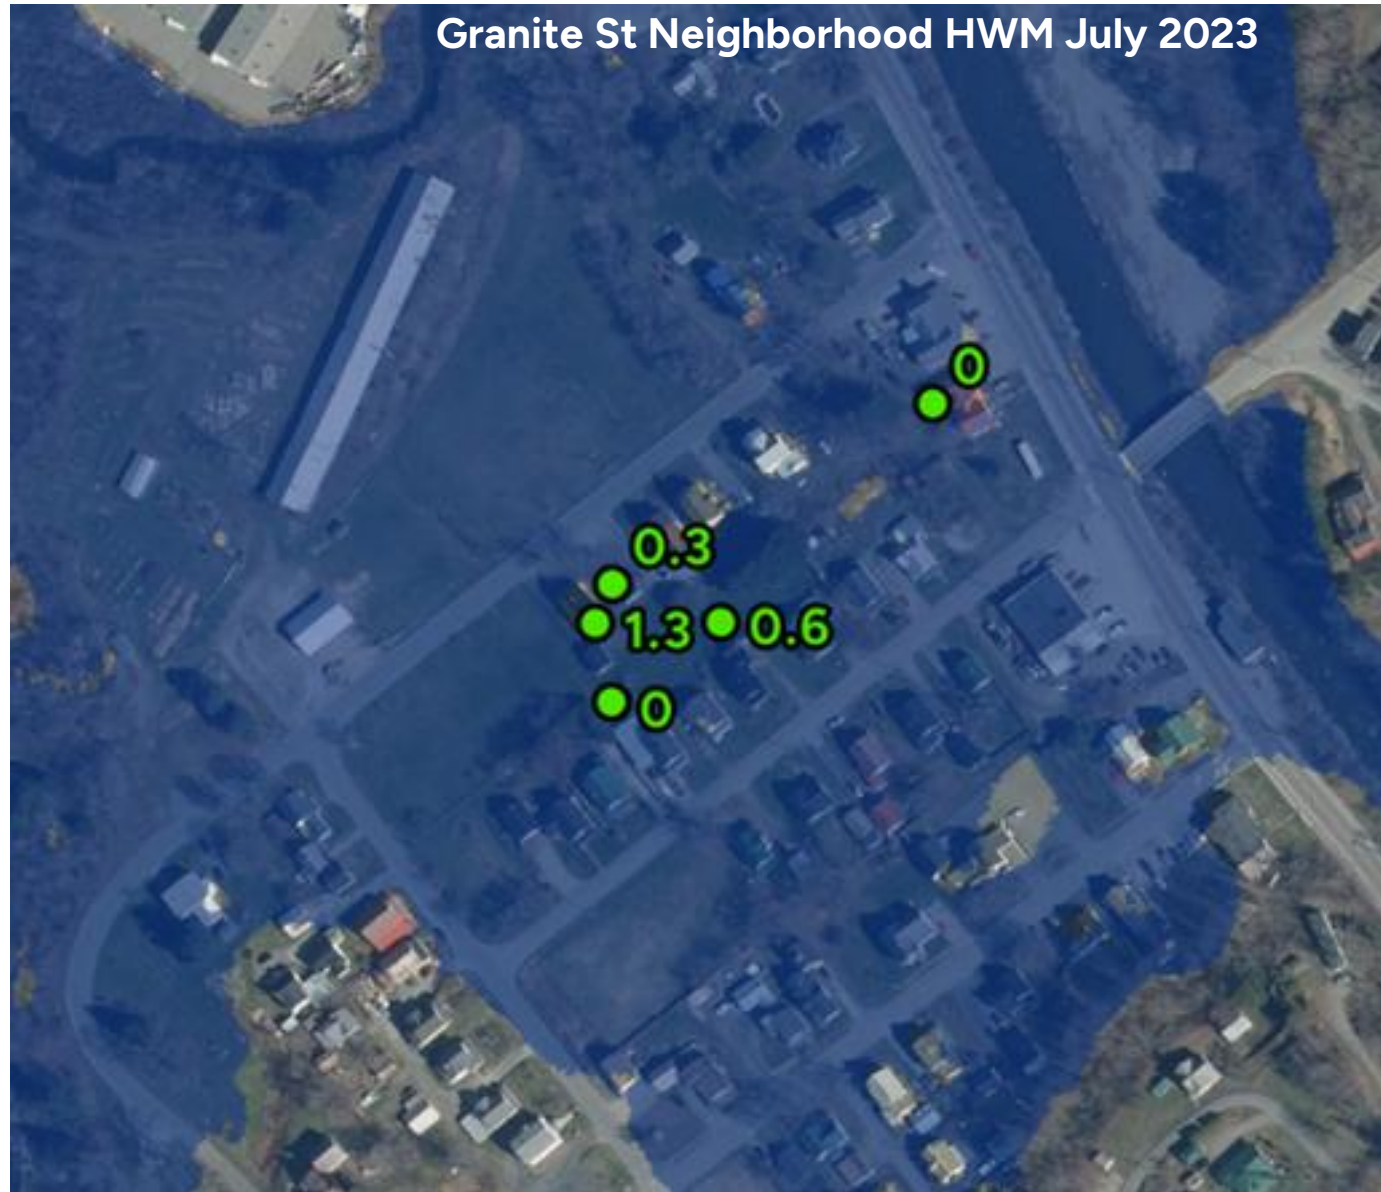
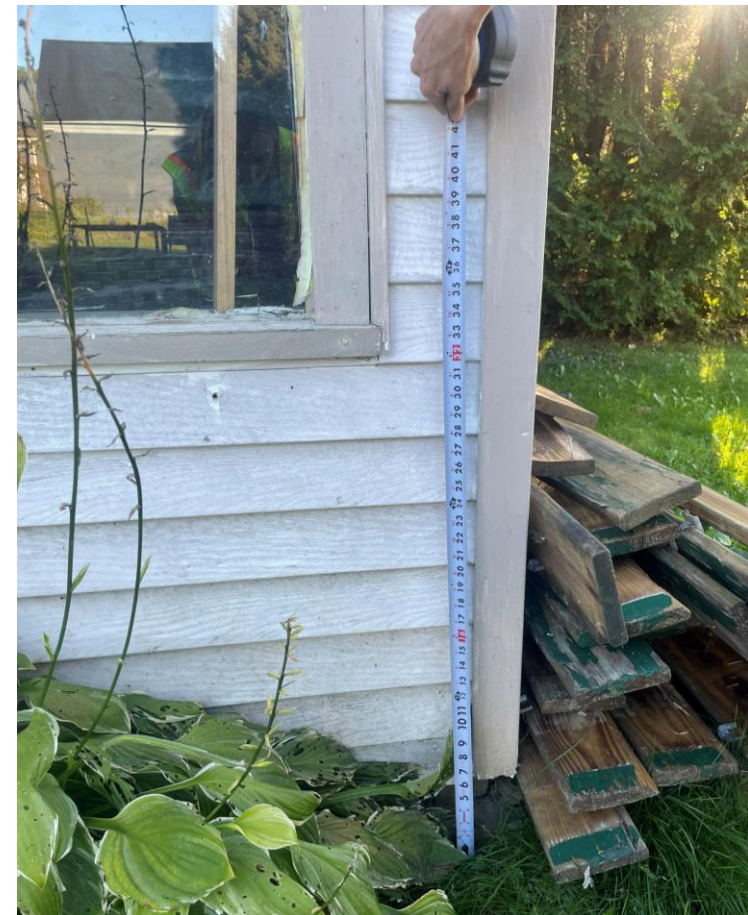
# How Accurate is it?

## Calibration / Validation:

- High Water Marks (HWMs)
- Accuracy is within 1 ft
- Good for comparing alternatives

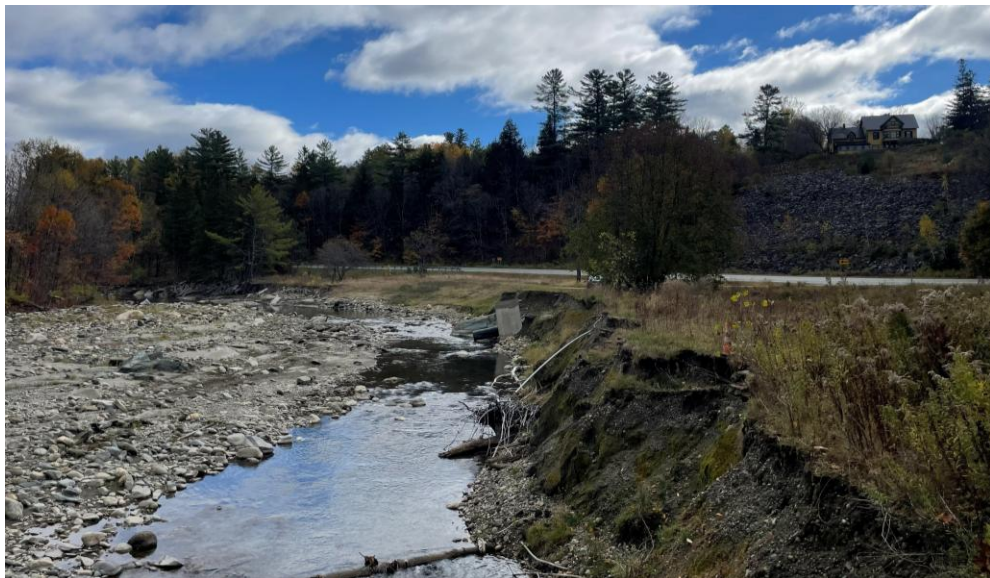
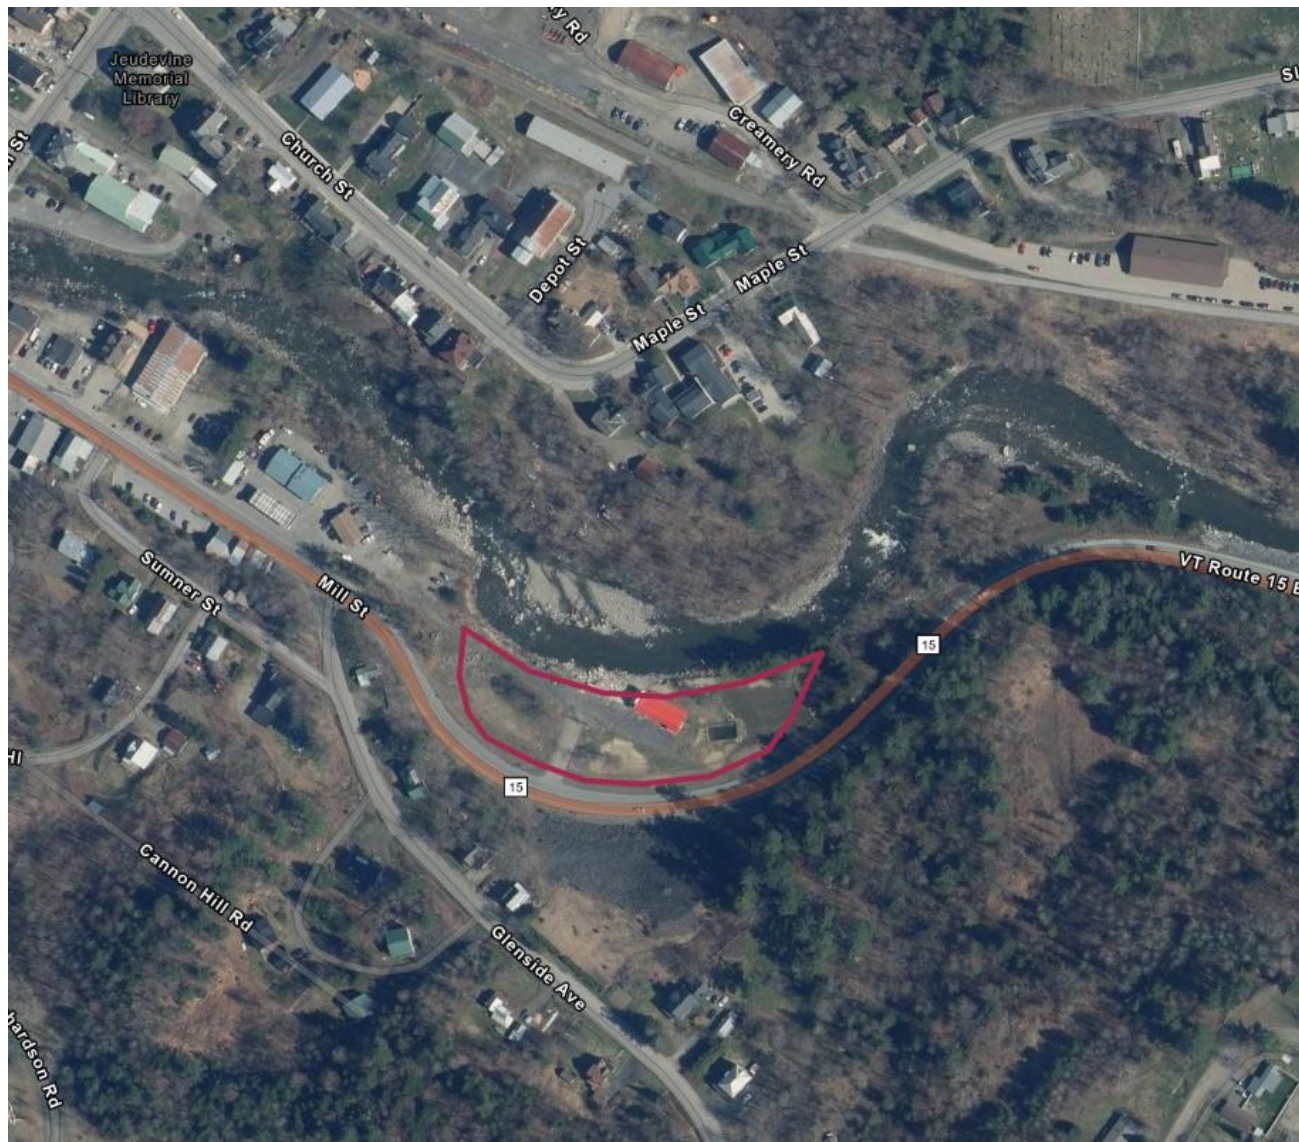
# Mill Street Floodplain

## Problems

- Eroding bank
- Buyout

## Possible Solutions

- Slope stabilization/bank armoring
- Floodplain restoration
  - Space for Debris and Ice Shedding

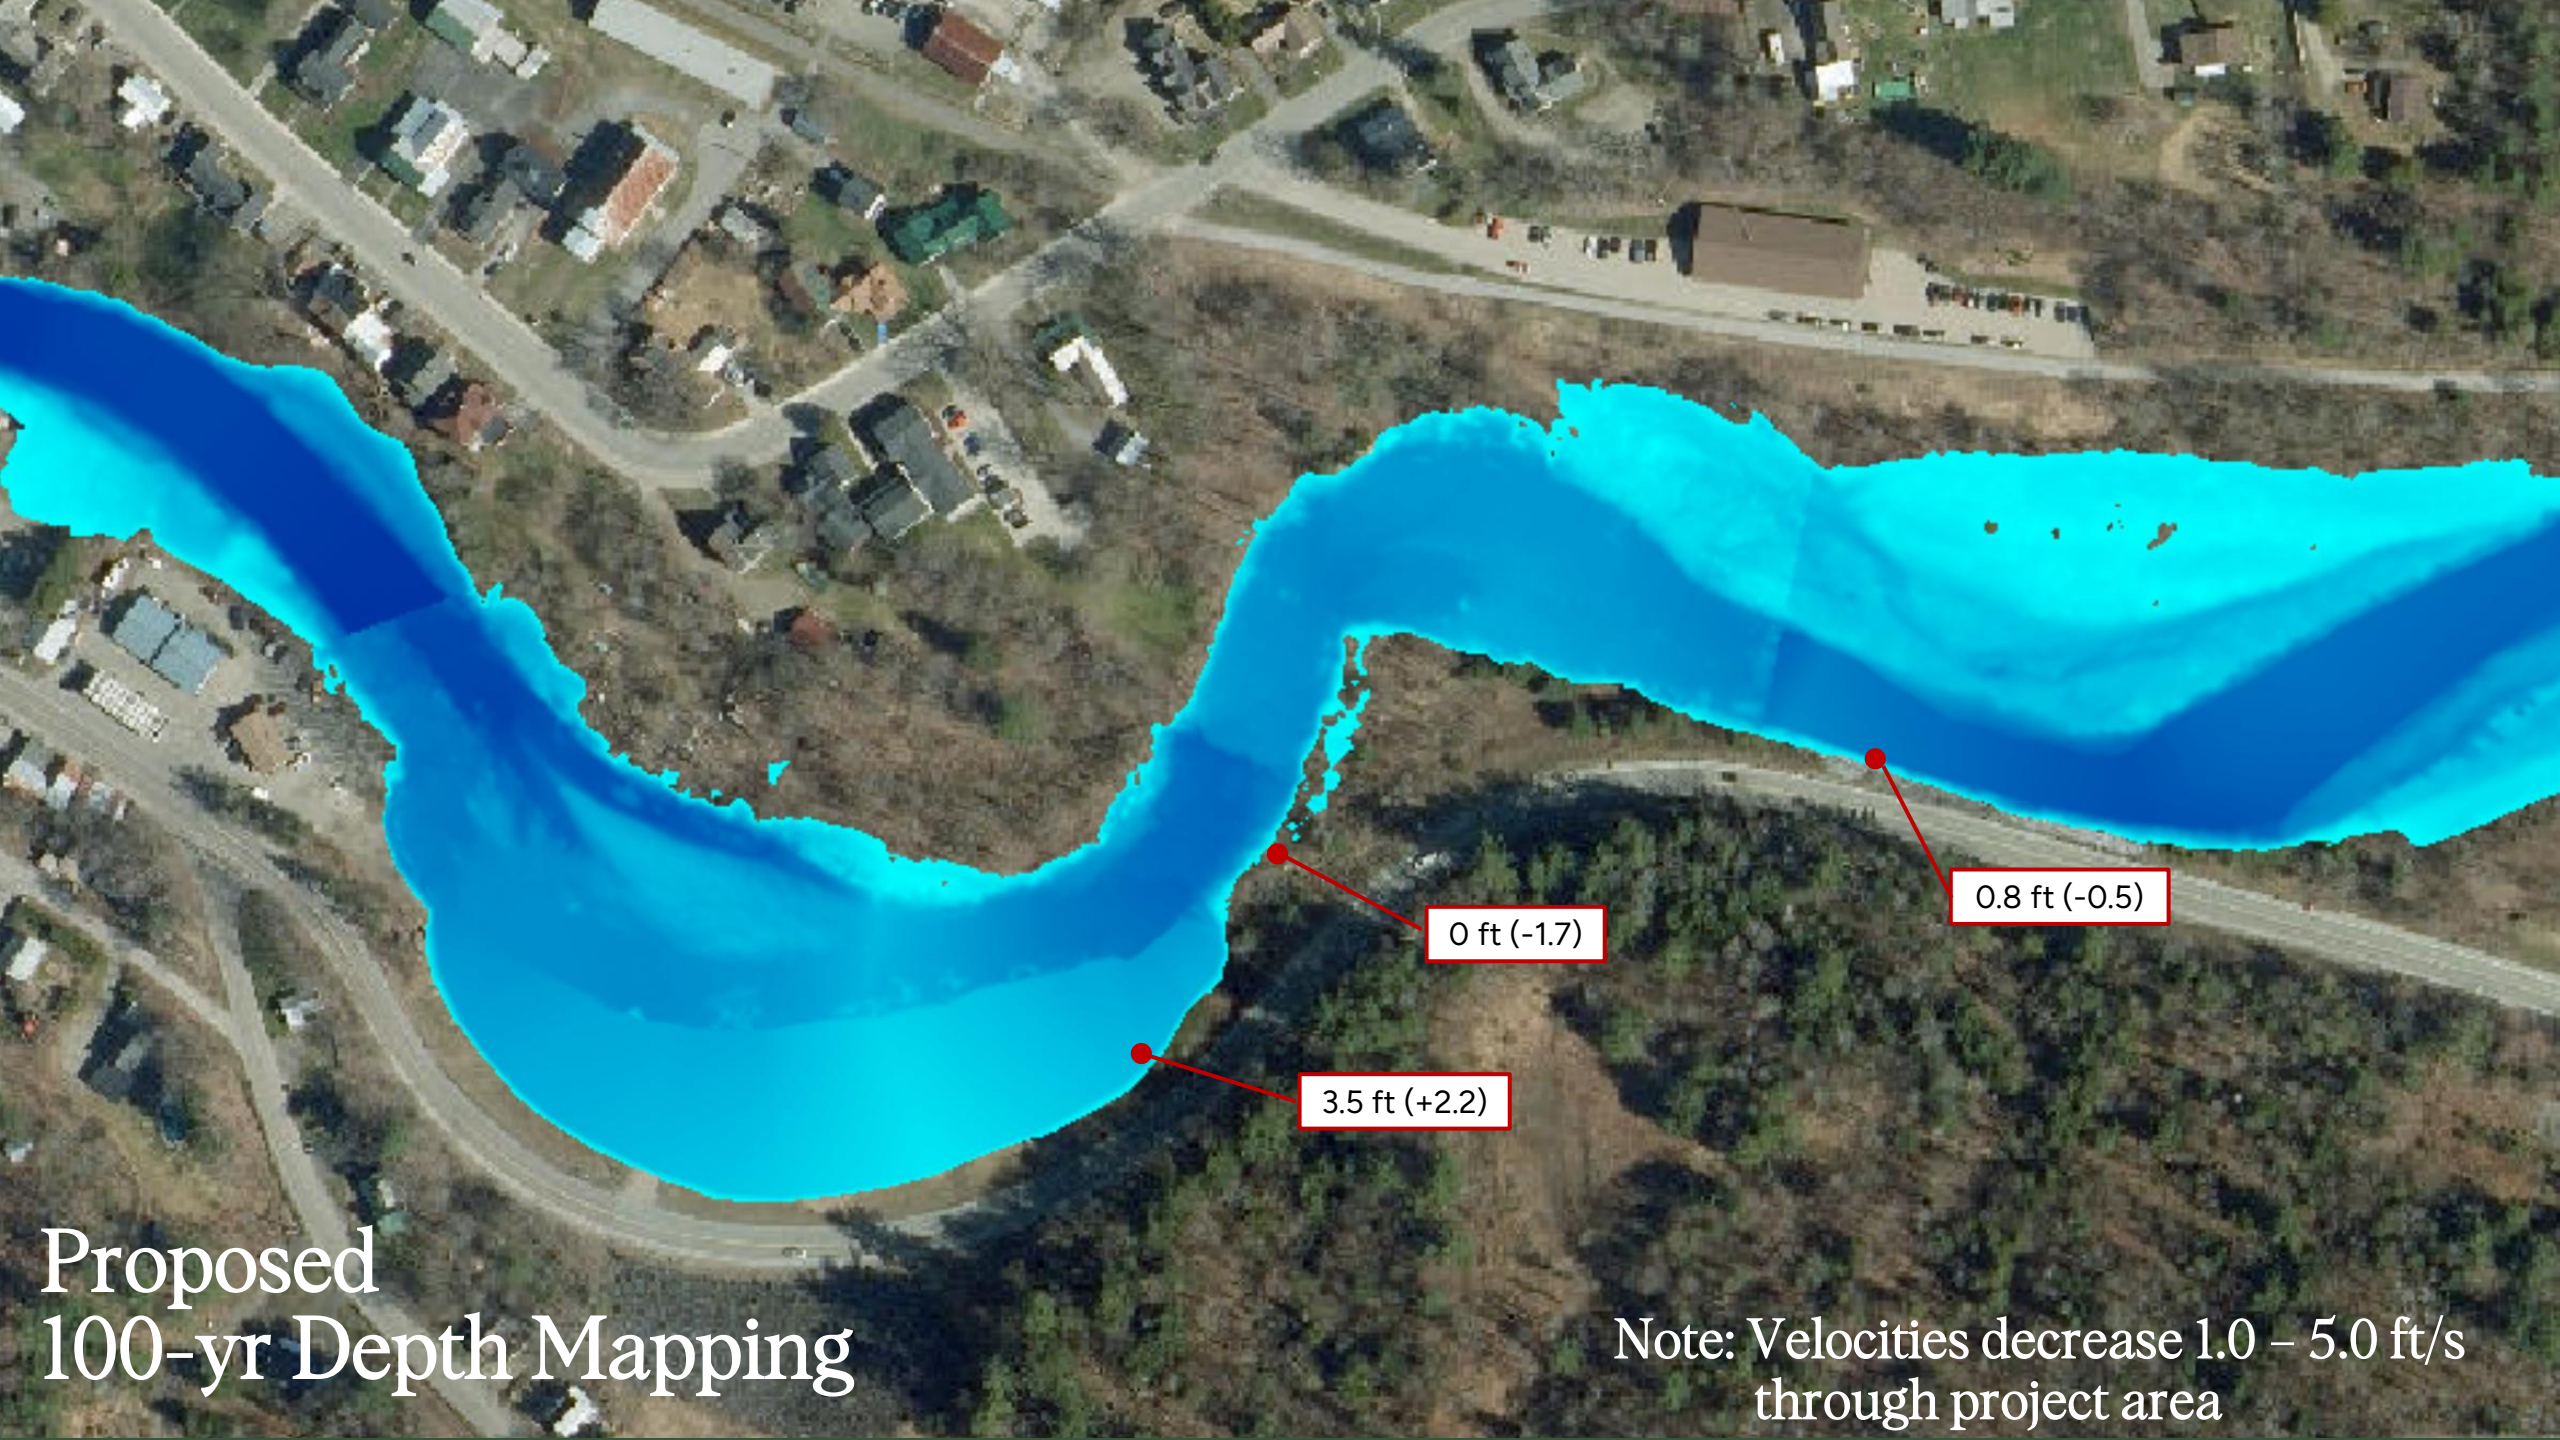
# Proposed 100-yr Depth Mapping

Note: Velocities decrease 1.0 – 5.0 ft/s  
through project area

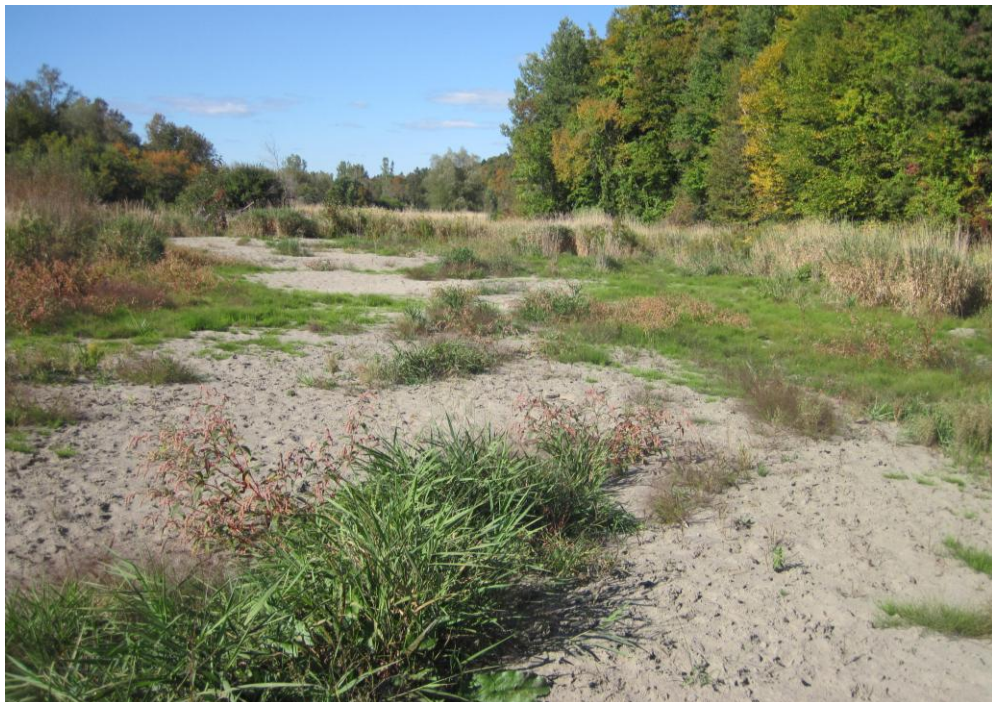
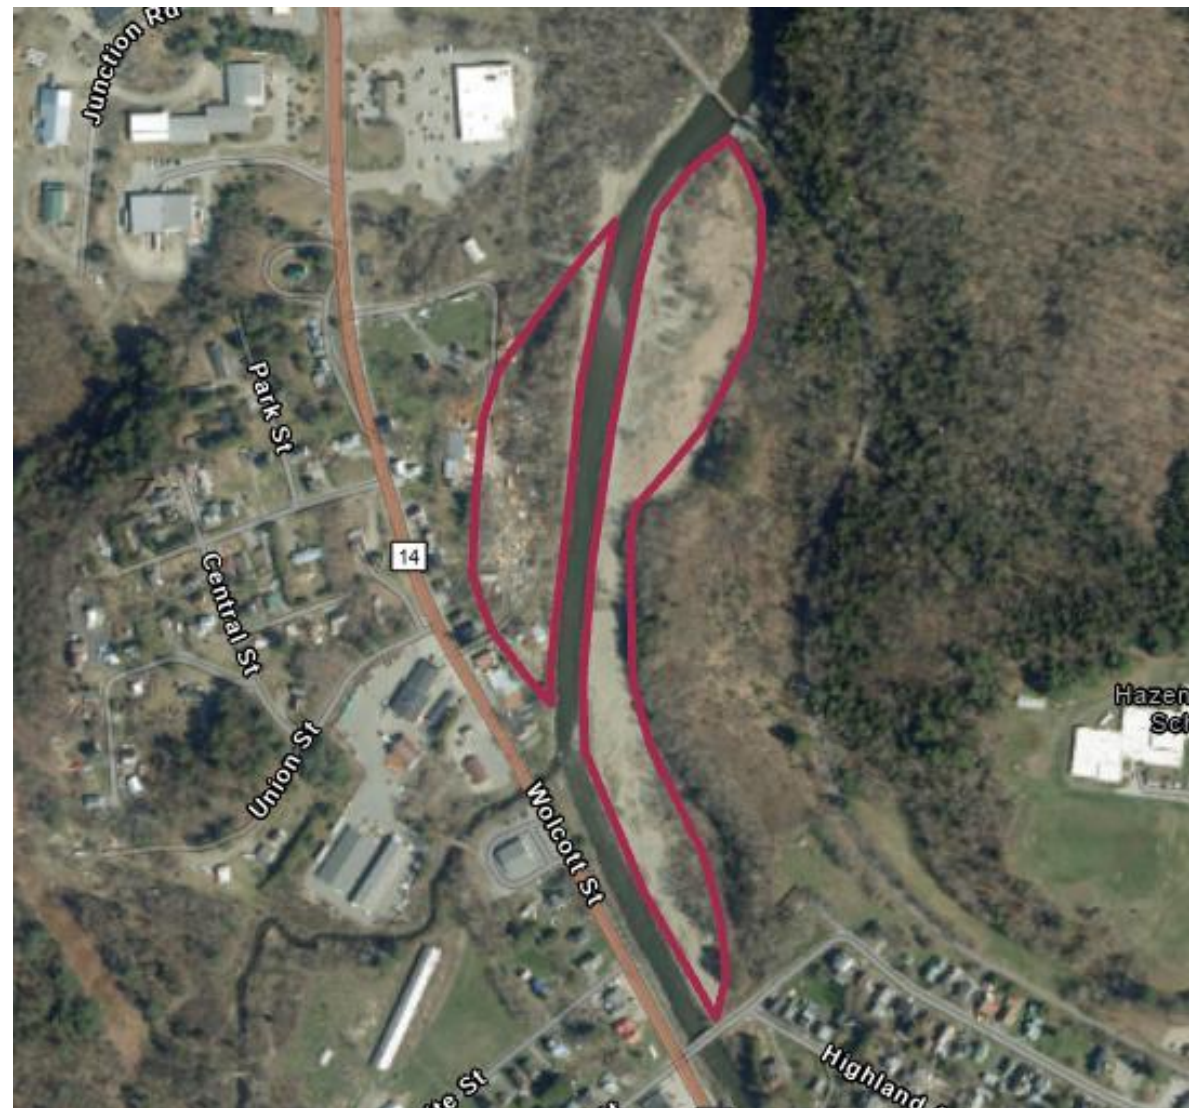
# Wolcott Street and Sawmill Lane Floodplains

## Problems

- Sediment deposition
- Inundation flooding
- Possible buyouts

## Possible Solutions

- Floodplain restoration opportunity

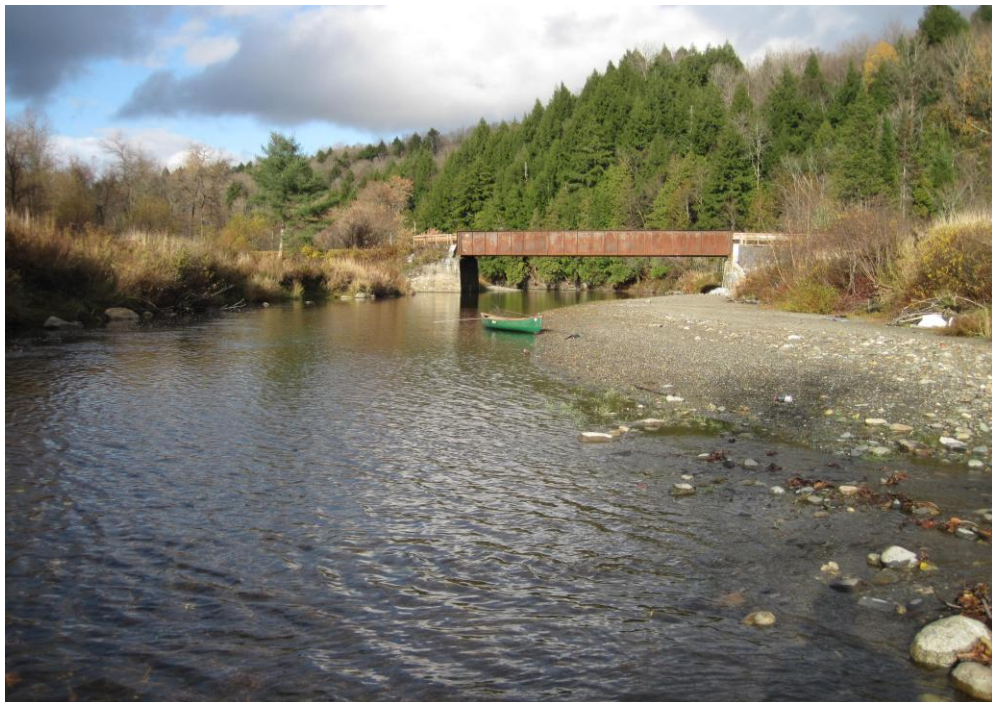
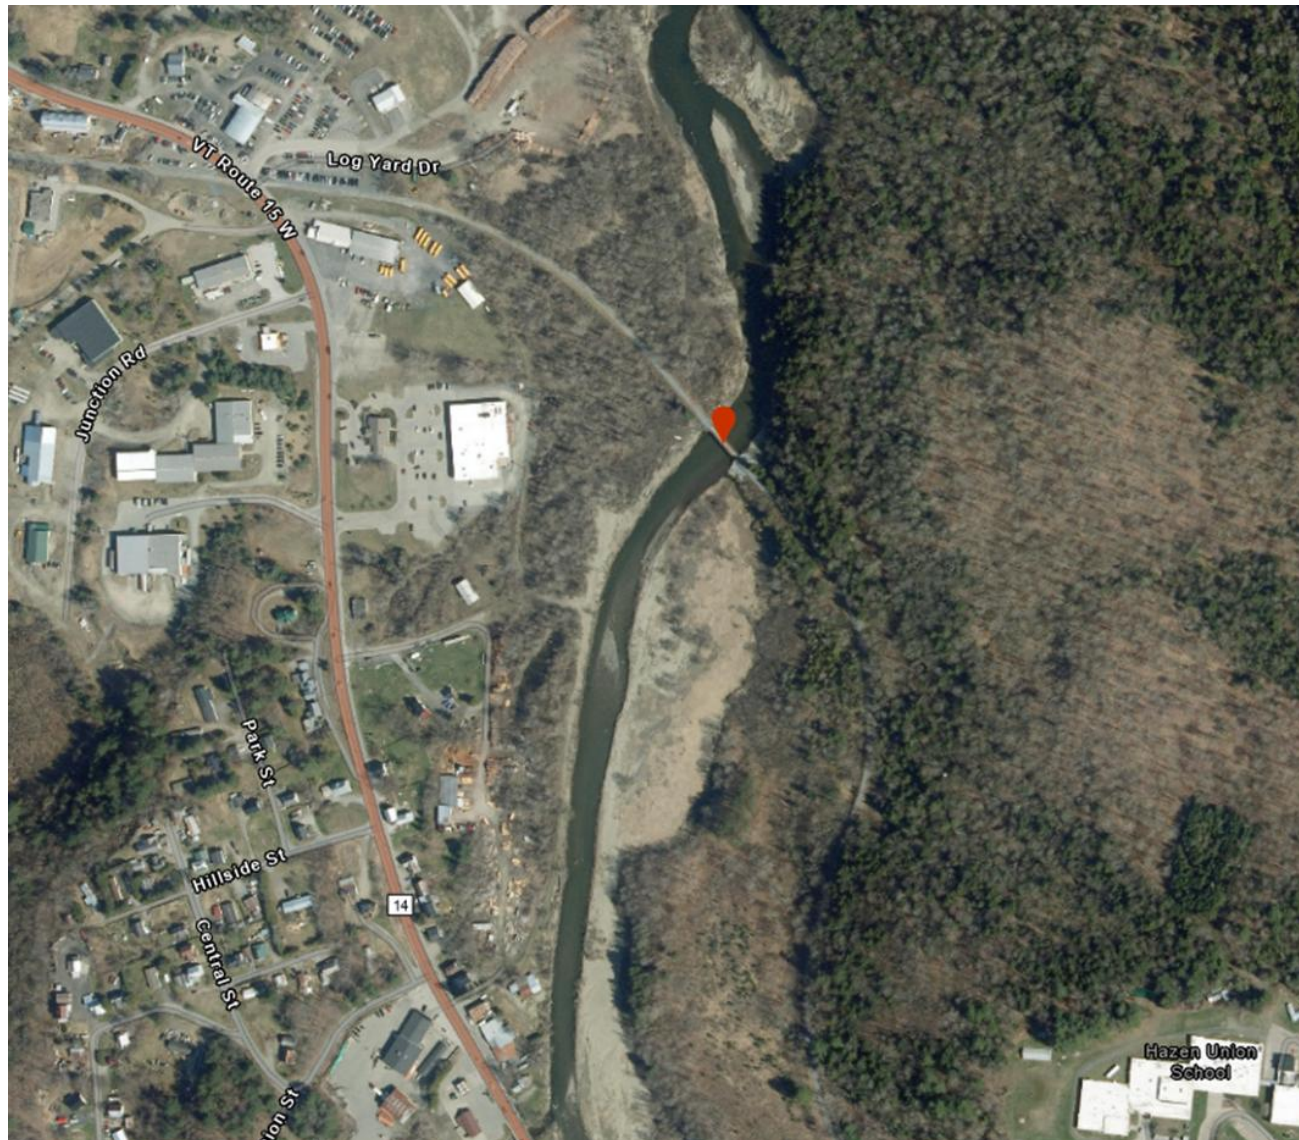
# LVRT Embankment

## Problems

- LVRT Bridge is a constriction and backs up flow
- Embankment fully blocks floodplain

## Possible Solutions

- Lower Embankment / Planned Overflow
- Widen Bridge

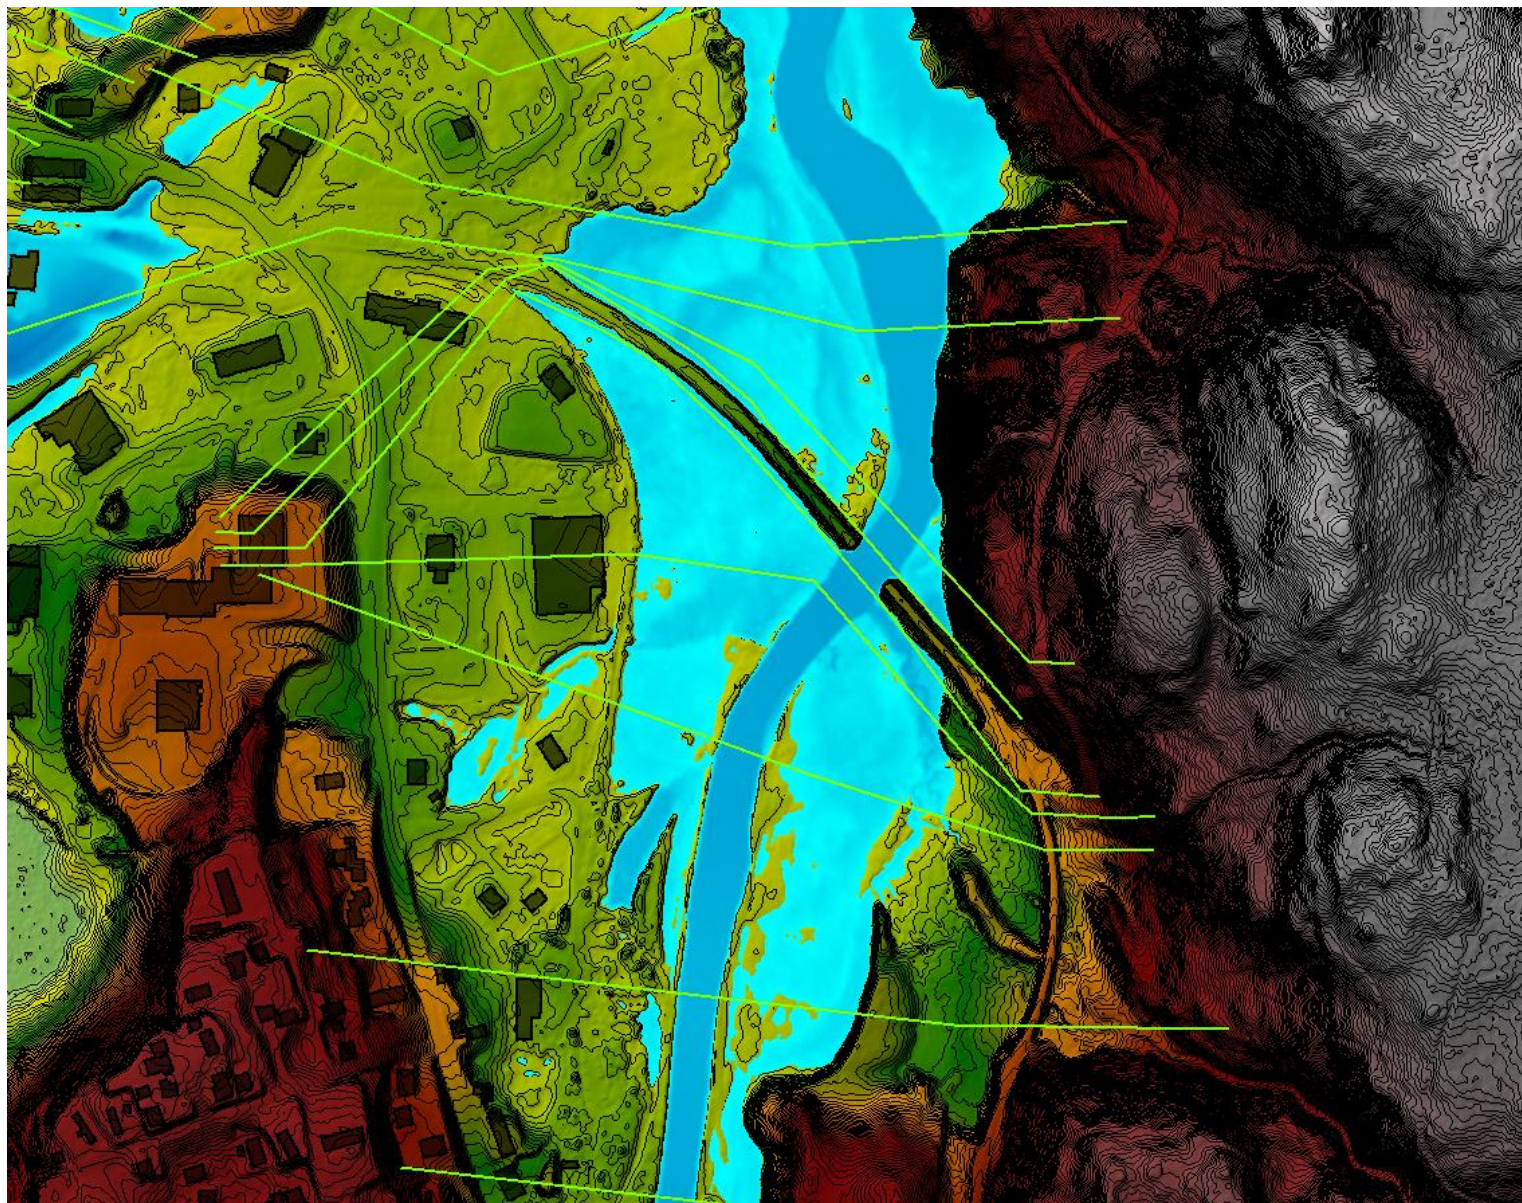
# Small Flood (2-yr)

Model Cross Sections

Terrain (2-ft contour)

Buildings

Water Depth

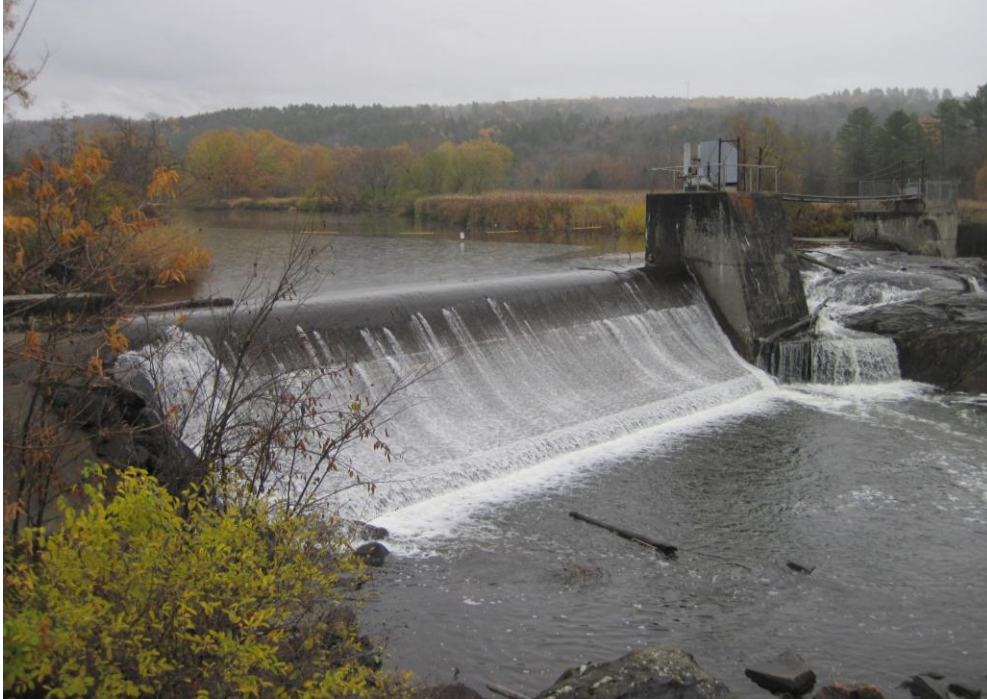
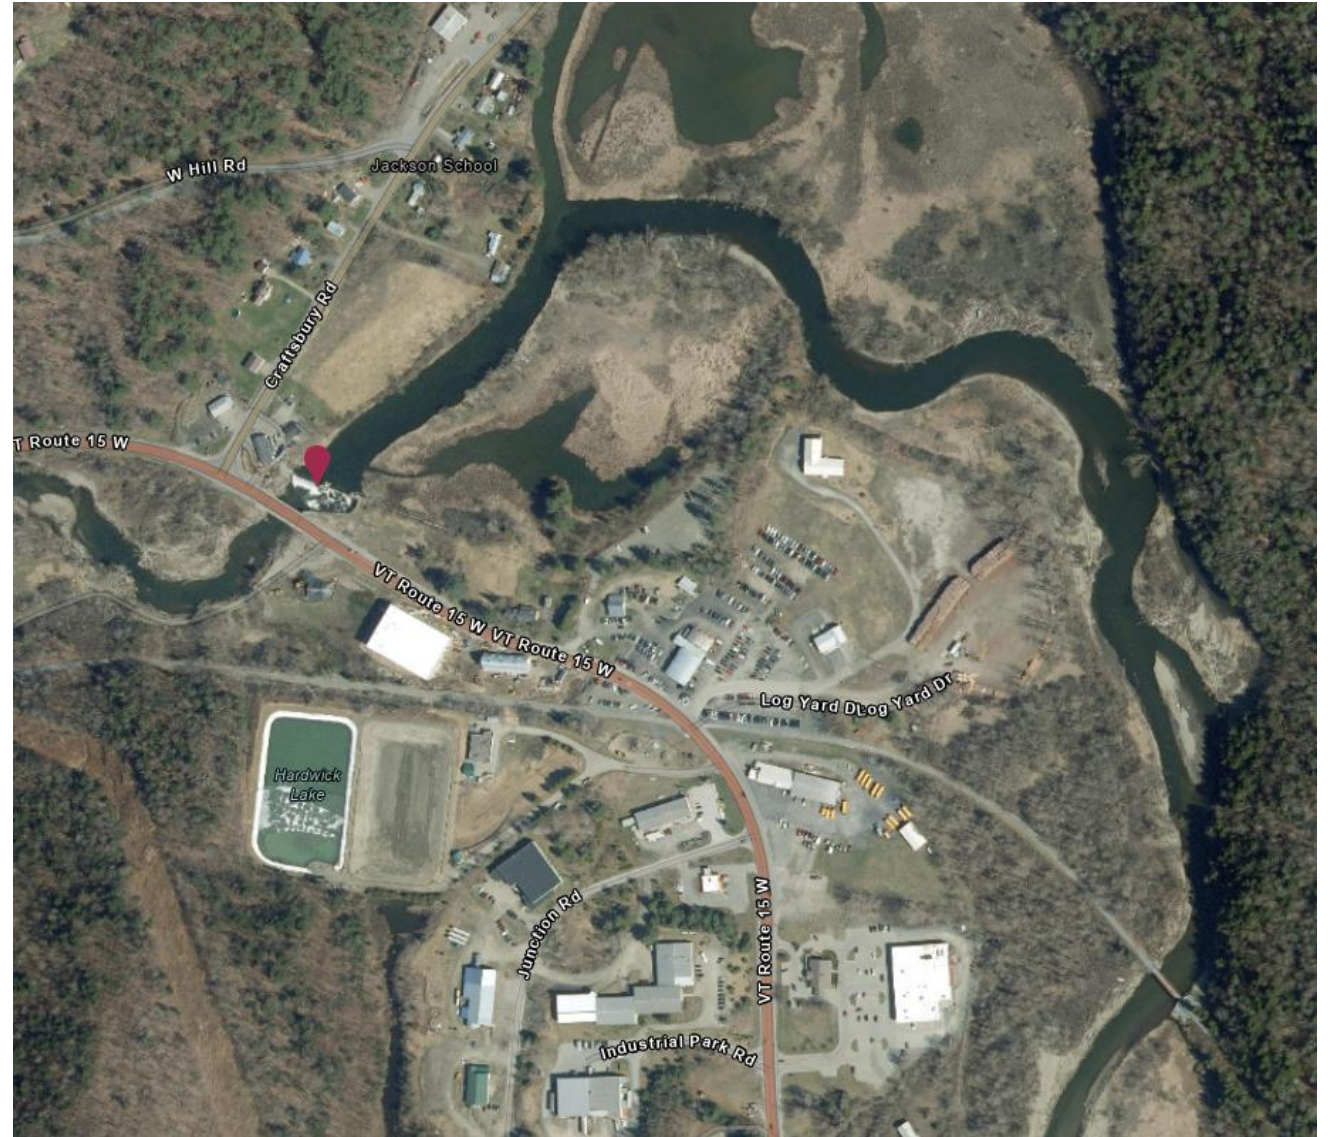
# Jackson Dam

## Problems

- Barrier in River

## Possible Solutions

- Dam removal
- Permanent drawdown
