Final Report, East Hardwick Better Connections Process

Appendix 5. East Hardwick Stormwater Plan

# Clean Water Project Plan for EAST HARDWICK STORMWATER TREATMENT HARDWICK, VERMONT

April 30, 2025

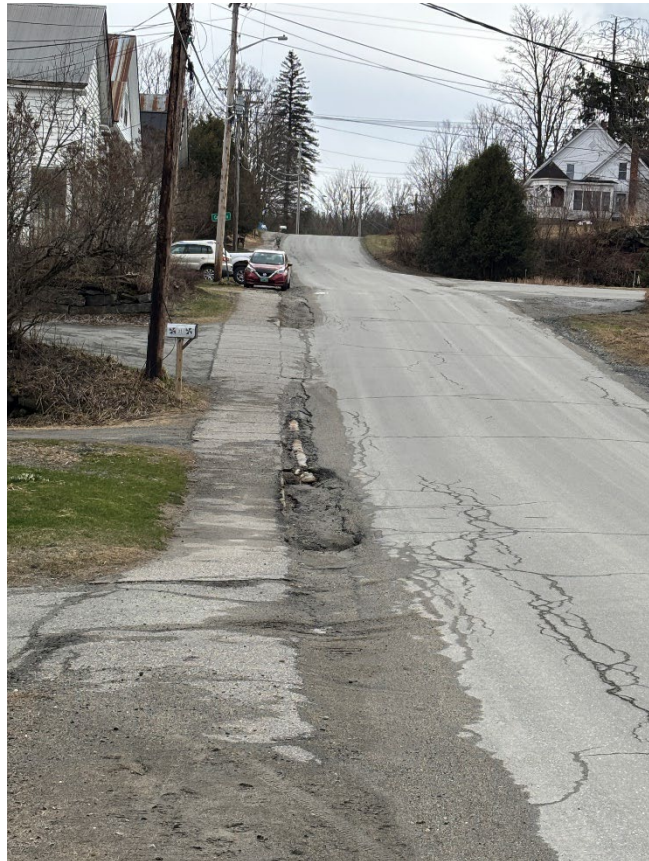
**Image 2-1: Main Street Exposed Storm Drain**

The existing stormwater system is limited and in poor condition. It consists of catch basins, storm drain pipe, ditches and culverts. Several locations of the collection system are exposed and have failed, the catch basins are not adequately capturing stormwater and discharge points do not have adequate erosion control. This results in sheet flow at the Main Street Bridge causing erosion as the stormwater flows over the ends of the abutments down the banks to the river. These issues are shown in the images below and in images from the Town's storm damage documentation from June 2024 in Section 2.2 below.

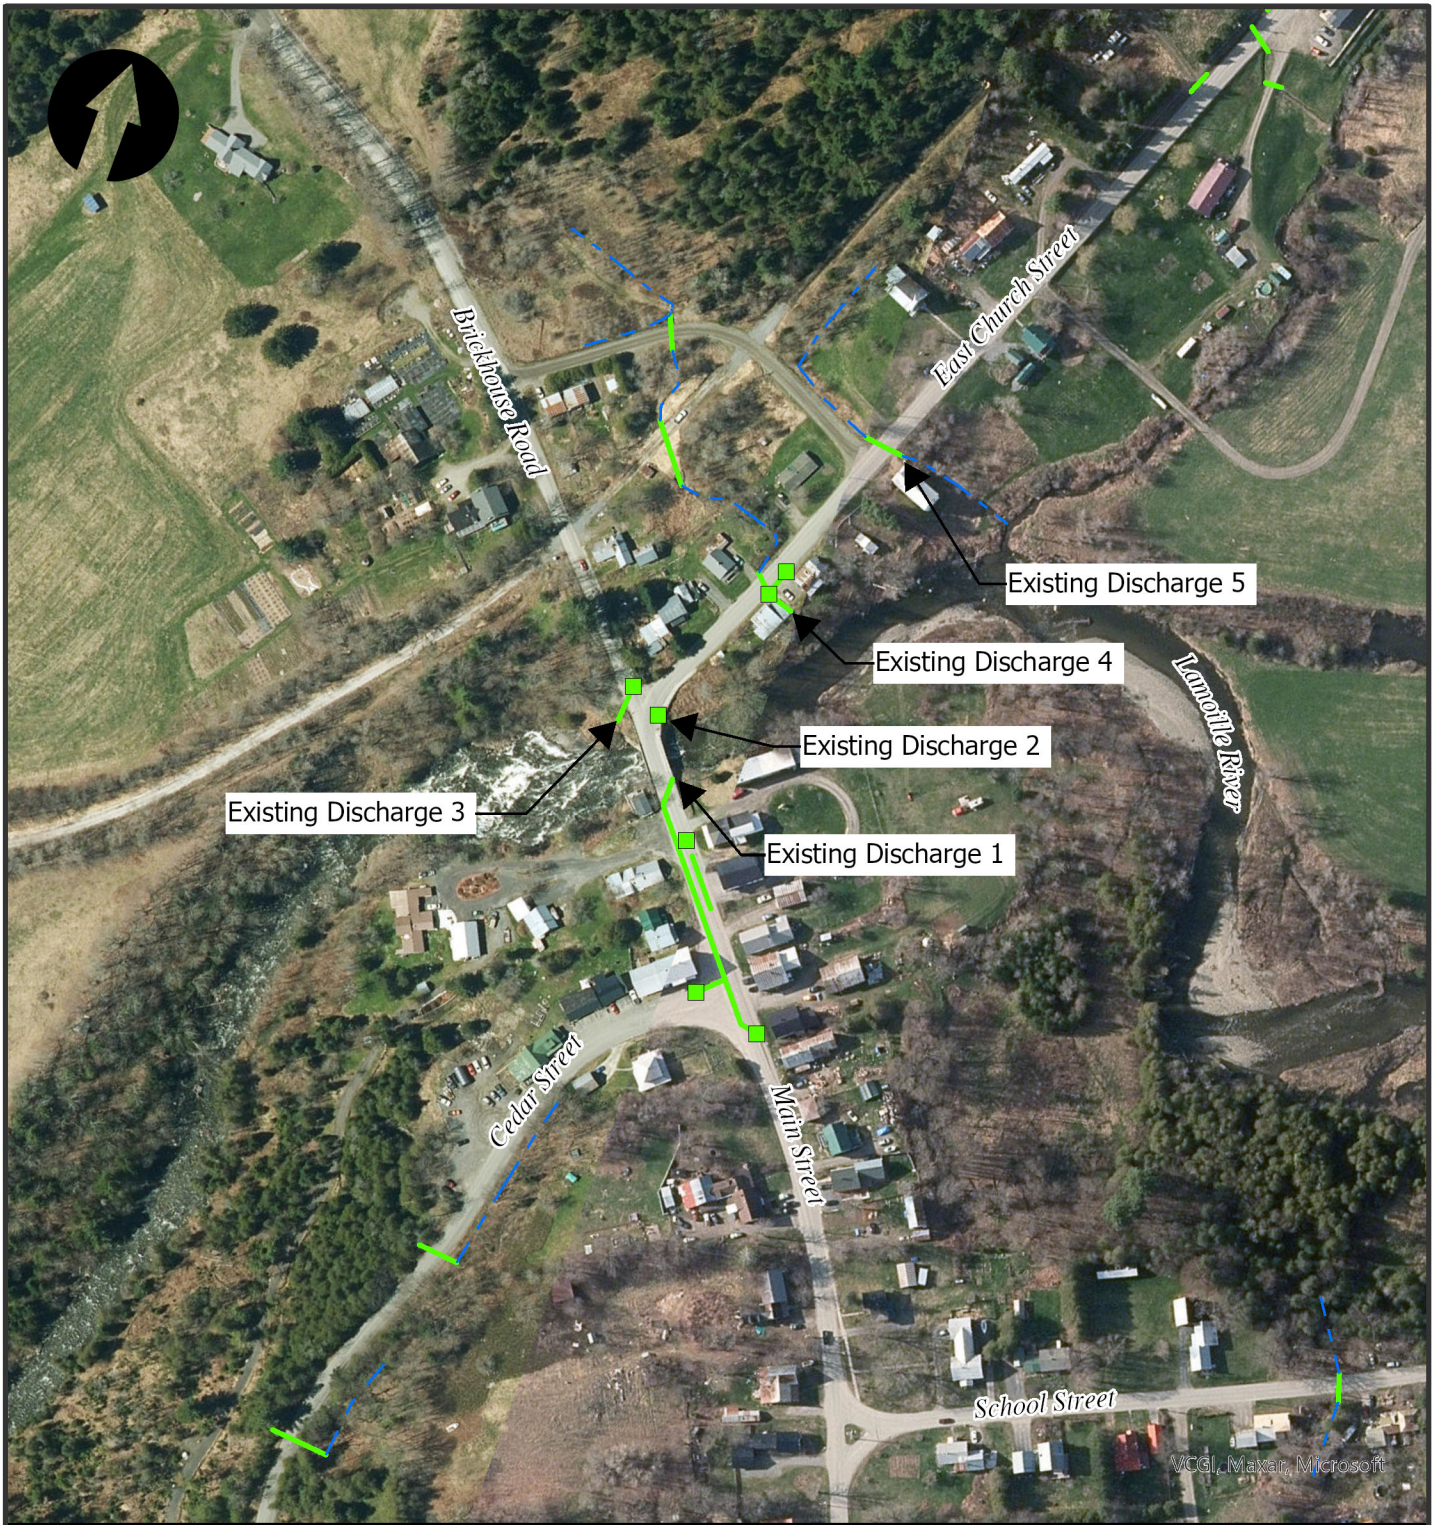
FIGURE NO. 2-1

A map of the existing collection system is included as Figure 2-1 below.

See previous Figure 2-1 of existing stormwater infrastructure.

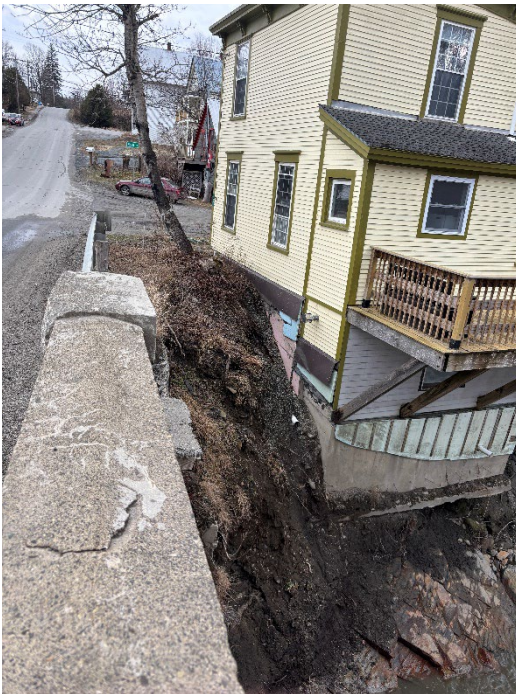
**Image 2-2: Southeast Embankment of Main Street Bridge**

The most problematic area is on each side of the Main Street Bridge. The Main Street bridge is at the low point in the Village. Stormwater comes down Main Street and discharges along the eastern side of the bridge causing erosion. The existing stormwater collection system on Main Street has failed in several locations and is therefore not adequately collecting stormwater. This results in stormwater sheeting down Main Street and discharging over the bank on each side of the bridge. On the western side of the bridge, stormwater from Brickhouse Road and East Church Street sheets across the road and causes erosion on the western side of the bridge.

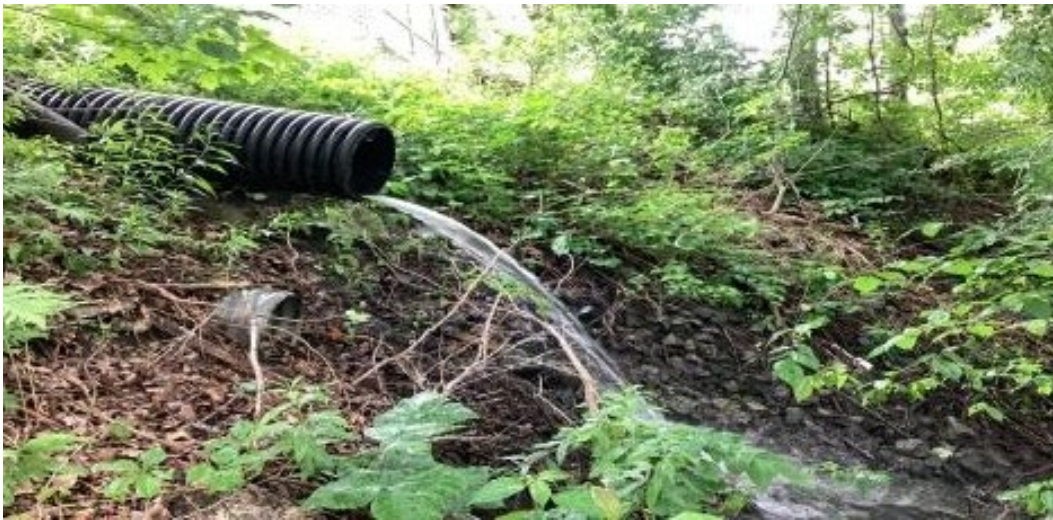
**Image 2-4: East Church Street Culvert Discharge**

The hillsides northwest of East Church Street have several areas of high groundwater and groundwater seeps that limit infiltration and increase runoff during periods of the year when groundwater is elevated or when frequent rain events occur. This groundwater, combined with stormwater runoff contributes to roadside ditches along Stevens Lane and East Church Street which are eventually carried in a culvert under East Church Street and discharged to the river. Erosion occurs at that culvert discharge.

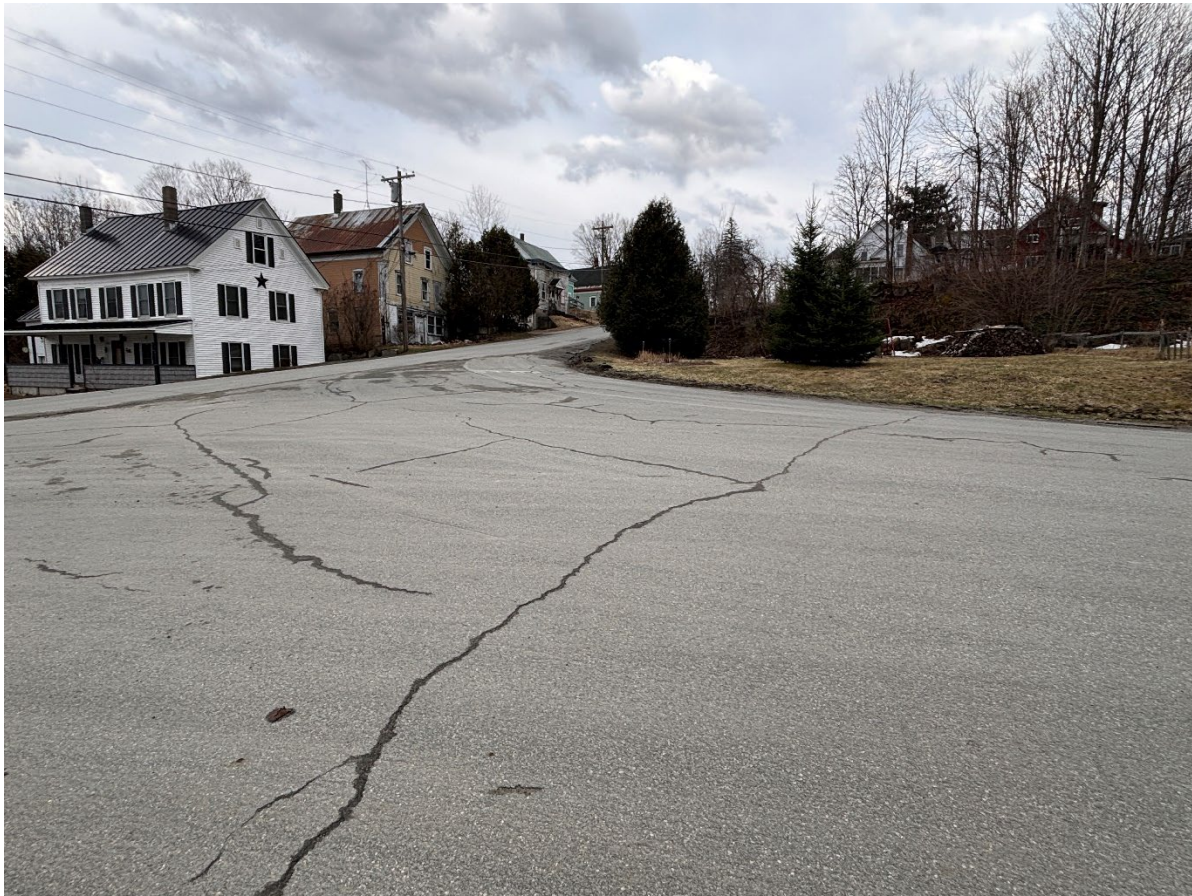
**Image 2-5: Main and Cedar Street Intersection**

The intersection of Main and Cedar Street has excessive impervious area, beyond what is necessary for the flow of traffic. Opportunity exists to reduce stormwater runoff through the reduction of impervious area at the Main and Cedar Street intersection. The reduction of impervious area would decrease runoff.

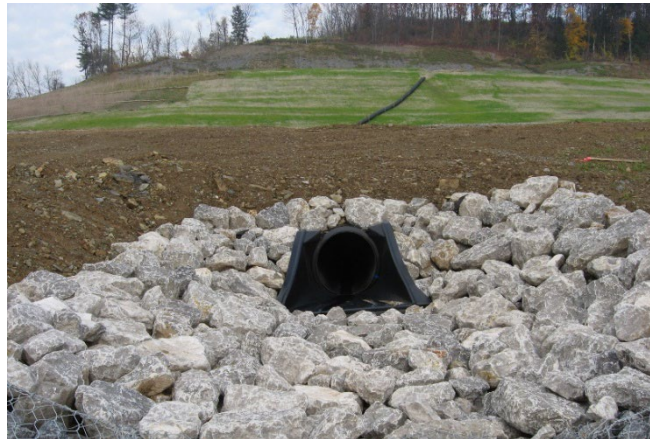
**Image 3-2: Outfall Stabilization**

There are three discharge outfalls within 500 feet of the Lamoille River identified in the report that should be addressed and are within the project area, one on each side of the bridge and one just north of the bridge on E. Church Street. The recommendations in

the report for this area are to utilize swirl separators for treatment prior to discharge and construct outfall stabilization at each discharge like that shown in Image 3-2.

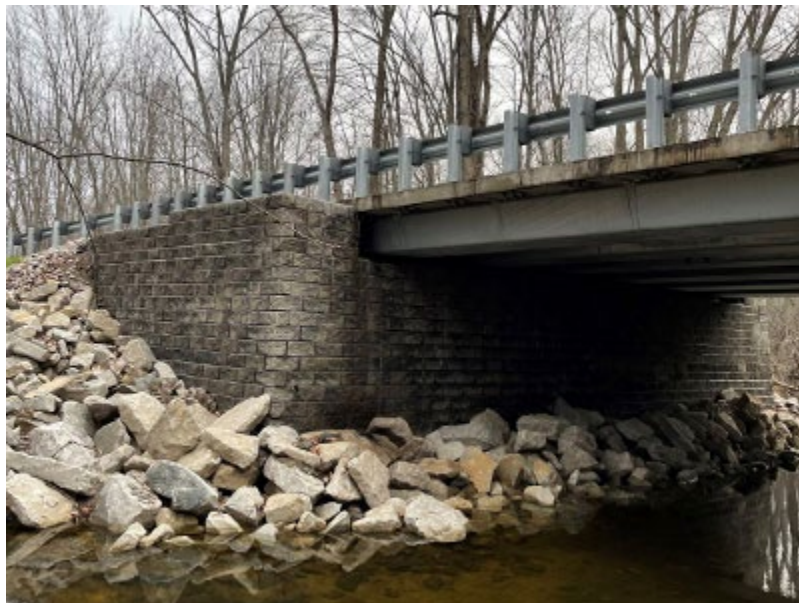
**Image 3-6 Stone Stabilization**

At the southeast corner, a conceptual recommendation to address erosion at the storm drain outlet include stone splash pads with overall bank stabilization using large stone like that shown in Image 3-6.

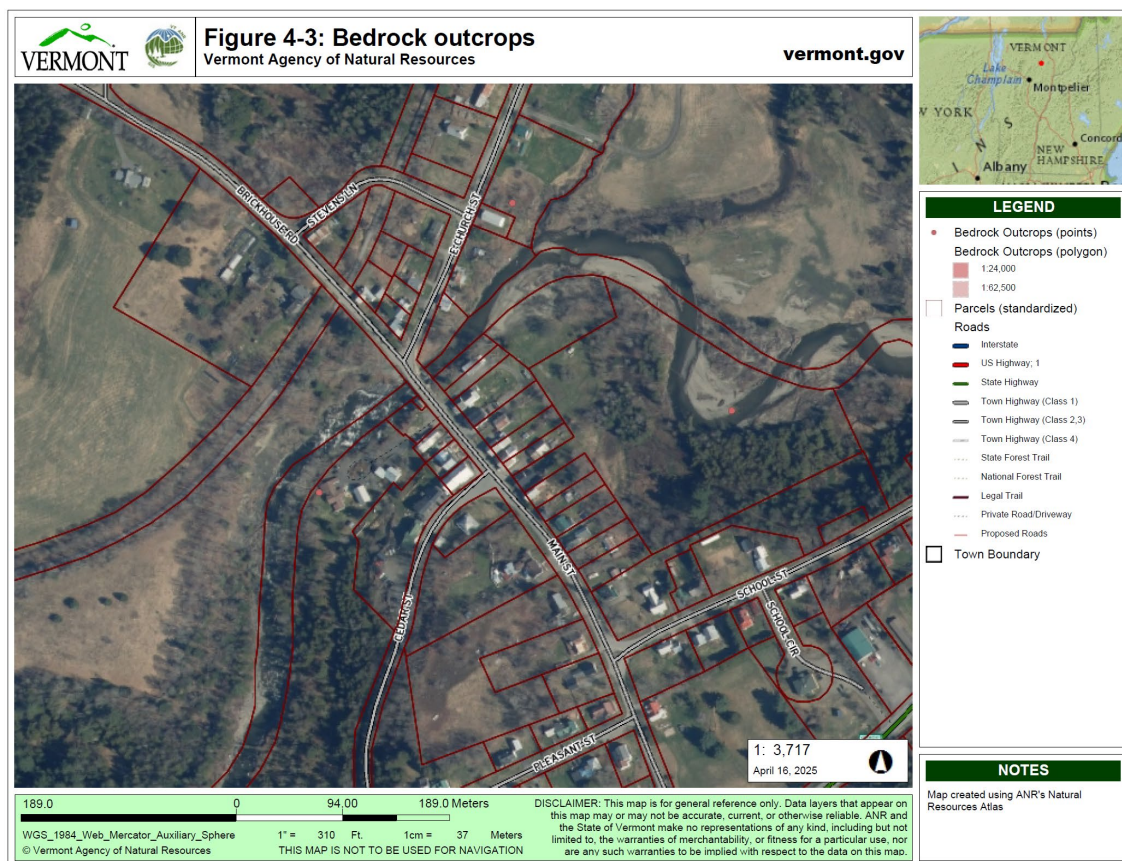
The ANR Atlas shows three bedrock outcrops adjacent to the project area as shown in Figure 4-3 below. Any proposed infiltration practices will need to avoid bedrock.

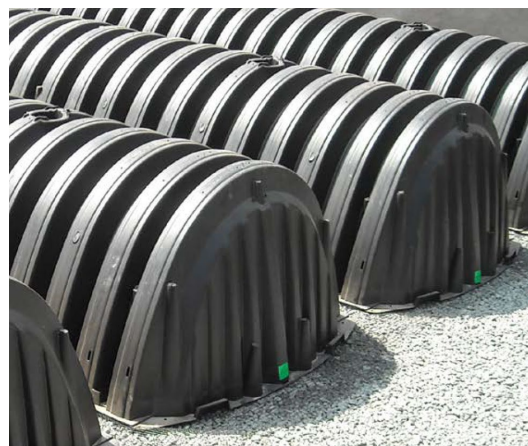
**Image 5-1: Infiltration Chambers**

Infiltration chambers are manufactured by several vendors and provide a way to store stormwater subsurface until the water infiltrates into the soil. The amount of treatment provided is directly proportional to the area allotted for the infiltration chambers and requires a generally level area. Pretreatment is required to remove large debris from the water to avoid clogging the stone base.

Bypass options: The infiltration chamber requires external bypass in the form of a manhole or tank that can divert high flows past the unit to a discharge location. The bypass is typically combined with pretreatment by providing a deep sump (greater than 4-feet) structure with a hooded outlet.

- Bypass/pretreatment manhole access points from which a vacuum truck can remove sediment and solids retained in the structure.
- Floatables and sediment are primarily retained in the pretreatment structure.
- Chambers have regularly spaced access ports for flushing sediment.
- There are no mechanical items to replace within the treatment unit.

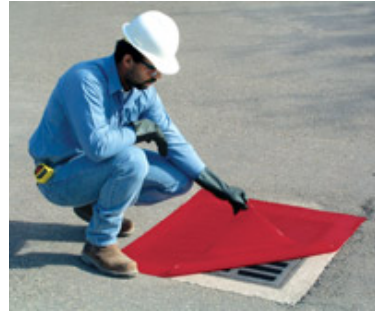
### Urethane Drain Protector

Urethane Drain Protectors are positive sealing drain covers that ensure spills do not enter drains. Drain Protectors are environmentally safe and resistant to chemicals, solvents and hydrocarbons. After use, the Drain Protector can be washed and stored in its tube storage container.

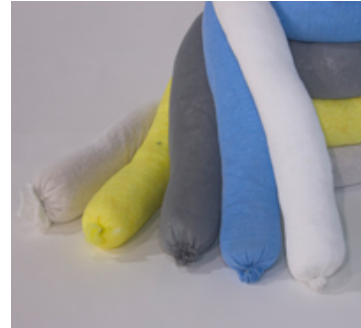
### Absorbent Socks

Absorbent socks are flexible tubes used to contain and clean-up spilled fluids. Socks are widely used in industrial applications and are ideal for Spill Kits. Fast spreading spills are quickly stopped with a sock.

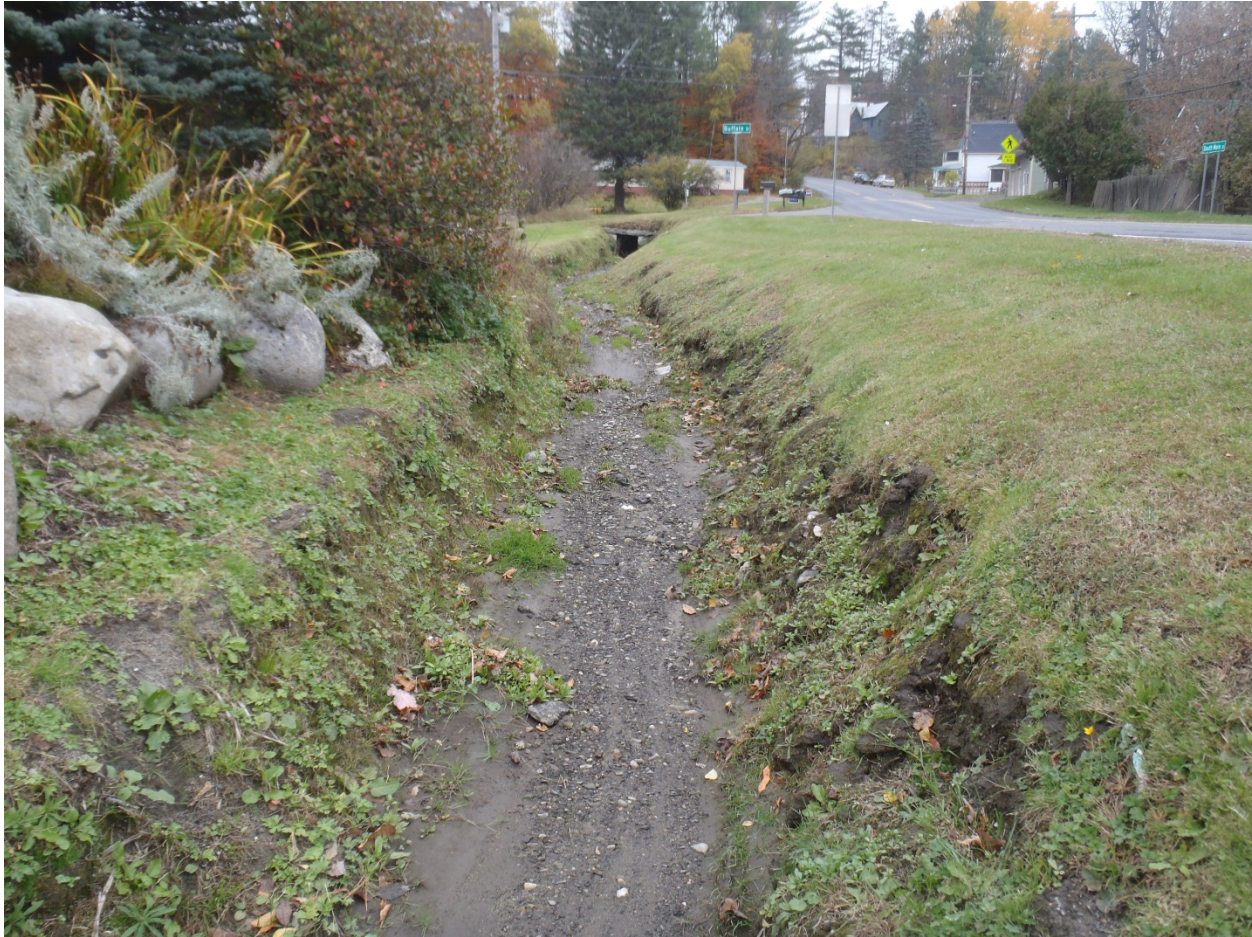
also subject to regular ditching and re-shaping by either the Town or VTrans, roughly once every 2-4 years. It is suspected that the channel is in adjustment due to the increased impervious area upstream, meaning that the channel is adjusting its cross sectional area to accommodate the increase in flows and stream power conveyed during storm events. The severity of sediment transport and active erosion can be observed in the photo below.

The Buffalo Storage site includes a first order unnamed tributary to Cooper Brook that runs generally north to south, parallel to Route 14, and directly adjacent to the Buffalo Storage facility (see CB-05 PADS in Appendix B, and conceptual design plans in Appendix D). The existing channel is essentially serving as a drainage ditch that conveys roughly 111 acres of drainage from lands that have been steadily developed over time. The channel is actively transporting large sediment loads directly to Cooper Brook. This portion of the channel is

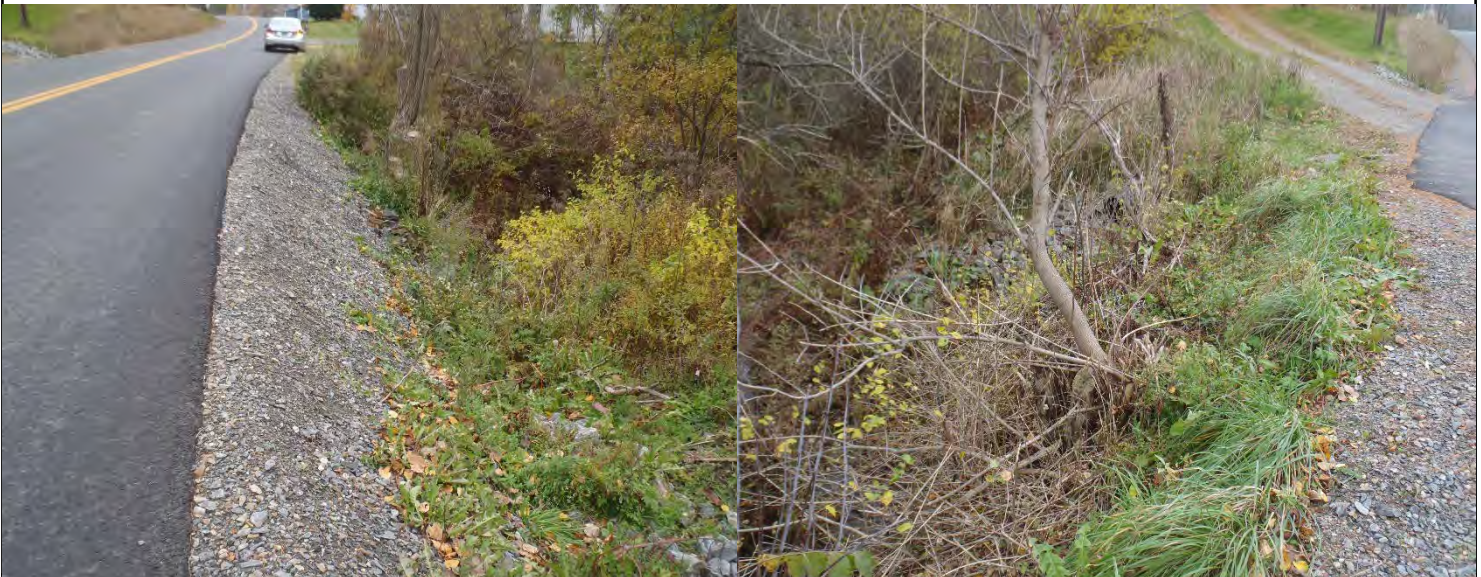
Photo 1. West edge of Mackville Road

Photo 2. East edge of Mackville Road

The embankment leading to the stream below is over steepened and comprised of very small stone, and shows signs of minor rill erosion. Larger stone should be installed, especially at the toe of the slope, to stabilize the embankment and road shoulder.

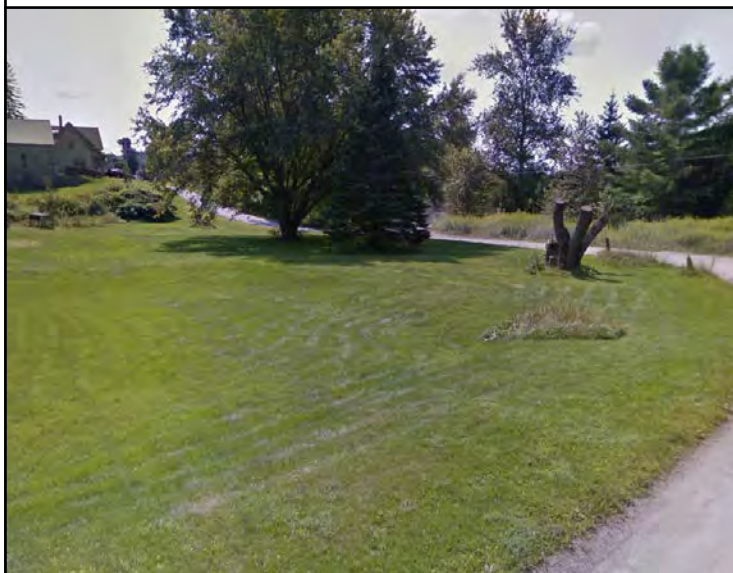
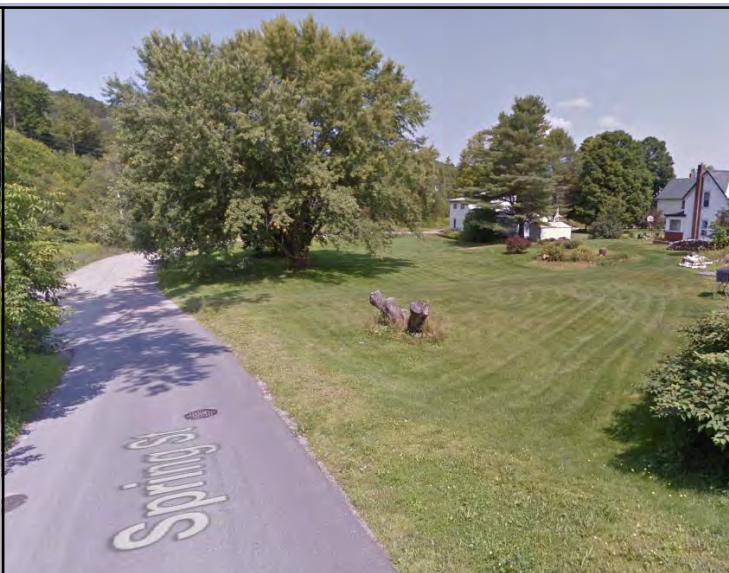
Photo 1. Potential treatment area, looking southeast from Granite Street. (Photo from Google Street View, Aug. 2014)

Photo 2. Potential treatment area, looking north from Spring Street. Last manhole in the closed drainage system can be seen in the foreground. (Photo from Google Street View, Aug. 2014)

The closed drainage system that drains Spring, Summer, and Dewey Streets outfalls into Cooper Brook just north-west of the Spring Street-Granite Street intersection. The existing green space east of that intersection could be utilized for stormwater volume capture and water quality treatment. Any stormwater treatment retrofit practices here, however, would be located in the brook's 100-year floodplain.

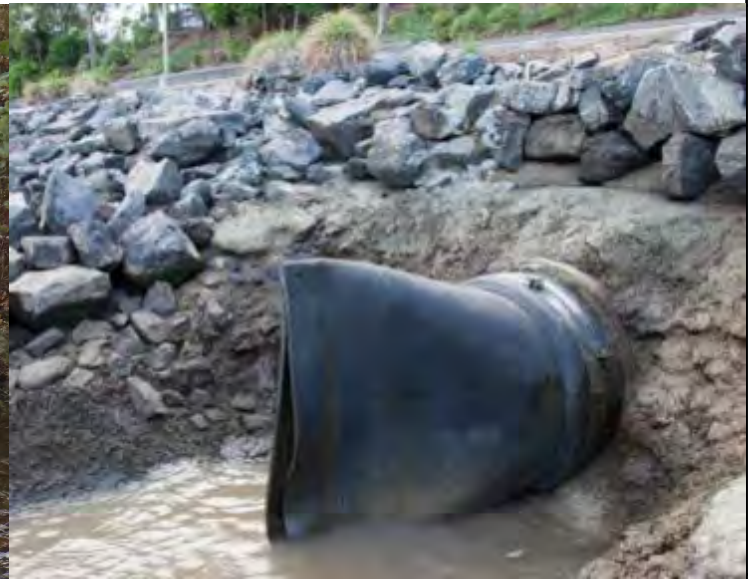
Photo 2. Example of a duck bill outlet structure

The Town has indicated that the current “trash can” style outlet cover does not adequately protect against backwater. This culvert, and ultimately the pipe system connected to it backs up during seasonal high water. This outlet structure could be replaced with a “duck bill” outlet structure, or similar device, as shown in Photo 2 below.

<b>Project Benefits:</b> <ul style="list-style-type: none"><li>• “Duck bill” outlet structure installation will prevent backwater conditions when the river elevation is above the outlet.</li></ul>

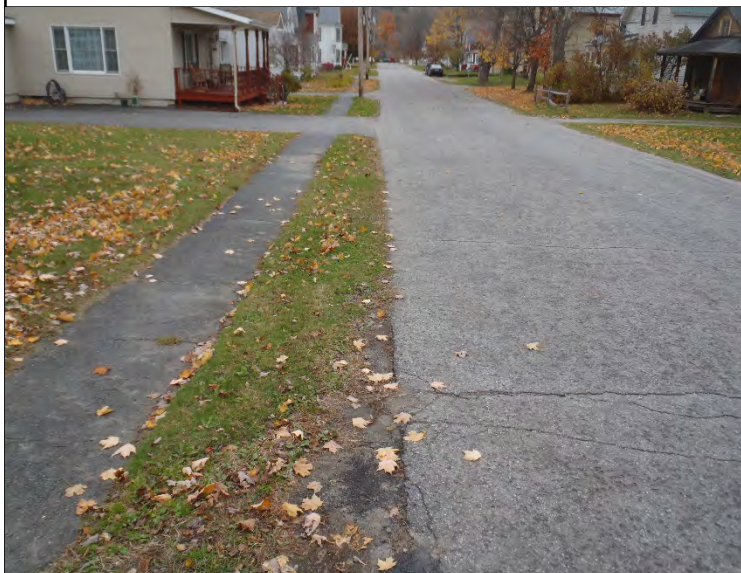
Photo 1. Green space available for stormwater capture and treatment

There is green space available between Elm Street and the sidewalk along the north edge of the road that could be utilized to capture and treat roadway runoff. There may also be available green space along the south edge between Elm Street and private fences that could be utilized for capture and treatment as well.

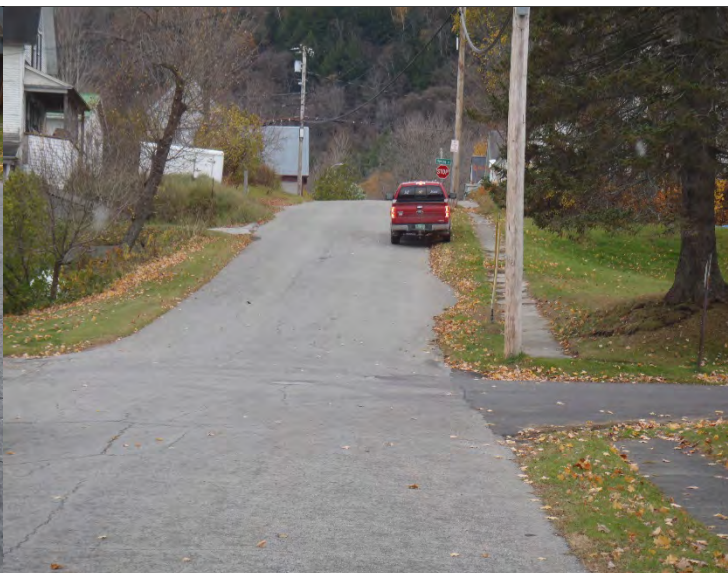
Photo 2. Green space available for stormwater capture and treatment

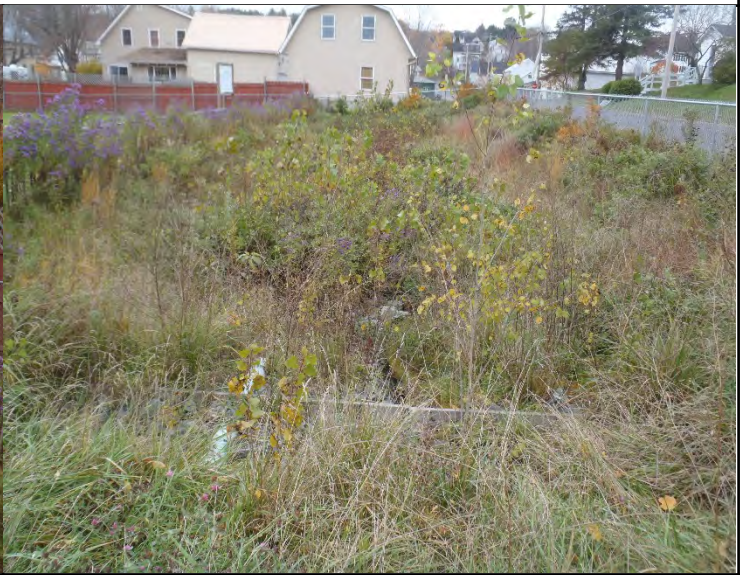
Photo 2. Bioretention area at Community Recreation Park in need of maintenance

A previously established bioretention area is in need of maintenance. The area should be cleaned of weeds, woody growth, and invasives, and reestablished to operate as designed. A simple Operations & Maintenance plan could be developed to ensure sustainable maintenance in the future.

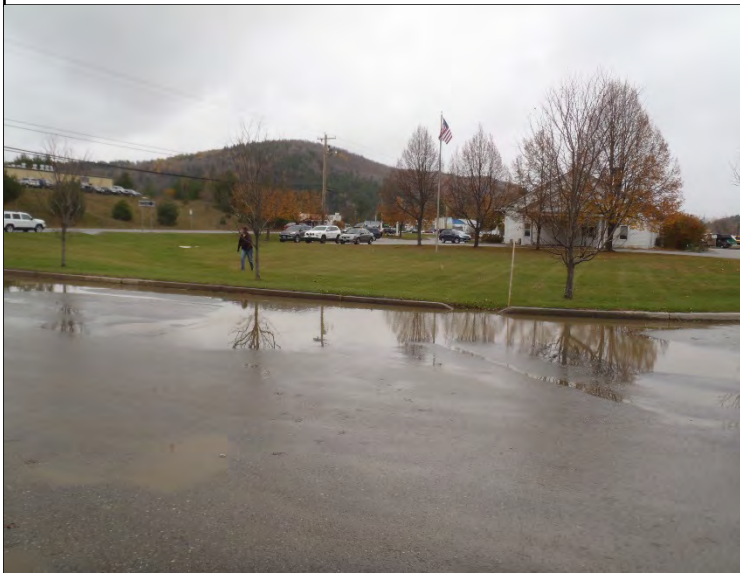
Photo 1. Ponding water due to settling and/or plugged or damaged drainage infrastructure

Much, if not all, of the stormwater from the site appears to drain to the center of the parking lot and flow south where it enters a stone channel. The stone has become plugged and the banks are eroded. The parking lot also looks to have settled in locations causing ponding. The existing drainage pattern could be reestablished, and a portion of the parking lot to the south, that appears to be mostly unused, could be converted to a stormwater practice to capture and treat runoff from approximately 3 acres of impervious surface.

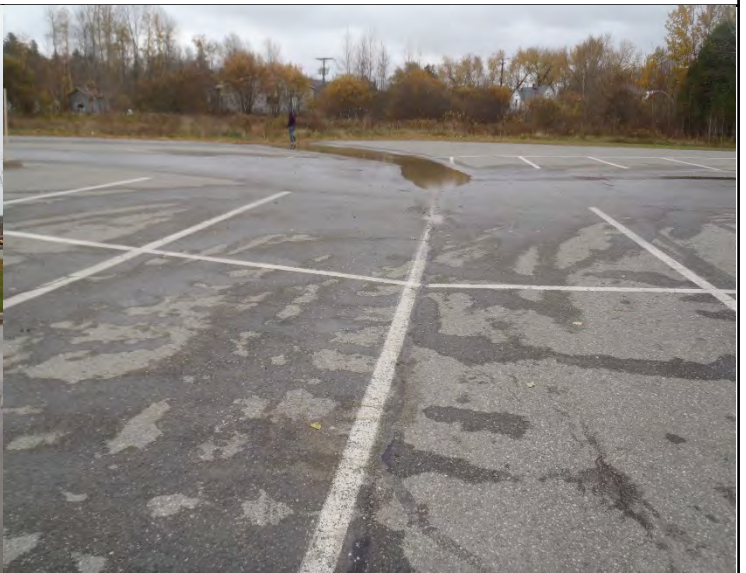
Photo 2. Parking lot drainage pattern with ponding water and potential stormwater practice location

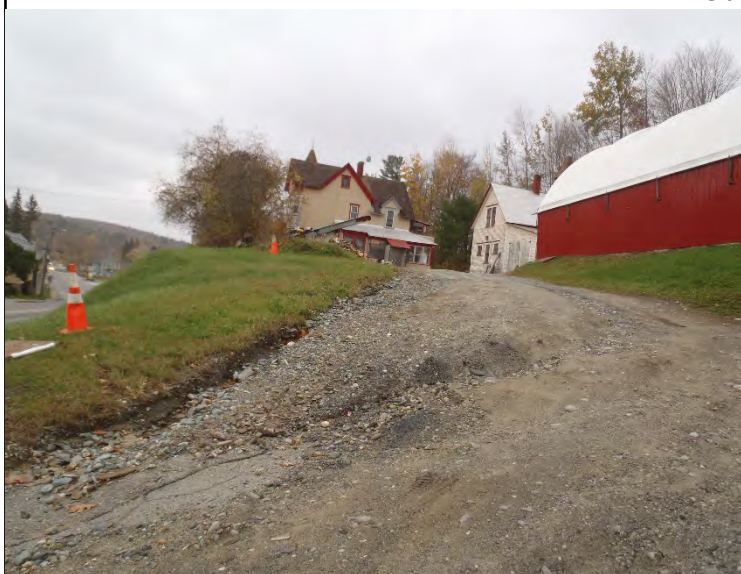
Photo 1. Driveway erosion at the home on the south corner of Hillside Street and Wolcott Street

Lower Prospect Street is eroding into intersection of Hillside Street, Lower Prospect Street, and Wolcott Street. It appears that the cause of the erosion is primarily runoff from the barn roof to the southwest.

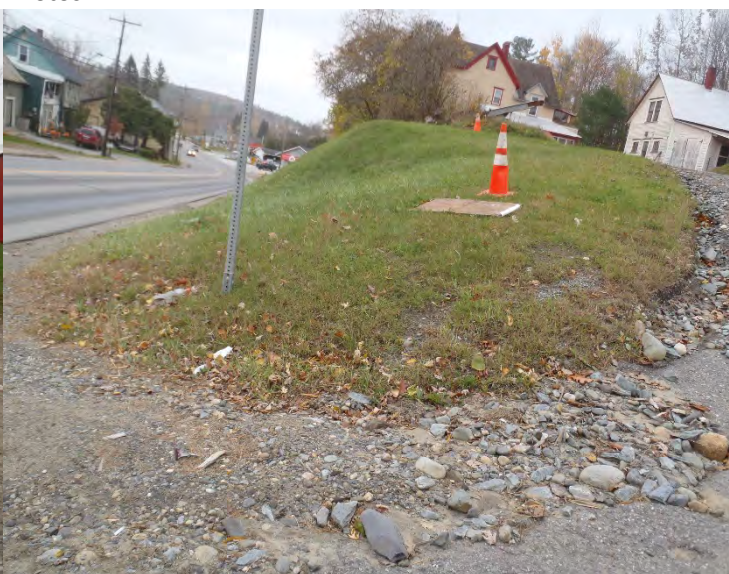
Photo 2. Sediment transport, deposition, and erosion at the intersection of Hillside Street and Wolcott Street

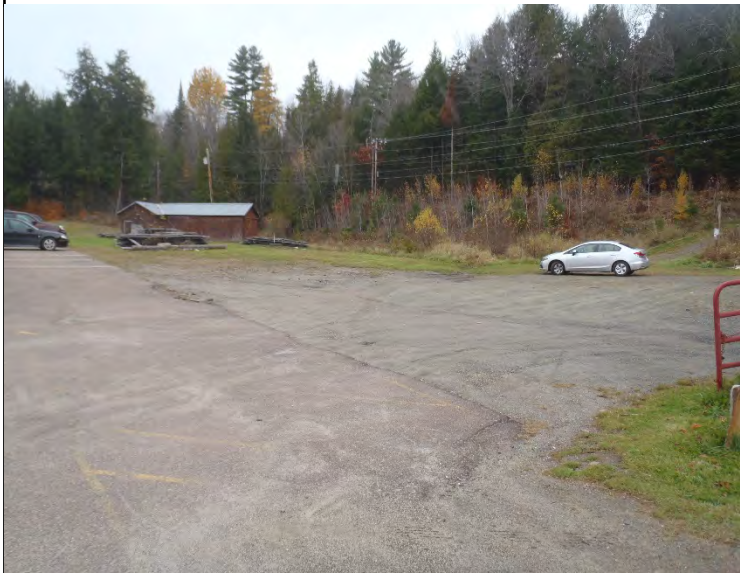
Photo 1. Existing drainage and green space with retrofit potential

Runoff from the parking lot and uphill area to the east gravel area near Hardwick Trails. The runoff could be routed to the existing green space where it could be captured and treated. Ideally the existing green space could be used to infiltrate, pending soil investigations.

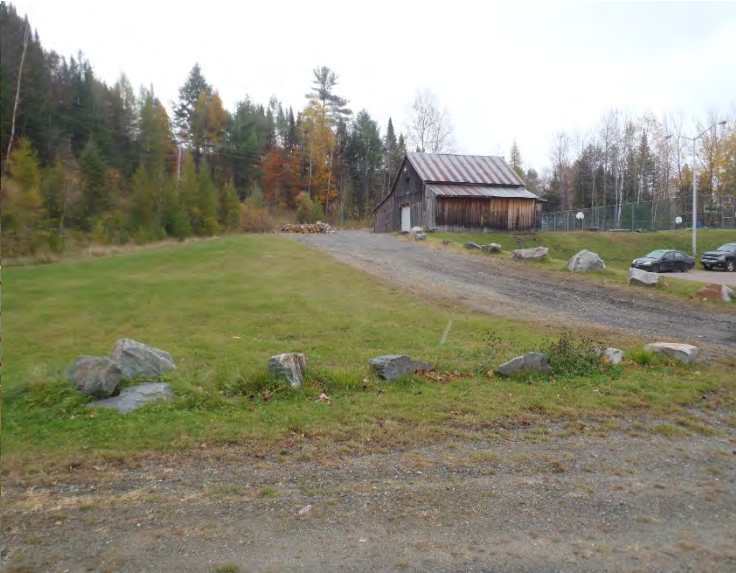
Photo 2. Uphill area that drains towards Hardwick Trails

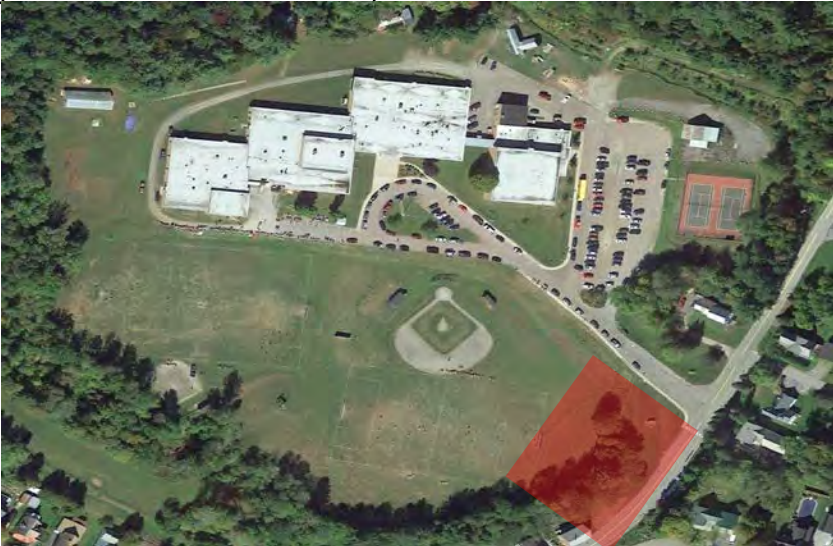
Runoff from virtually all of the paved surfaces on campus flows to the south via pavement, swales, and culverts before ultimately discharging over the bank in the area highlighted in red above. The runoff is then conveyed by a paved swale to a detention basin southwest of the school entrance. The detention basin and its outlet structure could be rehabilitated and extended to use the area shown below.

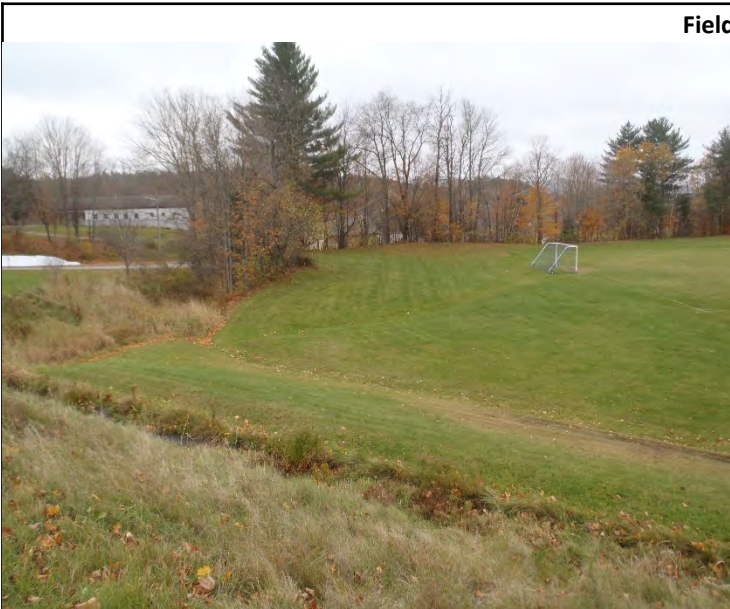
Photo 1. Potential retrofit location south east of school

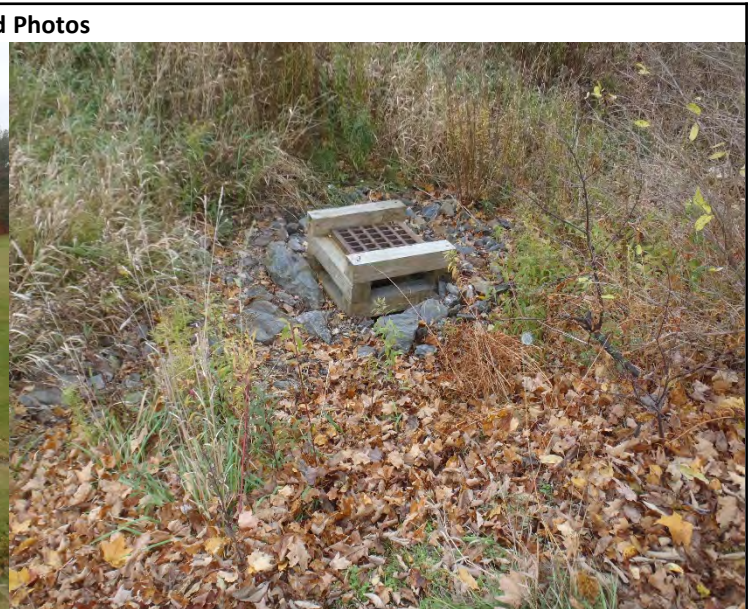
Photo 2. Existing detention basin outlet structure

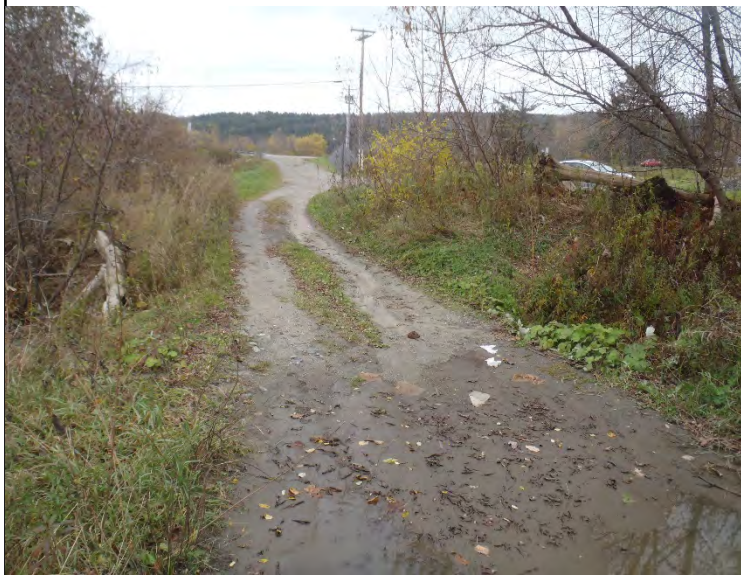
Photo 1. Sediment transport from VT Route 15 onto Wright Farm Road

Road runoff as well as runoff from the CATT/VASA trail deposits large amounts of sediment in a small tributary immediately above its confluence with the Lamoille River. A stormwater retrofit could be installed within the green space to the south of the parking area. Ideally the treatment practice would incorporate a sediment basin that could be easily cleaned and maintained. *Wright Farm Road is a Class IV road maintained by Greensboro Garage.*

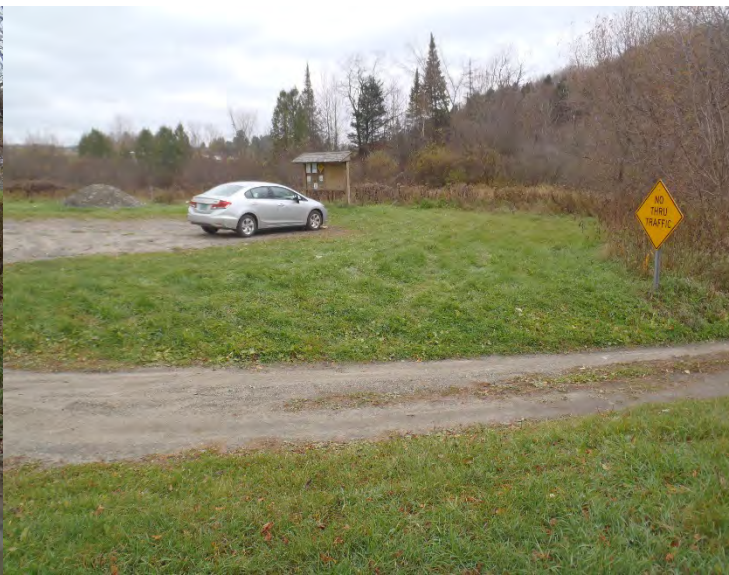
Photo 2. Green space available for stormwater retrofit

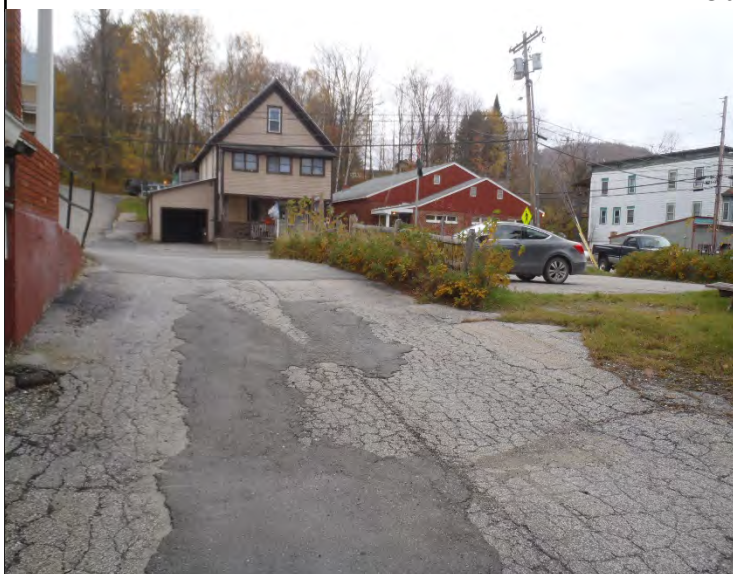
Photo 1. Available green space between Hardwick Village Market and GRACE

There is available green space between the parking lots of Hardwick Village Market, GRACE, and Brochu Auto Service that could be utilized for roadway, parking lot, and rooftop runoff capture and treatment. Narrow linear bioretention swales could be developed in these areas.

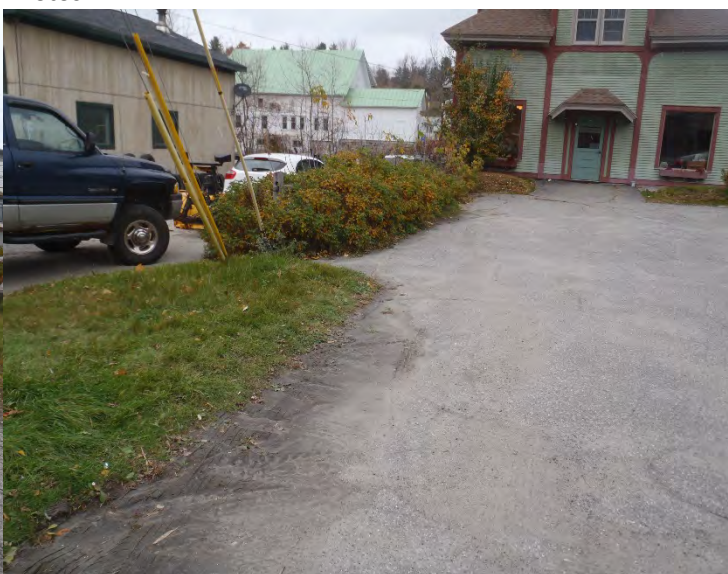
Photo 2. Available green space between GRACE and Brochu Auto Service

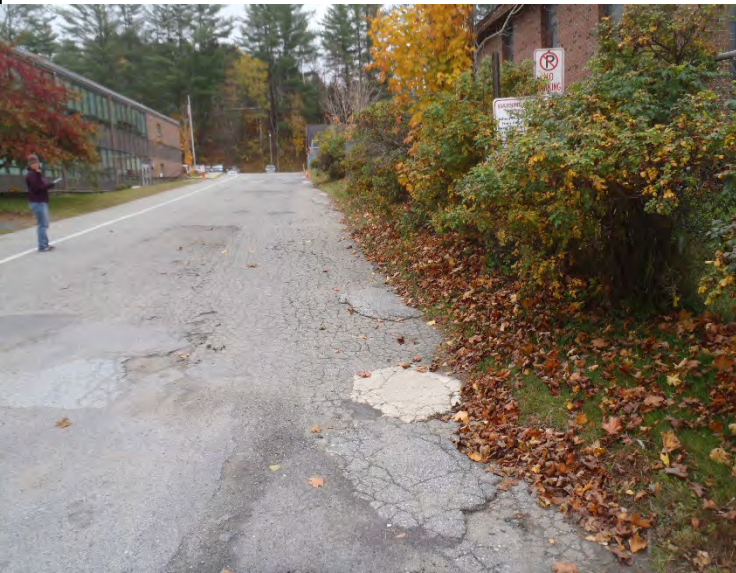
Photo 1. Green space available for linear stormwater retrofit

There is a vegetated green strip between Hardwick Elementary School and St. Norbert's Catholic Church available to implement a linear stormwater retrofit to capture and treat stormwater from parking area and rooftops. Further investigation into current site drainage would be required to assess how much of an impact such a retrofit would have.

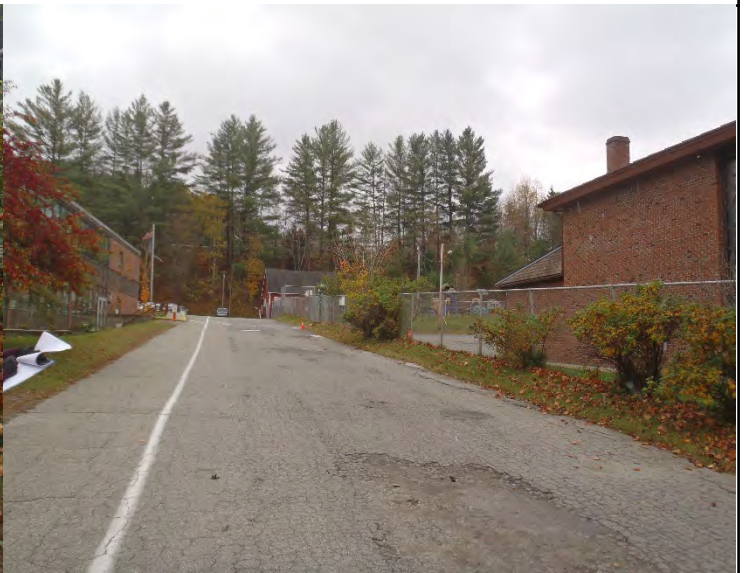
Photo 2. Green space available for linear stormwater retrofit

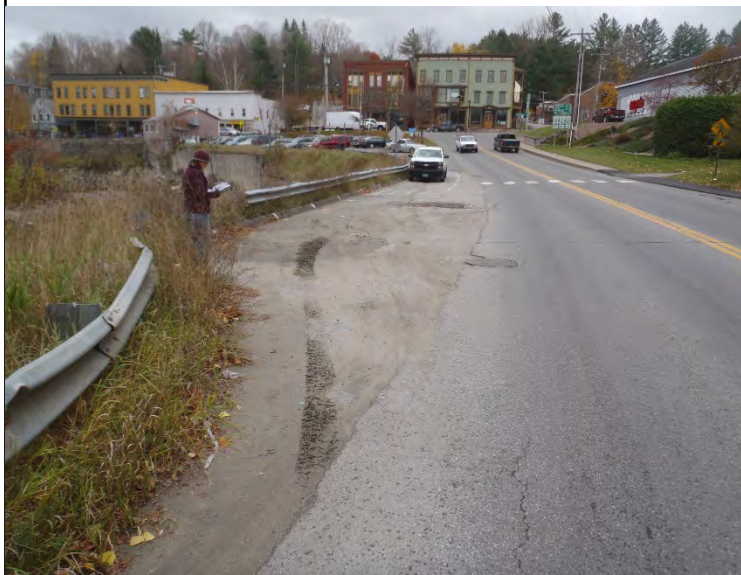
Photo 1. Existing conditions in the location of a potential sedimentation basin

There is a large area of impervious surface north of Wolcott Street between the roadway and the river that is currently intended as parking. This area receives considerable stormwater from Wolcott Street and collects substantial sediment. A sedimentation basin could be installed in this area to help reduce sediment loading to the river. Depending on required size, this retrofit could require the elimination of one or more parking spaces. *A swirl separator is anticipated to be installed here in conjunction with a sidewalk project on South Main Street in 2017.*

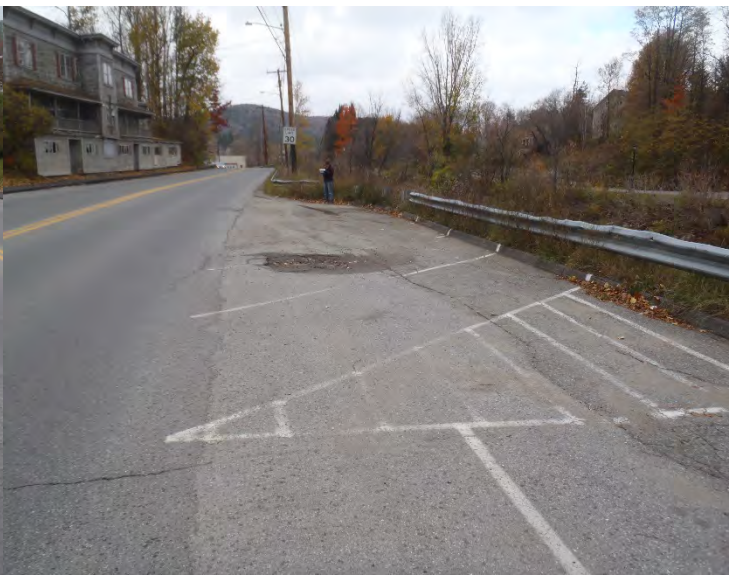
Photo 2. Existing conditions in the location of a potential sedimentation basin

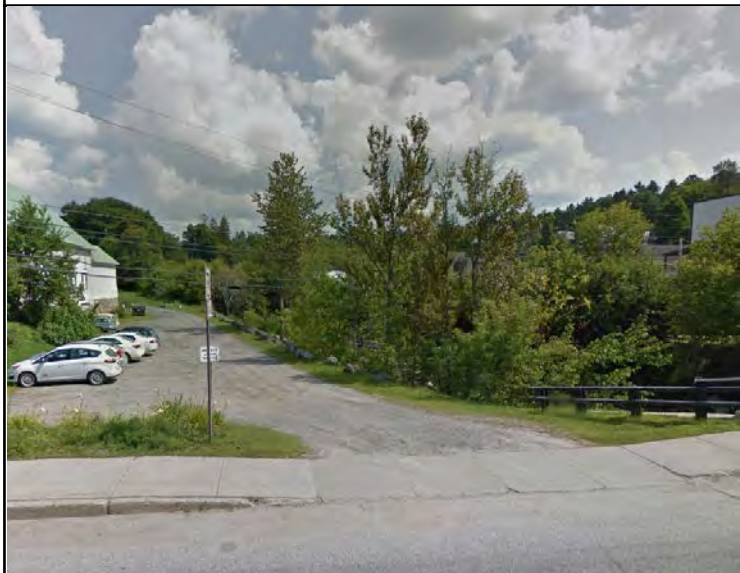
Photo 1. Green space available for additional vegetative buffer plantings (photo from Google Street View, Aug. 2014)

There is a vegetated green strip between the veterinary clinic's southern gravel parking lot and the north bank of the Lamoille River. The strip is narrow and adjacent to a retaining wall at the river's north bank, so there is not sufficient space for a bioswale between the parking lot and the river, but the mowed lawn area could be enhanced with perennials or shrubs to slow down and/or evapotranspire runoff from the gravel lot and nearby up-slope structures.
