Final Report, East Hardwick Better Connections Process

Appendix 5. East Hardwick Stormwater Plan

# Clean Water Project Plan for EAST HARDWICK STORMWATER TREATMENT HARDWICK, VERMONT

April 30, 2025

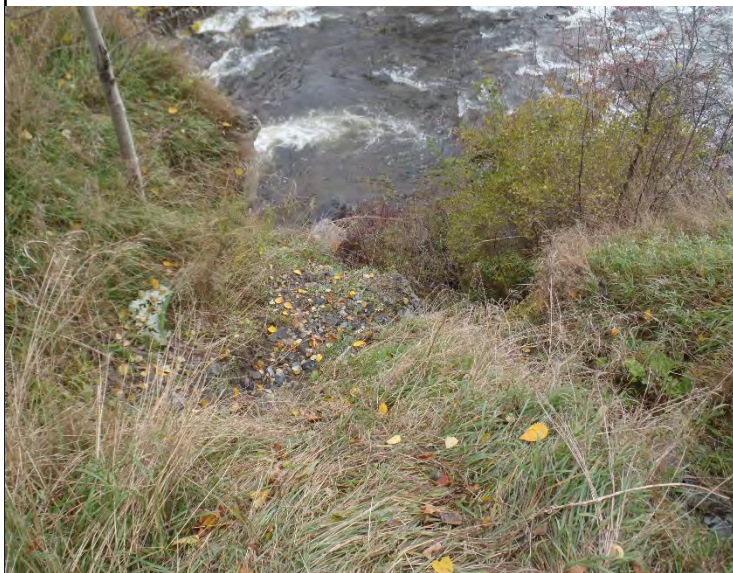
Photo 1. Marginal erosion on the northwest corner of the bridge

Overland stormwater runoff from Main Street is causing significant erosion at the southeast corner of the bridge. Marginal erosion created by overland runoff from Brickhouse Road is also present at the northwest corner of the bridge. Both areas would benefit from the installation of step-pools and/or large stone to slow water and reduce erosion. A retaining wall on private property on the southeast corner may need to be relocated to achieve proper conveyance.

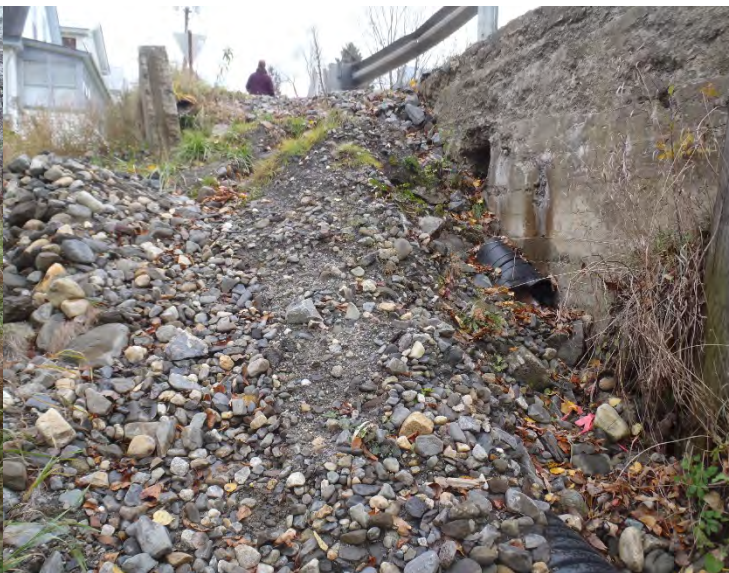
Photo 2. Substantial erosion on the southeast corner of the bridge

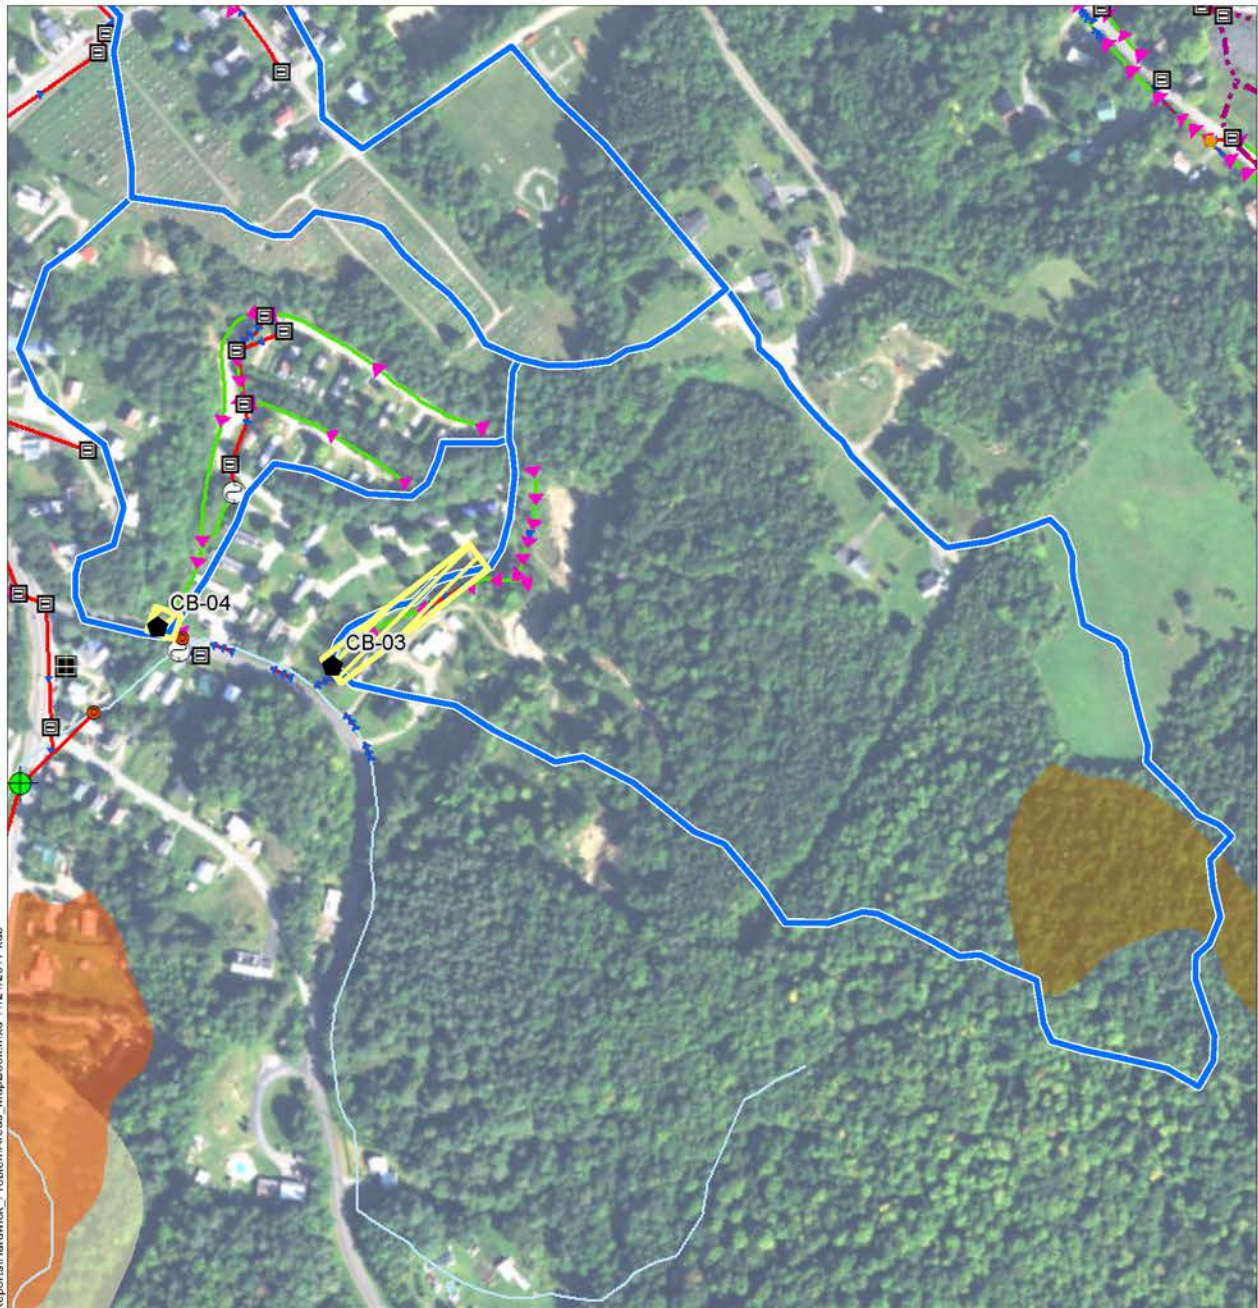
Latitude:	44.499297 N	
Longitude:	-72.369078 W	
Land Ownership:	Private (Lamoille Valley Housing Trust)	
Drainage Area (acres)	CB-03: 28.8 CB-04: 11.1	
Impervious (acres)	CB-03: 0.83 CB-04: 0.93	
<b>Site Description:</b> <ul style="list-style-type: none"><li>CB-03: The swale draining an area adjacent to Spruce Drive was reshaped during construction of new lots in the mobile home park. Construction phase erosion was stabilized, but opportunities remain for stabilization of the park's open drainage channels, as well as for BMP retrofits to improve water quality treatment.</li><li>CB-04: The fire hydrant access is slumping and eroding into the ditch line, plugging the stone and contributing to sediment transport. The slope should be stabilized by installing stone and leveling the access.</li></ul>		
<b>Proposed Scope of Work</b>

Install BMPs	<ul style="list-style-type: none"><li>Establish erosion prevention measures within the channel (stone lining, stone check dams, or both depending upon channel slope).</li><li>Investigate construction of a sedimentation basin within the flow path to further reduce sediment transport, or bioswale retrofits in the existing channels.</li></ul>	
Stabilize Overflow / Flow Path	<ul style="list-style-type: none"><li>Strategically place stone in areas more prone to erosion (where existing channels turn sharply or drop in elevation).</li><li>Vegetate the swale as well as possible.</li><li>Consider installing check dams to slow flow velocity and promote sediment deposition.</li><li>At the fire hydrant access, place concrete waste blocks or large stones at the toe of slope and level the access to discourage slumping.</li><li>If snow is plowed to this location, take care to not add too much weight at the top of slope as doing so can increase the risk of saturating the soil at the access and creating a failure plane causing the slope to slip or slump into the roadside ditch.</li></ul>

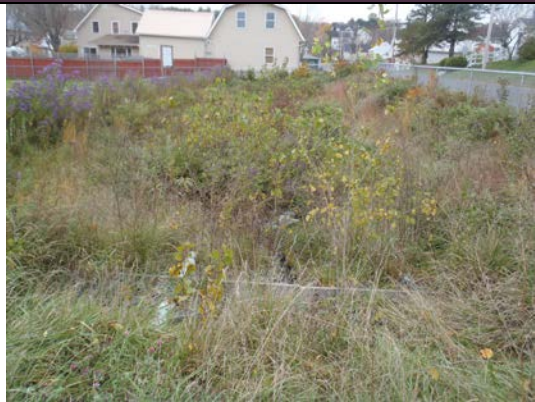
Project: LR-03		Hardwick VT SWMP, Site Restoration Plan	
Location:	Community Recreation Park (Corner of Cottage Street and Cherry Street)

Latitude:	44.505053 N		
Longitude:	-72.372303 W		
Land Ownership:	Town of Hardwick		
Drainage Area (acres)	24.5		
Impervious (acres)	7.8		
<b>Site Description:</b> <ul style="list-style-type: none"><li>A previously established bioretention area is in need of maintenance. The forebay should be cleaned of sediment. Small trees, invasive species, and dead vegetation should be removed. Creation of a simple Operations &amp; Maintenance plan will ensure sustainable maintenance in the future.</li></ul>			
<b>Proposed Scope of Work</b>			
Improve Site Drainage	<ul style="list-style-type: none"><li>The site appears to drain adequately.</li></ul>		
Restore BMP	<ul style="list-style-type: none"><li>The forebay should be cleaned of sediment.</li><li>Small trees, invasive species, and dead vegetation should be removed.</li><li>Creation of a simple Operations &amp; Maintenance plan will ensure sustainable maintenance in the future.</li></ul>

11	Create O&M Plan for existing bioretention area (LR-03)	Complete practice maintenance, including sediment and weed removal. Consider replacement of original plantings with vegetation more easily maintained by Town staff. Create simple operations and maintenance plan and train local staff to ensure sustainable maintenance. Consider practice restoration only if maintenance and inspection uncover performance issues.	Stormwater Master Planning	1		44.505053	-72.372303		Hardwick	Lower Headwaters Lamoille River	Caledonia County NRCD	Ecosystem Restoration Program		Stormwater Master Plan	Medium
12	Tops/Rite Aid retrofit opportunity (LR-04)	Much of, if not all of the stormwater from the site appears to drain to the south edge of the paved area, transporting sediment and creating ponding. A section of pavement at south edge appears to be unused. If soils are suitable for infiltration, excavating existing paved surface and installing infiltration basin with sediment forebay would reduce runoff from the site and provide treatment.	Stormwater Master Planning	1		44.513236	-72.372586	Infiltration is not allowed if practice is within Zone I WHPA. Entire site is within town well field's gw recharge area. Most of site is within floodplain.	Hardwick	Lower Headwaters Lamoille River	Caledonia County NRCD	Ecosystem Restoration Program		Stormwater Master Plan	Medium

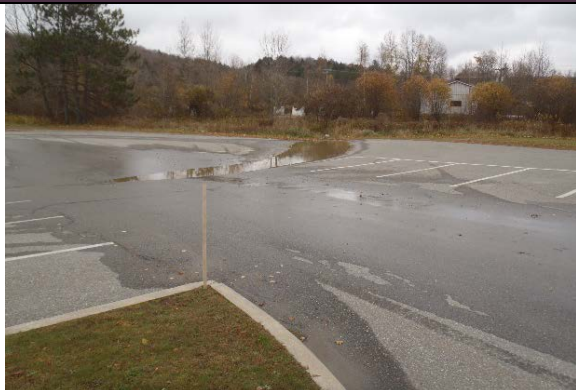
Project: LR-04		Hardwick VT SWMP, Site Restoration Plan	
Location:	Tops/Rite-Aid Parking lot

Latitude:	44.512336 N		
Longitude:	-72.372586 W		
Land Ownership:	Private (Tops/Rite-Aid)		
Drainage Area (acres)	1.64		
Impervious (acres)	1.64		
<b>Site Description:</b> Much of, if not all of, of the stormwater from the site appears to drain to the center of the parking lot and flow south where it transports sediment, creates ponding, and enters a stone lined swale. The stone has become plugged and the banks are eroded. The parking lot has also settled, causing ponding. The likely original drainage pattern could be re-established, and a portion of the parking lot to the south, which appears unused, could be converted to a stormwater BMP to capture and treat runoff from up to 2.8 acres of impervious surface.			
<b>Proposed Scope of Work</b>			
Improve Site Drainage	<ul style="list-style-type: none"><li>• Regrade raised lawn area at curb inlet on the north side of the access drive to allow disconnection of ponded runoff towards existing grass swale.</li><li>• Consider re-grading the parking lot to better direct stormwater to existing flow path and reduce ponding. If regraded, it would be possible to collect and treat drainage from the northern edge and eastern edge of the parking lot (behind Tops/Rite Aid) at a single location. If this was accomplished, the total drainage area captured and treated would increase to 2.75 acres.</li></ul>

Install BMPs	<ul style="list-style-type: none"><li>• Install sedimentation basin along edge of parking lot within the existing flow path.</li><li>• Improve stone lined swale conveyance and install check dams to promote additional sediment capture and velocity reduction.</li><li>• Consider installing a second stone lined swale with check dams or lined linear bioretention at the site discharge point at the southeast corner of the parking lot.</li></ul>		
Stabilize Overflow / Flow Path	<ul style="list-style-type: none"><li>• Stabilize the overflow from the sedimentation basin with a stone lined swale and check dams extending to the adjacent wetland or stable location.</li></ul>		
Improve Winter Maintenance	<ul style="list-style-type: none"><li>• Work with Tops/Rite Aid to create a snow plowing and snow stockpiling plan that will protect the drainage and BMP features while reducing sediment loading to the wetland and river.</li></ul>

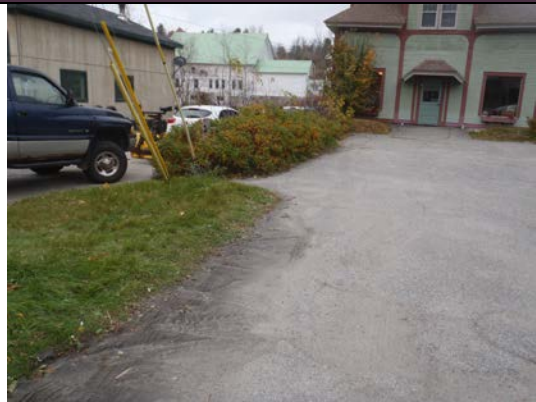
Location:	Hardwick Village Market / GRACE / Brochu Auto Service Parking Areas

Latitude:	44.512336 N	
Longitude:	-72.372586 W	
Land Ownership:	Private (Hardwick Village Market / GRACE / Brochu Auto Service)	
Drainage Area (acres)	0.40	
Impervious (acres)	0.34	
<b>Site Description:</b> There is available green space between the parking lots of Hardwick Village Market, GRACE, and Brochu Auto Service that could be utilized for stormwater treatment. Bioswales could be developed in these areas to capture and treat runoff from Mill Street, parking areas, and roofs.		
<b>Proposed Scope of Work</b>		
Improve Site Drainage	<ul style="list-style-type: none"><li>• Regrade parking areas to direct stormwater to linear bioretention swales.</li><li>• Consider adding gutters to all buildings that outlet to the bioswales, whether directly or via surface flow. Currently, most site runoff drains to the north and discharges directly to the river. The addition of gutters would reduce erosion and sediment transport from individual driveways/parking lots, and reduce volume and velocity of flow to the river.</li></ul>

Install BMPs	<ul style="list-style-type: none"><li>• Install bioswales in existing green strips.</li><li>• There is a dumpster in the alley between Hardwick Village Market and G.R.A.C.E. that is leaking. It would be possible to either replace the dumpster, or position it to encourage the leak to flow into the bioswale and receive treatment.</li><li>• Install stable overflow structure from bioswales to existing closed drainage system or to Lamoille River.</li></ul>	
Improve Winter Maintenance	<ul style="list-style-type: none"><li>• Property owners may plow snow into the bioswales. This would provide snow storage and treatment during spring thaw, but may also cause compaction within the practices.</li><li>• If the swales are used for winter snow storage, the maintenance plan must specify sediment removal following snowmelt each year to ensure adequate permeability is maintained within the bioretention swales.</li></ul>

17	GRACE Retrofit opportunities (LR-09)	Two green strips exist between the buildings of Hardwick Village Market, GRACE, and Brochu Auto Service. These strips can be used for linear bioretention areas to capture, treat, and infiltrate runoff from Mill Street, parking areas, and roofs.	Stormwater Master Planning	1		44.504292	-72.365131		Hardwick	Lower Headwaters Lamoille River	Caledonia County NRCD	Ecosystem Restoration Program		Stormwater Master Plan	Medium
18	Positive Pie and Yummy Wok park Retrofit opportunity (LR-10)	Promote infiltration and reestablish plantings within the existing park.	Stormwater Master Planning	1		44.504292	-72.365131		Hardwick	Lower Headwaters Lamoille River	Caledonia County NRCD	Ecosystem Restoration Program		Stormwater Master Plan	Low

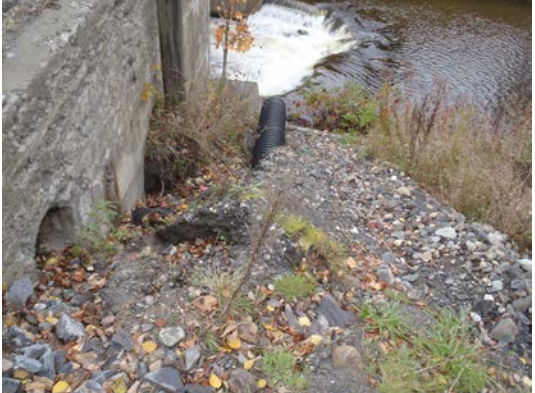
<b>Location:</b>	Main Street Bridge, East Hardwick

<b>Latitude:</b>	44.521125 N	
<b>Longitude:</b>	-72.307869 W	
<b>Land Ownership:</b>	Town of East Hardwick	
<b>Drainage Area (acres)</b>	18.4	
<b>Impervious (acres)</b>	3.7

**Site Description:**  
 Overland stormwater runoff from Main Street is causing significant erosion at the southeast corner of the bridge. Marginal erosion created by overland runoff from Brickhouse Road is also present at the northwest corner of the bridge. Both areas would benefit from the installation of step-pools and/or large stone to slow water and reduce erosion. A retaining wall on private property on the southeast corner may need to be relocated to achieve proper conveyance. Moderate erosion also exists at the east edge of Church Street, northeast of the bridge. Overall, erosion in this drainage area is caused by high velocity overland flow and by active outlet scour at storm drain outlets.

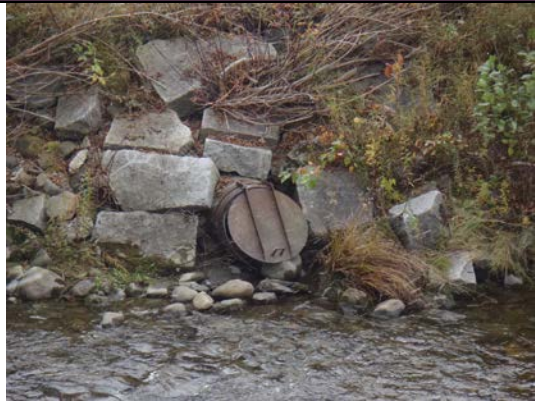
Project: LR-01		Hardwick VT SWMP, Design Build Plan	
Location:	West Church Street Bridge

Latitude:	44.50658 N		
Longitude:	-72.37008 W		
Land Ownership:	Town of Hardwick		
Drainage Area (acres)	32.0		
Impervious (acres)	9.43		
<b>Site Description:</b> The Town has indicated that the current “trash can” style outlet cover does not adequately protect against backwater. This culvert, and ultimately the pipe system connected to it, backs up during seasonal high water. This outlet structure could be replaced with a “duck bill” outlet structure, or similar device.			
<b>Proposed Scope of Work</b>			
Install BMPs	<ul style="list-style-type: none"><li>• Install a “duck bill” outlet structure or in-line backflow prevention valve installation to improve drainage through the closed stormwater drainage system by providing protection against backwater conditions within the system.</li><li>• Tideflex TF-2 Curved Bill Check Valve or similar recommended for installation at the outfall (see attached cut sheet)</li></ul>

<b>Project Benefits:</b> <ul style="list-style-type: none"><li>• “Duck bill” outlet structure installation will prevent backwater conditions when the river elevation is above the outlet.</li></ul>

9	Corner of Wolcott St. and W. Church St. Retrofit Opportunity (LR-01)	The existing “trash can” style outlet cover does not protect against backwater when the river rises, causing the closed drainage system to back up. Replace the cover with a “duck bill” outlet structure or similar device. This location could be used as a demonstration, as there are many similar situations along the river.	Stormwater Master Planning	1		44.506528	-72.375955	More infrastructure and property protection than water quality benefit, may not be easily advanced through ERP	Hardwick	Lower Headwaters Lamoille River	Caledonia County NRCD	Ecosystem Restoration Program		Stormwater Master Plan	Low
10	Elm Street Retrofit opportunity (LR-02)	There is opportunity to utilize green space between sidewalks and the roadway for treatment should the Town wish to implement further treatment in the neighborhood.	Stormwater Master Planning	1		44.505069	-72.370919	Low priority, this area already drains to the bioretention system at LR-03.	Hardwick	Lower Headwaters Lamoille River	Caledonia County NRCD	Ecosystem Restoration Program		Stormwater Master Plan	Low

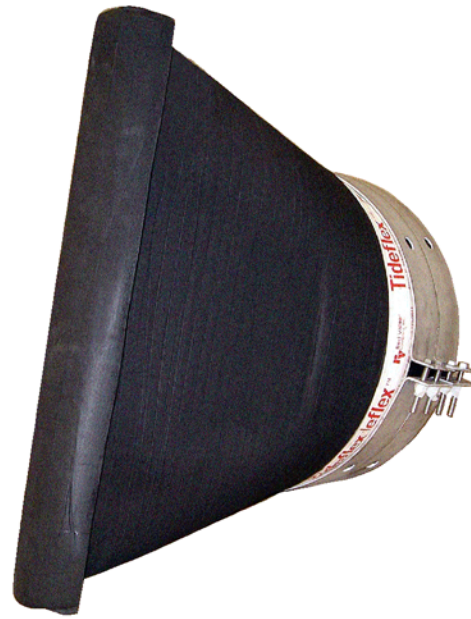
The inside diameter of the TF-2's cuff is constructed to exactly match the outside diameter of the pipe.

The valve is slid onto the pipe and held in place with steel or stainless steel band clamps, eliminating flanging costs. Tideflex® TF-2 valves are constructed with a curved bill as standard.

Pipe O.D. (A)	Length (L)	Bill Height (H)	Cuff Length (C)
1/2	3	1 1/2	1/2
3/4	3	2	1
1	4	2	1
1 1/2	7	4	1
2	6	4	1
2 1/2	8	5	1
3	9	6	1 1/2
4	12	7	1 1/2
5	16	9	2
6	16	11	2
8	17	13	2
10	23	17	3
12	27	21	4
14	26	22	4
16	28	27	5
18	30	27	6
20	34	33	8 1/2
22	38	33	8
24	42	39	8
26	42	39	8
28	42	39	8
30	45	50	9
32	46	53	10
36	50	61	10
38	50	61	10
40	50	61	10
42	55	71	10
44	55	71	10
48	60	78	12
50	60	78	12
54	72	97	12
58	72	97	12
60	75	97	15
68	75	97	15
72	95	115	17
84	92	111	18
90	102	119	17
92	102	119	17
96	102	119	17

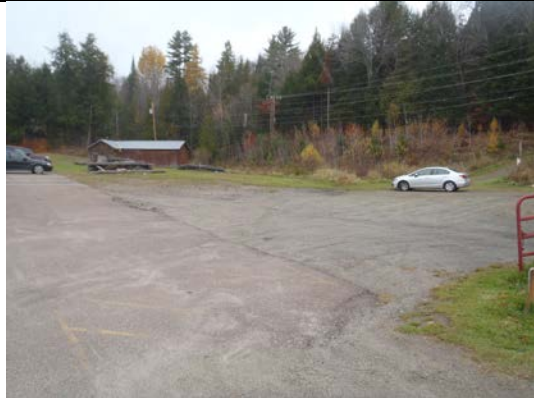
Location:	Hazen Union School / Hardwick Trails Access

Latitude: Longitude:	44.50913 N -72.36337 W	
Land Ownership:	Town of Hardwick / Hazen Union School	
Drainage Area (acres)	0.69	
Impervious (acres)	0.55	
<b>Site Description:</b> Stormwater runoff from the paved parking lot, gravel parking area, and uphill area near the tennis courts is causing erosion and sediment transport to an unmapped wetland area and an unnamed tributary to the Lamoille River .		
<b>Proposed Scope of Work</b>		
Improve Site Drainage	<ul style="list-style-type: none"><li>• Vegetate the existing flow path adjacent to the parking area as well as possible.</li></ul>	
Install BMPs	<ul style="list-style-type: none"><li>• Reduce the size of the gravel parking area slightly and direct flow to a hardened sediment basin with stabilized outlet to the existing flow path.</li><li>• Excavate the gravel parking area and install permeable parking. This could be done by creating an underdrained gravel reservoir (12", with 4" perforated PVC set at the bottom, sloped to daylight towards the wetland/stream) and adding a 3" pea stone choker course, topped with a plastic grid system which can be filled with topsoil and seeded for the parking surface, or by installing permeable pavers.</li><li>• If desired, install bollards or other measures to limit vehicle traffic within the wetland buffer.</li></ul>

Stabilize Overflow / Flow Path	<ul style="list-style-type: none"><li>• A controlled outlet from the sediment basin will reduce flow velocity, creating a stable flow path to the wetland that can be allowed to revegetate naturally.</li></ul>	
Improve Winter Maintenance	<ul style="list-style-type: none"><li>• The sediment basin may be used for snow storage. When the snow melts, sediment will be trapped within the basin and allow for easy removal via skid steer and/or shovels.</li></ul>	
<b>Additional Design/Permitting Requirements:</b> <ul style="list-style-type: none"><li>• Additional engineering support includes approximately one half-week for hydrologic modeling, two days to provide design support and materials estimates, two days of technical field oversight during construction to assist with BMP sizing, location, layout, grading, and outlet structure configuration, and one half-day for final construction inspection (~15-20% of total project cost).</li><li>• Improvements cannot be constructed within 50 feet of the wet swale at the back of the parking area (assume that the mowing line is the edge of wetland). Soil restoration and amendments may be installed within the buffer, but BMP installation is discouraged. Further dialogue with Wetlands Program staff may be needed if permeable parking installation in the current parking area is desired.</li></ul>

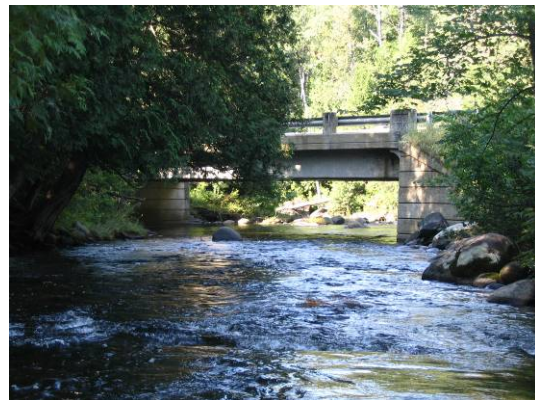
Figure 5. R30A. Bridge and channel constriction

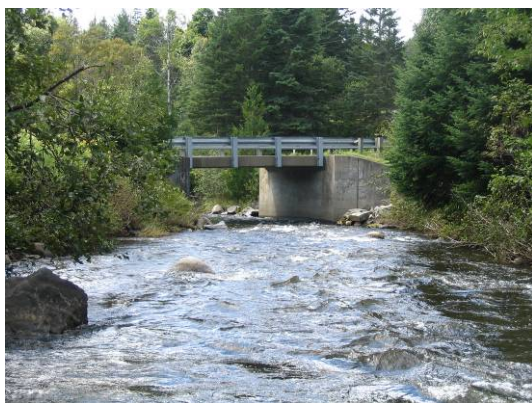
Figure 6. Undersized bridge with poor alignment in R30B

- There are multiple long term planning opportunities for the undersized bridge structures. A comprehensive bridge survey is recommended to help prioritize upgrades to these structures. The modification of the channel widths due to these undersized structures should be noted when the channel width of a new structure is considered.
- 1902 Greensboro Road (Route 16) is a long term area of conflict as the stream has been armored and modified around the house and yard. Restoring channel equilibrium at this section is greatly limited by the residence and land use. Installing vegetated buffers is recommended.
- The installation of buffers throughout open areas of the segment is also recommended.

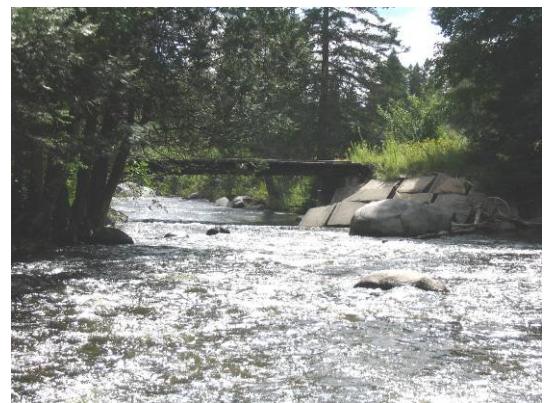
Figure 7. Problem bridge and channelization in R30B
