106 Associates 193 Saint Paul St., Suite 10 Burlington, VT 05401 (802) 777-1572 scottnewman@106associates.com

Re: <u>Hardwick Yellow Barn Business Accelerator Project</u> Section 106 Evaluation – HUD/CDBG

This letter will provide you with comments regarding the plans for the Hardwick Yellow Barn Business Accelerator Project which includes the rehabilitation of the historic Hardwick Yellow Barn at 281 VT RT 15 in Hardwick.

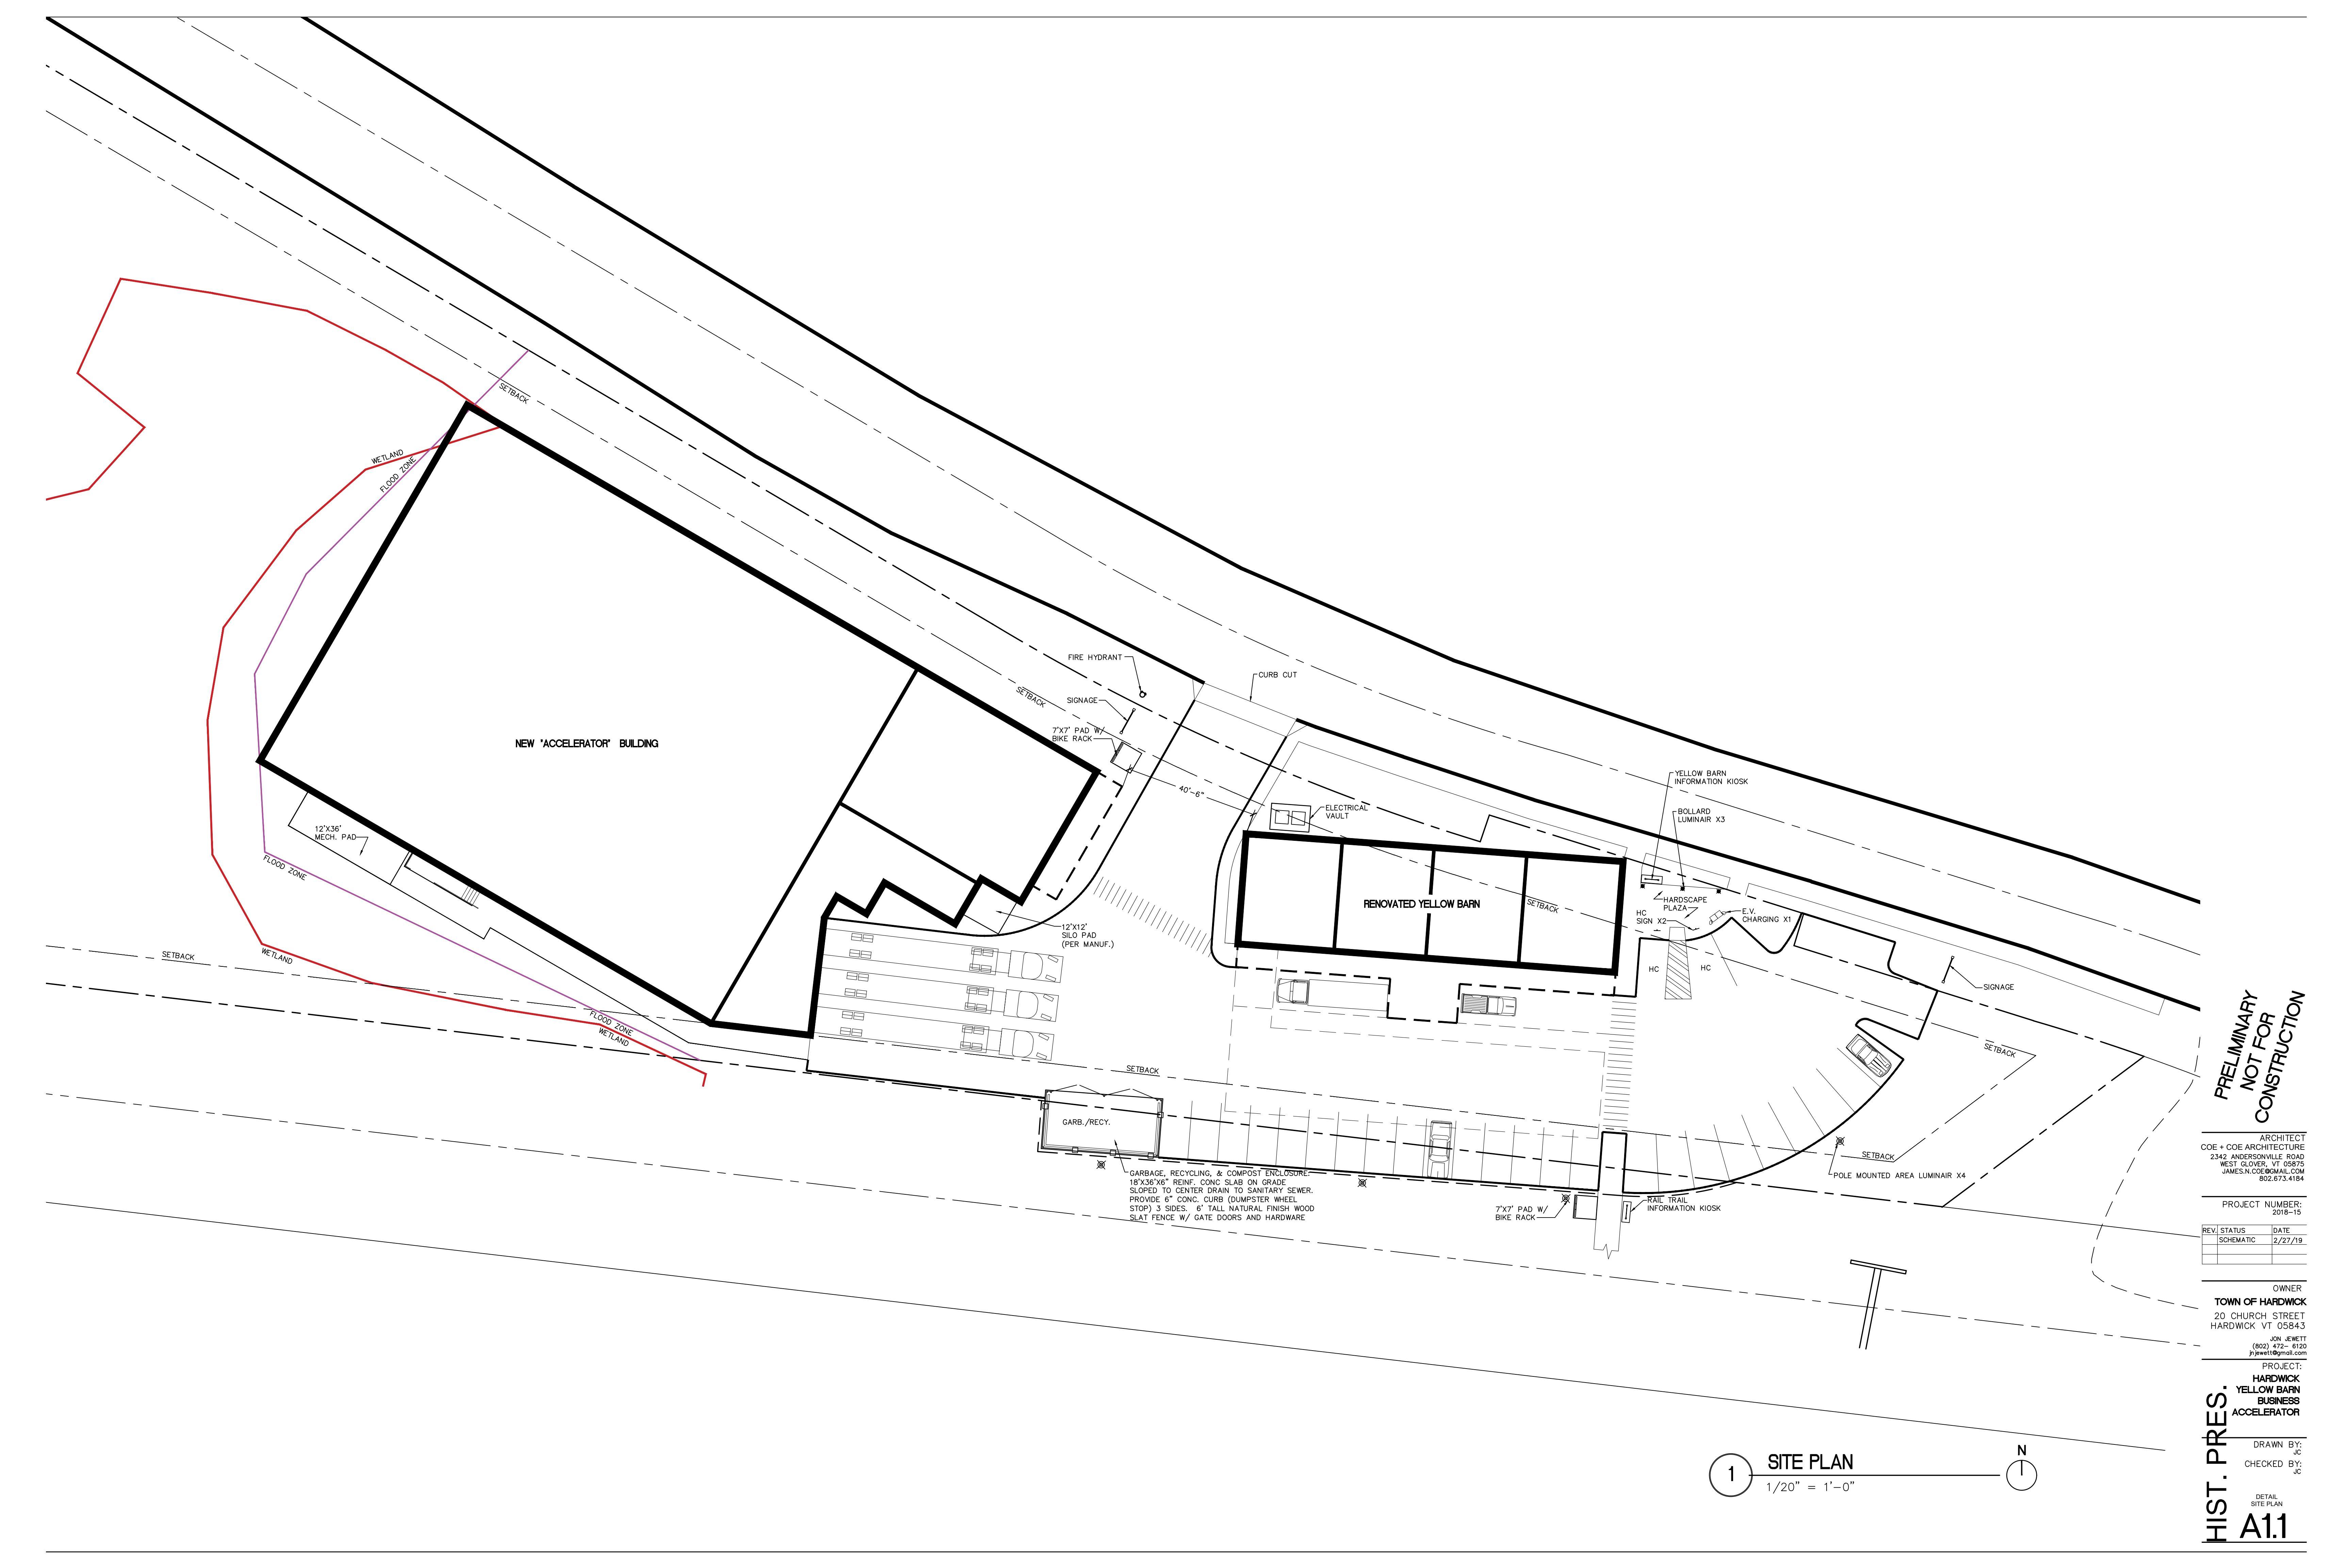
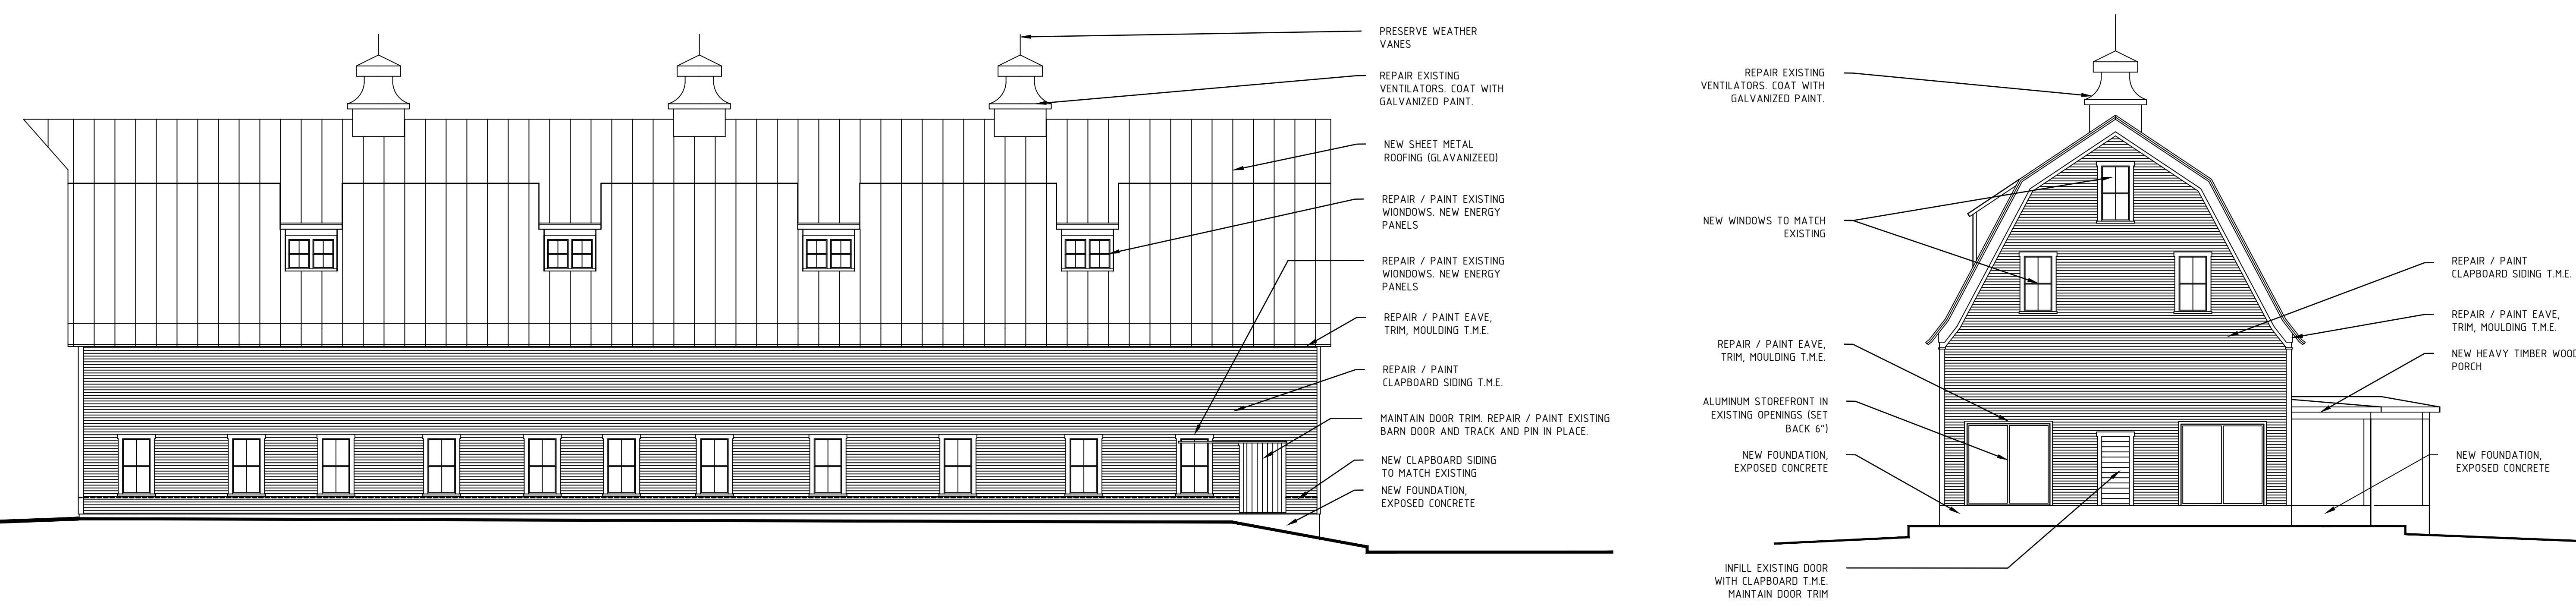
SIDE ELEVATION - WEST $\frac{1}{8}$ " = 1'-0"

REPAIR EXISTING VENTILATORS. COAT WITH GALVANIZED PAINT.

REPAIR / PAINT EXISTING DOORS / TRIM

REPAIR / RESTORE / PAINT EXISTING WINDOW. NEW ENERGY PANELS

REPAIR / PAINT EAVE, TRIM, MOULDING T.M.E. REPAIR / PAINT

CLAPBOARD SIDING T.M.E. ALUMINUM STOREFRONT IN EXISTING OPENINGS (SET BACK 6")

INFILL EXISTING DOOR WITH CLAPBOARD T.M.E. NEW $\frac{2}{2}$ DOUBLE HUNG WOOD

REPLACEMENT WINDOW TO MATCH EXIST.

NEW CLAPBOARD SIDING AT BASE TO MATCH EXISTING

NEW FOUNDATION, EXPOSED CONCRETE

West Elevation: Features preserved on this elevation include the clapboards, eaves, gable window openings and trim, and outside door openings on the first story and trim. The vertical planks covering the three gable windows will be removed and new 2/2 SDL wood double hung windows will be installed in the openings. The outer two doors on the first story are not original to the building. Vertical plank doors will be removed, and aluminum-framed storefronts will be installed in the openings and set back 6" from the building face. The center door will be infilled with clapboards, maintaining the existing trim. Repairs to wood elements as needed will be treated with wood epoxy where possible, or with replacement to match the existing materials, methods and geometry if needed. All wood elements as needed will be treated with replacement to match the existing materials, methods and geometry if needed. All wood elements as needed will be treated with replacement to match the existing materials, methods and geometry if needed. All wood elements as needed will be treated with replacement to match the existing materials, methods and geometry if needed. All wood elements as needed will be treated with wood epoxy where possible, or with replacement to match the existing materials, methods and geometry if needed. All wood elements as needed will be treated with wood epoxy where possible, or with replacement to match the existing materials, methods and geometry. All wood elements will be properly prepared and painted with high values will be properly prepared and painted with high values will be properly prepared and painted with high values will be properly prepared and painted with high values will be properly prepared and painted with high values will be properly prepared and painted with high values will be properly prepared and painted with high values will be properly prepared and painted with high values will be properly prepared and painted with high values will be properly prepared and painted with high values will b

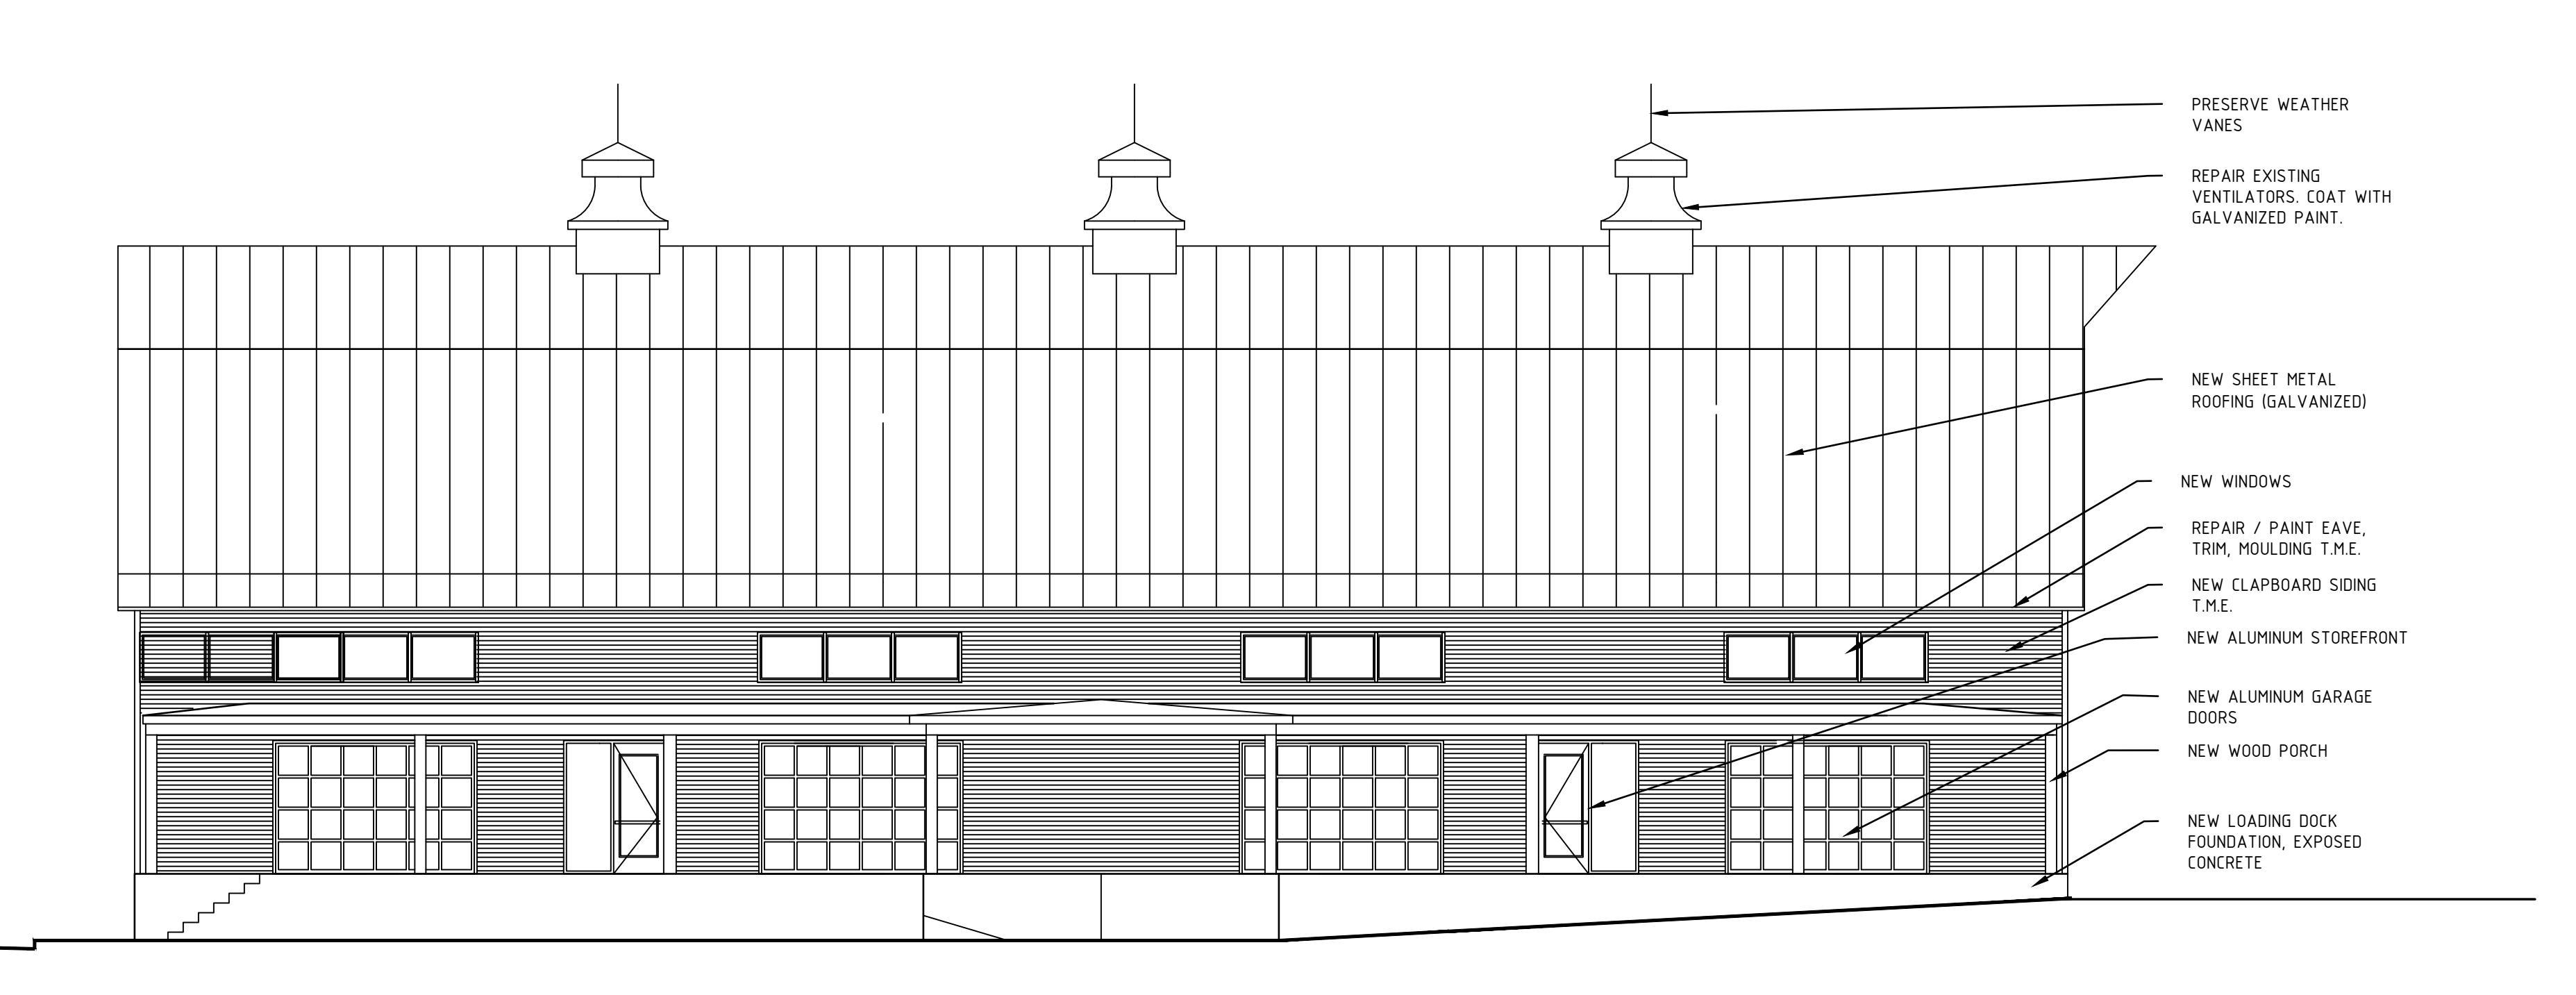
REAR ELEVATION - SOUTH 3 $\frac{1}{8}$ " = 1'-0"

RESTORE OPENING HEIGHT REPAIR / PAINT EAVE,

> TRIM, MOULDING T.M.E. NEW WOOD PORCH DOCK

NEW FOUNDATION BEYOND, EXPOSED CONCRETE

South Elevation: Work to this less visible elevation addresses functional issues critical for the new occupancies. A covered loading dock will extend the length of the south elevation with a shallow-pitched, membrane-covered roof with galvanized drip edge, gutters, downspouts, and square wood post supports. A centered projection will handle materials loading and unloading. Sheltered by the loading dock roof are four, regularly spaced, aluminum-framed overhead doors, one for each commercial space. Two aluminum storefront doors with side panels are also added. Above the loading dock roof and aligned with each overhead door is a 3-light transom window to allow more natural light into the commercial spaces. The original eaves, corner boards, and remaining clapboard siding is retained and repaired. Repairs to wood elements as needed will be treated with wood epoxy where possible, or with replacement to match the existing materials, methods and geometry. All wood elements will be properly prepared and painted with high quality primers and top coats. The exposed wall of the loading dock below the deck will be concrete.

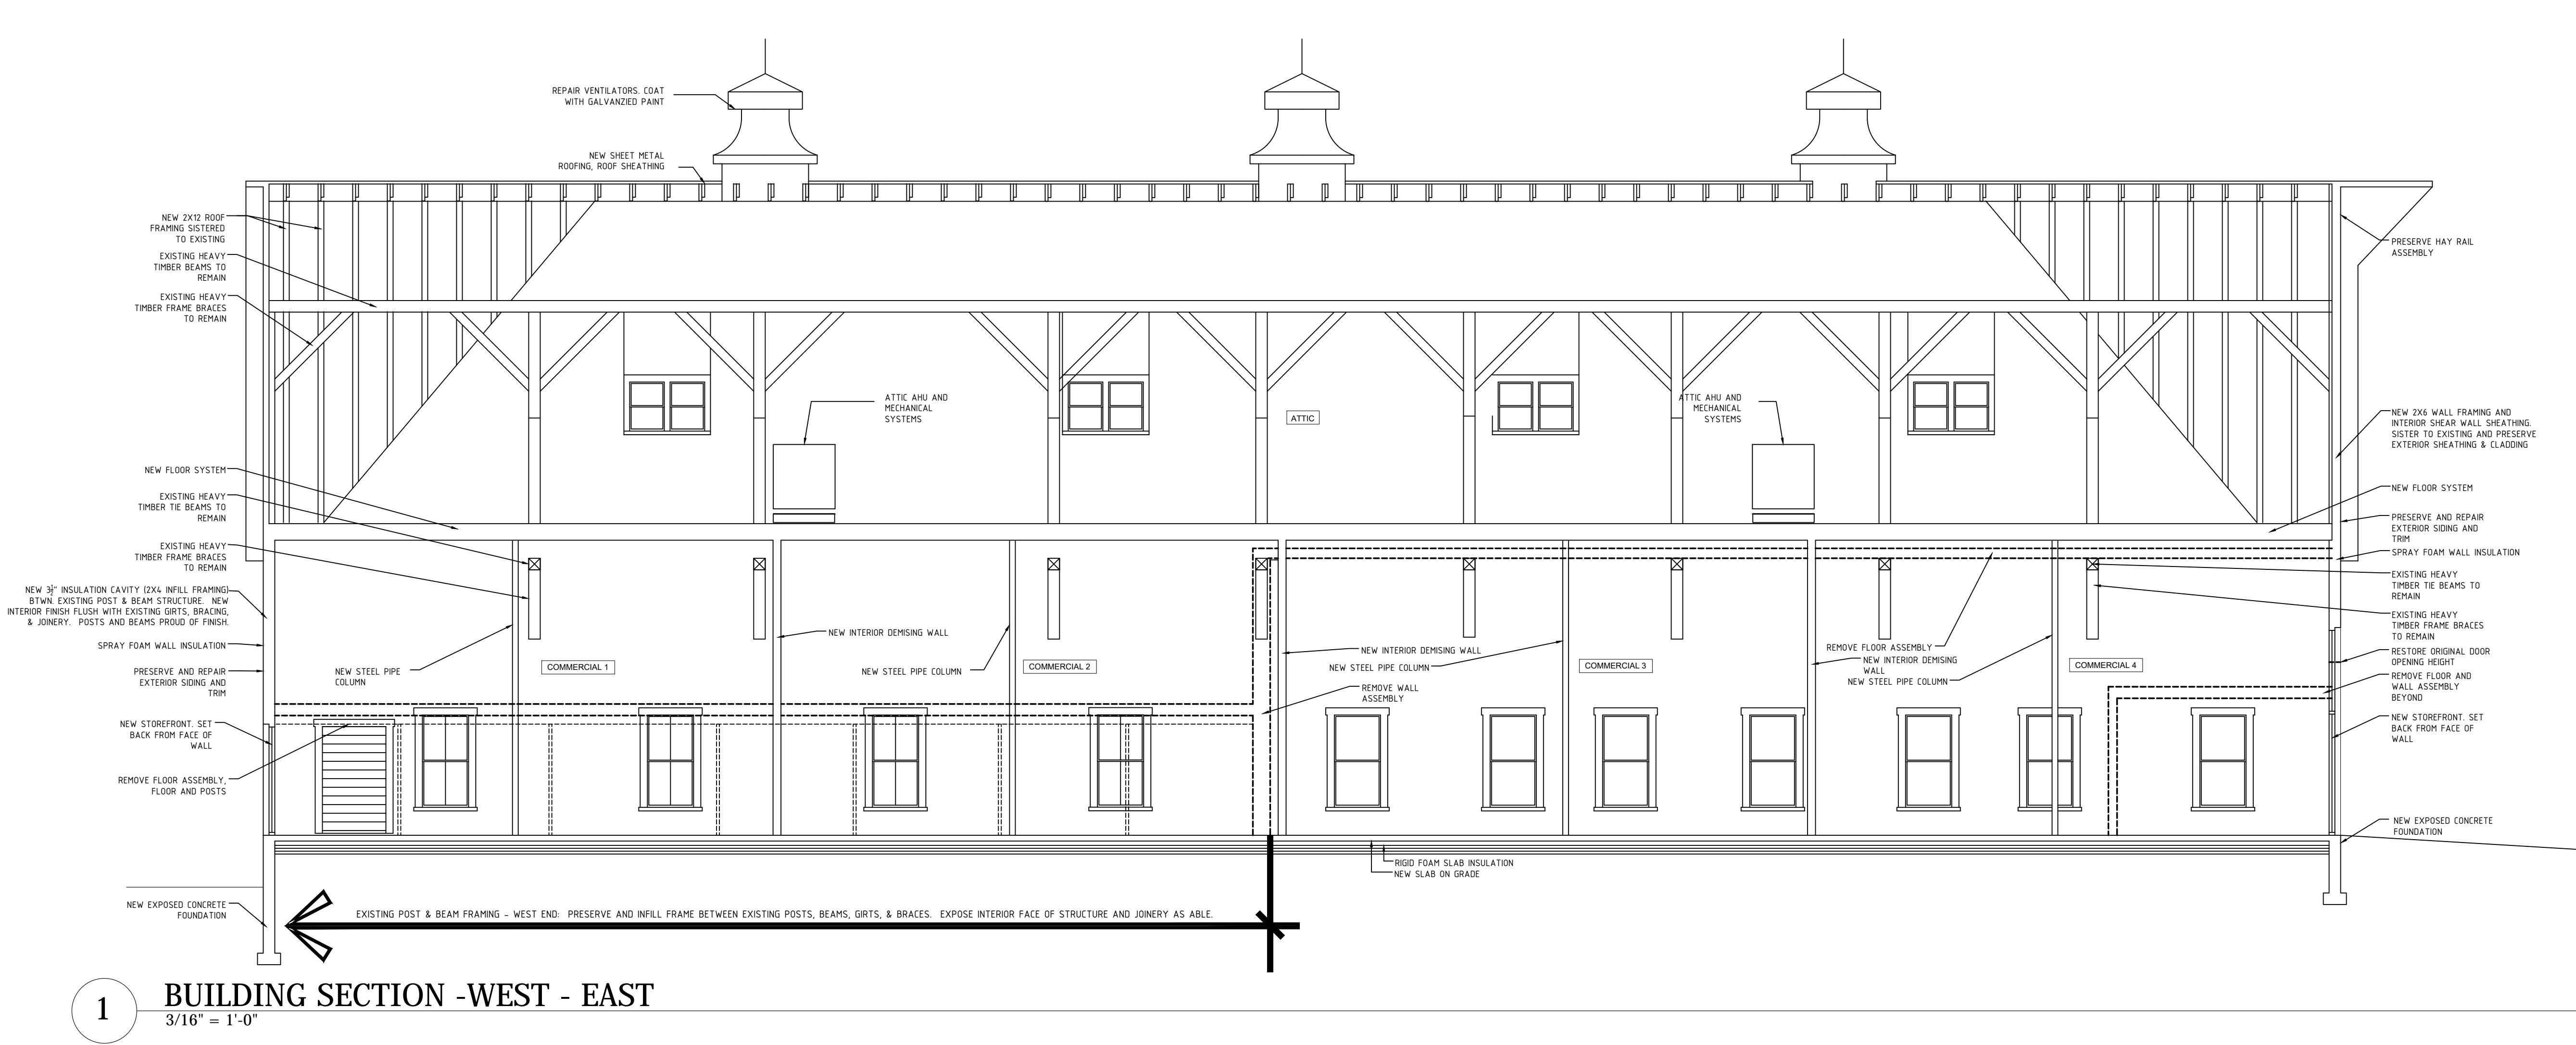
TYPICAL WALL SECTION 31-1/2" = 1'-0"

- TYP. EXTERIOR WALLS

REPAIR / PAINT EXISTING SIDING AND TRIM

- EXISTING SHEATHING TO REMAIN
- HOUSE WRAP SEPERATION LAYER
- SPRAY FOAM INSULATION
- NEW 2X6 STUDS SISTERED TO EXISTING WOOD FRAMING
- INSULATED PLYWOOD SHEATHING
- GYPSUM BOARD

Existing wall 2"x6" studs at the east end will be retained and sistered with 2"x6" studs. The exposed wall sheathing will be protected with Tyvek wrap and the cavities insulated with closed-cell cellulose foam. The interior of the studs will then be covered with ½" plywood to achieve required shear strength, then faced with sheetrock. At the west end of the barn the walls are framed with 8"x10" timbers and 4"x4" lateral beams up to the wall plate, all of which is exposed in the hayloft. The walls are covered below the existing parlor ceiling and framing details and conditions there are unknown. Where the heavy timber framing is present, the areas between the 8"x10" posts and beams will be infilled with a 2"x4" frame against the sheathing so the inside faces and half the sides of the framing will be exposed to the interior. If possible, the face of the lower, original lateral beams will be also be exposed. The wall sheathing and portions of the framing to be covered will be protected by Tyvek and the cavities in the framing filled with closed cell cellulose foam and covered in ½" plywood. This treatment will not meet the engineer's specifications for shear strength so the westernmost demising wall may be sheathed in plywood. This treatment is subject to structural engineering requirements and compliance with the 2015 IBC for structural design.
