Hardwick Projects after 2023 and 2024 flooding events

August 1, 2024

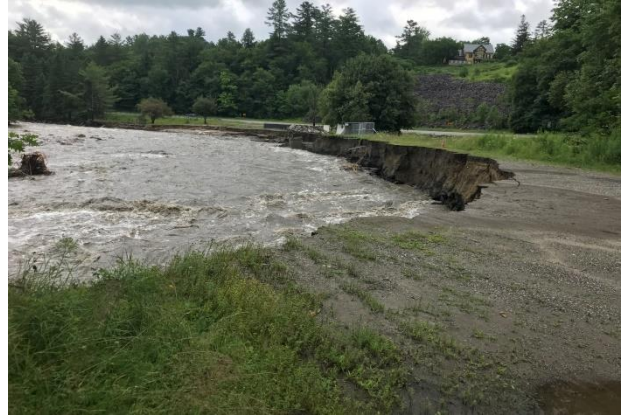
In July 2024, Hays Service Station/Jiffy Mart and the Town of Hardwick lost 100 feet of property, 3 vehicles were swept downstream, and 3 in-ground fuel tanks are now on the river edge. A 10,000 gallon tank is in place and filled with concrete. The propane tank was removed on Thursday, July 11, 2024 as it was in imminent danger of falling into the Lamoille River. The continued erosion at this location is a

threat to both the Hays Service Station but also the Hardwick downtown and the correlating Routes 14/15/16. This has been elevated to a State-level emergency. Temporary Bank Stabilization was done on July 24 -25 by the State of Vermont at the request of the Town.

- **HMPG pre-application submitted to VEM after July 2023 to make the former Inn by the River location more flood resilient and to stability the riverbank. Possible RIVER help. Possible EWP after July 2024.**

July – 2024 - Pre-application was invited to apply for funding to stabilize the entire section and create more flood resiliency on the former Inn by the River location – Top 3 priority

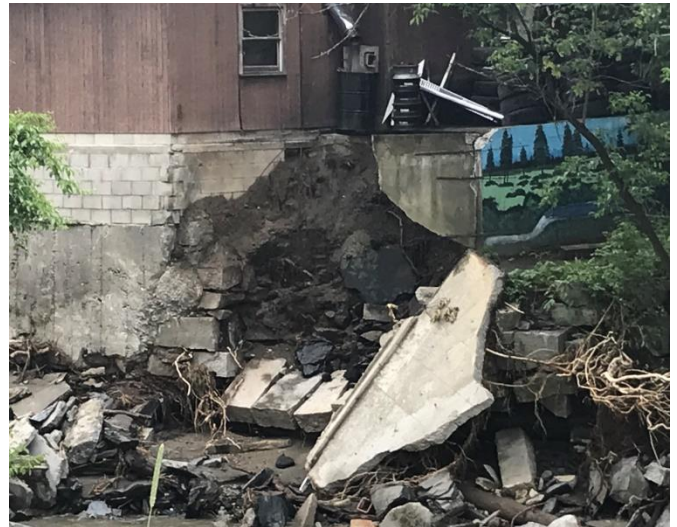
- **HMPG pre-application submitted to VEM after July 2024 to protect and create a comprehensive approach to the riverbanks in the center of town from above the North Main Street Bridge to the Cottage Street Bridge. Possible RIVER help. Possible NRCS Emergency Watershed Protection (EWP) after July 2024.** In July 2024, the parking area for the Hardwick Inn/Mike's Service Station/Civic Standard all lost considerable retaining wall sections. Mike's Service Station is in danger of being demolished by the Lamoille River in the next heavy rain event. This would be a threat to these structures and to Hardwick downtown and the correlating Routes 14/15/16.

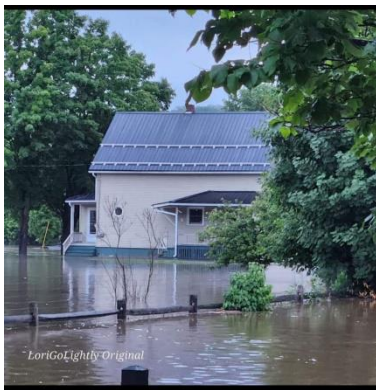
- Storm water/flood mitigation assistance for Granite Street

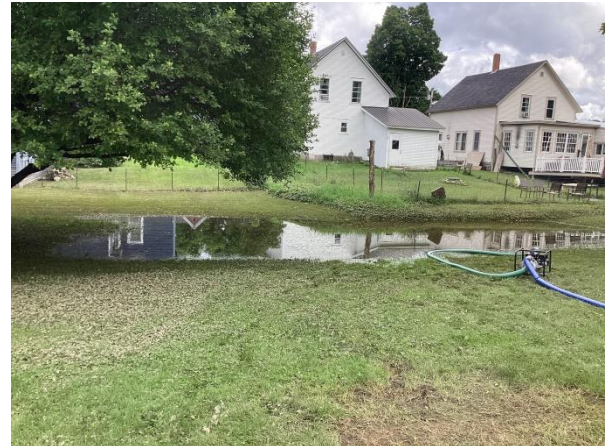
Historic district – install backflow prevention devices for water in all homes, create more resilient yard and catch basins. At intersection of Cooper and Lamoille – this section is more likely to be flooded. This area of Hardwick received higher amounts of

flooding. Neighborhood focused response – Sump pump was purchased by one resident (\$1200) and utilized by several homes. A complete review of this historic residential section was on the list after 2023 but needs to be prioritized. Atkins Field would like to be included in the discussion. **A BRIC grant from FEMA may be applicable.**

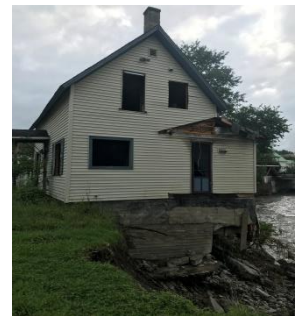
4. 5 Sawmill Lane – Flooded on first floor (Lamoille River)
 5. 444 Wolcott Street – Flooded on first Floor (Lamoille River)
 6. 41 Brush Street – further undermined and leaning dangerously into the river (Lamoille River) (*Looking for immediate solutions*)

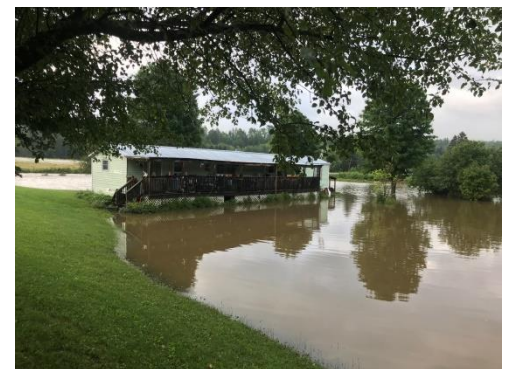
- Vermont Fish and Wildlife is interested in owning 2 of the parcels. Still in discussion. One property is in the EWP program – house is now in danger of being swept away in a larger rain event.
