Historic and Existing Parking Conditions on South Main Street

From Lower Cherry Street to Alpine Heights, Hardwick
Date: 5/28/24 and 9/13/24

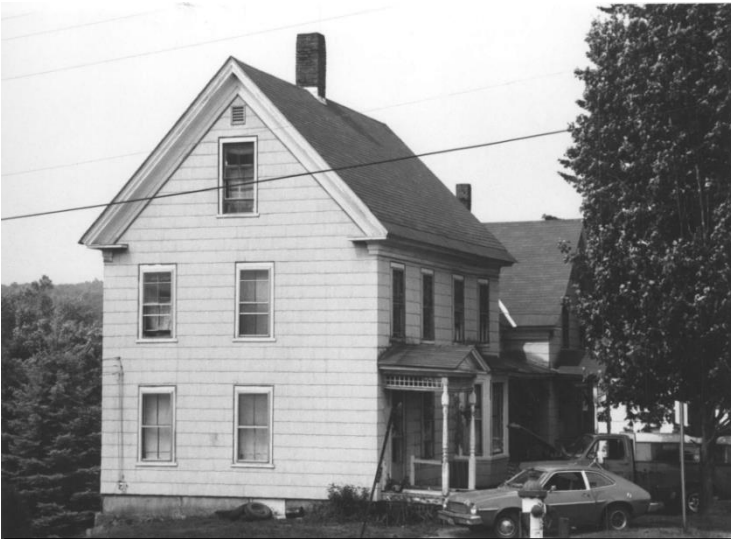
270 South Main Street in 1985 - Image courtesy of the Granite Street Historic District Inventory.

- The west side of South Main Street had a sidewalk as recently as 1985.
- The lack of curb cuts on South Main Street has been a consistent condition since at least 1985.

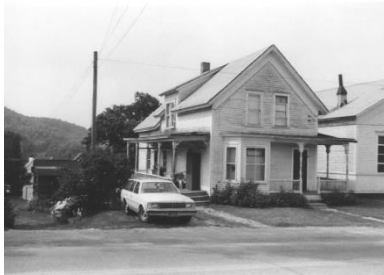
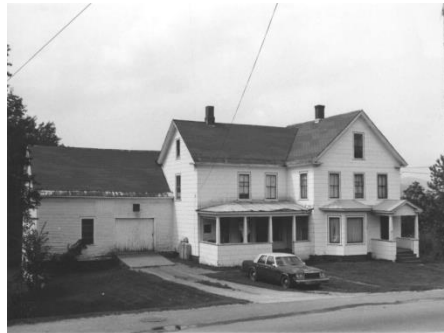
Images courtesy of the Granite Street Historic District Inventory from 1985

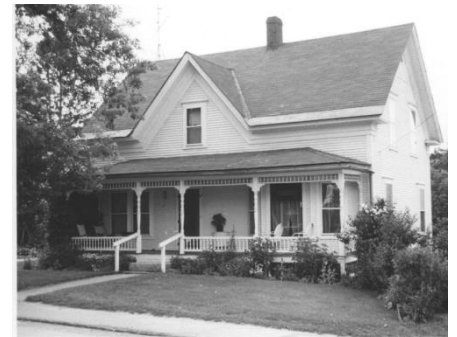
Image courtesy of the Granite Street Historic District Inventory from 1985

- Several South Main Street properties continue to have a similar parking situations today in 2024 as they did in 1985

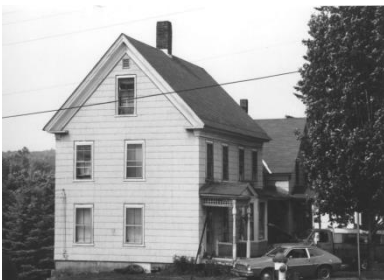
270 South Main Street in 1985 - Image courtesy of the Granite Street Historic District Inventory from 1985.

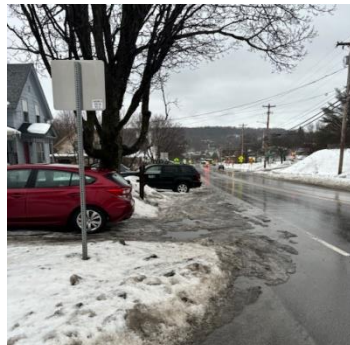
270 South Main Street in 2024 - Image courtesy of the Town Manager's office.

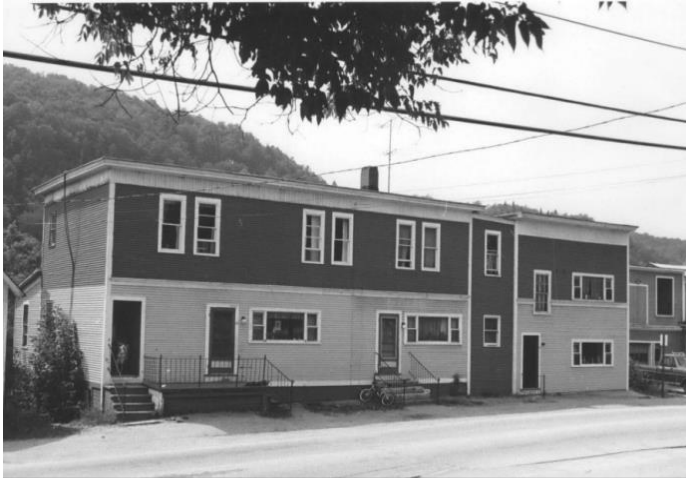
Image of 426 South Main Street is courtesy of the Granite Street Historic District Inventory.

- 426 South Main Street parking situation has been altered due to an increase in housing units and tenants in the property. In 1985, the parking was completely behind the structure. Today, tenants also park next to the building on South Main Street.

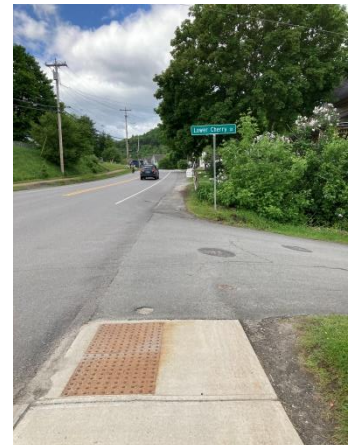
- The west sidewalk ends at Lower Cherry Street . No separation from the traffic is provided. Over the span of 10 minutes, 4-10 heavy and/or large trucks traveled west through the downtown and were precariously close to the pedestrians on the side. Drivers honked at the Planning Commission members as they walked along the west side of South Main Street on May 2024.
- The west sidewalk beyond Upper Cherry is nonexistent. Tenants and owners park in the path of pedestrian or bicycle access on the west side of South Main Street.

After Lower Cherry Street, the west sidewalk of South Main Street is nonexistent.

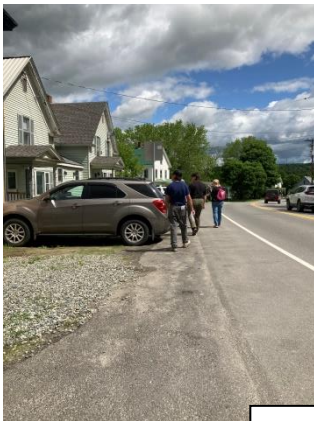
Parking on South Main Street in May 2024

- Vehicles that are parked in the line of sight of drivers need to be adjusted by the owner(s) of the structure. The Zoning Administrator will work with owners to see that this safety issue is addressed (Fall 2024).

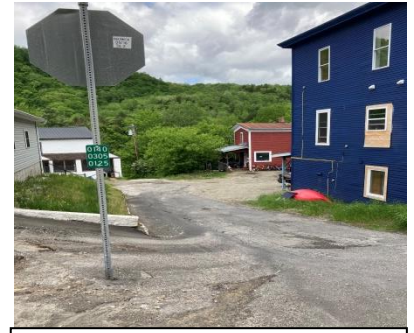
- Drainage does not appear to be adequate for increased capacity rain events. Water drains off of the east side and collects or erodes on the west side of South Main Street.

Intersection of South Main Street and Farr Street – after a minimal rain event.

- A storm water review and installation of better drainage needs to be addressed prior to any design of a sidewalk. Possible funding sources should be examined so that access management on the west side of South Main Street can be addressed in the future (2025 onward).
